#### APPENDIX 7.1-2 CHECK TABLE

LUCENA ~ ATIMONAN SECTION

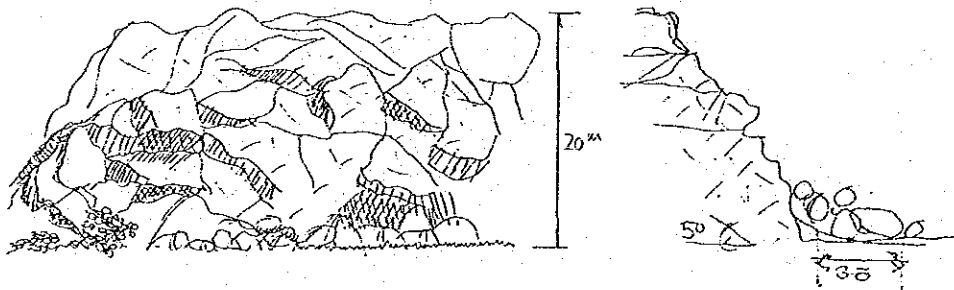
Route		M.H (TVA - 5)	Km. Post	153.900	Width	15.0 M	Sheet No.	S-5	
							Region	TVA	
Evidence of Falls	1	Kind of Slope	(1) Cut Slope	(2) Natural Slope					
	2	Type of Fall	(1) Debris Fall	(2) Rock Fall					
	3	Fallen Rock Size	(1) 20 <sup>m</sup> >	(2) 20 <sup>m</sup> ~ 50 <sup>m</sup>	(3) 50 <sup>m</sup> <				
	4	Date Occured	Day	Month	Year				
	5	Traffic Interruption Period	(1) 1 day >	(2) 1 day ~ 7 days	(3) 7 days <				
	6	Counter Measure Taken	(1) Structure ( )	(2) Removal of Fallen Rock	(3) Others				
	7	Rainfall Intensity/Day	(1) 100 <sup>mm</sup> >	(2) 100 <sup>mm</sup> ~ 200 <sup>mm</sup>	(3) 200 <sup>mm</sup> ~ 300 <sup>mm</sup>	(4) 300 <sup>mm</sup> <			
Existing Slope Condition	8	Slope Height	(1) 10 <sup>m</sup> >	(2) 10 <sup>m</sup> ~ 30 <sup>m</sup>	(3) 30 <sup>m</sup> ~ 50 <sup>m</sup>	(4) 50 <sup>m</sup> <			
	9	Slope Gradient	(1) 45° >	(2) 45° ~ 60°	(3) 60° <	(4) Overhung			
	10	Degree of Saturation	(1) Dry	(2) Wet	(3) Seepage	(4) Spring

11	Surface Water Concentration	(1) None	(2) Low	(3) High				
	12	Berm	(1) Existing Number ( ) With ( )	(2) Nothing					
	13	Slope Protection	(1) Structure ( )	(2) Vegetation	(3) Nothing				
	14	Drainage Facilities	(1) Existing ( )	(2) Nothing					
Geological Condition	Debris Fall	15	Matrix Condition	(1) Hard	(2) Soft	(3) Loose	(4) Loose with detached cabbles		
		16	Gully	(1) Rare	(2) Common	(3) Frequently			
		17	Detached Rock or cabbles	(1) Nothing	(2) Supported Stably	(3) Supported Unstably			
	Rock Fall	18	Rock Name	(1) Granite (2) Diorite (3) Diabase (4) Andesite (5) Dacite (6) Schist (7) Slate (8) Limestone (9) Schalstein (10) Tuff (11) Tuffbreccie (12) Sandstone (13) Shale (14) Mudstone (15) Conglomerate (16) Masa (17) Volcaniclastics					
		19	Weathering Condition	(1) Fresh	(2) Slightly Weathered	(3) Highly Weathered			
		20	Condition of Crack	(1) Sparse	(2) Regular	(3) Developed			
		21	Direction of Crack	(1) Inclined to Mountain	(2) Irregular Inclination	(3) Inclined to Slope

Engi- neering Judge- ment	22	Impact to Road	(1) Low	(2) Average	(3) High				
	23	Cause of Fall							
	24	Counter Measure							
Sketch, etc.						Photo No.

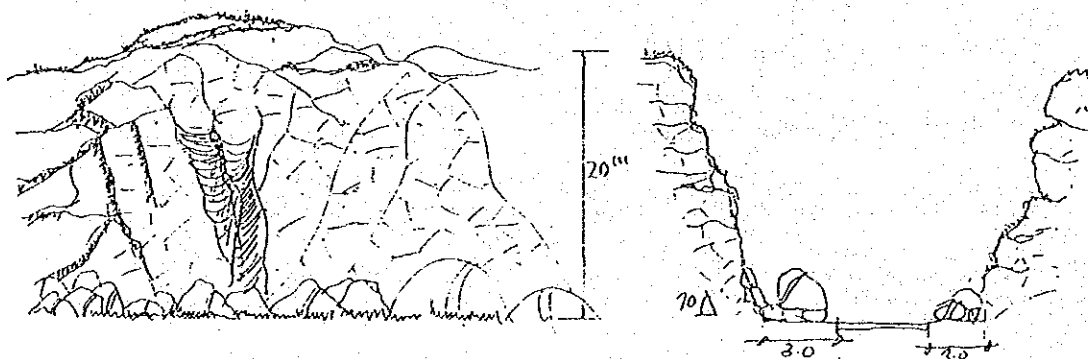
11	Surface Water Concentration	(1) None	(2) Low	(3) High				
	12	Berm	(1) Existing Number ( ) With ( )	(2) Nothing					
	13	Slope Protection	(1) Structure ( )	(2) Vegetation	(3) Nothing				
	14	Drainage Facilities	(1) Existing ( )	(2) Nothing					
Geological Condition	Debris Fall	15	Matrix Condition	(1) Hard	(2) Soft	(3) Loose	(4) Loose with detached cabbie		
		16	Gully	(1) Rare	(2) Common	(3) Frequently			
		17	Detached Rock or cabbie	(1) Nothing	(2) Supported Stably	(3) Supported Unstably			
	Rock Fall	18	Rock Name	(1) Granite (2) Diorite (3) Diabase (4) Andesite (5) Dacite (6) Schist (7) Slate (8) Limestone (9) Schalstein (10) Tuff (11) Tuffbreccie (12) Sandstone (13) Shale (14) Mudstone (15) Conglomerate (16) Masa (17) Volcaniclastics					
		19	Weathering Condition	(1) Fresh	(2) Slightly Weathered	(3) Highly Weathered			
		20	Condition of Crack	(1) Sparse	(2) Regular	(3) Developed			
		21	Direction of Crack	(1) Inclined to Mountain	(2) Irregular Inclination	(3) Inclined to Slope

Engi- neering Judge- ment	22	Impact to Road	(1) Low	(2) Average	(3) High				
	23	Cause of Fall							
	24	Counter Measure							
Sketch, etc.						Photo No.

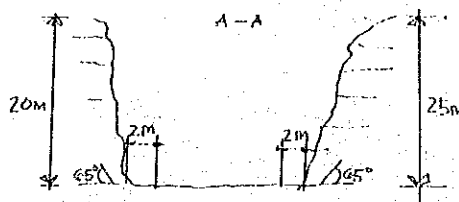
9	Slope Gradient	(1) 45° >		(2) 45° ~ 60°		(1) <input checked="" type="checkbox"/> 60° < (4) Overhung		
	10	Degree of Saturation	(1) <input checked="" type="checkbox"/> Dry		(2) Wet		(3) Seepage (4) Spring		
	11	Surface Water Concentration	(1) <input checked="" type="checkbox"/> None		(2) Low		(3) High		
	12	Berm	(1) Existing Number ( ) With ( )		(1) <input checked="" type="checkbox"/> Nothing				
	13	Slope Protection	(1) Structure ( )		(2) Vegetation		(1) <input checked="" type="checkbox"/> Nothing		
	14	Drainage Facilities	(1) Existing ( )		(1) <input checked="" type="checkbox"/> Nothing				
Geological Condition	Debris Fall	15	Matrix Condition	(1) Hard		(2) Soft (3) Loose (4) Loose with detached cabbie			
		16	Gully	(1) Rare		(2) Common (3) Frequently			
		17	Detached Rock or cabbie	(1) Nothing		(2) Supported Stably (3) Supported Unstably			
	Rock Fall	18	Rock Name	(1) Granite (2) Diorite (3) Diabase (4) Andesite (5) Dacite (6) Schist (7) Slate (1) <input checked="" type="checkbox"/> Limestone (9) Schalstein (10) Tuff (11) Tuffbreccie (12) Sandstone (13) Shale (14) Mudstone (15) Conglomerate (16) Masa (17) Volcaniclastics

19	Weathering Condition	(1) Fresh		(2) Slightly Heatliered		(1) <input checked="" type="checkbox"/> Highly Weathered	
		20	Condition of Crack	(1) Sparse		(2) Regular		(1) <input checked="" type="checkbox"/> Developed	
		21	Direction of Crack	(1) Inclined to Mountain		(1) <input checked="" type="checkbox"/> Irregular Inclination		(3) Inclined to Slope	
Engi-neering Judge-ment	22	Impact to Road	(1) Low		(2) Average		(1) <input checked="" type="checkbox"/> High		
	23	Cause of Fall							
	24	Counter Measure							
Sketch, etc.						Photo No.

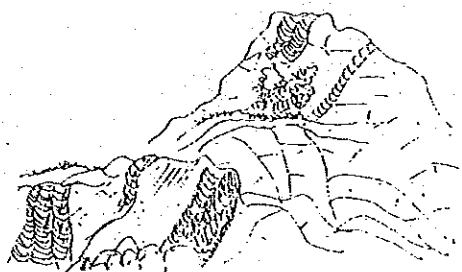
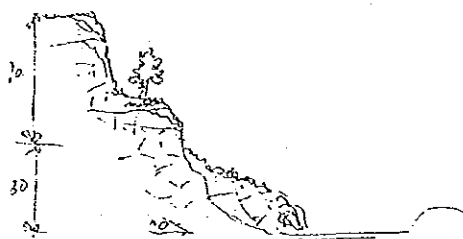
Route		M.H (TWA - 20)	Km. Post	160.800	Width	150 M.	Sheet No.	S-13
							Region	TWA
Evidence of Landslide	1	Kind of Slope	(1) Cut Slope	(2) Natural Slope				
	2	Kind of Landslide	(1) Rock	(2) Talus	(3) Soil			
	3	Size of Landslide	(1) 2,000 <sup>m2</sup> >	(2) 2,000 <sup>m2</sup> ~ 5,000 <sup>m2</sup>	(3) 5,000 <sup>m2</sup> <			
	4	Date Occurred	Day	Month	Year			
	5	Traffic Interruptions Period	(1) day >	(2) 1 day ~ 7 days	(3) 7 days <			
	6	Rainfall Intensity/Day	(1) 100 mm >	(2) 100 <sup>mm</sup> ~ 200 <sup>mm</sup>	(3) 200 <sup>mm</sup> ~ 300 <sup>mm</sup>	(4) 300 <sup>mm</sup> <		
Topographic and Geological Condition	7	Existence of irregular surface with steps, sharp cliff and puddles	(1) Unnoticed	(2) Medium	(3) Remarkable			
	8	Geology	(1) Others	(2) Sedimentary Rock	(3) Highly Weathered Sedimentary Rock or Talus or Soil			
Order's Condition	9	Degree of Saturation	(1) Dry	(2) Wet	(3) Seepage	(4) Spring

10	Gradient of Slide Plane	(1) 10° >	(2) 10° ~ 20°	(3) 20° <			
	11	Continuity of Slide Movement	(1) Unnoticed	(2) Medium	(3) Remarkable			
Engineering Judgement	12	Impact to Road	(1) Low	(2) Average	(3) High			
	13	Cause of Landslide						
	14	Counter Measure						
Sketch, etc.					Photo No.

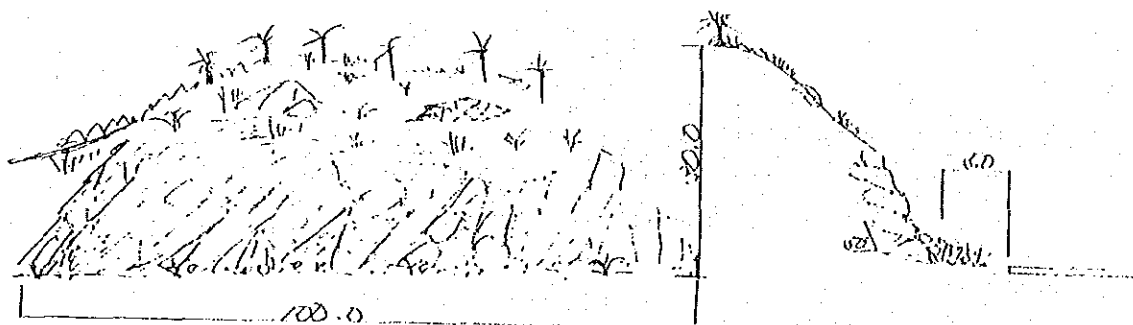
9	Slope Gradient	(1) 45° >	(2) <input checked="" type="checkbox"/> 45° ~ 60°	(3) 60°	(4) Overhung			
	10	Degree of Saturation	(1) Dry	(2) Wet	(3) Seepage	(4) Spring			
	11	Surface Water Concentration	(1) <input checked="" type="checkbox"/> None	(2) Low	(3) High				
	12	Berm	(1) Existing Number ( ) With ( )	(2) <input checked="" type="checkbox"/> Nothing					
	13	Slope Protection	(1) Structure ( )	(2) Vegetation	(3) <input checked="" type="checkbox"/> Nothing				
	14	Drainage Facilities	(1) Existing ( )	(2) <input checked="" type="checkbox"/> Nothing					
Geological Condition	Debris Fall	15	Matrix Condition	(1) <input checked="" type="checkbox"/> Hard	(2) Soft	(3) Loose	(4) Loose with detached cabbie		
		16	Gully	(1) Rare	(2) Common	(3) Frequently			
		17	Detached Rock or cabbie	(1) Nothing	(2) Supported Stably	(3) Supported Unstably			
	Rock Fall	18	Rock Name	(1) Granite (2) Diorite (3) Diabase (4) Andesite (5) Basalt (6) Schist (7) Slate (8) Limestone (9) Schalstein (10) Tuff (11) Tuffbreccie (12) <input checked="" type="checkbox"/> Sandstone (13) Shale (14) Mudstone (15) Conglomerate (16) Masa (17) Volcaniclastics

19	Weathering Condition	(1) Fresh	(2) <input checked="" type="checkbox"/> Slightly Weathered	(3) Highly Weathered			
		20	Condition of Crack	(1) Sparse	(2) <input checked="" type="checkbox"/> Regular	(3) Developed			
		21	Direction of Crack	(1) Inclined to Mountain	(2) <input checked="" type="checkbox"/> Irregular Inclination	(3) Inclined to Slope			
Engi- neering Judge- ment	22	Impact to Road	(1) Low	(2) <input checked="" type="checkbox"/> Average	(3) High				
	23	Cause of Fall							
	24	Counter Measure							
Sketch, etc.						Photo No.

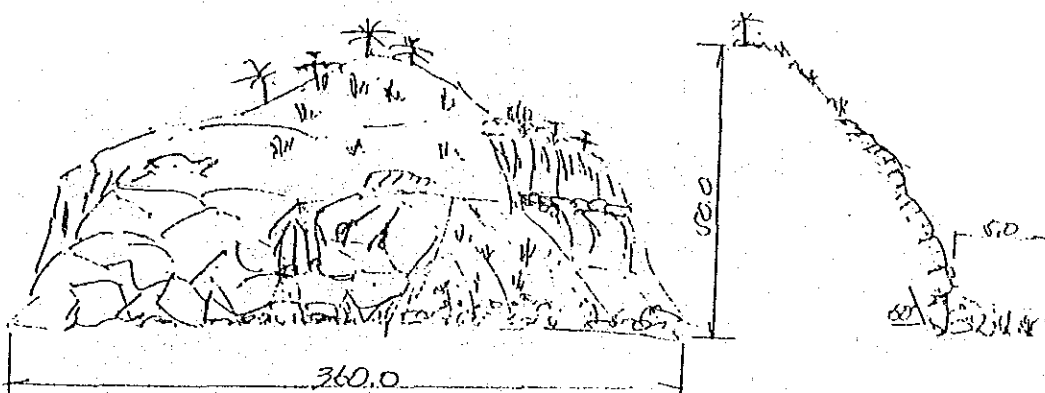
9	Slope Gradient	(1) 45° > (2) 45° ~ 60° (3) <del>60° &lt;</del> (4) Overhung						
	10	Degree of Saturation	(1) <del>Dry</del> (2) Wet (3) Seepage (4) Spring						
	11	Surface Water Concentration	(1) None (2) Low (3) High						
	12	Berim	(1) Existing Number ( ) With ( ) (2) <del>Nothing</del>						
	13	Slope Protection	(1) Structure ( ) (2) Vegetation (3) <del>Nothing</del>						
	14	Drainage Facilities	(1) Existing ( ) (2) <del>Nothing</del>						
Geological Condition	Debris Fall	15	Matrix Condition	(1) Hard (2) <del>Soft</del> (3) Loose (4) Loose with detached cabbie					
		16	Gully	(1) Rare (2) Common (3) Frequently					
		17	Detached Rock or cabbie	(1) Nothing (2) Supported Stably (3) Supported Unstably					
	Rock Fall	18	Rock Name	(1) Granite (2) Diorite (3) Diabase (4) Andesite (5) Dacite (6) Schist (7) Slate (8) Limestone (9) <del>Schiststein</del> (10) Tuff (11) Tuffbreccie (12) <del>Sandstone</del> (13) Shale (14) Mudstone (15) Conglomerate (16) Masa (17) Volcaniclastics

19	Weathering Condition	(1) Fresh (2) Slightly Weathered (3) <del>Highly Weathered</del>					
		20	Condition of Crack	(1) <del>Sparse</del> (2) Regular (3) <del>Developed</del>					
		21	Direction of Crack	(1) Inclined to Mountain (2) <del>Irregular Inclination</del> (3) Inclined to Slope					
Engi- neering Judge- ment	22	Impact to Road	(1) Low (2) <del>Average</del> (3) High						
	23	Cause of Fall							
	24	Counter Measure							
Sketch, etc.						Photo No.

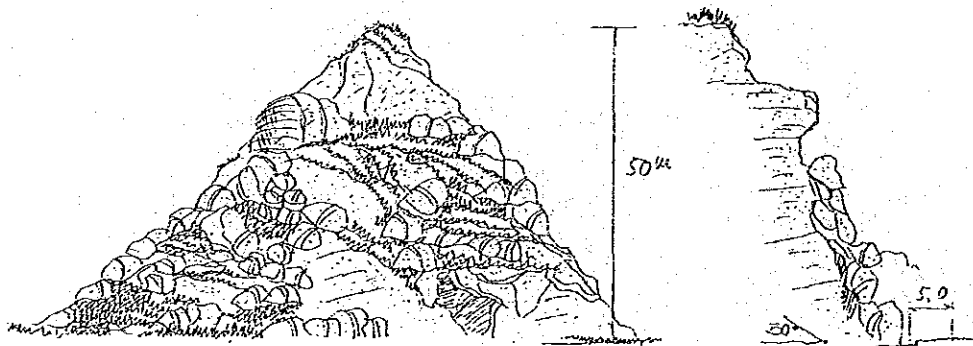
9	Slope Gradient	(1) 45 > (2) 45 ~ 60 <input checked="" type="checkbox"/> 60 < (4) Overhung						
	10	Degree of Saturation	<input checked="" type="checkbox"/> Dry (2) Wet (3) Seepage (4) Spring						
	11	Surface Water Concentration	<input checked="" type="checkbox"/> None (2) Low (3) High						
	12	Berm	(1) Existing Number ( ) With ( ) <input checked="" type="checkbox"/> Nothing						
	13	Slope Protection	(1) Structure ( ) (2) Vegetation <input checked="" type="checkbox"/> Nothing						
	14	Drainage Facilities	(1) Existing ( ) <input checked="" type="checkbox"/> Nothing						
Geological Condition	Debris Fall	15	Matrix Condition	<input checked="" type="checkbox"/> Hard (2) Soft (3) Loose (4) Loose with detached cabbie					
		16	Gully	(1) Rare (2) Common (3) Frequently					
		17	Detached Rock or cabbie	(1) Nothing (2) Supported Stably (3) Supported Unstably					
	Rock Fall	18	Rock Name	(1) Granite (2) Diorite (3) Diabase (4) Andesite (5) Dacite (6) Schist (7) Slate (8) Limestone (9) Schalstein (10) Tuff (11) Tuffbreccie <input checked="" type="checkbox"/> Sandstone (13) Shale (14) Mudstone (15) Conglomerate (16) Masa (17) Volcaniclasties

19	Weathering Condition	(1) Fresh (2) Slightly Weathered <input checked="" type="checkbox"/> Highly Weathered					
		20	Condition of Crack	(1) Sparse <input checked="" type="checkbox"/> Regular (3) Developed					
		21	Direction of Crack	(1) Inclined to Mountain <input checked="" type="checkbox"/> Irregular Inclination (3) Inclined to Slope					
		22	Impact to Road	(1) Low <input checked="" type="checkbox"/> Average (3) High					
		23	Cause of Fall						
		24	Counter Measure						
Sketch, etc.					Photo No.

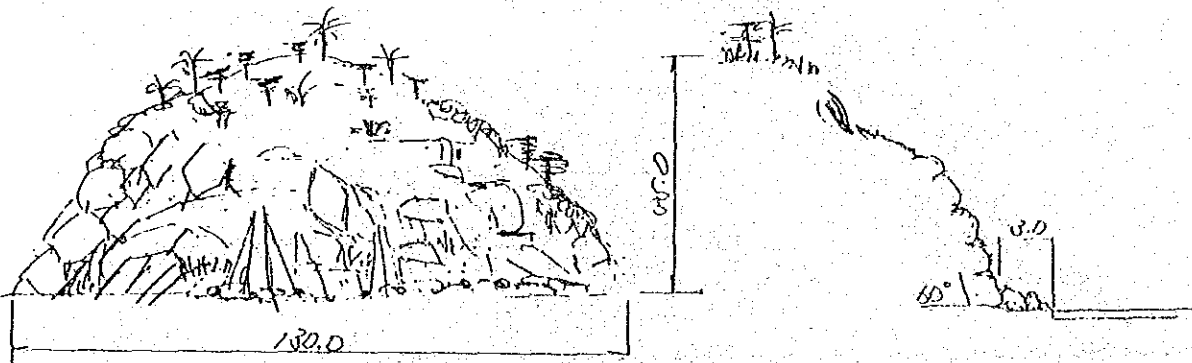
10	Degree of Saturation	(X) Dry		(2) Wet		(3) Seepage (4) Spring		
	11	Surface Water Concentration	(1) None		(2) Low		(3) High		
	12	Berm	(1) Existing Number ( ) With ( )		(2) Nothing				
	13	Slope Protection	(1) Structure ( )		(2) Vegetation		(3) Nothing		
	14	Drainage Facilities	(1) Existing ( )		(2) Nothing				
Geological Condition	Debris Fall	15	Matrix Condition	(1) Hard		(2) Soft (3) Loose (4) Loose with detached cabbie			
		16	Gully	(1) Rare		(2) Common (3) Frequently			
		17	Detached Rock or cabbie	(1) Nothing		(2) Supported Stably (3) Supported Unstably			
	Rock Fall	18	Rock Name	(1) Granite (2) Diorite (3) Diabase (4) Andesite (5) Dacite (6) Schist (7) Slate (8) Limestone (9) Schiststein (10) Luff (11) Tuffbreccie (12) Sandstone (13) Shale (14) Mudstone (15) Conglomerate (16) Masa (17) Volcaniclastics					
		19	Weathering Condition	(1) Fresh		(2) Slightly Weathered		(3) Highly Weathered

20	Condition of Crack	(1) Sparse		(2) Regular		(3) Developed	
		21	Direction of Crack	(1) Inclined to Mountain		(2) Irregular Inclination		(3) Inclined to Slope	
Engi- neering Judge- ment	22	Impact to Road	(1) Low		(2) Average		(3) High		
	23	Cause of Fall							
	24	Counter Measure							
Sketch, etc.						Photo No.

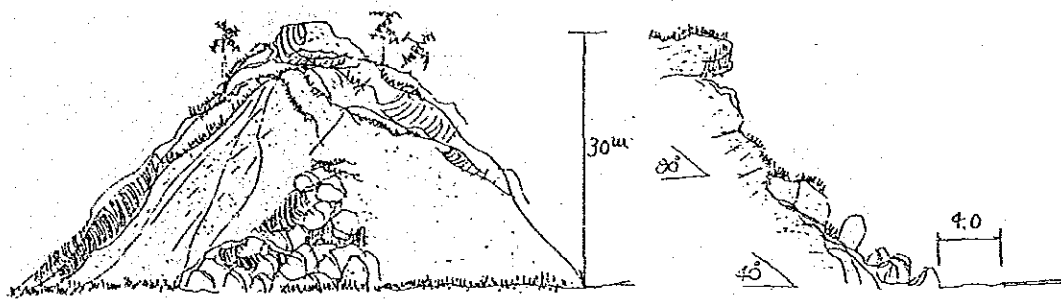
10	Degree of Saturation	(1) Dry (2) Wet (3) Seepage (4) Spring									
	11	Surface Water Concentration	(1) None (2) Low (3) High									
	12	Berm	(1) Existing Number ( ) With ( ) (2) Nothing									
	13	Slope Protection	(1) Structure ( ) (2) Vegetation (3) Nothing									
	14	Drainage Facilities	(1) Existing ( ) (2) Nothing									
Geological Condition	Debris Fall	15	Matrix Condition	(1) Hard (2) Soft (3) Loose (4) Loose with detached cabbie								
		16	Gully	(1) Rare (2) Common (3) Frequently								
	Rock Fall	17	Detached Rock or cabbie	(1) Nothing (2) Supported Stably (3) Supported Unstably								
		18	Rock Name	(1) Granite (2) Diorite (3) Diabase (4) Andesite (5) Dacite (6) Schist (7) Slate (8) Limestone (9) Schalstein (10) Tuff (11) Tuffbreccie (12) Sandstone (13) Shale (14) Mudstone (15) Conglomerate (16) Masa (17) Volcaniclastics								
		19	Weathering Condition	(1) Fresh (2) Slightly Weathered (3) Highly Weathered

20	Condition of Crack	(1) Soarse (2) Regular (3) Developed								
		21	Direction of Crack	(1) Inclined to Mountain (2) Irregular Inclination (3) Inclined to Slope								
Engi- neering Judge- ment	22	Impact to Road	(1) Low (2) Average (3) High									
	23	Cause of Fall										
	24	Counter Measure										
Sketch, etc.										Photo No.

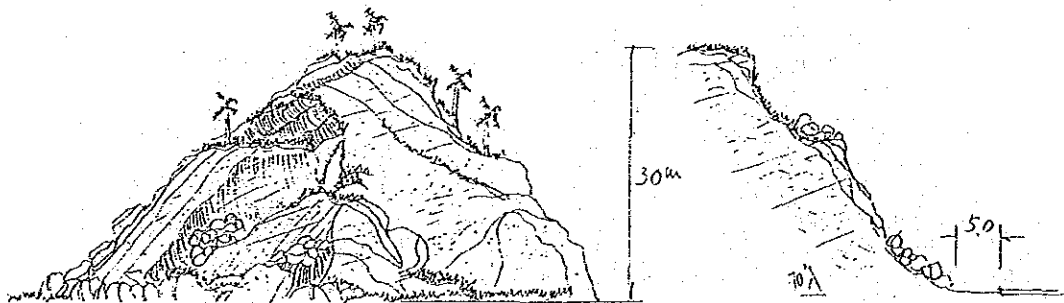
9	Slope Gradient	(1) 45 > (2) 45 ~ 60 (3) <input checked="" type="checkbox"/> 60 < (4) <input checked="" type="checkbox"/> Overhung						
	10	Degree of Saturation	(1) <input checked="" type="checkbox"/> Dry (2) Wet (3) Seepage (4) Spring						
	11	Surface Water Concentration	(1) <input checked="" type="checkbox"/> None (2) Low (3) High						
	12	Berm	(1) Existing Number ( ) With ( ) (2) <input checked="" type="checkbox"/> Nothing						
	13	Slope Protection	(1) Structure ( ) (2) Vegetation (3) <input checked="" type="checkbox"/> Nothing						
	14	Drainage Facilities	(1) Existing ( ) (2) <input checked="" type="checkbox"/> Nothing						
Geological Condition	Debris Fall	15	Matrix Condition	(1) Hard (2) <input checked="" type="checkbox"/> Soft (3) Loose (4) Loose with detached cabbles					
		16	Gully	(1) Rare (2) Common (3) Frequently					
		17	Detached Rock or cabbles	(1) Nothing (2) Supported Stably (3) Supported Unstably

Rock Fall	18	Rock Name	(1) Granite (2) Diorite (3) Diabase (4) Andesite (5) Dacite (6) Schist (7) Slate (8) Limestone (9) Schalstein (10) Tuff (11) Tuifbreccie (12) <input checked="" type="checkbox"/> Sandstone (13) <input checked="" type="checkbox"/> Shale (14) Mudstone (15) Conglomerate (16) Masa (17) Volcaniclastics					
		19	Weathering Condition	(1) Fresh (2) <input checked="" type="checkbox"/> Slightly Weathered (3) Highly Weathered					
		20	Condition of Crack	(1) Sparse (2) Regular (3) <input checked="" type="checkbox"/> Developed					
		21	Direction of Crack	(1) Inclined to Mountain (2) Irregular Inclination (3) <input checked="" type="checkbox"/> Inclined to Slope					
		22	Impact to Road	(1) Low (2) Average (3) <input checked="" type="checkbox"/> High					
		23	Cause of Fall						
		24	Counter Measure						
Sketch, etc.					Photo No.

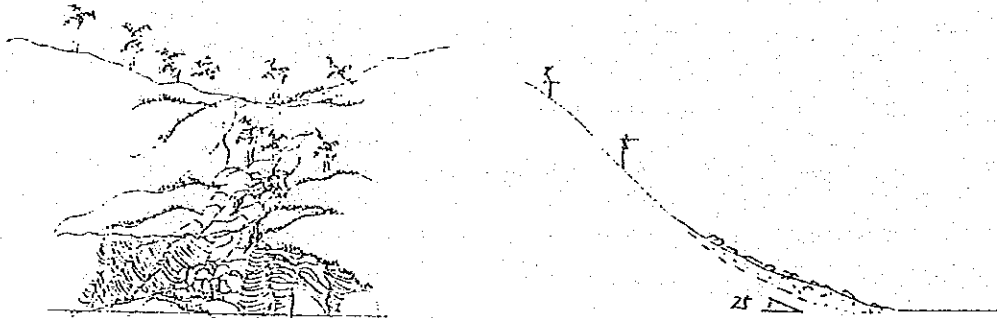
Route		MH (VII-36)	Km. Post	718.100	Width	20 M	Sheet No.	S-67	
							Region	VII	
Evidence of Debris Flow	1	Existence of Depositional Toe	(1) Nothing	(2) Existing					
	2	Size of Disaster	(1) $50\text{m}^3 >$	(2) $50\text{m}^3 \sim 500\text{m}^3$ (3) $500\text{m}^3 \sim 2,000\text{m}^3$ (4) $2,000\text{m}^3 <$					
	3	Date Occured	Day	Month	Year Every year at Tophson				
	4	Traffic Interruption Period	(1) 1 day >	(2) 1 day $\sim$ 7 days (3) 7 days <					
	5	Counter Measure Taken	(1) Structure ( )	(2) Removal of Deposit Materials (3) Others					
	7	Rainfall Intensity/Day	(1) $100\text{mm} >$	(2) $100\text{mm} \sim 200\text{mm}$ (3) $200\text{mm} \sim 300\text{mm}$ (4) $300\text{mm} <$					
	Existing Stream Condition	8	Average Gradient	(1) $20\% >$	(2) $20\% <$				
9		Area of Basin	(1) $0.24\text{Km}^2 >$	(2) $0.24\text{Km}^2 <$					
10		Deposit on River Bed	(1) Nothing	(2) Rare (3) Abundance					
11		Plant Condition	(1) $50\% >$ Occupancy Rate of Bare Land or Thin Forest (2) $50\% <$

Engineering Judgment	12	Impact to Road	(1) Low	(2) Average (3) High					
	13	Cause of Disaster							
	14	Counter Measure							
Sketch, etc.						Photo No.

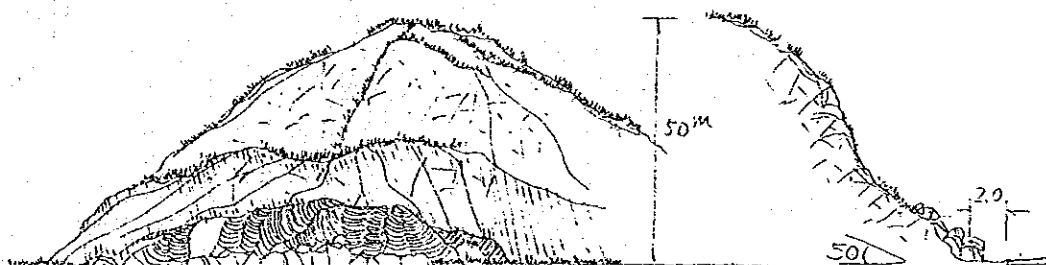
9	Slope Gradient	(1) 45° > (2) 45° ~ 60° <input checked="" type="checkbox"/> 60° < <input checked="" type="checkbox"/> Overhung						
	10	Degree of Saturation	<input checked="" type="checkbox"/> Dry (2) Wet (3) Seepage (4) Spring						
	11	Surface Water Concentration	<input checked="" type="checkbox"/> None (2) Low (3) High						
Geological Condition	12	Berm	(1) Existing Number ( ) With ( ) <input checked="" type="checkbox"/> Nothing						
	13	Slope Protection	(1) Structure ( ) (2) Vegetation <input checked="" type="checkbox"/> Nothing						
	14	Drainage Facilities	(1) Existing ( ) <input checked="" type="checkbox"/> Nothing						
	Debris Fall	15	Matrix Condition	<input checked="" type="checkbox"/> Hard (2) Soft (3) Loose (4) Loose with detached cabbie					
		16	Gully	(1) Rare (2) Common (3) Frequently					
	Rock Fall	17	Detached Rock or cabbie	(1) Nothing (2) Supported Stably (3) Supported Unstably

18	Rock Name	(1) Granite (2) Diorite (3) Diabase <input checked="" type="checkbox"/> Andesite (5) Dacite (6) Schist (7) Slate (8) Limestone (9) Schalstein (10) Tuff (11) Tuffbreccie (12) Sandstone (13) Shale (14) Mudstone (15) Conglomerate (16) Masa (17) Volcaniclasties					
		19	Weathering Condition	(1) Fresh (2) Slightly Weathered <input checked="" type="checkbox"/> Highly Weathered					
		20	Condition of Crack	(1) Sparse (2) Regular <input checked="" type="checkbox"/> Developed					
	Engl-nearng Judge-ment	21	Direction of Crack	(1) Inclined to Mountain <input checked="" type="checkbox"/> Irregular Inclination (3) Inclined to Slope					
22		Impact to Road	(1) Low <input checked="" type="checkbox"/> Average (3) High						
23		Cause of Fall							
24		Counter Measure							
Sketch, etc.						Photo No.

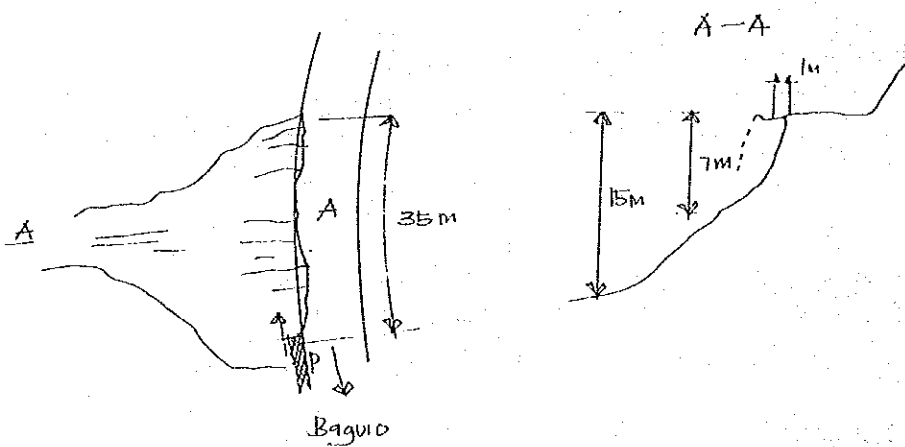
Route		N(1N-4-4)	Km. Post	286,600	Width	35 M	Sheet No.	B-86-3
							Region	I
Evidence of Failure	1	Kind of Slope	(1) <input checked="" type="checkbox"/> Embankment Slope (2) Natural Slope (3) Overflow Section (5) Others					
	2	Location	(1) Approach of Bridge (2) Adjacent to River or Sea (3) Inside of Curve (4) <input checked="" type="checkbox"/> Others					
	3	Size of Disaster	(1) 50 <sup>m3</sup> > (2) <input checked="" type="checkbox"/> 50 <sup>m3</sup> ~ 100 <sup>m3</sup> (3) 100 <sup>m3</sup> <					
	4	Date Occured	Day 27~30 Month Aug. Year 1984 - by Marine					
	5	Traffic Interruption Period	(1) 1 day > (2) 1 day ~ 7 days (3) 7 days <					
	6	Counter Measure Taken	(1) Only Fill (2) Riprap (3) Other Structure ( )					
	7	Rainfall Intensity/Day	(1) 100 <sup>mm</sup> > (2) 100 <sup>mm</sup> ~ 200 <sup>mm</sup> (3) 200 <sup>mm</sup> ~ 300 <sup>mm</sup> (4) <input checked="" type="checkbox"/> 300 <sup>mm</sup> <

Existing Slope Condition	8	Slope Height	(1) 5 <sup>m</sup> > (2) 5 <sup>m</sup> ~ 10 <sup>m</sup> (3) <input checked="" type="checkbox"/> 10 <sup>m</sup> <					
	9	Slope Gradient	(1) 45° > (2) <input checked="" type="checkbox"/> 45° ~ 60° (3) 60° <					
	10	Surface Water Concentration	(1) None (2) Low (3) <input checked="" type="checkbox"/> High					
	11	Slope Protection	(1) Nothing (2) Vegetation (3) <input checked="" type="checkbox"/> Riprap (4) Other Structure ( )					
	12	Drainage Facilities	(1) <input checked="" type="checkbox"/> Nothing (2) Existing					
Engi- neering Judge- ment	13	Impact to Road	(1) Low (2) <input checked="" type="checkbox"/> Average (3) High					
	14	Cause of Disaster	(1) <input checked="" type="checkbox"/> Concentration of Surface Water (2) River Stream (3) Sea Wave (4) Others					
	15	Counter Measure						
Sketch, etc.							Photo No.

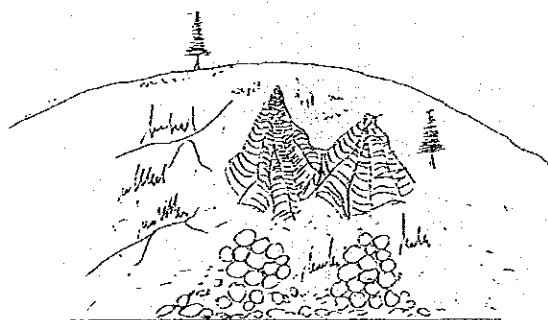
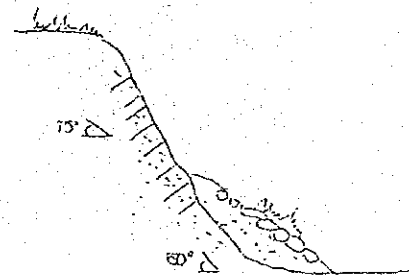
10	Degree of Saturation	(✓) Dry (2) Wet (3) Seepage (4) Spring							
	11	Surface Water Concentration	(1) None (2) Low (✓) High							
	12	Berm	(1) Existing Number ( ) With ( ) (✓) Nothing							
	13	Slope Protection	(1) Structure ( ) (2) Vegetation (✓) Nothing							
	14	Drainage Facilities	(1) Existing ( ) (2) Nothing							
Geological Condition	Debris Fall	15	Matrix Condition	(1) Hard (2) Soft (3) Loose (4) Loose with detached cabbie						
		16	Gully	(1) Rare (2) Common (3) Frequently						
		17	Detached Rock or cabbie	(1) Nothing (2) Supported Stably (3) Supported Unstably						
	Rock Fall	18	Rock Name	(1) Granite (2) Diorite (3) Diabase (4) Andesite (5) Dacite (6) Schist (7) Slate (8) Limestone (9) Schalstein (✓) Tuff (11) Tuffbreccie (12) Sandstone (13) Shale (14) Mudstone (15) Conglomerate (16) Masa (17) Volcaniclastics						
		19	Weathering Condition	(1) Fresh (2) Slightly Weathered (✓) Highly Weathered

20	Condition of Crack	(1) Sparse (2) Regular (✓) Developed						
		21	Direction of Crack	(✓) Inclined to Mountain (2) Irregular Inclination (3) Inclined to Slope						
		Engi- neering Judge- ment	22	Impact to Road	(1) Low (✓) Average (3) High					
			23	Cause of Fall						
			24	Counter Measure						
Sketch, etc.							Photo No.

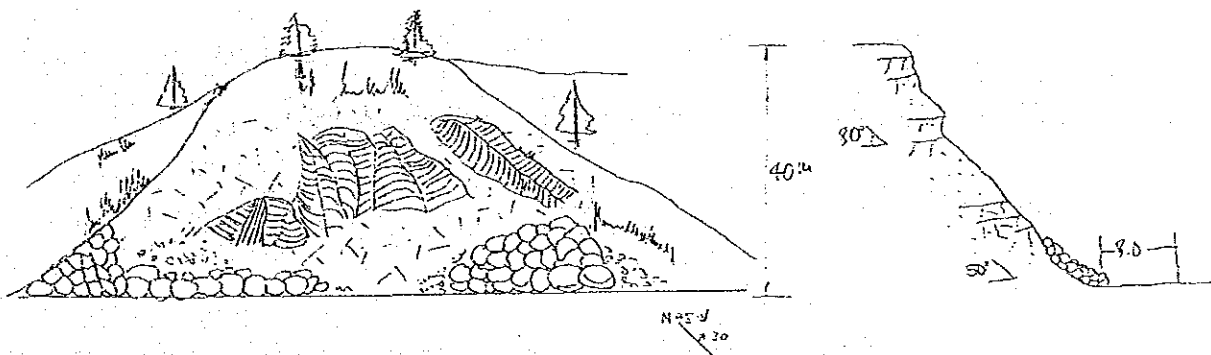
9	Slope Gradient	(1) 45° > (2) <input checked="" type="checkbox"/> 45 ~ 60° (3) 60° < (4) Overhung					
	10	Degree of Saturation	(1) <input checked="" type="checkbox"/> Dry (2) Wet (3) Seepage (4) Spring					
	11	Surface Water Concentration	(1) <input checked="" type="checkbox"/> None (2) Low (3) High					
	12	Berm	(1) Existing Number ( ) With ( ) (2) <input checked="" type="checkbox"/> Nothing					
	13	Slope Protection	(1) Structure ( ) (2) Vegetation (3) <input checked="" type="checkbox"/> Nothing					
	14	Drainage Facilities	(1) Existing ( ) (2) <input checked="" type="checkbox"/> Nothing					
Geological Condition	Debris Fall	15	Matrix Condition	(1) <input checked="" type="checkbox"/> Hard (2) Soft (3) Loose (4) Loose with detached cabbie				
		16	Gully	(1) Rare (2) Common (3) Frequently				
		17	Detached Rock or cabbie	(1) Nothing (2) Supported Stably (3) Supported Unstably				
	Rock Fall	18	Rock Name	(1) Granite (2) Diorite (3) Diabase (4) Andesite (5) Dacite (6) Schist (7) Slate (8) Limestone (9) Schalstein (10) <input checked="" type="checkbox"/> Tuff (11) Tuffbreccie (12) Sandstone (13) Shale (14) Mudstone (15) Conglomerate (16) Masa (17) Volcaniclasties

19	Weathering Condition	(1) <input checked="" type="checkbox"/> Fresh (2) Slightly Weathered (3) Highly Weathered				
		20	Condition of Crack	(1) Sparse (2) Regular (3) <input checked="" type="checkbox"/> Developed				
		21	Direction of Crack	(1) Inclined to Mountain (2) Irregular Inclination (3) <input checked="" type="checkbox"/> Inclined to Slope				
		22	Impact to Road	(1) Low (2) <input checked="" type="checkbox"/> Average (3) High				
		23	Cause of Fall					
		24	Counter Measure					
Sketch, etc.						Photo No.

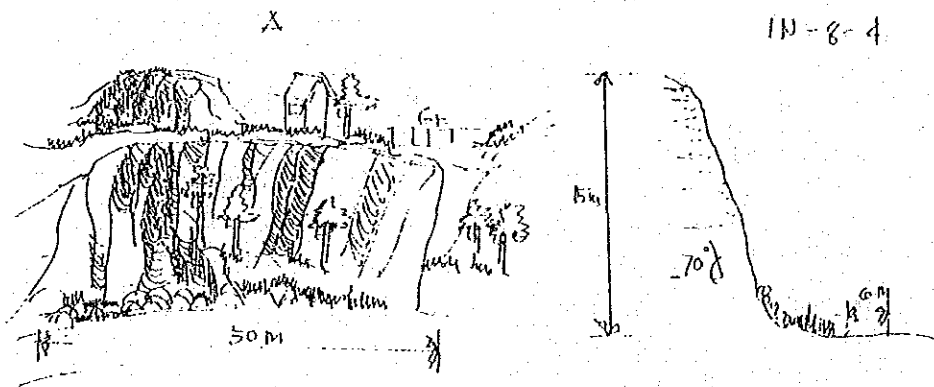
Route		N (N-8-4)	Km. Post	291.000	Width	50 M	Region	I		
Evidence of Failure	1	Kind of Slope	(1) Cut Slope	(2) Natural Slope						
	2	Kind of Failure	(1) Nothing	(2) Surface Failure	(3) Deep Failure					
	3	Size of Failure	(1) $50m^3 >$	(2) $50m^3 \sim 500m^3$	(3) $500m^3 \sim 2,000m^3$	(4) $2,000m^3 <$				
	4	Date Occured	Day 27-30	Month Aug.	Year 1984	by Haring				
	5	Traffic Interruption Period	(1) 1 day >	(2) 1 day ~ 7 days	(3) 7 days <					
	6	Counter Measure Taken	(1) Structure ( )	(2) Removal of Slide Materials	(3) Others					
	7	Rainfall Intensity/Day	(1) $100mm >$	(2) $100mm \sim 200mm$	(3) $200mm \sim 300mm$	(4) $300mm <$				
Existing Slope Condition	8	Height	(1) $10m >$	(2) $10m \sim 30m$	(3) $30m \sim 50m$	(4) $50m <$				
	9	Gradient	(1) $45^\circ >$	(2) $45^\circ \sim 60^\circ$	(3) $60^\circ <$	(4) Overhanging				
	10	Berm	(1) Existing	Number ( )	Width ( )	(2) Nothing				
	11	Slope Protection	(1) Structure ( )	(2) Vegetation	(3) Nothing

Geological Condition	Rock	12	Hardness	(1) Hard Rock	(2) Soft Rock					
		13	Name	(1) Granite (2) Diorite (3) Diabase (4) Andesite (5) Dacite (6) Schist (7) Slate (8) Limestone (9) Schistslein (10) Tuff (11) Tuffbreccia (12) Sandstone (13) Shale (14) Mudstone (15) Conglomerate (16) Basalt (17) Volcaniclastics						
		14	Weathering Condition	(1) Fresh	(2) Slightly Weathered	(3) Highly Weathered	(4) Nearly Soil			
	Soil	15	Condition of Crack	(1) Sparse	(2) Regular	(3) Developed				
		16	Direction of Crack	(1) Inclined to Mountain	(2) Irregular Inclination	(3) Inclined to Slope				
		17	Thickness	(1) $5m >$	(2) $5m \sim 10m$	(3) $10m \sim 20m$	(4) $20m <$			
		18	Compactness	(1) Tight	(2) Slightly loose	(3) Loose				
Water Condition	19	Degree of Saturation	(1) Dry	(2) Wet	(3) Seepage	(4) Spring				
	20	Surface Water Concentration	(1) None	(2) Low	(3) High					
	21	Drainage Facilities	(1) Existing ( )	(2) Nothing

Engineer's Judgment	22	Impact to Road	(1) Low	(2) Average	(3) High					
	23	Cause of Disaster								
	24	Counter Measure								
Sketch, etc.					Photo No.

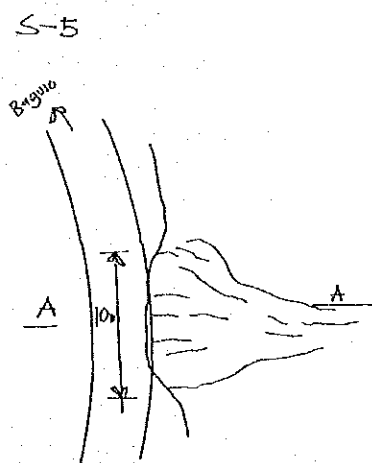
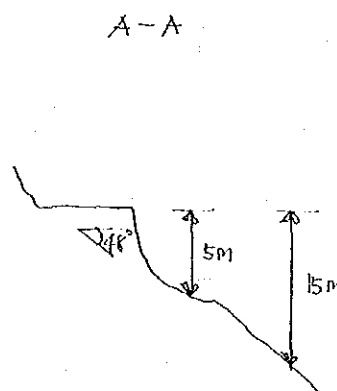
Route		N (1N-8-5)	Km. Post	291.050	Width	10 M	Sheet No.	B-88-2
							Region	I
Evidence of Failure	1	Kind of Slope	(1) <input checked="" type="checkbox"/> Embankment Slope (2) Natural Slope (3) Overflow Section (5) Others					
	2	Location	(1) Approach of Bridge (2) Adjacent to River or Sea (3) Inside of Curve (4) <input checked="" type="checkbox"/> Others					
	3	Size of Disaster	(1) $50^{m^3} >$ (2) <input checked="" type="checkbox"/> $50^{m^3} \sim 100^{m^3}$ (3) $100^{m^3} <$					
	4	Date Occured	Day 27~30 Month Aug. Year 1984 by Harung					
	5	Traffic Interruption Period	(1) 1 day > (2) 1 day ~ 7 days (3) 7 days <					
	6	Counter Measure Taken	(1) <input checked="" type="checkbox"/> Only Fill (2) Riprap (3) Other Structure ( )					
	7	Rainfall Intensity/Day	(1) $100^{mm} >$ (2) $100^{mm} \sim 200^{mm}$ (3) $200^{mm} \sim 300^{mm}$ (4) <input checked="" type="checkbox"/> $300^{mm} <$					
Existing Slope Condition	8	Slope Height	(1) $5^m >$ (2) $5^m \sim 10^m$ (3) <input checked="" type="checkbox"/> $10^m <$

9	Slope Gradient	(1) $45^\circ >$ (2) <input checked="" type="checkbox"/> $45^\circ \sim 60^\circ$ (3) $60^\circ <$					
	10	Surface Water Concentration	(1) None (2) <input checked="" type="checkbox"/> Low (3) High					
	11	Slope Protection	(1) Nothing (2) <input checked="" type="checkbox"/> Vegetation (3) Riprap (4) Other Structure ( )					
Engi- neering Judge- ment	12	Drainage Facilities	(1) <input checked="" type="checkbox"/> Nothing (2) Existing					
	13	Impact to Road	(1) Low (2) <input checked="" type="checkbox"/> Average (3) High					
	14	Cause of Disaster	(1) <input checked="" type="checkbox"/> Concentration of Surface Water (2) River Stream (3) Sea Wave (4) Others					
	15	Counter Measure						
Sketch, etc.							Photo No.

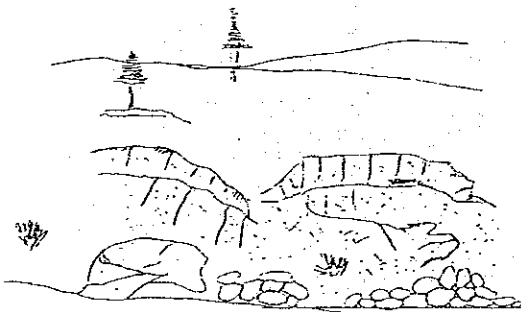
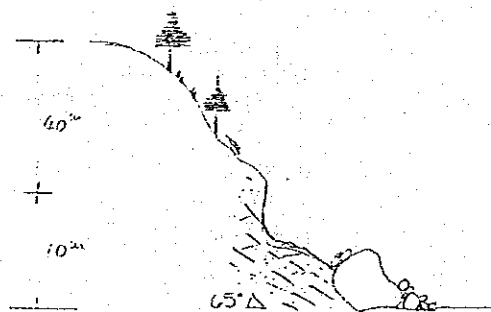
9	Slope Gradient	(1) 45 > (2) 45 ~ 60 (3) <input checked="" type="checkbox"/> 60 < (4) Overhung					
	10	Degree of Saturation	(1) <input checked="" type="checkbox"/> Dry (2) Wet (3) Seepage (4) Spring					
	11	Surface Water Concentration	(1) None (2) <input checked="" type="checkbox"/> Low (3) High					
	12	Berm	(1) Existing Number ( ) With ( ) (2) <input checked="" type="checkbox"/> Nothing					
	13	Slope Protection	(1) Structure ( ) (2) Vegetation (3) <input checked="" type="checkbox"/> Nothing					
	14	Drainage Facilities	(1) Existing ( ) (2) <input checked="" type="checkbox"/> Nothing					
Geological Condition	Debris Fall	15	Matrix Condition	(1) Hard (2) Soft (3) Loose (4) Loose with detached cabbles				
		16	Gully	(1) Rare (2) Common (3) Frequently				
		17	Detached Rock or cabbles	(1) Nothing (2) Supported Stably (3) Supported Unstably				
	Rock Fall	18	Rock Name	(1) Granite (2) Diorite (3) Diabase (4) Andesite (5) Dacite (6) Schist (7) Slate (8) Limestone (9) Schalstein (10) Tuff (11) Tuffbreccie (12) Sandstone (13) Shale (14) Mudstone (15) <input checked="" type="checkbox"/> Conglomerate (16) Masa (17) Volcaniclastics

19	Weathering Condition	(1) <input checked="" type="checkbox"/> Fresh (2) Slightly Weathered (3) Highly Weathered				
		20	Condition of Crack	(1) Sparse (2) <input checked="" type="checkbox"/> Regular (3) Developed				
		21	Direction of Crack	(1) Inclined to Mountain (2) Irregular Inclination (3) <input checked="" type="checkbox"/> Inclined to Slope				
Engineering Judgment	22	Impact to Road	(1) Low (2) <input checked="" type="checkbox"/> Average (3) High					
	23	Cause of Fall						
	24	Counter Measure						
Sketch, etc.						Photo No.

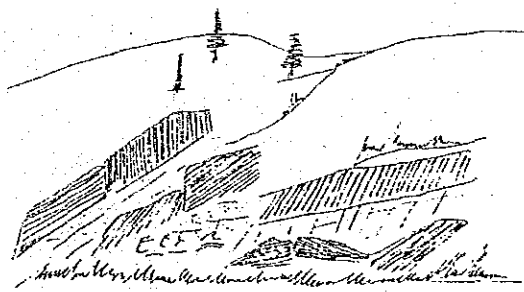
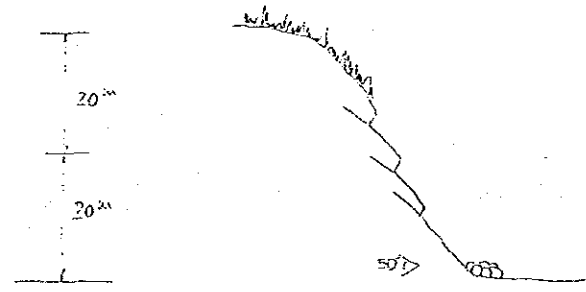
11	Surface Water Concentration	(1) None (2) Low (3) High					
	12	Berm	(1) Existing Number ( ) With ( ) (2) Nothing					
	13	Slope Protection	(1) Structure ( ) (2) Vegetation (3) Nothing					
	14	Drainage Facilities	(1) Existing ( ) (2) Nothing					
Geological Condition	Debris Fall	15	Matrix Condition	(1) Hard (2) Soft (3) Loose (4) Loose with detached cabbie				
		16	Gully	(1) Rare (2) Common (3) Frequently				
		17	Detached Rock or cabbie	(1) Nothing (2) Supported Stably (3) Supported Unstably				
	Rock Fall	18	Rock Name	(1) Granite (2) Diorite (3) Diabase (4) Andesite (5) Dacite (6) Schist (7) Slate (8) Limestone (9) Schalstein (10) Tuff (11) Tuffbreccie (12) Sandstone (13) Shale (14) Mudstone (15) Conglomerate (16) Masa (17) Volcaniclastics				
		19	Weathering Condition	(1) Fresh (2) Slightly Weathered (3) Highly Weathered				
		20	Condition of Crack	(1) Sparse (2) Regular (3) Developed				
		21	Direction of Crack	(1) Inclined to Mountain (2) Irregular Inclination (3) Inclined to Slope

Engineering Judgment	22	Impact to Road	(1) Low (2) Average (3) High					
	23	Cause of Fall						
	24	Counter Measure						
Sketch, etc.						Photo No.

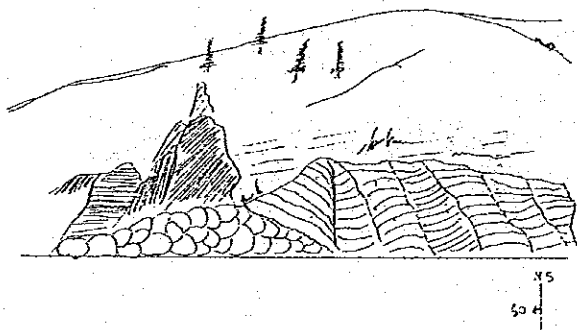
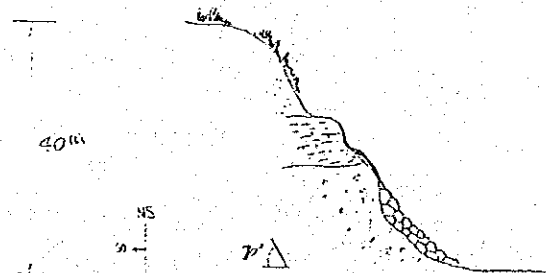
Route		N (IN-13)	Km. Post	294.400	Width	50 M	Sheet No.	B-91		
							Region	I		
Evidence of Failure	1	Kind of Slope	(1) Cut Slope	(2) Natural Slope						
	2	Kind of Failure	(1) Nothing	(2) Surface Failure	(3) Deep Failure					
	3	Size of Failure	(1) 50 <sup>m3</sup> >	(2) 50 <sup>m3</sup> ~ 500 <sup>m3</sup>	(3) 500 <sup>m3</sup> ~ 2,000 <sup>m3</sup>	(4) 2,000 <sup>m3</sup> <				
	4	Date Occured	Day	Month	Year					
	5	Traffic Interruption Period	(1) 1 day >	(2) 1 day ~ 7 days	(3) 7 days <					
	6	Counter Measure Taken	(1) Structure ( )	(2) Removal of Slide Materials	(3) Others					
	7	Rainfall Intensity/Day	(1) 100 mm >	(2) 100 <sup>mm</sup> ~ 200 <sup>mm</sup>	(3) 200 <sup>mm</sup> ~ 300 <sup>mm</sup>	(4) 300 <sup>mm</sup> <				
Existing Slope Condition	8	Height	(1) 10 <sup>m</sup> >	(2) 10 <sup>m</sup> ~ 30 <sup>m</sup>	(3) 30 <sup>m</sup> ~ 50 <sup>m</sup>	(4) 50 <sup>m</sup> <				
	9	Gradient	(1) 45° >	(2) 45° ~ 60°	(3) 60° <	(4) Overhung

10	Berm	(1) Existing	Number ( )	Width ( )	(2) Nothing				
	11	Slope Protection	(1) Structure ( )	(2) Vegetation	(3) Nothing					
Geological Condition	Rock	12	Hardness	(1) Hard Rock	(2) Soft Rock					
		13	Name	(1) Granite (2) Diorite (3) Diabase (4) Andesite (5) Dacite (6) Schist (7) Slate (8) Limestone (9) Schalstein (10) Tuff (11) Tuffbreccie (12) Sandstone (13) Shale (14) Mudstone (15) Conglomerate (16) Masa (17) Volcaniclasties						
		14	Weathering Condition	(1) Fresh	(2) Slightly Weathered	(3) Highly Weathered	(4) Nearly Soil			
		15	Condition of Crack	(1) Soarse	(2) Regular	(3) Developed				
	Soil	16	Direction of Crack	(1) Inclined to Mountain	(2) Irregular Inclination	(3) Inclined to Slope				
		17	Thickness	(1) 5 <sup>m</sup> >	(2) 5 <sup>m</sup> ~ 10 <sup>m</sup>	(3) 10 <sup>m</sup> ~ 20 <sup>m</sup>	(4) 20 <sup>m</sup> <			
		18	Compactness	(1) Tight	(2) Slightly loose	(3) Loose				
		19	Degree of Saturation	(1) Dry	(2) Wet	(3) Seepage (4) Spring

Water Condition	20	Surface Water Concentration	(1) None	(2) Low	(3) High					
	21	Drainage Facilities	(1) Existing ( )	(2) Nothing						
Engi- neering Judge- ment	22	Impact to Road	(1) Low	(2) Average	(3) High					
	23	Cause of Disaster								
	24	Counter Measure								
Sketch, etc.						Photo No.

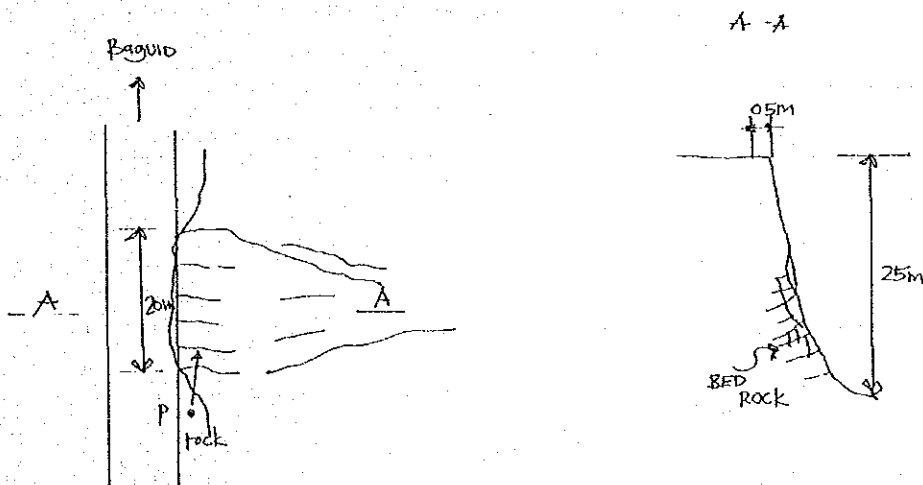
Route		N(1N-14)	Km. Post	294.600	Width	20 M	Sheet No.	S-91-1
							Region	I
Evidence of Failure	1	Kind of Slope	(1) <input checked="" type="checkbox"/> Embankment Slope (2) Natural Slope (3) Overflow Section (5) Others					
	2	Location	(1) Approach of Bridge (2) Adjacent to River or Sea (3) <input checked="" type="checkbox"/> Inside of Curve (4) Others					
	3	Size of Disaster	(1) <input checked="" type="checkbox"/> $50m^3 >$ (2) $50m^3 \sim 100m^3$ (3) $100m^3 <$					
	4	Date Occured	Day                      Month                      Year					
	5	Traffic Interruption Period	(1) 1 day > (2) 1 day ~ 7 days (3) 7 days <					
	6	Counter Measure Taken	(1) Only Fill (2) Riprap (3) Other Structure (    )					
	7	Rainfall Intensity/Day	(1) $100mm >$ (2) $100mm \sim 200mm$ (3) $200mm \sim 300mm$ (4) $300mm <$					
Existing Slope Condition	8	Slope Height	(1) $5m >$ (2) $5m \sim 10m$ (3) <input checked="" type="checkbox"/> $10m <$

9	Slope Gradient	(1) $45^\circ >$ (2) $45^\circ \sim 60^\circ$ (3) <input checked="" type="checkbox"/> $60^\circ <$					
	10	Surface Water Concentration	(1) None (2) <input checked="" type="checkbox"/> Low (3) High					
	11	Slope Protection	(1) <input checked="" type="checkbox"/> Nothing (2) Vegetation (3) Riprap (4) Other Structure (    )					
Engineering Judgment	12	Drainage Facilities	(1) <input checked="" type="checkbox"/> Nothing (2) Existing					
	13	Impact to Road	(1) Low (2) <input checked="" type="checkbox"/> Average (3) High					
	14	Cause of Disaster	(1) <input checked="" type="checkbox"/> Concentration of Surface Water (2) River Stream (3) Sea Wave (4) Others					
	15	Counter Measure						
Sketch, etc.							Photo No.

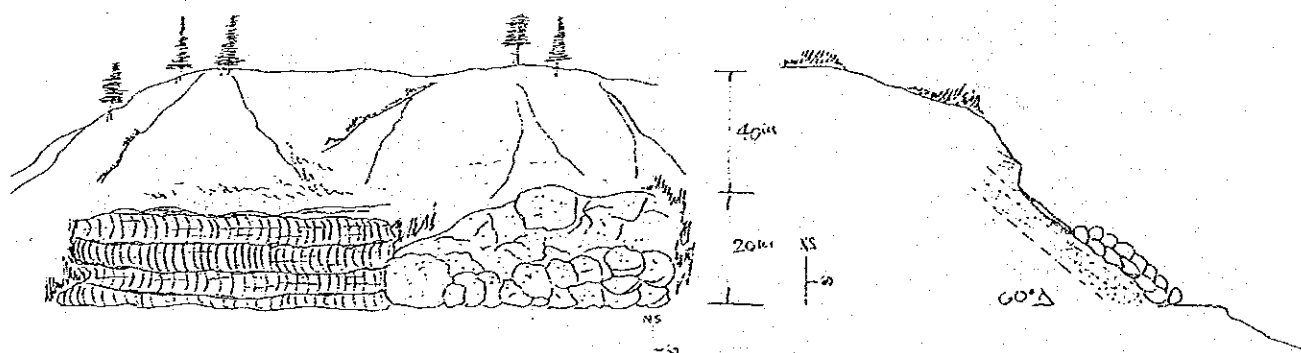
11	Surface Water Concentration	(1) None	(2) Low	(3) High					
	12	Berm	(1) Existing Number ( ) With ( )	(2) Nothing						
	13	Slope Protection	(1) Structure ( )	(2) Vegetation	(3) Nothing					
	14	Drainage Facilities	(1) Existing ( )	(2) Nothing						
Geological Condition	Debris Fall	15	Matrix Condition	(1) Hard	(2) Soft	(3) Loose	(4) Loose with detached cabbles			
		16	Gully	(1) Rare	(2) Common	(3) Frequently				
		17	Detached Rock or cabbles	(1) Nothing	(2) Supported Stably	(3) Supported Unstably				
	Rock Fall	18	Rock Name	(1) Granite (2) Diorite (3) Diabase (4) Andesite (5) Dacite (6) Schist (7) Slate (8) Limestone (9) Schalstein (10) Tuff (11) Tuffbreccia (12) Sandstone (13) Shale (14) Mudstone (15) Conglomerate (16) Masa (17) Volcaniclastics						
		19	Weathering Condition	(1) Fresh	(2) Slightly Weathered	(3) Highly Weathered				
		20	Condition of Crack	(1) Coarse	(2) Regular	(3) Developed

21	Direction of Crack	(1) Inclined to Mountain	(2) Irregular Inclination	(3) Inclined to Slope				
Engi- neering Judge- ment	22	Impact to Road	(1) Low	(2) Average	(3) High					
	23	Cause of Fall	Inclined to slope							
	24	Counter Measure								
Sketch, etc.							Photo No.

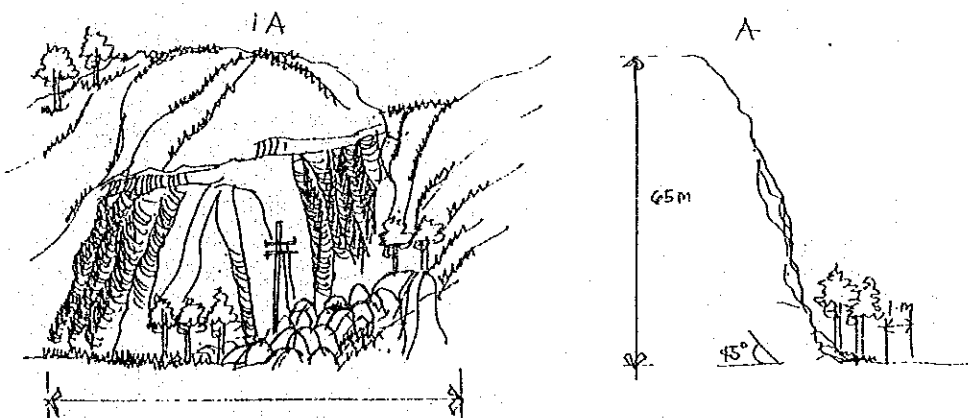
9 Slope Gradient	(1) <input checked="" type="checkbox"/> 45° >	(2) 45° ~ 60°	(3) 60° < (4) Overhung
	10 Degree of Saturation	(1) Dry	(2) <input checked="" type="checkbox"/> Wet	(3) Seepage (4) Spring
	11 Surface Water Concentration	(1) None	(2) Low	(3) <input checked="" type="checkbox"/> High
	12 Berm	(1) Existing Number ( ) With ( )	(2) <input checked="" type="checkbox"/> Nothing	
	13 Slope Protection	(1) Structure ( )	(2) <input checked="" type="checkbox"/> Vegetation	(3) Nothing
	14 Drainage Facilities	(1) Existing ( )	(2) <input checked="" type="checkbox"/> Nothing	
Geological Condition	Debris Fall	15 Matrix Condition	(1) <input checked="" type="checkbox"/> Hard	(2) Soft (3) Loose (4) Loose with detached cabbie
		16 Gully	(1) <input checked="" type="checkbox"/> Rare	(2) Common (3) Frequently
		17 Detached Rock or cabbie	(1) <input checked="" type="checkbox"/> Nothing	(2) Supported Stably (3) Supported Unstably

Rock Fall	18 Rock Name	(1) Granite (2) Diorite (3) Diabase (4) Andesite (5) Dacite (6) Schist (7) Slate (8) Limestone (9) Schiststein (10) <input checked="" type="checkbox"/> Tuff (11) <input checked="" type="checkbox"/> Tuffbreccie (12) Sandstone (13) Shale (14) Mudstone (15) Conglomerate (16) Masa (17) Volcaniclastics	
		19 Weathering Condition	(1) <input checked="" type="checkbox"/> Fresh (2) Slightly Weathered (3) Highly Weathered	
		20 Condition of Crack	(1) Sparse (2) <input checked="" type="checkbox"/> Regular (3) Developed	
		21 Direction of Crack	(1) Inclined to Mountain (2) Irregular Inclination (3) <input checked="" type="checkbox"/> Inclined to Slope	
Engi- neering Judge- ment	22 Impact to Road	(1) Low (2) Average (3) <input checked="" type="checkbox"/> High		
	23 Cause of Fall			
	24 Counter Measure			
Sketch, etc.			Photo No.

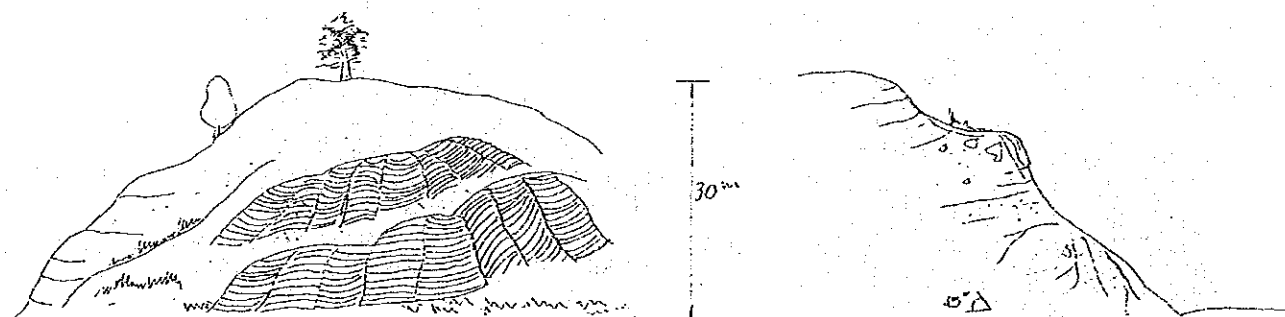
Route		N (IN-16)	Km. Post	298.200	Width	60 M	Sheet No.	B-93
							Region	I
Evidence of Failure	1	Kind of Slope	(✓) Cut Slope (2) Natural Slope					
	2	Kind of Failure	(1) Nothing (2) Surface Failure (3) Deep Failure					
	3	Size of Failure	(1) 50 <sup>m3</sup> > (2) 50 <sup>m3</sup> ~ 500 <sup>m3</sup> (3) 500 <sup>m3</sup> ~ 2,000 <sup>m3</sup> (4) 2,000 <sup>m3</sup> <					
	4	Date Occured	Day Month Year					
	5	Traffic Interruption Period	(1) 1 day > (2) 1 day ~ 7 days (3) 7 days <					
	6	Counter Measure Taken	(1) Structure ( ) (2) Removal of Slide Materials (3) Others					
	7	Rainfall Intensity/Day	(1) 100 mm > (2) 100 <sup>mm</sup> ~ 200 <sup>mm</sup> (3) 200 <sup>mm</sup> ~ 300 <sup>mm</sup> (4) 300 <sup>mm</sup> <					
Existing Slope Condition	8	Height	(1) 10 <sup>m</sup> > (2) 10 <sup>m</sup> ~ 30 <sup>m</sup> (3) 30 <sup>m</sup> ~ 50 <sup>m</sup> (4) 50 <sup>m</sup> <					
	9	Gradient	(1) 45° > (2) 45° ~ 60° (3) 60° < (4) Overhung

10	Berm	(1) Existing Number ( ) Width ( ) (2) Nothing					
	11	Slope Protection	(1) Structure ( ) (2) Vegetation (3) Nothing					
Geological Condition	Rock	12	Hardness	(1) Hard Rock (2) Soft Rock				
		13	Name	(1) Granite (2) Diorite (3) Diabase (4) Andesite (5) Dacite (6) Schist (7) Slate (8) Limestone (9) Schalstein (10) Tuff (11) Tuffbreccie (12) Sandstone (13) Shale (14) Mudstone (15) Conglomerate (16) Masa (17) Volcaniclastics				
		14	Weathering Condition	(1) Fresh (2) Slightly Weathered (3) Highly Weathered (4) Nearly Soil				
		15	Condition of Crack	(1) Sparse (2) Regular (3) Developed				
	Soil	16	Direction of Crack	(1) Inclined to Mountain (2) Irregular Inclination (3) Inclined to Slope				
		17	Thickness	(1) 5 <sup>m</sup> > (2) 5 <sup>m</sup> ~ 10 <sup>m</sup> (3) 10 <sup>m</sup> ~ 20 <sup>m</sup> (4) 20 <sup>m</sup> <				
		18	Compactness	(1) Tight (2) Slightly loose (3) Loose				
		Water Condition	19	Degree of Saturation	(1) Dry (2) Wet (3) Seepage (4) Spring

20	Surface Water Concentration		(1) None (2) Low (3) High					
21	Drainage Facilities		(1) Existing ( ) (2) Nothing					
Engineering Judgment	22	Impact to Road	(1) Low (2) Average (3) High					
	23	Cause of Disaster						
	24	Counter Measure						
Sketch, etc.						Photo No.

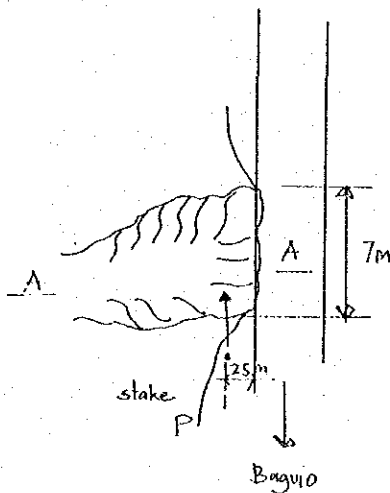
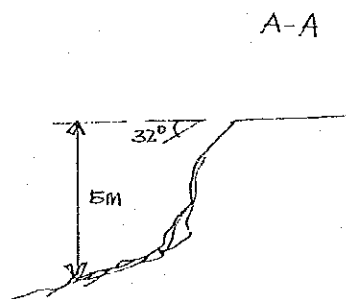
Route		N (N-19-1)	Km. Post	301.000	Width	7 M	Sheet No.	B-94-1
							Region	I
Evidence of Failure	1	Kind of Slope	(1) <input checked="" type="checkbox"/> Embankment Slope (2) Natural Slope (3) Overflow Section (5) Others					
	2	Location	(1) Approach of Bridge (2) Adjacent to River or Sea (3) Inside of Curve (4) <input checked="" type="checkbox"/> Others					
	3	Size of Disaster	(1) $50m^3 >$ (2) <input checked="" type="checkbox"/> $50m^3 \sim 100m^3$ (3) $100m^3 <$					
	4	Date Occured	Day 27~30 Month Aug, Year 1984, by Haring					
	5	Traffic Interruption Period	(1) 1 day > (2) 1 day ~ 7 days (3) 7 days <					
	6	Counter Measure Taken	(1) Only Fill (2) Riprap (3) Other Structure ( )					
	7	Rainfall Intensity/Day	(1) $100mm >$ (2) $100mm \sim 200mm$ (3) $200mm \sim 300mm$ (4) <input checked="" type="checkbox"/> $300mm <$					
Existing Slope Condition	8	Slope Height	(1) <input checked="" type="checkbox"/> $5m >$ (2) $5m \sim 10m$ (3) $10m <$

9	Slope Gradient	(1) $45^\circ >$ (2) <input checked="" type="checkbox"/> $45^\circ \sim 60^\circ$ (3) $60^\circ <$					
	10	Surface Water Concentration	(1) None (2) <input checked="" type="checkbox"/> Low (3) High					
	11	Slope Protection	(1) Nothing (2) Vegetation (3) <input checked="" type="checkbox"/> Riprap (4) Other Structure ( )					
Engineering Judgment	12	Drainage Facilities	(1) <input checked="" type="checkbox"/> Nothing (2) Existing					
	13	Impact to Road	(1) Low (2) <input checked="" type="checkbox"/> Average (3) High					
	14	Cause of Disaster	(1) <input checked="" type="checkbox"/> Concentration of Surface Water (2) River Stream (3) Sea Wave (4) Others					
	15	Counter Measure						
Sketch, etc.							Photo No.

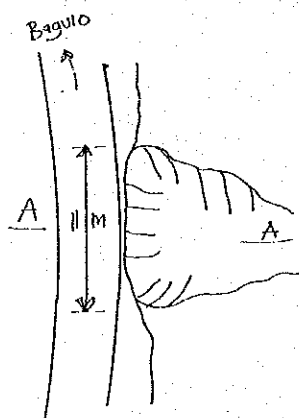
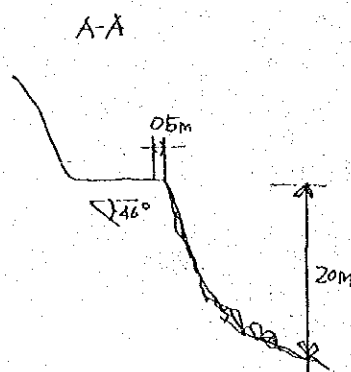
Sheet No.	B-94-2		
Route	N (1N-19-2)	Km. Post	301,600	Width	11 M
		Region	I		
Evidence of Failure	1	Kind of Slope	(1) <input checked="" type="checkbox"/> Embankment Slope (2) Natural Slope (3) Overflow Section (5) Others		
	2	Location	(1) Approach of Bridge (2) Adjacent to River or Sea (3) Inside of Curve (4) <input checked="" type="checkbox"/> Others		
	3	Size of Disaster	(1) $50m^3 >$ (2) $50m^3 \sim 100m^3$ (3) $100m^3 <$		
	4	Date Occured	Day 27~30 Month Aug. Year 1984 by Harup		
	5	Traffic Interruption Period	(1) 1 day > (2) 1 day ~ 7 days (3) 7 days <		
	6	Counter Measure Taken	(1) <input checked="" type="checkbox"/> Only Fill (2) Riprap (3) Other Structure ( )		
	7	Rainfall Intensity/Day	(1) $100mm >$ (2) $100mm \sim 200mm$ (3) $200mm \sim 300mm$ (4) <input checked="" type="checkbox"/> $300mm <$		
Existing Slope Condition	8	Slope Height	(1) $5m >$ (2) $5m \sim 10m$ (3) <input checked="" type="checkbox"/> $10m <$

9	Slope Gradient	(1) $45^\circ >$ (2) <input checked="" type="checkbox"/> $45^\circ \sim 60^\circ$ (3) $60^\circ <$		
	10	Surface Water Concentration	(1) None (2) <input checked="" type="checkbox"/> Low (3) High		
	11	Slope Protection	(1) <input checked="" type="checkbox"/> Nothing (2) Vegetation (3) Riprap (4) Other Structure ( )		
Engineering Judgment	12	Drainage Facilities	(1) <input checked="" type="checkbox"/> Nothing (2) Existing		
	13	Impact to Road	(1) Low (2) <input checked="" type="checkbox"/> Average (3) High		
	14	Cause of Disaster	(1) <input checked="" type="checkbox"/> Concentration of Surface Water (2) River Stream (3) Sea Wave (4) Others		
	15	Counter Measure			
Sketch, etc.					Photo No.

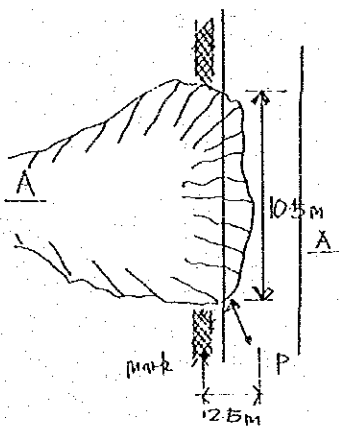
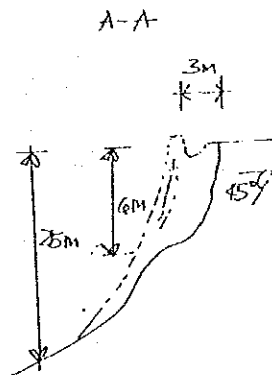
Route		N(N-23-1)	Km. Post	304.500	Width	10.5 M	Sheet No.	B-95-1
							Region	t
Evidence of Failure	1	Kind of Slope	(1) <input checked="" type="checkbox"/> Embankment Slope (2) Natural Slope (3) Overflow Section (5) Others					
	2	Location	(1) Approach of Bridge (2) Adjacent to River or Sea (3) Inside of Curve (4) <input checked="" type="checkbox"/> Others					
	3	Size of Disaster	(1) $50^{\text{m}^3}$ > (2) <input checked="" type="checkbox"/> $50^{\text{m}^3} \sim 100^{\text{m}^3}$ (3) $100^{\text{m}^3}$ <					
	4	Date Occured	Day 27~30 Month Aug Year 1984 Day Morning					
	5	Traffic Interruption Period	(1) 1 day > (2) 1 day ~ 7 days (3) 7 days <					
	6	Counter Measure Taken	(1) Only Fill (2) Riprap (3) Other Structure ( )					
	7	Rainfall Intensity/Day	(1) $100^{\text{mm}}$ > (2) $100^{\text{mm}} \sim 200^{\text{mm}}$ (3) $200^{\text{mm}} \sim 300^{\text{mm}}$ (4) <input checked="" type="checkbox"/> $300^{\text{mm}}$ <

Existing Slope Condition	8	Slope Height	(1) $5^{\text{m}}$ > (2) $5^{\text{m}} \sim 10^{\text{m}}$ (3) <input checked="" type="checkbox"/> $10^{\text{m}}$ <					
	9	Slope Gradient	(1) $45^\circ$ > (2) <input checked="" type="checkbox"/> $45^\circ \sim 60^\circ$ (3) $60^\circ$ <					
	10	Surface Water Concentration	(1) None (2) Low (3) <input checked="" type="checkbox"/> High					
	11	Slope Protection	(1) Nothing (2) Vegetation (3) <input checked="" type="checkbox"/> Riprap (4) Other Structure ( )					
	12	Drainage Facilities	(1) Nothing (2) <input checked="" type="checkbox"/> Existing					
Engi- neering Judge- ment	13	Impact to Road	(1) Low (2) <input checked="" type="checkbox"/> Average (3) High					
	14	Cause of Disaster	(1) <input checked="" type="checkbox"/> Concentration of Surface Water (2) River Stream (3) Sea Wave (4) Others					
	15	Counter Measure						
Sketch, etc.							Photo No.
