5.3 EXISTING CONDITIONS OF ROAD DISASTERS

5.3.1 Lucena-Calauag Section, M-10 along Maharlika Highway

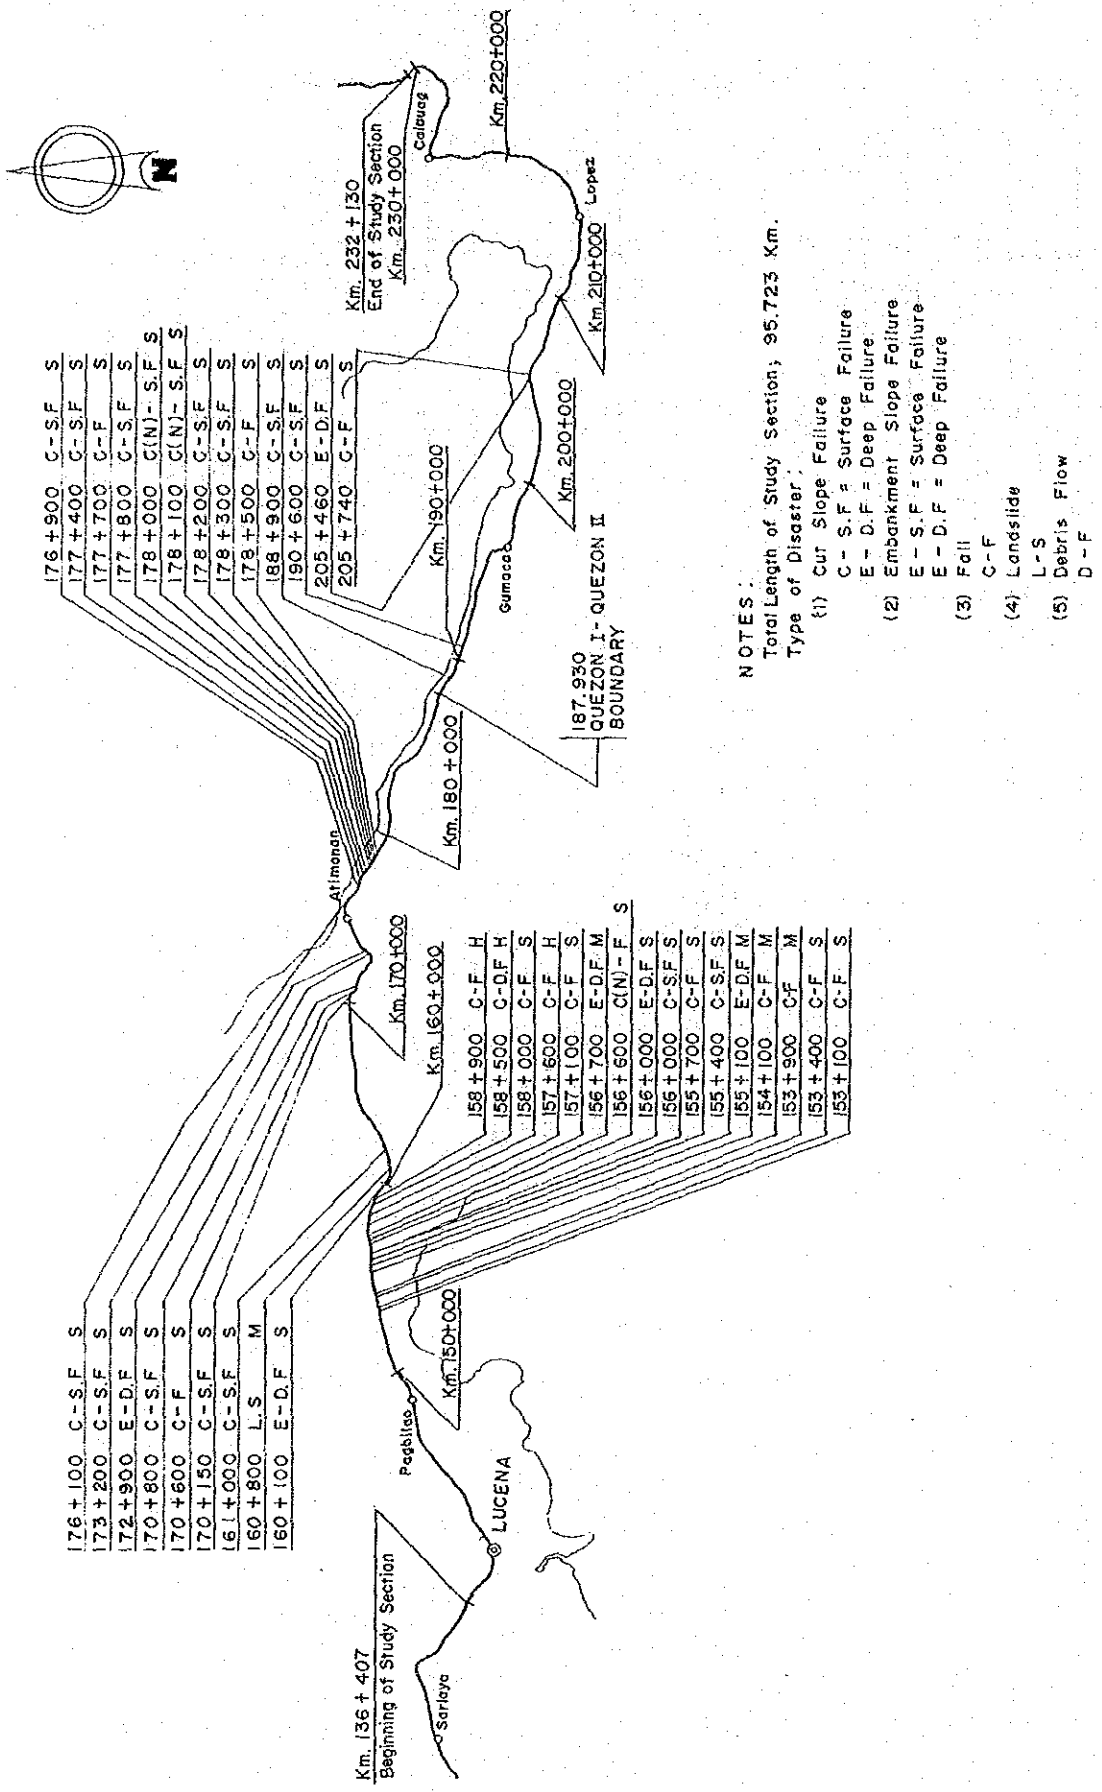
FIGURE 5.3-1 LOCATION MAP OF DISASTER SPOTS
 LUCENA-CALAUAG SECTION (M-10)

Occurrence of a large number of falls is mainly due to severely weathered limestone with developed cracks. The sizes of fallen rocks are 1.5 to 2.5 meters. These failures are feared to occur in the future.

Embankment slope failures were mainly caused by scouring due to the concentration of road surface water, particularly at inner curves of roads with steep vertical gradients. Side ditches are recommended to be adequately constructed.

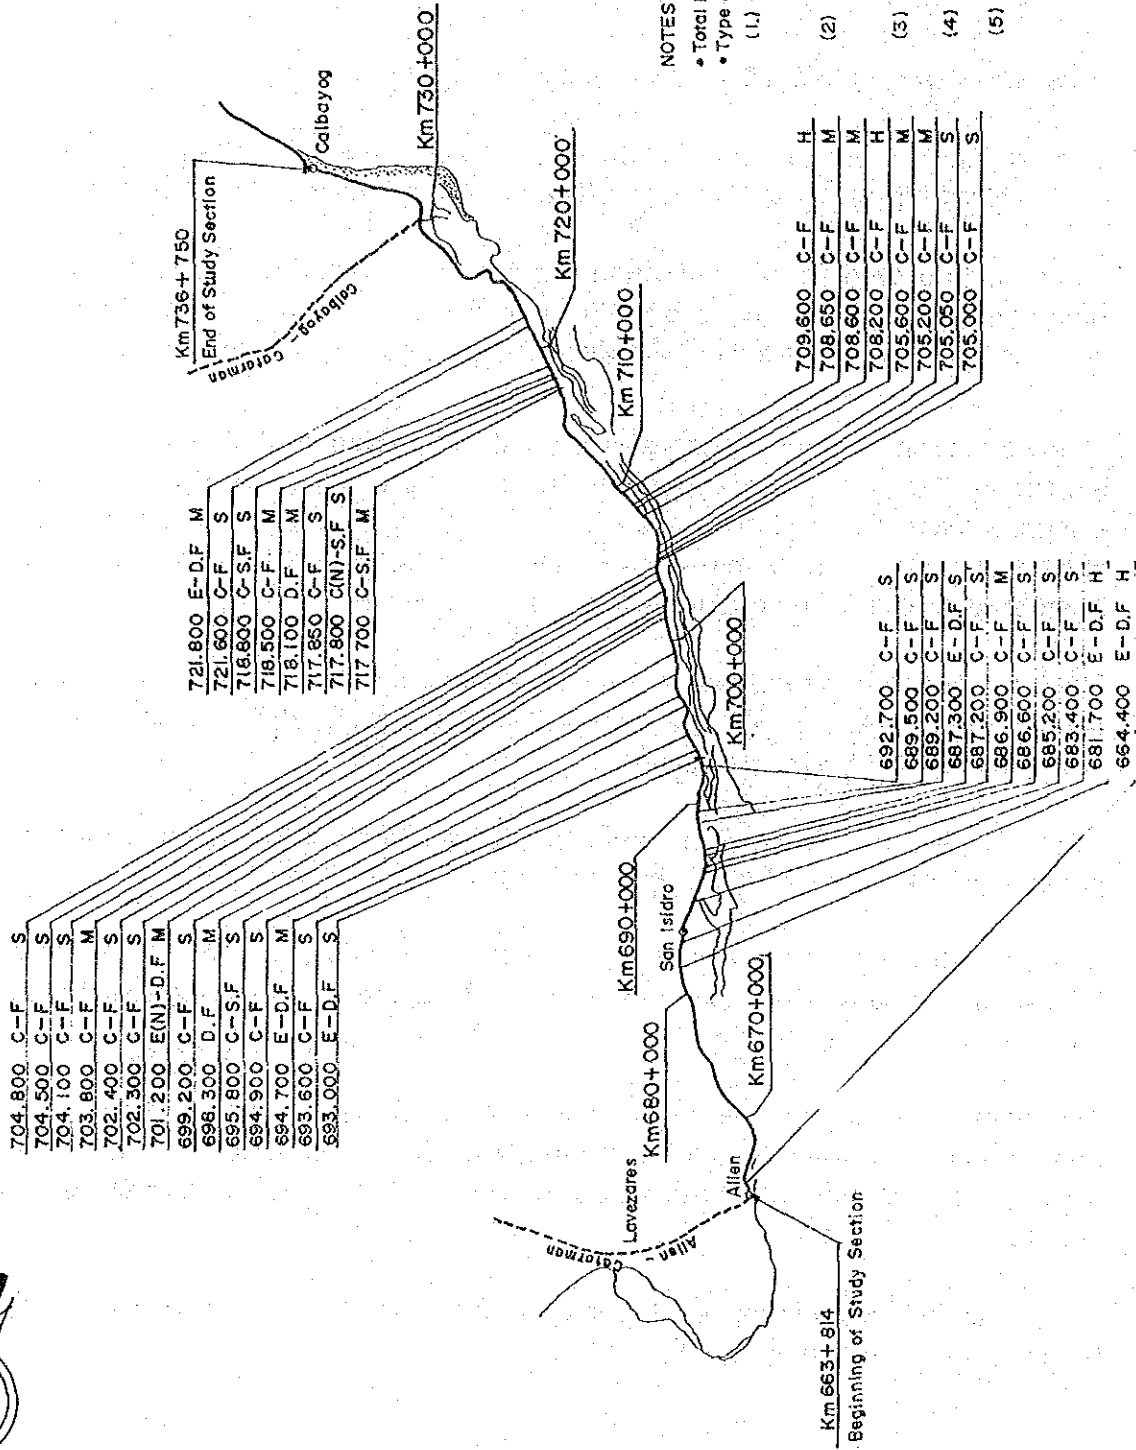
FIGURE 5.3-2 LOCATION MAP OF DISASTER SPOTS ALLEN-CALBAYOG SECTION (M-16)

The majority of fall occurred on cut slopes of highly weathered sandstones with developed cracks. Most of fallen rocks are 30 to 50 centimeters in size but occasionally over 3 meters. These falls may continue if no countermeasures are adopted.

Almost all embankment slope failures were observed along the coastline, caused by scouring due to waves and flood water.

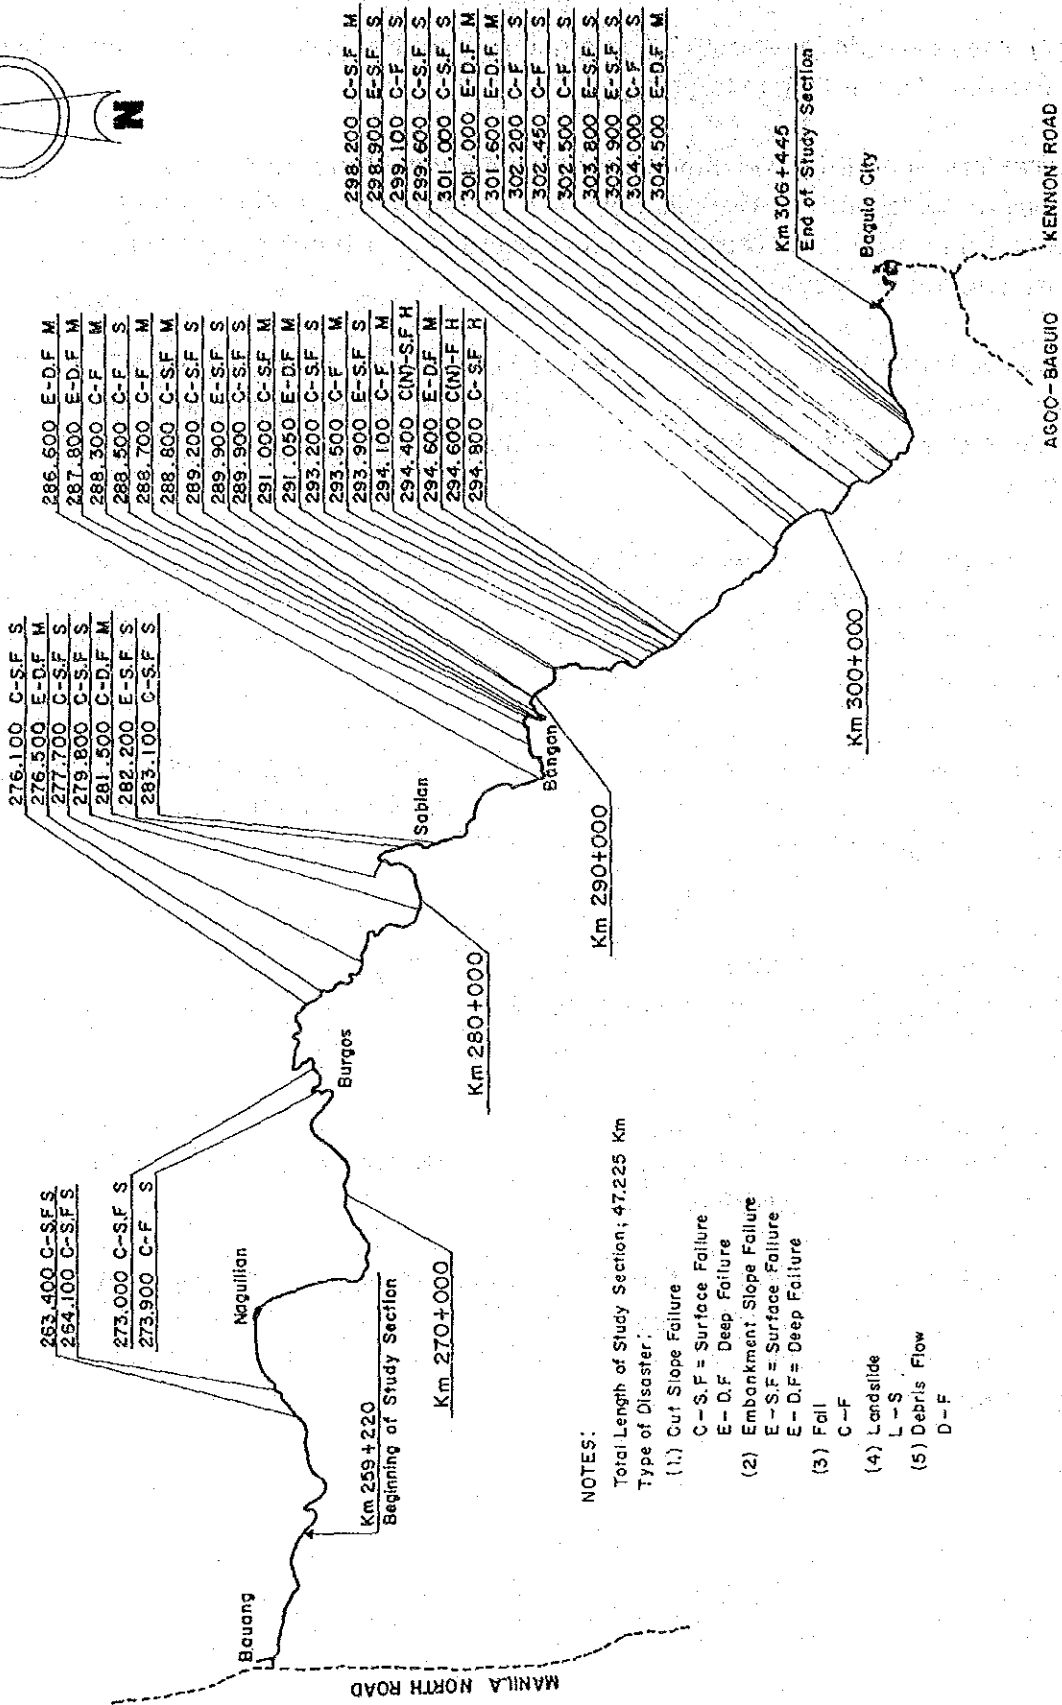
FIGURE 5.3-3 LOCATION MAP OF DISASTER SPOTS NAGUILIAN ROAD (B-3)

In this road, embankment slope failures means the collapse of stone masonry applied to embankment slopes at valley side. These collapses were observed at the considerable number of spots and are feared to occur at other spots in the future.

Cut slope failures and falls were seen on slopes composed of hard rocks such as tuff, tuff breccia and conglomerate. Since these are relatively hard with many open cracks, fall is likely to occur.

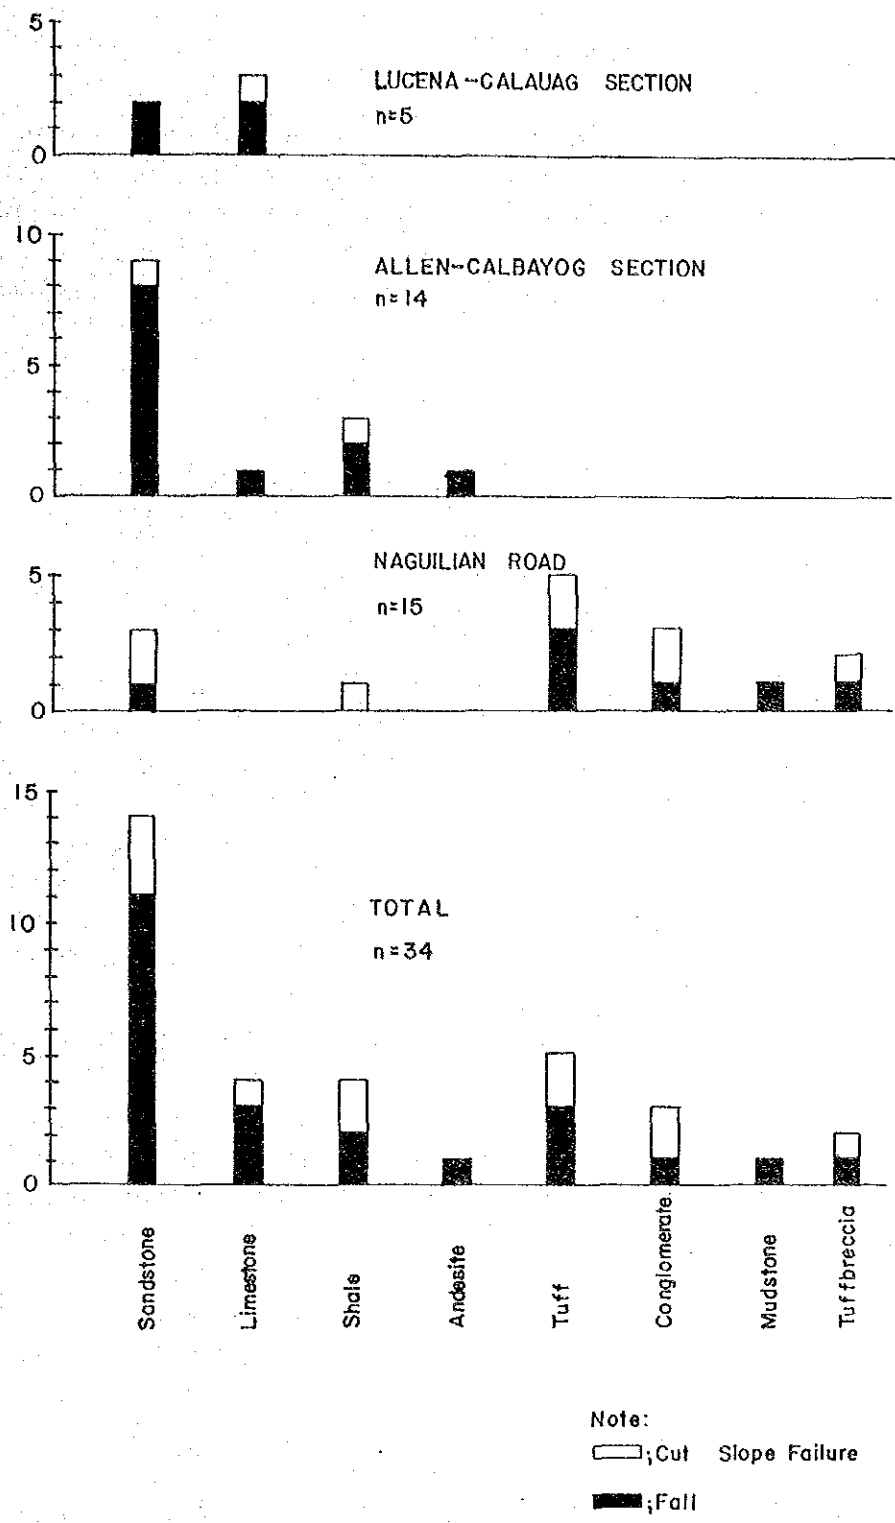
FIGURE 5.3-4 NUMBER OF CUT SLOPE FAILURES AND FALLS AND KINDS OF ROCKS

Shown in Figure 5.3-4 is the number of cut slope failures and fall with the disaster potentials of Heavy and Medium in relation to the kind of rocks. The numbers do not tally with the number of disaster spots because slope has more than two kinds of rock.
