**THE FEASIBILITY STUDY
OF
PHILIPPINE ROAD DISASTER PREVENTION PROJECT**

STAGE II

FINAL REPORT
EXECUTIVE SUMMARY

JULY, 1985

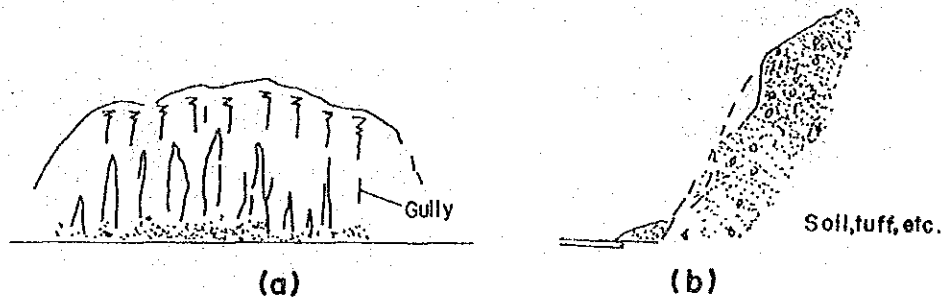
Surface Failure due to erosion

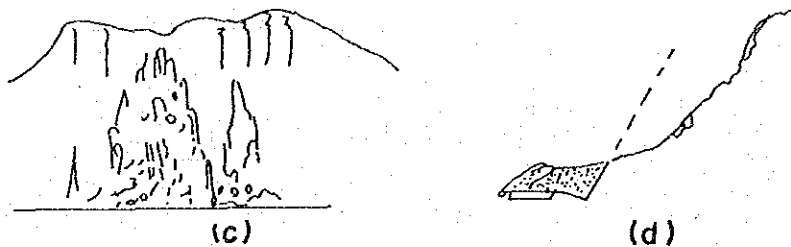
Deep Failure due to scouring

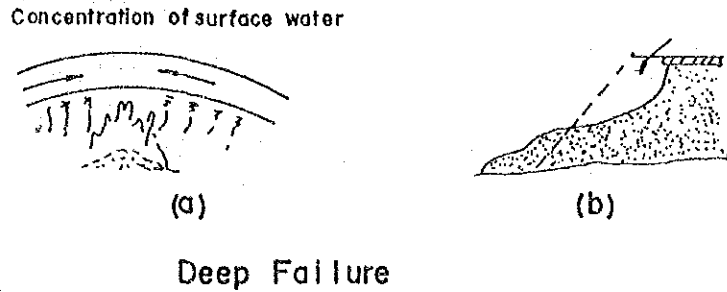
FIGURE 3-2 EMBANKMENT SLOPE FAILURE

This type is sub-classified into surface failure due to erosion and deep failure due to scouring and saturation. See Figure 3-2.

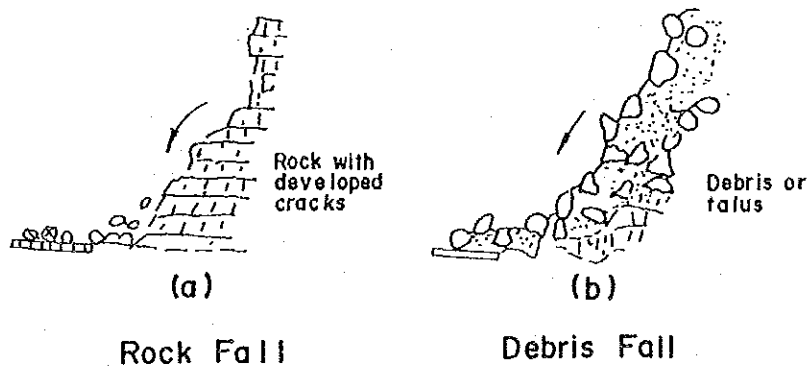
FIGURE 3-3 FALL

This type is sub-classified into rock and debris falls. The former is free fall of rocks detached from bedrocks, while the latter is that of unsupported pebbles, cobbles, and boulders on a slope. See Figure 3-3.

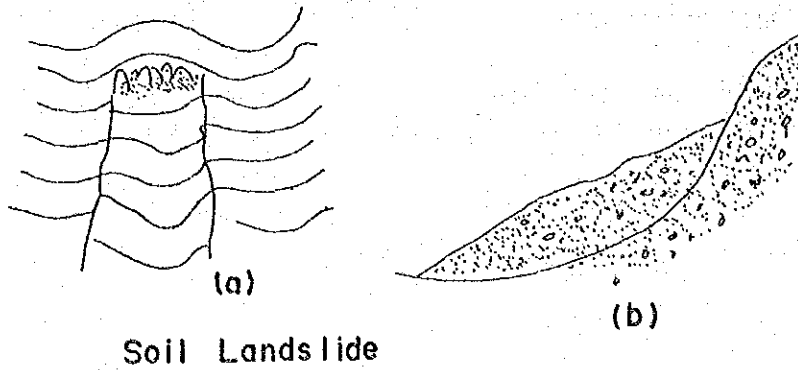
FIGURE 3-4 LANDSLIDE

Landslide is caused by loss of balance between shear strength of materials and movement force along a specific slide plane. This type is sub-classified into rock and soil landslides. See Figure 3-4.

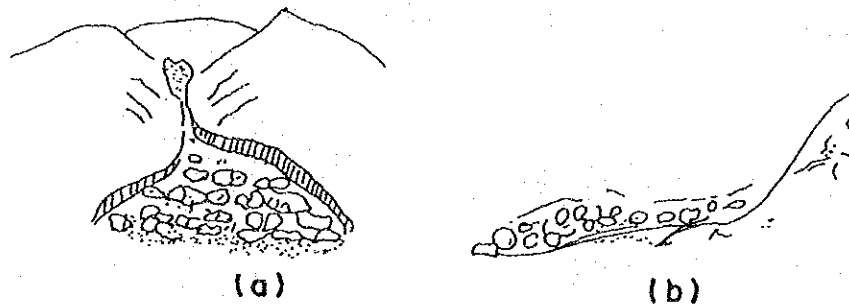
FIGURE 3-5 DEBRIS FLOW

Debris flow is induced by a force of flow caused by floods where there exist deposits on torrent or riverbed. This type is sub-classified into debris and mud flows. See Figure 3-5.

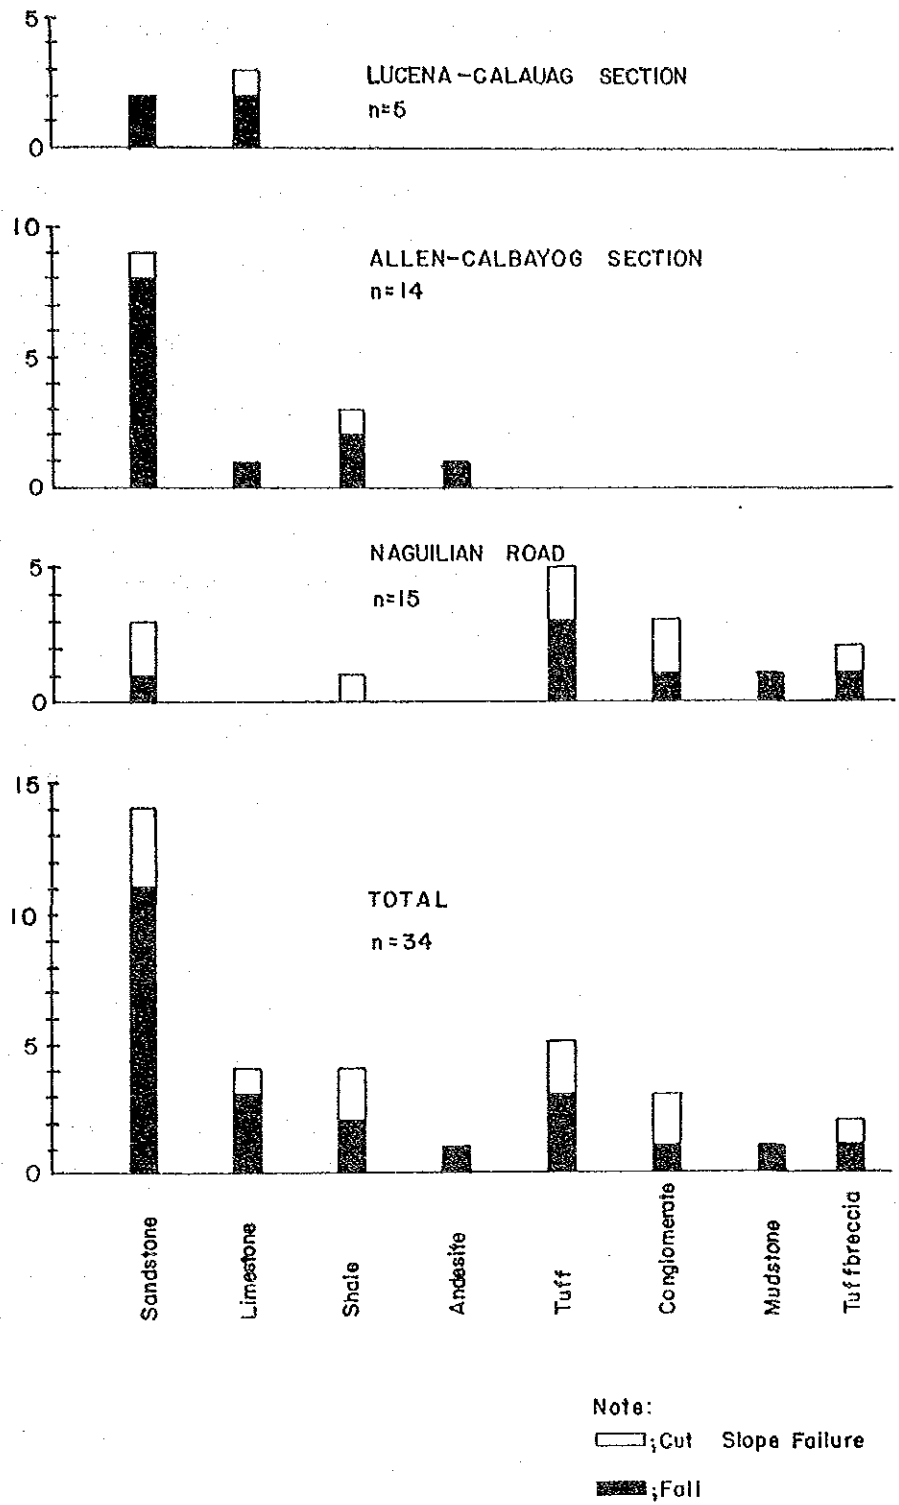
FIGURE 3-6 NUMBER OF CUT SLOPE FAILURES AND FALLS AND KINDS OF ROCKS

Shown in Figure 3-6 is the number of cut slope failures and falls with the disaster potential of Heavy and Medium in relation to kinds of rocks. This number do not tally with the number of disaster spots because slope is often composed of more than two kinds of rocks.
