## 5. Spillway Facilities

CALIRAYA REHABILITATION PROJECT	
SPILLWAY	
LEAK SEALING (1st step)	
PLANS, SECTIONS and DETAILS	
JAN. 1986	CHEP-R-J-1
THE JAPAN INTERNATIONAL COOPERATION AGENCY

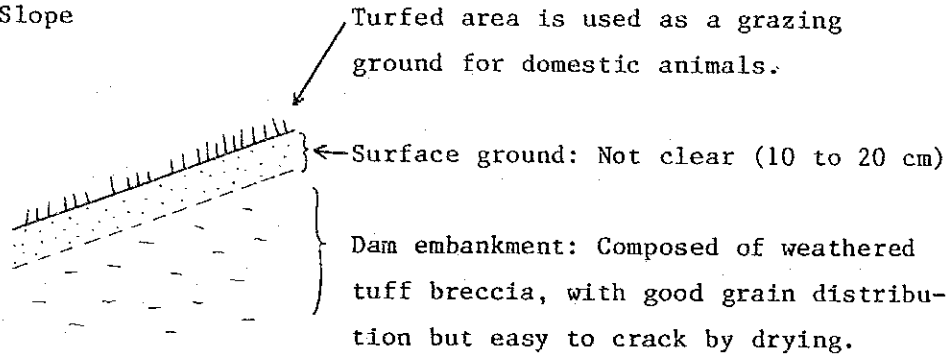
FIG. V-8 Explanation of Erosion Process  
at Downstream Face of Caliraya Dam

Face of slope is damaged by animal footmarks. This damage develops through rainwater erosion. Thus, the surface becomes exposed.

Cracks occur on the exposed surface of the embankment of which material is already easily detachable and broken into small pieces. These pieces are washed out by rainwater.

"A" surface is always exposed. (Since the broken pieces are washed out by rainwater).

Some of the washed pieces are settled on "B" surface until the next rainfall. Because of this, the generation of cracking is mitigated on "B" surface.

As reported above, widespread damage caused by rainfall erosion stripping grass and top soil was found on the downstream face of the dam. Without remedial measures it is probable that the damage will rapidly deteriorate. It is therefore recommended that a programme of remedial work is established without delay.

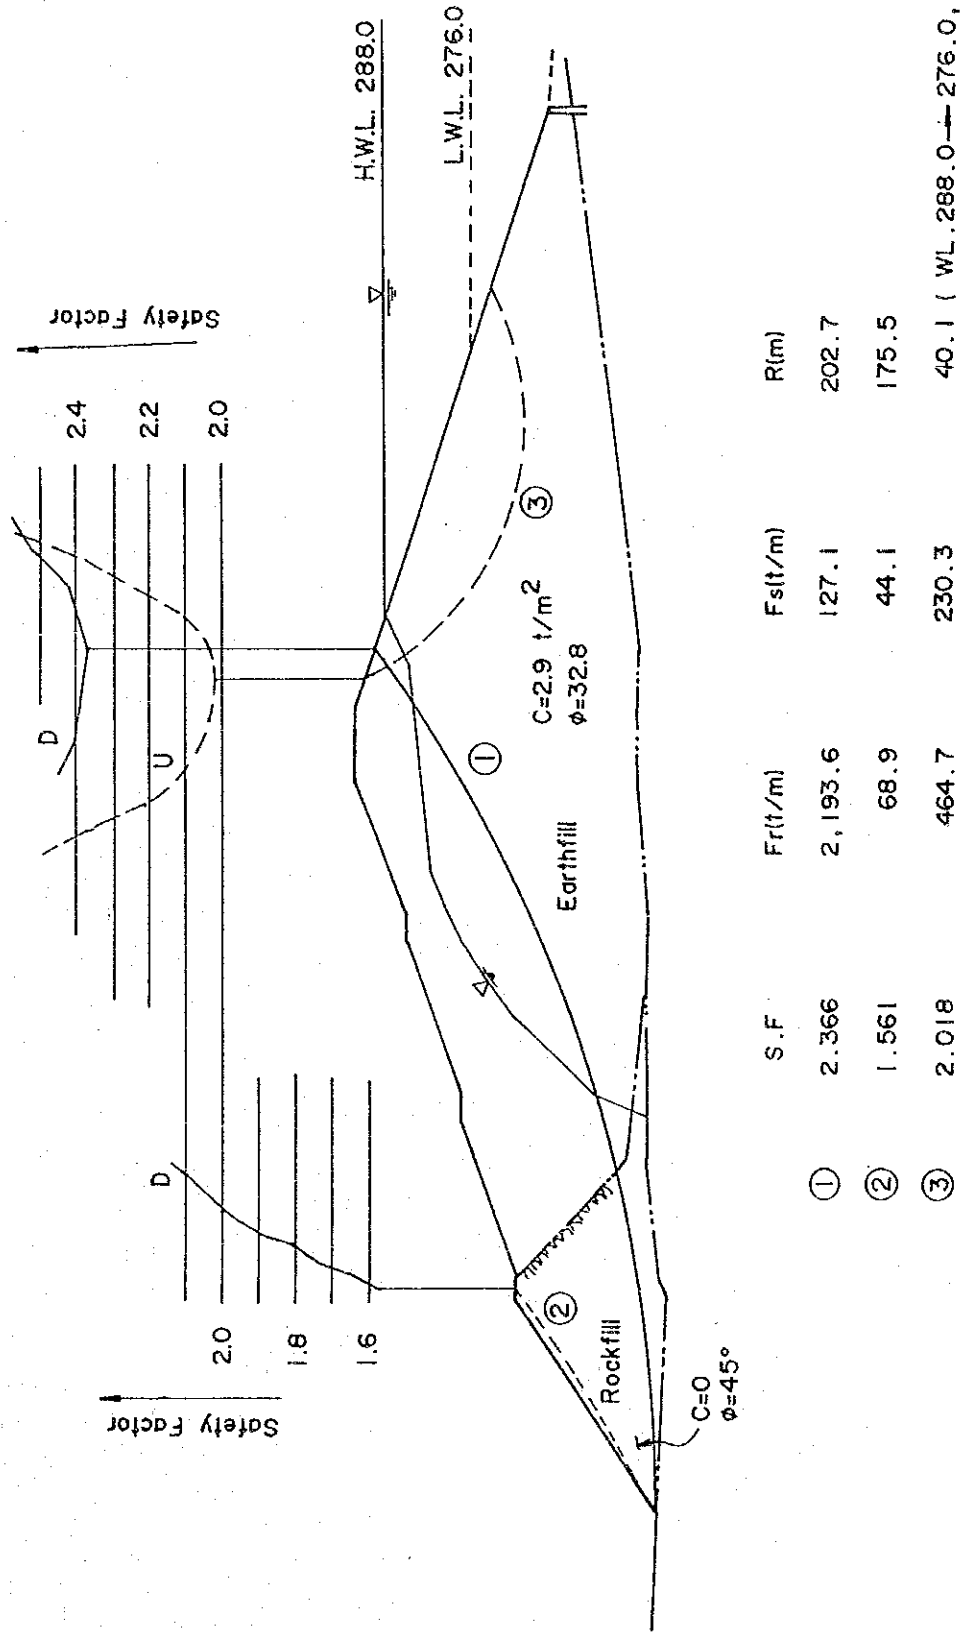
FIG. VII-2 CALIRAYA DAM STABILITY (Normal)  
 ( Section STA. 0 + 384 )

Line (1) indicates the downstream slope of the dam, normal condition (without earthquake) and the water level being the observed value.

Line (2) indicates the downstream slope of the dam, seismic condition being  $k=0.15$  and the ground water level being the observed value.

Referring to Fig.VII-5, it is considered that at present no significant landslide is likely to occur on either the upstream slope or the downstream slope of the Caliraya Dam, whether under normal conditions or even in case of a rapid drawdown of the reservoir water level from H.W.L. to L.W.L.

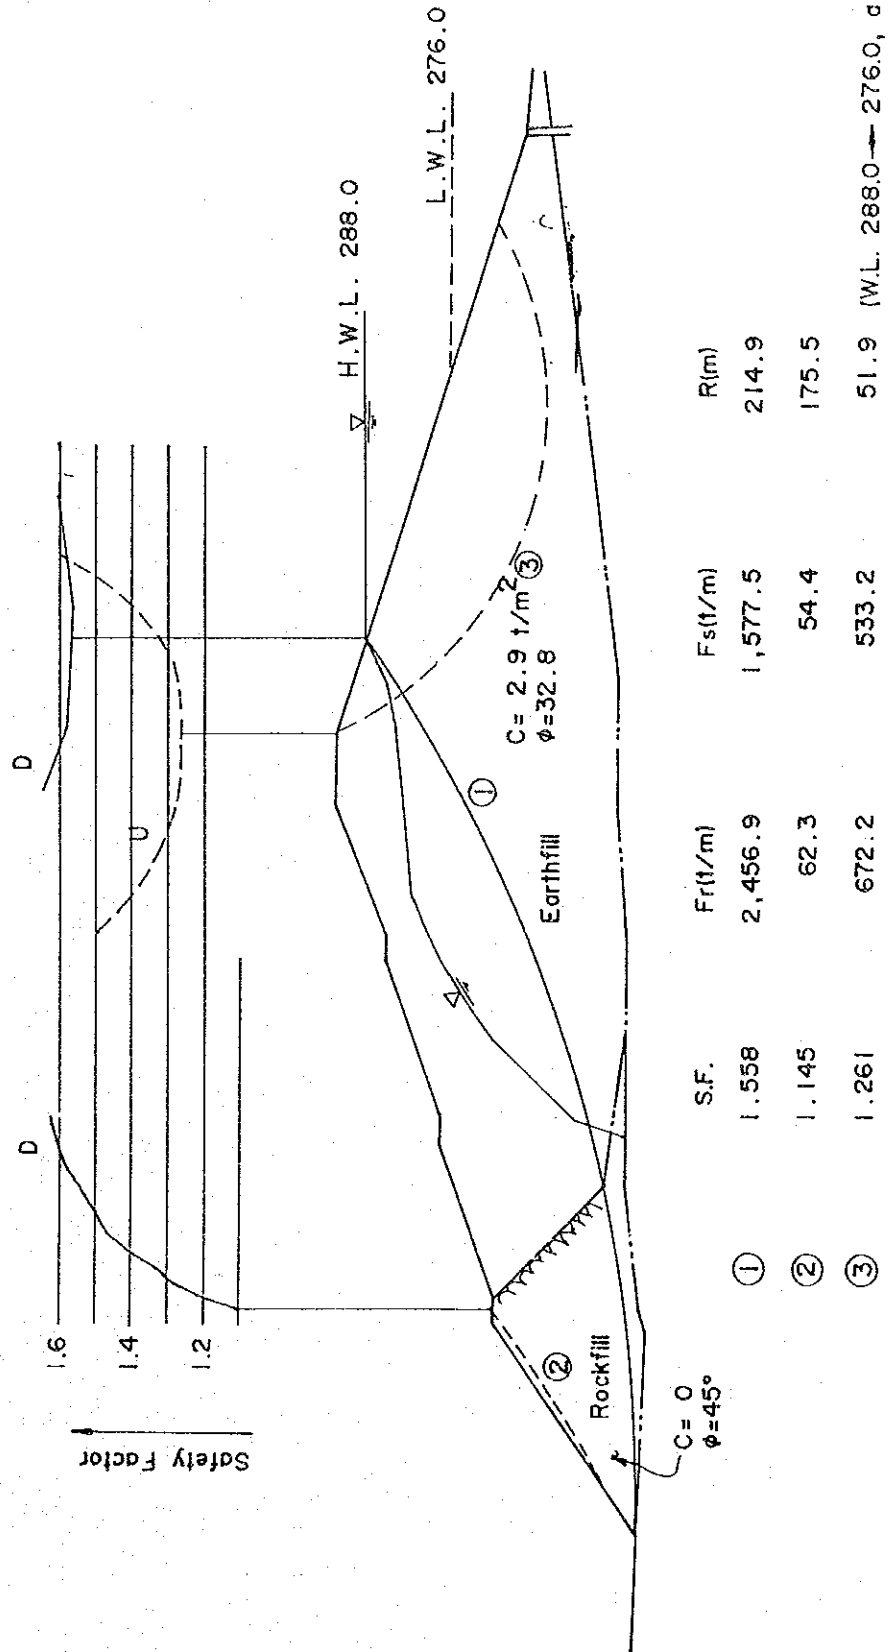
FIG. VII-3 CALIRAYA DAM STABILITY (Seismic Condition  $k = 0.15$ )  
 ( Section STA. 0 + 384 )

Line (3) indicates the upstream slope of the dam, normal condition and the reservoir water level with a rapid draw-down (EL.288  $\rightarrow$  EL.276).

Line (4) indicates the upstream slope of the dam, seismic condition being  $k=0.15$  and the reservoir water level with a rapid drawdown (EL.288  $\rightarrow$  EL.276).
