### 3.3 Structural Survey at South Harbor

The Port of Manila is comprised of North Harbor for domestic trade and South Harbor for foreign trade, and the Manila International Container Terminal (MICT). All the harbor facilities in the Port of Manila were constructed shortly after World War II. The facilities are seriously deteriorated and some parts of the facilities have reached very dangerous conditions for normal port operation because of lack of proper maintenance and repair works. Considering the unsatisfactory situation, the Study Team conducted a series of structural survey/inspection of the existing harbor facilities.

#### 3.3.2 Field Surveys at South Harbor

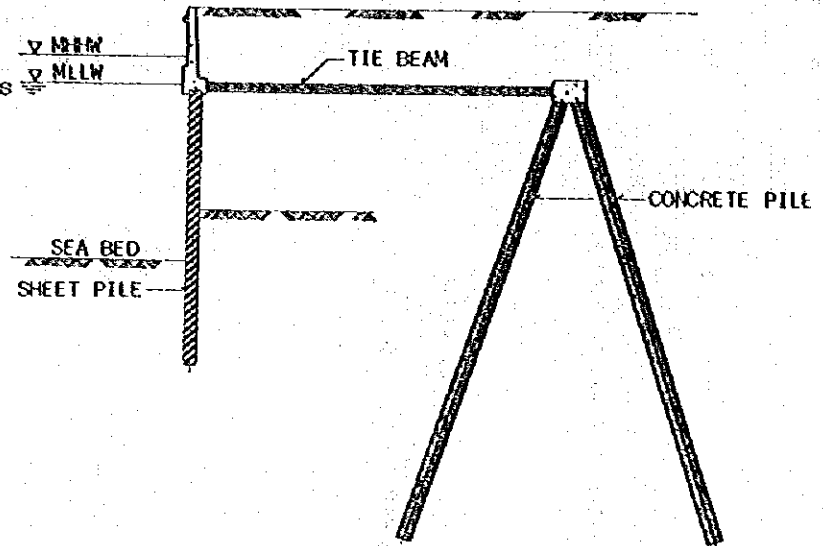
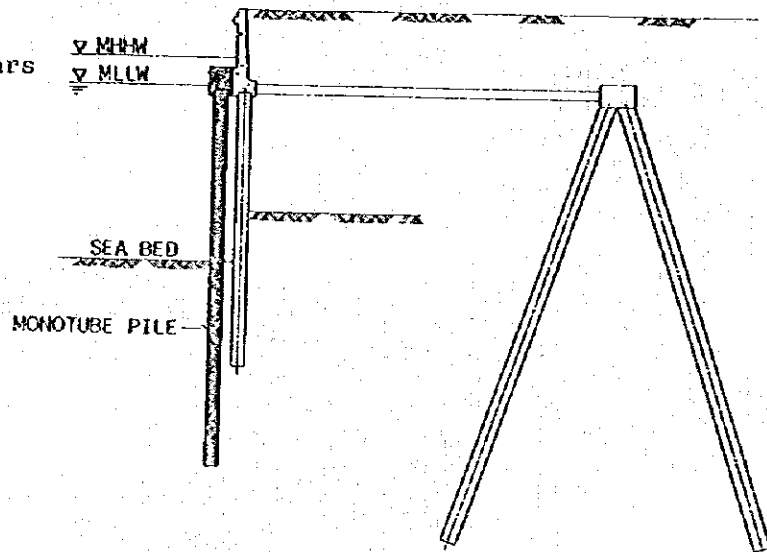
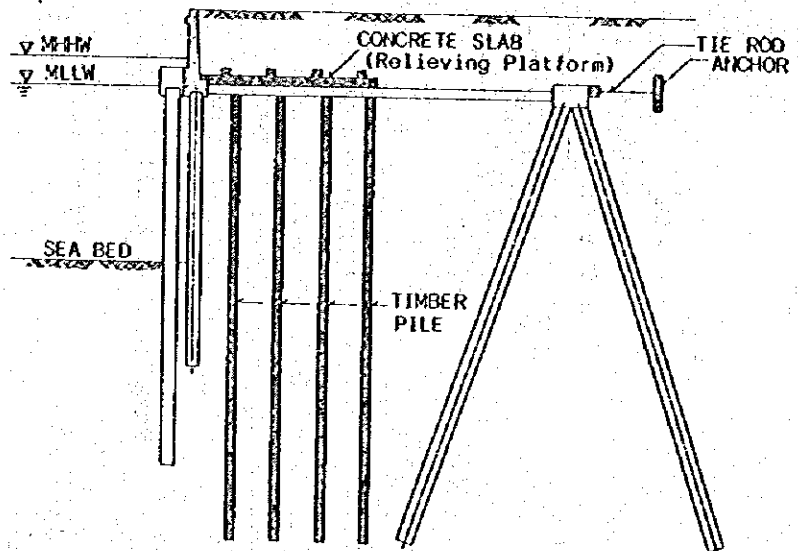
Fig. 3.4.3 Historical Stages of Remedial Measures

The trial excavation shows that the reinforced concrete tie-beams are broken and the reinforcing bars are exposed.

The failure of the tie-beams may have been brought about by the initial settlement of the backfilling material shortly after the completion of the structure. The existing tie-beams cannot be expected to transfer the reaction of the sheet piles to the anchor plates. Thus, this pier is very unstable from the structural point of view.
