**THE ROMANIA EARTHQUAKE  
SURVEY GROUP OF EXPERTS AND SPECIALISTS  
DISPATCHED BY THE GOVERNMENT OF JAPAN  
SURVEY REPORT**

**June 1977**

**Japan International Cooperation Agency**

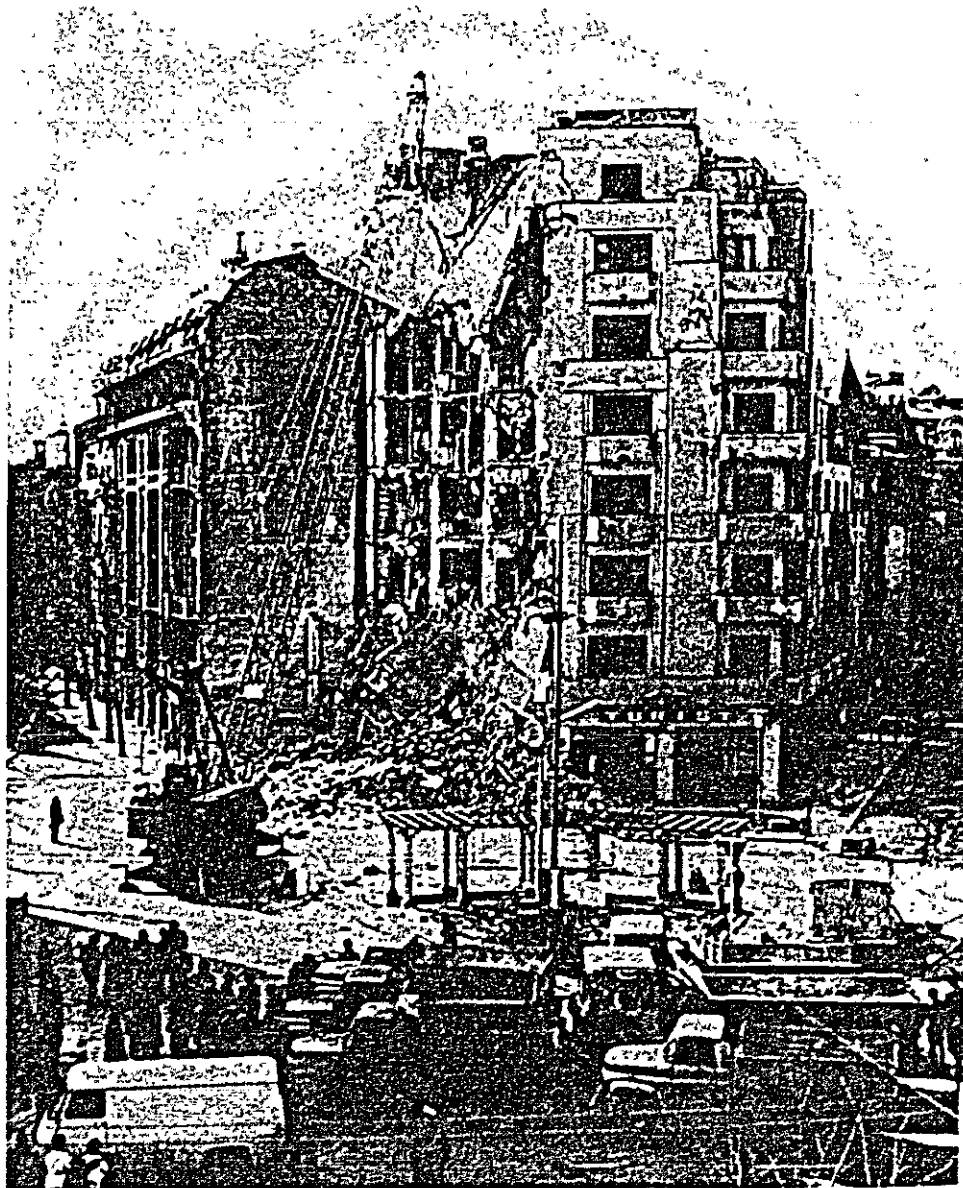
Photo 5.22 A destroyed building of reinforced brick construction No. 4, Bucharest.

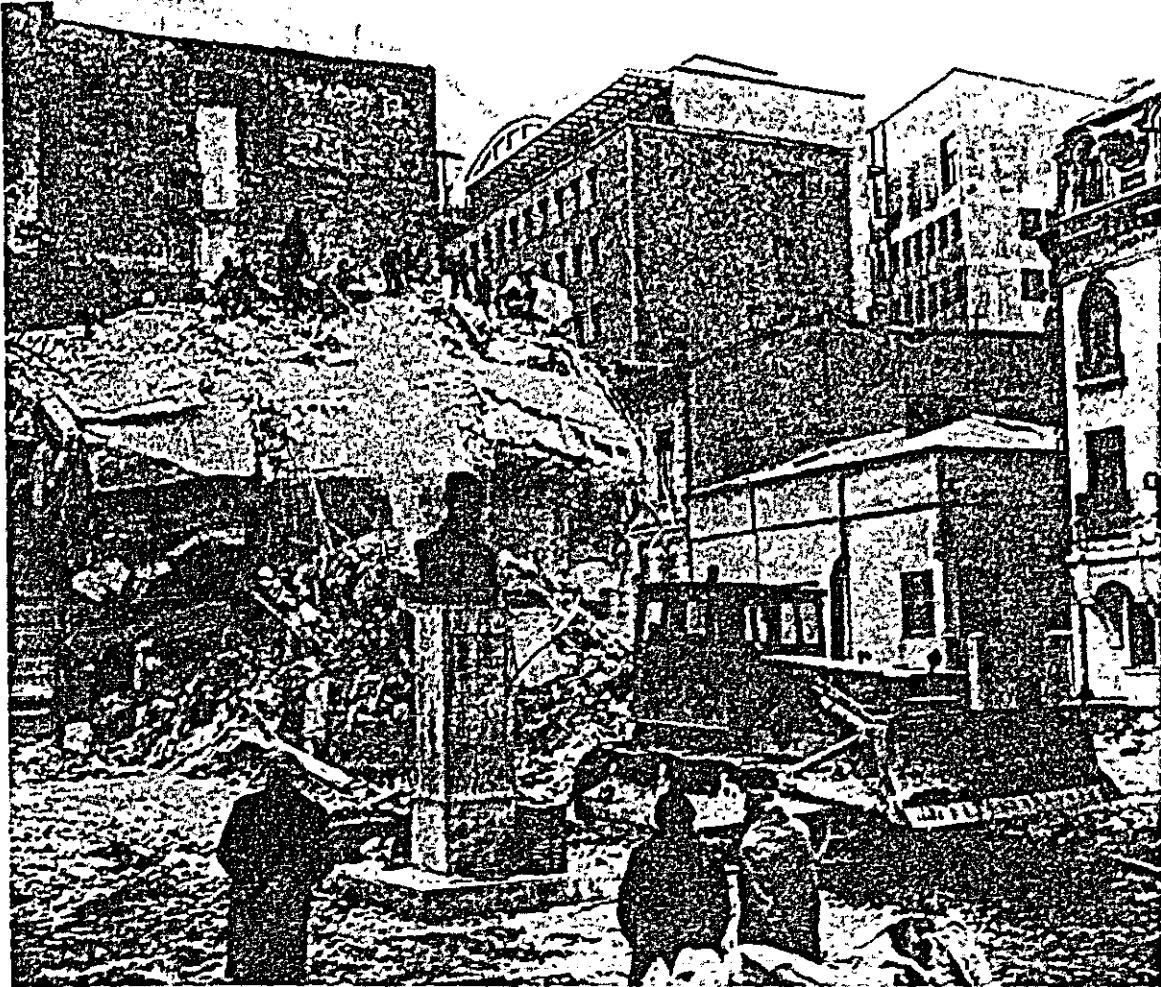
Photo 5.23 A collapsed building of reinforced brick construction  
No. 5, Bucharest.

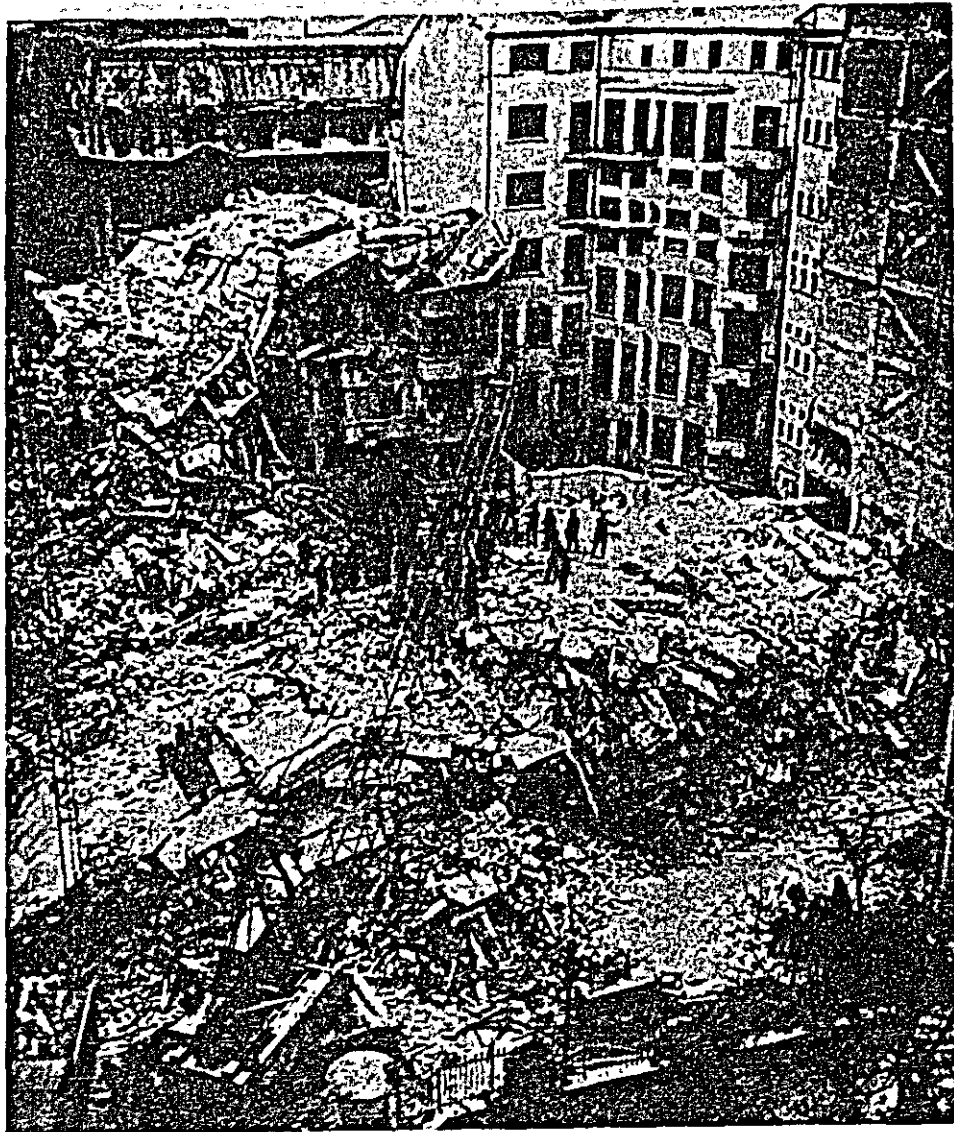
Photo 5.24 A fallen building of reinforced brick construction  
No. 6, Bucharest:

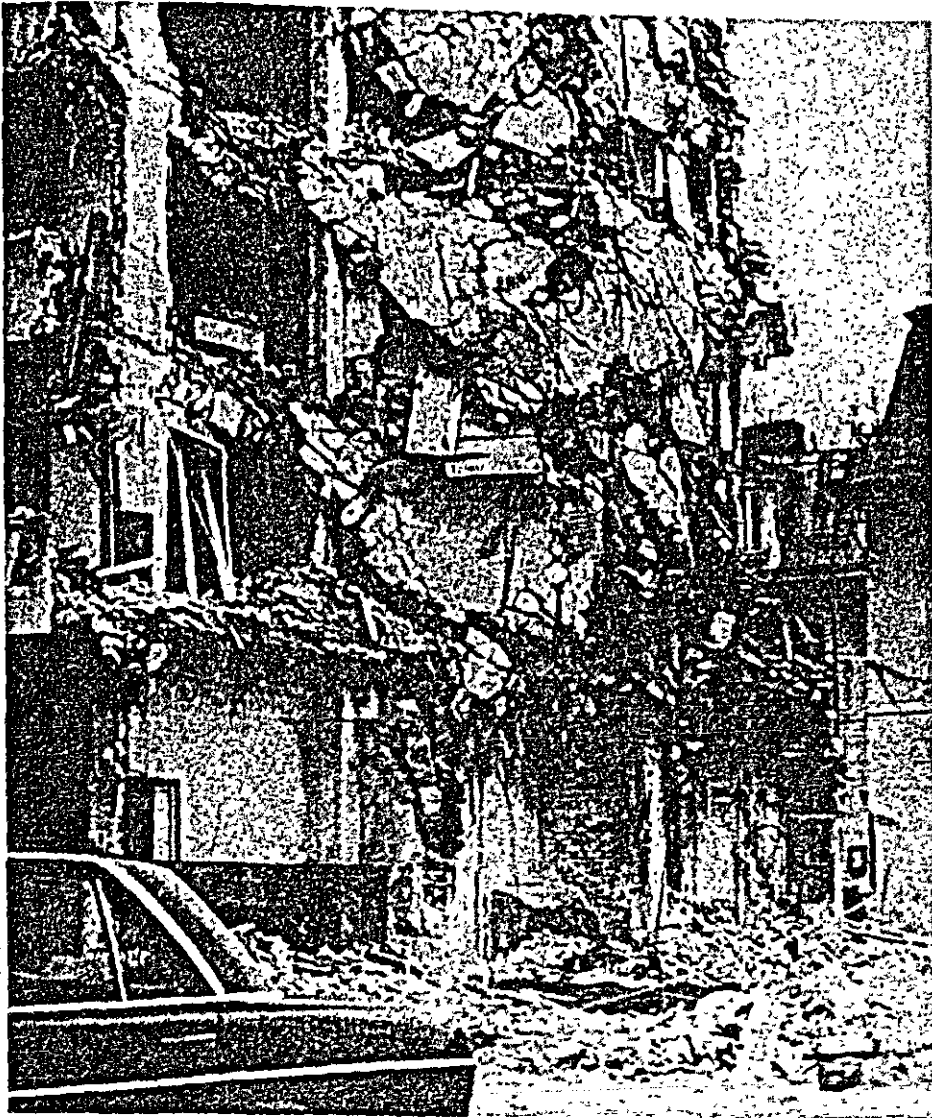
Photo 5.25 A destroyed building of reinforced brick construction No. 7, Bucharest.

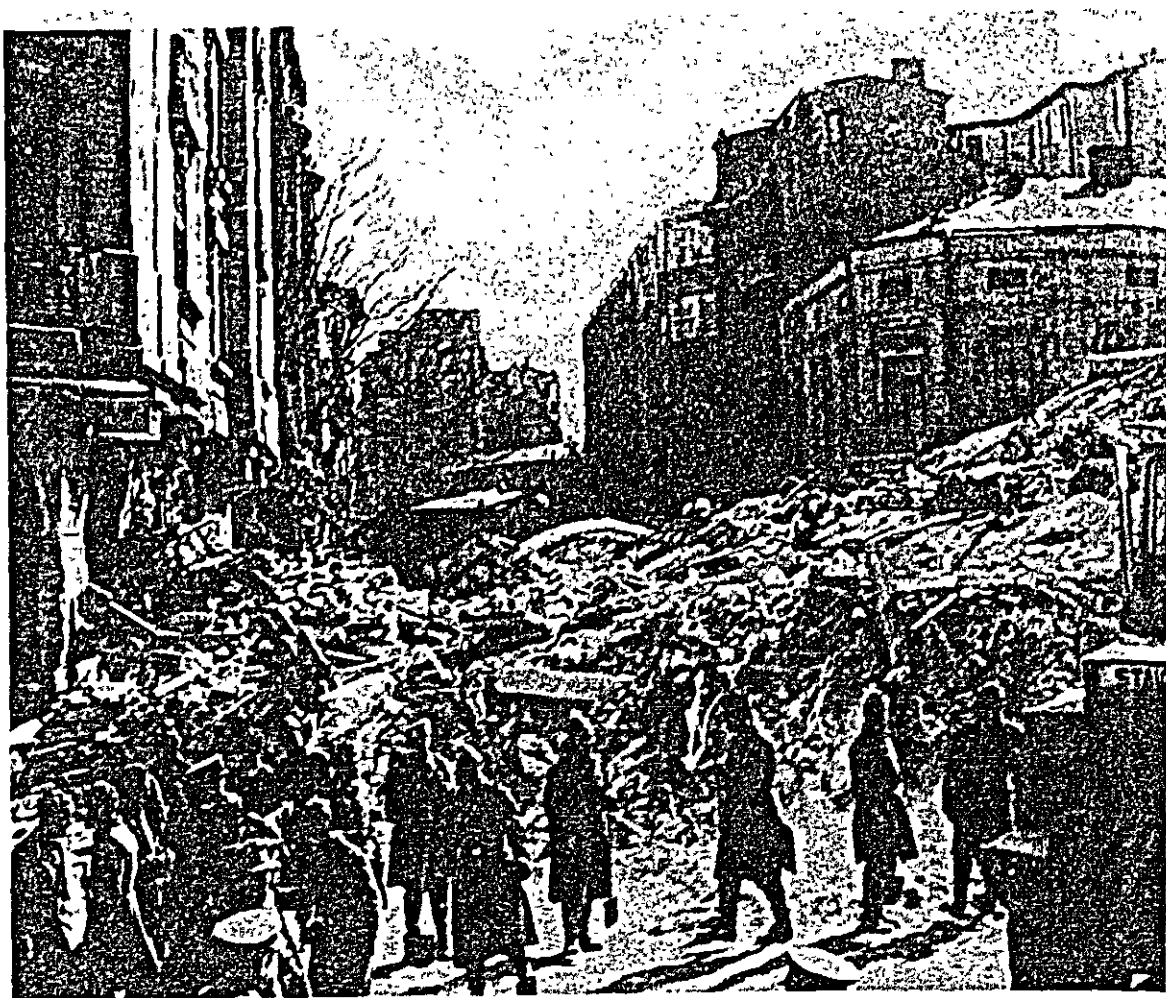
Photo 5.26 A destroyed building of reinforced brick construction  
No. 8, Bucharest.

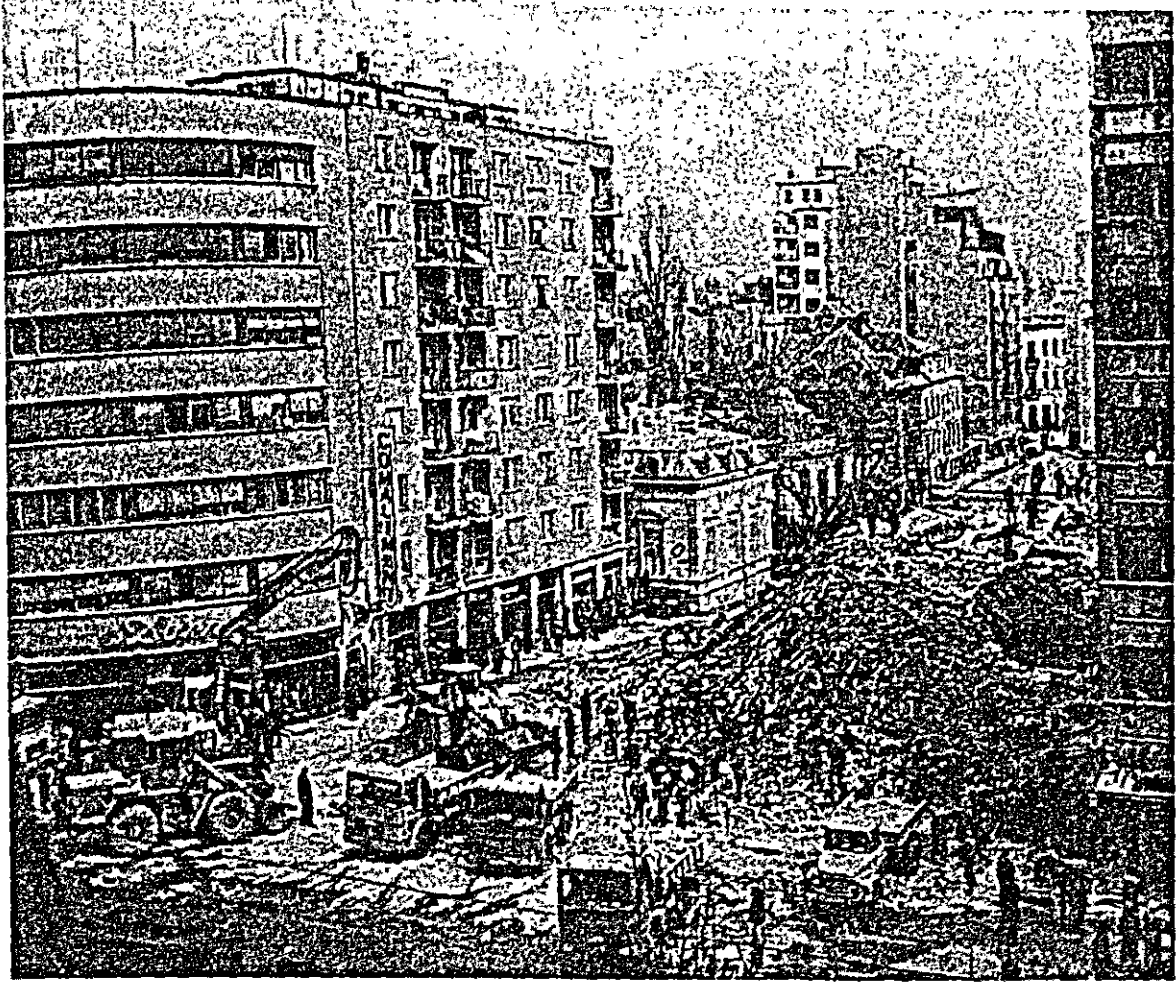
Photo 5.27 A destroyed building of brick construction No. 9,  
Bucharest.

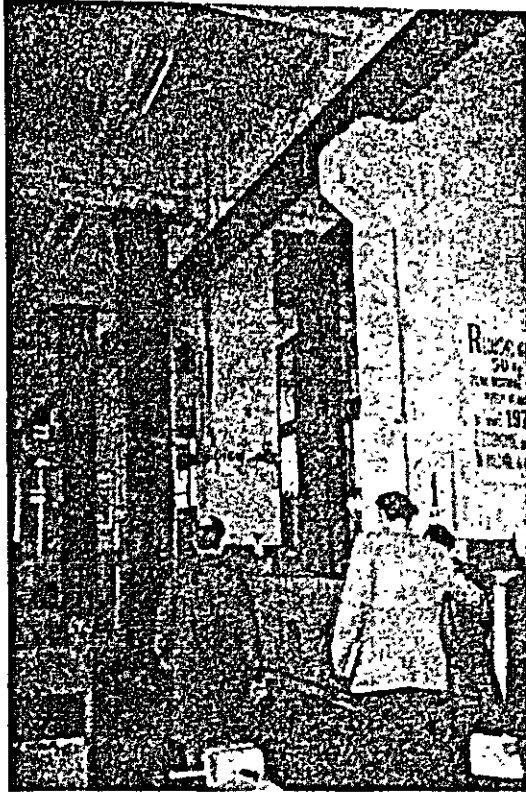
Photo 5.66

Separated concrete surface and buckling of main vertical bars in a column capital. A 5-story industrial plant of reinforced concrete rigid frame structure, Bucharest.
