INVESTIGATION REPORT
ON
THE COUNTER-MEASURES

FOR
THE PHILIPPINE-JAPAN FRIENDSHIP HIGHWAY DAMAGED
BY
TYPHOON DIDANG

AUGUST, 1977

JAPAN INTERNATIONAL COOPERATION AGENCY

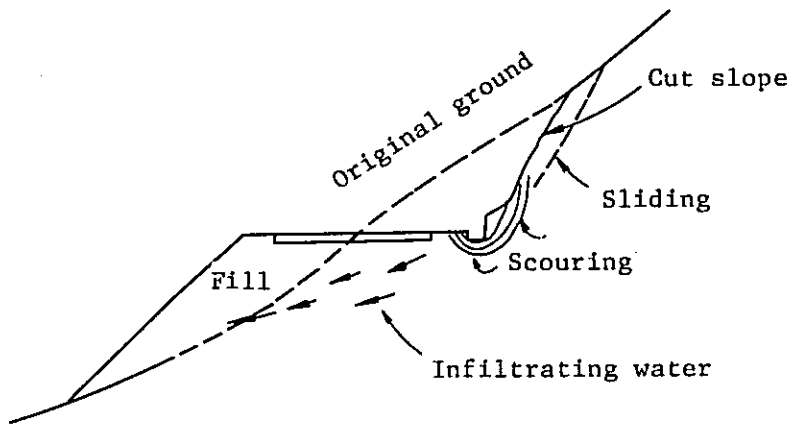
Figure I-4-4 Cut and Fill Section

- c - Similar type with b.
If the water infiltrates into fill section, sliding of fill section will be expected. (Figure I-4-4)

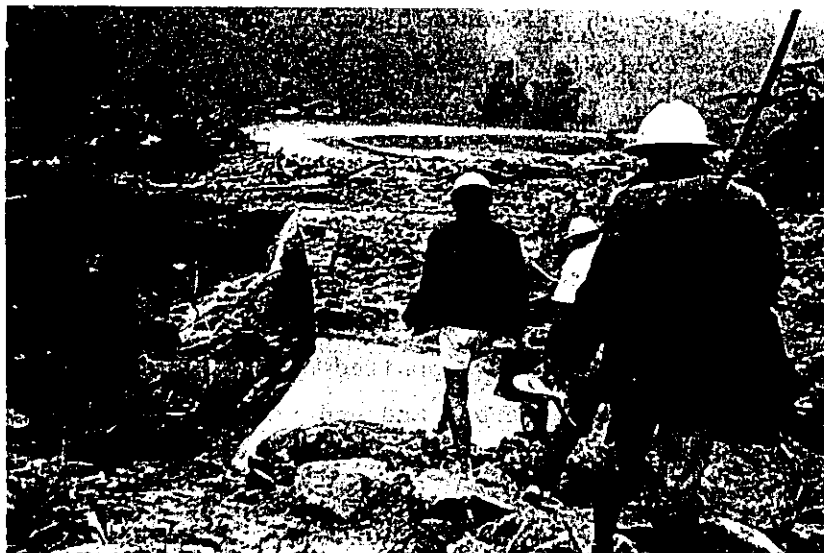
Photo I-4-7 Shoulder Scouring
Surface water on pavement overflowed by the
debris blockade of inlet scoured shoulder.
Sta. 192 ~ Sta. 193

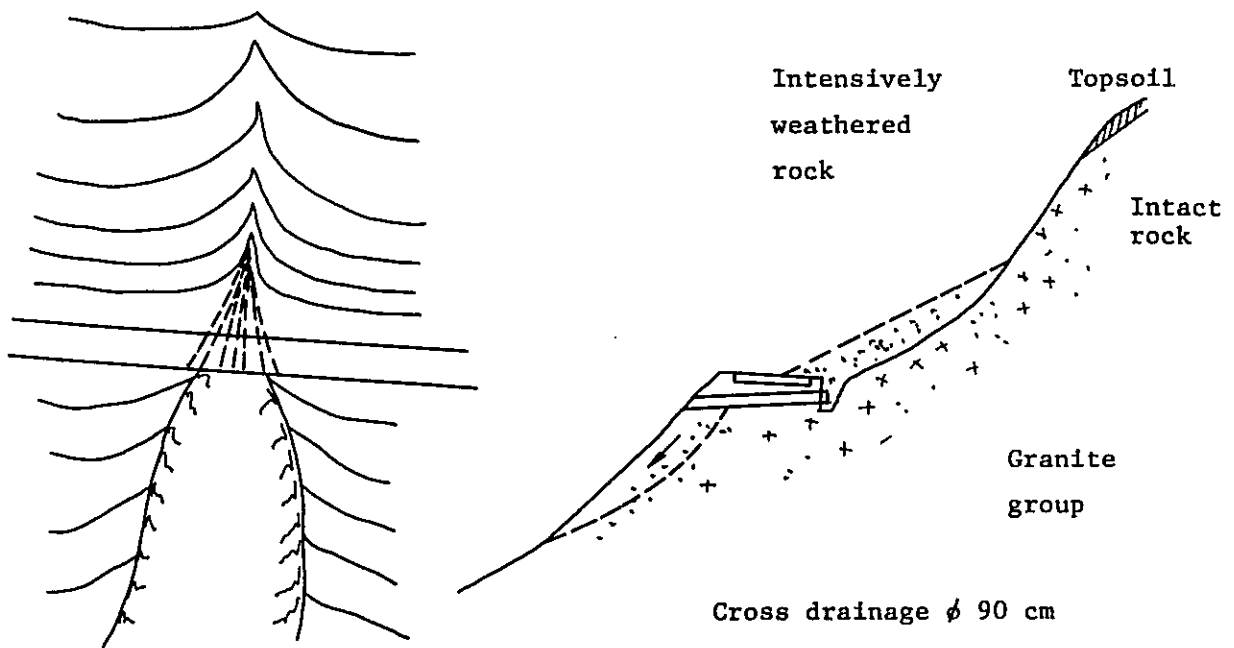
Figure I-4-8 Sta. 213(1)

The surface of slope is covered by weathered granite. The road crosses a small channel. This small channel yielded a great amount of sediment at the height of Typhoon Didang. The sediment deposited on the pavement. The water overflow on the pavement and scoured the embankment and resulted the sliding of embankment including pavement. (Figure I-4-8)

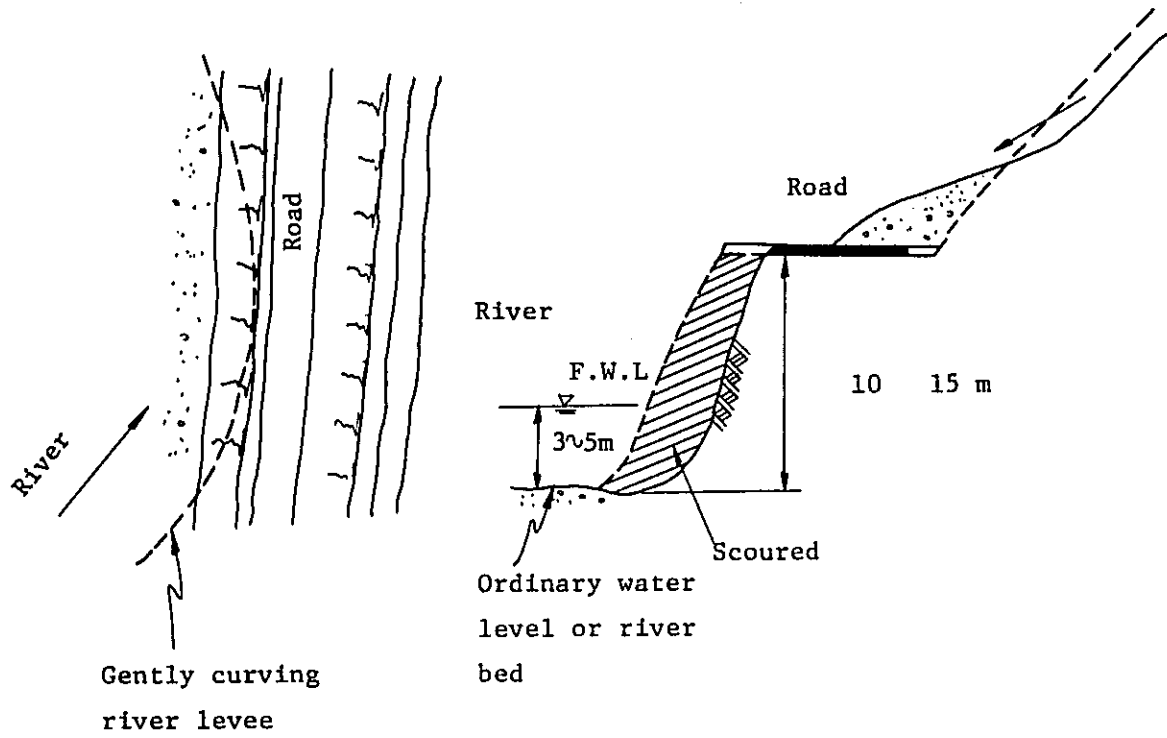
Figure I-4-10 Gently curving portion

Figure I-4-10 and I-4-11 show damage situations by embankment scouring.

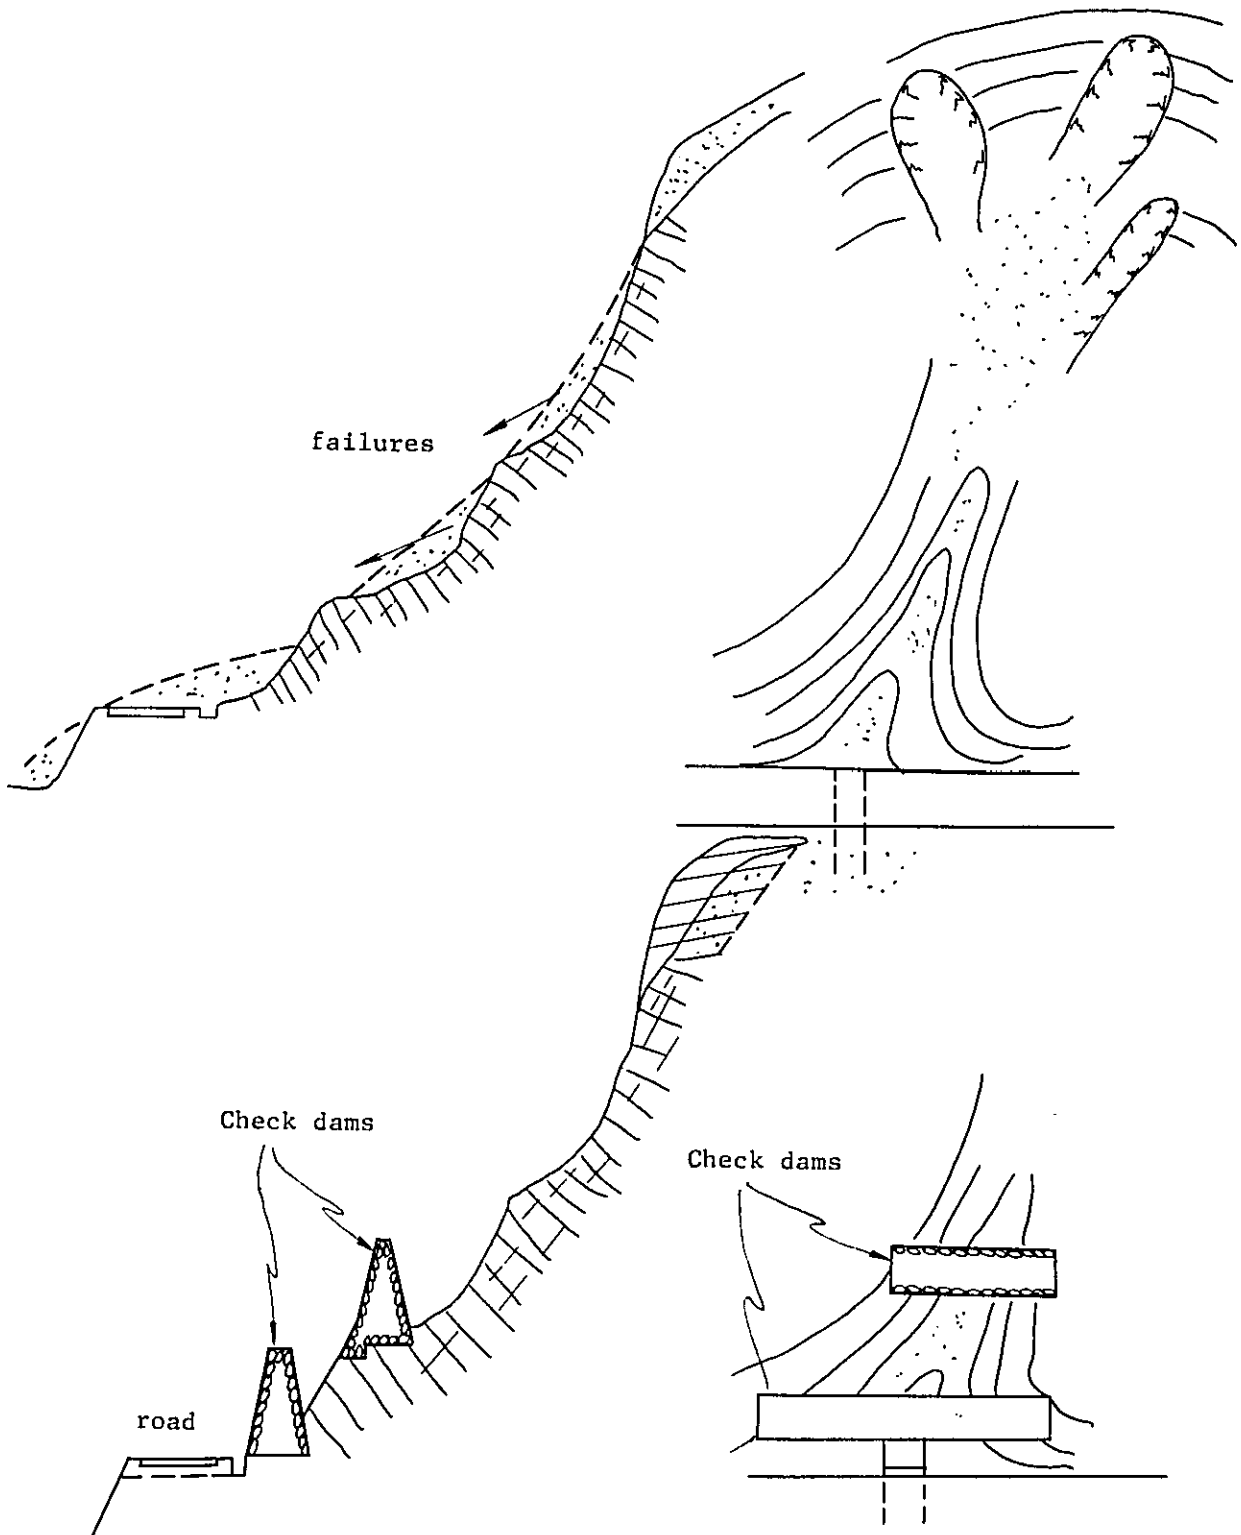
Figure II-1-2(1) Sta. 170 Case I

Failure occurred on the upper part of natural slope, and any slope protection works are not planned here. As the surface is highly eroded on its steep (approximately 50 degrees) and long (60 ~ 80 m length) slope, we can not design the protection works on the failed zone economically. Accordingly followings are recommended on this slope.

- ① Improvement of inlet capacity more suitably.
- ② Sediment discharge control by installing check dams on the channel bed.
- ③ Removal of unstable soil or sediment.
- ④ Removal of silt or sand depositing in inlets and behind check dams by usual rainfall must be necessary.
- ⑤ Road protection by shelter will be required to eliminate the damages against heavy rain as large as typhoon Didang.

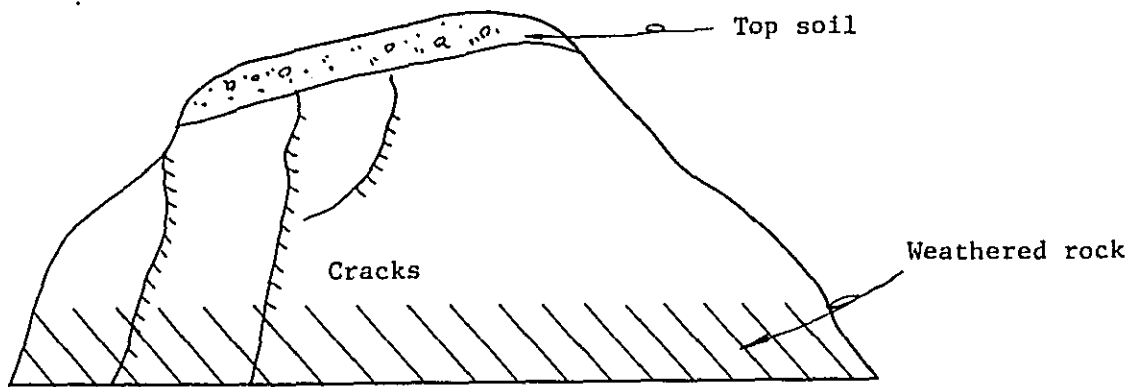
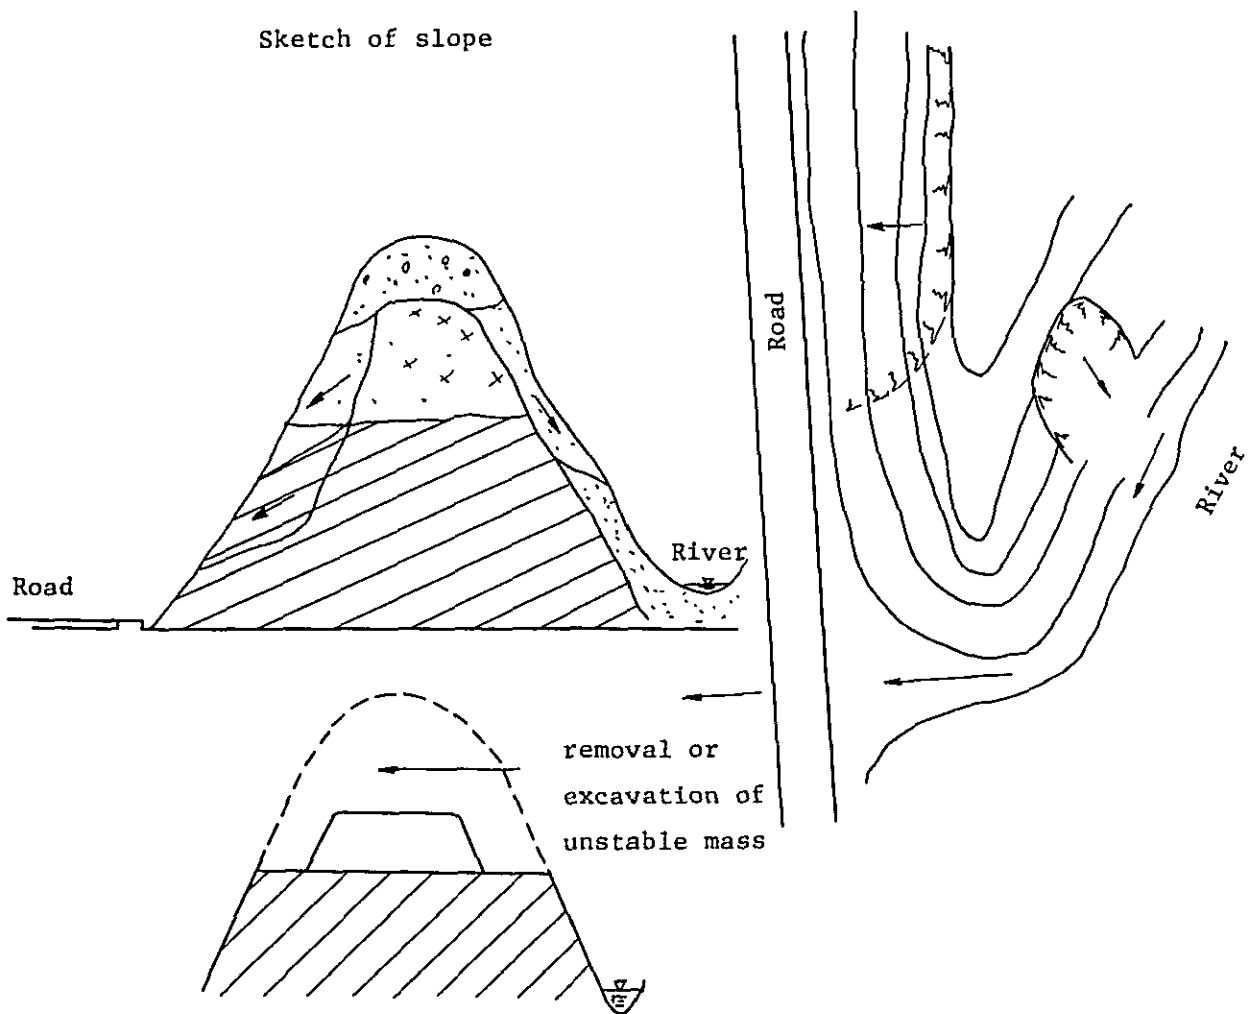
Figure II-1-4 Sta. 193 + 200 ~ 300

The base rock of this slope consists of volcanic detritus and is remarkably weathered. We have to say that this slope is very dangerous because of existence of several clear cracks. The slope is on the skinny ridge and has possibility the failures in both sides. In addition to the failures on the slope facing to the road side, failure on the opposite side of slope has danger of violent damage by damming up the water flow and being destroyed by water flow.

We recommend removal of unstable soil or rock mass from the slope to minimize the damages.

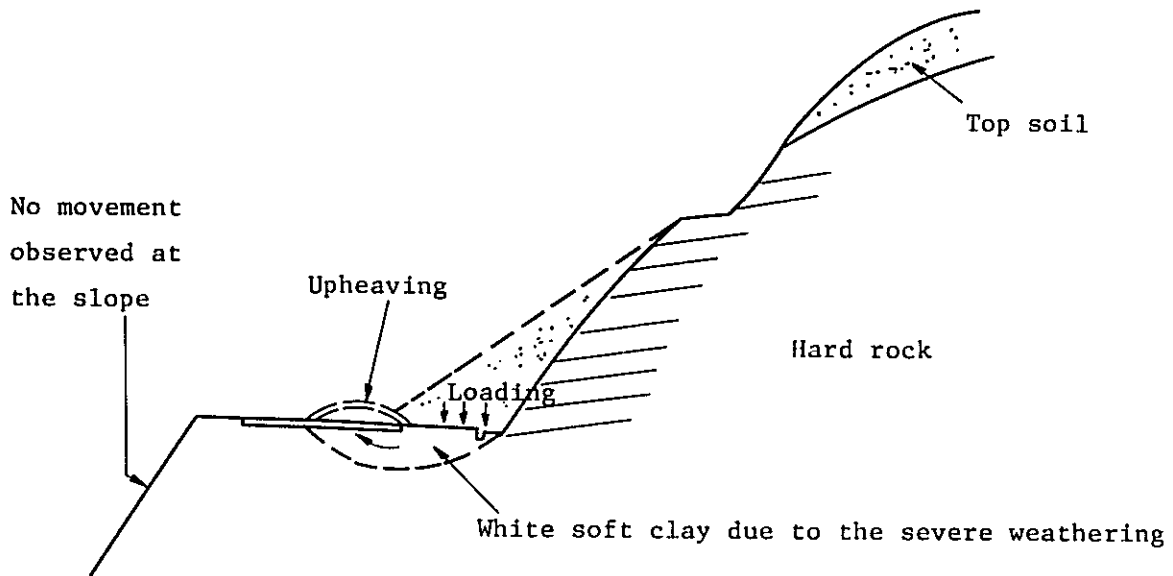
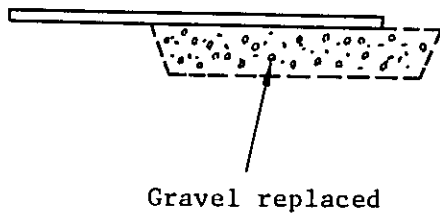
At this point, the road pavement upheaved approximately 1 meter extending to the area of 5 x 10 meters width and length respectively. We can explain the reason of this phenomenon as following: that is, the base under the white soft clay produced by heavy weathering collapsed by loading of failed debris from the slope.

For restoration works, the removal of soft clay and the replacement by gravel was adopted. No symptoms of movement are reported after new pavement. It was suitable remedy works.

The restoration work already adopted to this site is as following:

- 1) removal of soft material
- 2) replacement to gravel
- 3) reconstruction of pavement

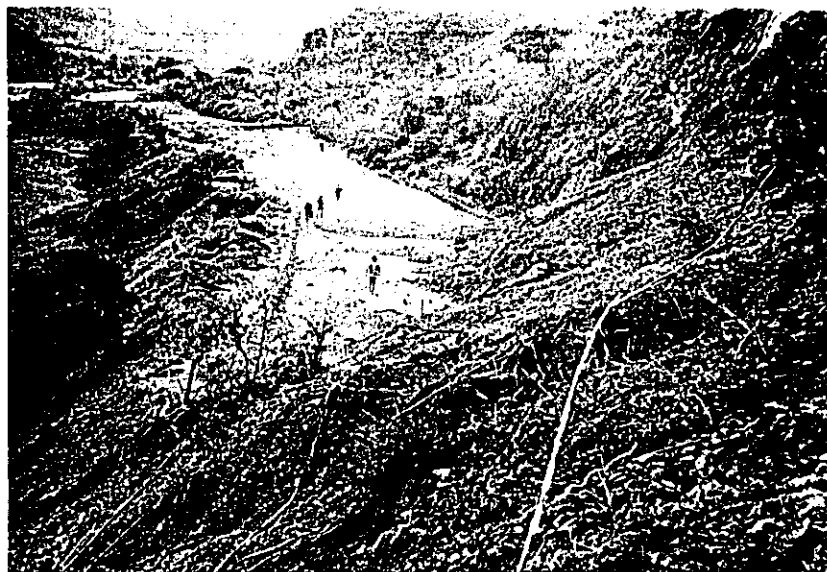
Photo II-1-3

Toe scouring of slopes often results the slope failure.
The failures shown on Photo II-1-2, II-1-3 has the possibility
to be caused by toe scouring.

Slope failures on cut slope. Sta. 190 ~ 191

The prevention of silting in the side ditches is necessary. For this purpose, the avoidance of abnormal curving and abnormal changes of longitudinal slope should be required. Additionally the slope protection behind the side ditches also should be considered for the avoidance of sediment inflow. And we recommend the installation of small retaining wall to protect the toe of slope from the scouring by jumping water in ditches and spring water on the slope.

(Figure II-1-20)

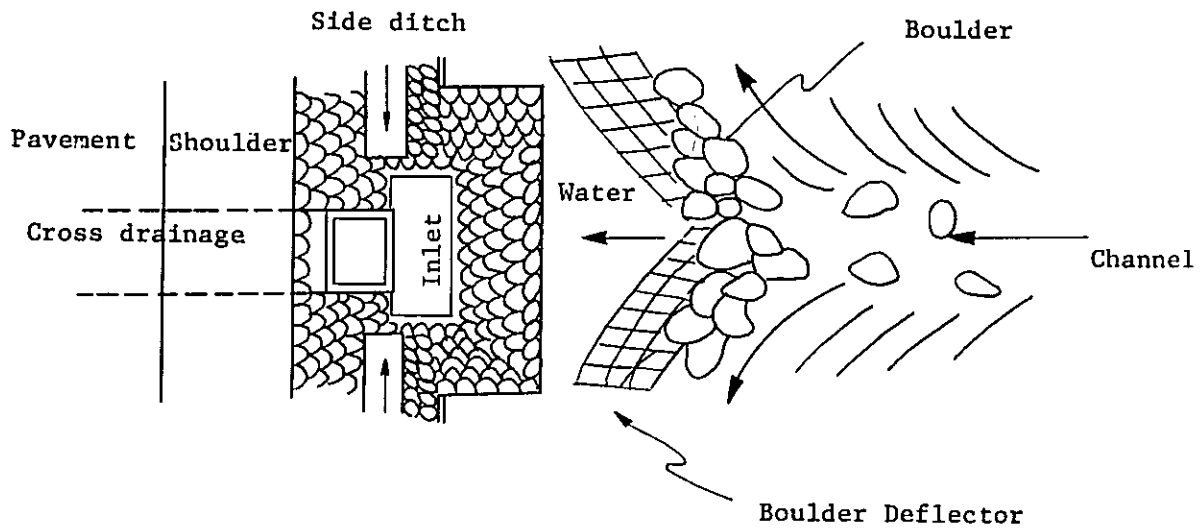
Figure II-1-23 Boulder Deflector

The road is crossing the original channel which debris flow is often expected to be reached to the road.

For avoidance the damages by debris flow, the road is recommended to cross this channel by bridge. Sta. 205 ~ 206

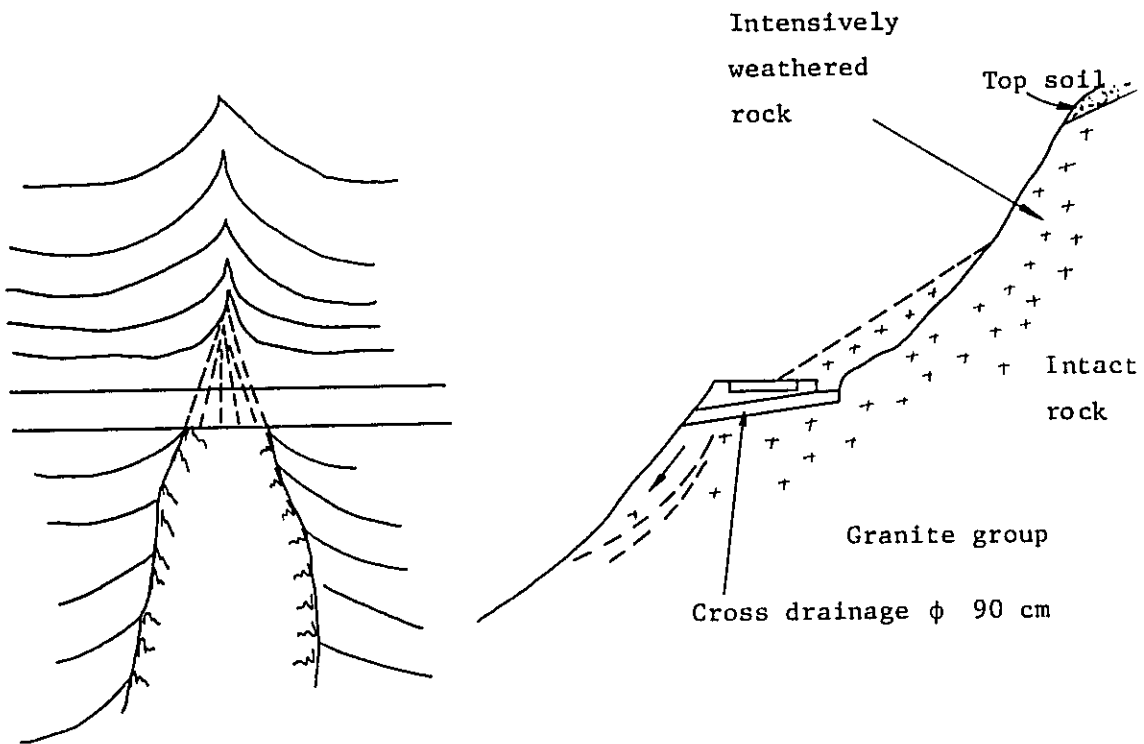
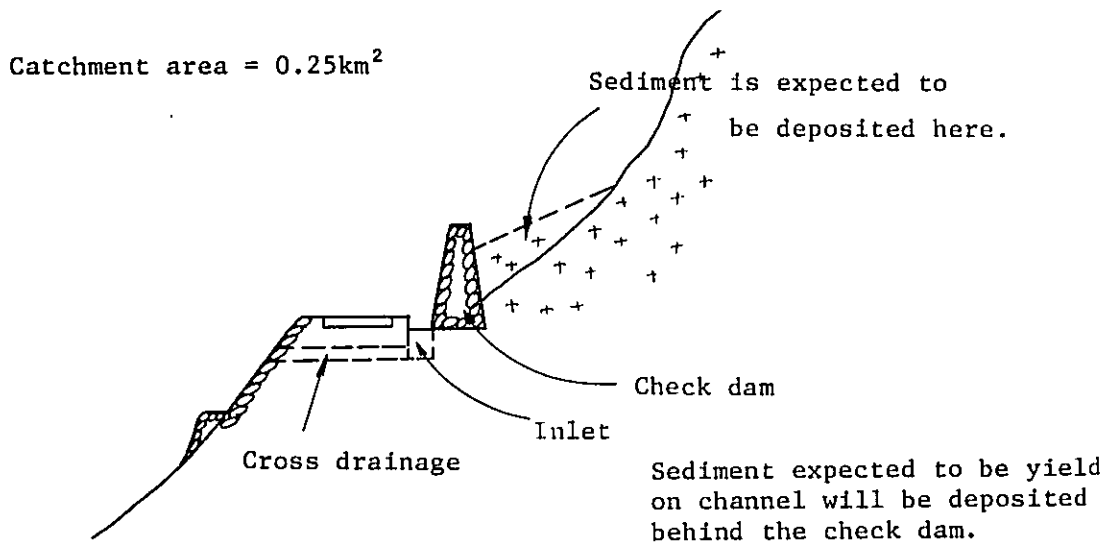
Figure II-1-27 Sta. 213 (1)

After Typhoon Didang, the small check dams by stone masonry were already constructed. This is very suitable for restoration works. We recommend following additional.

Situations of Damages

(i) Improvement of inlet and cross drainage capacity.

(ii) For coming heavy rain, the sediment yielded from channel must be checked by check dams to be installed on the channel bed. The sediment deposited on the road by usual heavy rain must be removed each time.
(Figure II-1-27)

Restoration Works Recommended

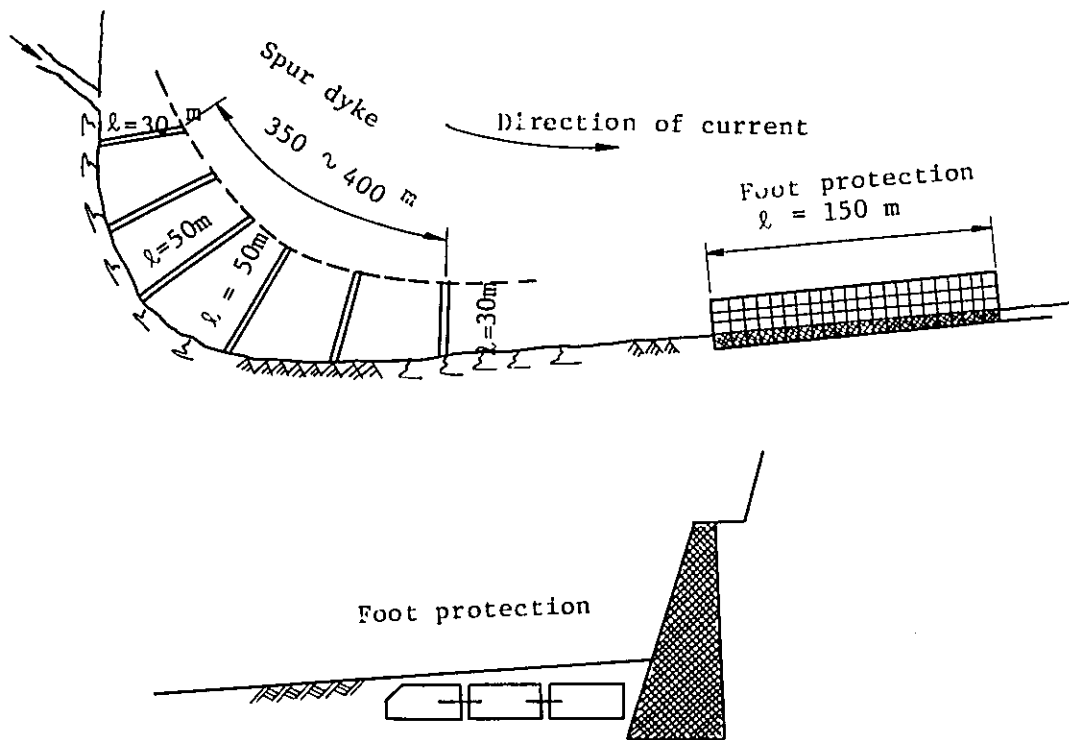
Figure II-1-40 Sta. 170 + 600 Counter-measure Method

After Typhoon "Didang", the road was shifted to cut slope side and was protected by revetment at downstream where the geologic condition is considerably bad.

We recommend to install the foot protection works to protect the revetment foundation and to complete until coming flood.

We recommend here to construct spur dykes promptly.

- i To modify the river curve, the middle part of spur dykes should be longer than others.
- ii Aggregate concrete, cylinder gabion or mattress type gabion are available for spur dykes.
- iii Cutrain block or mattress type gabion is recommended to be used for foot protection.

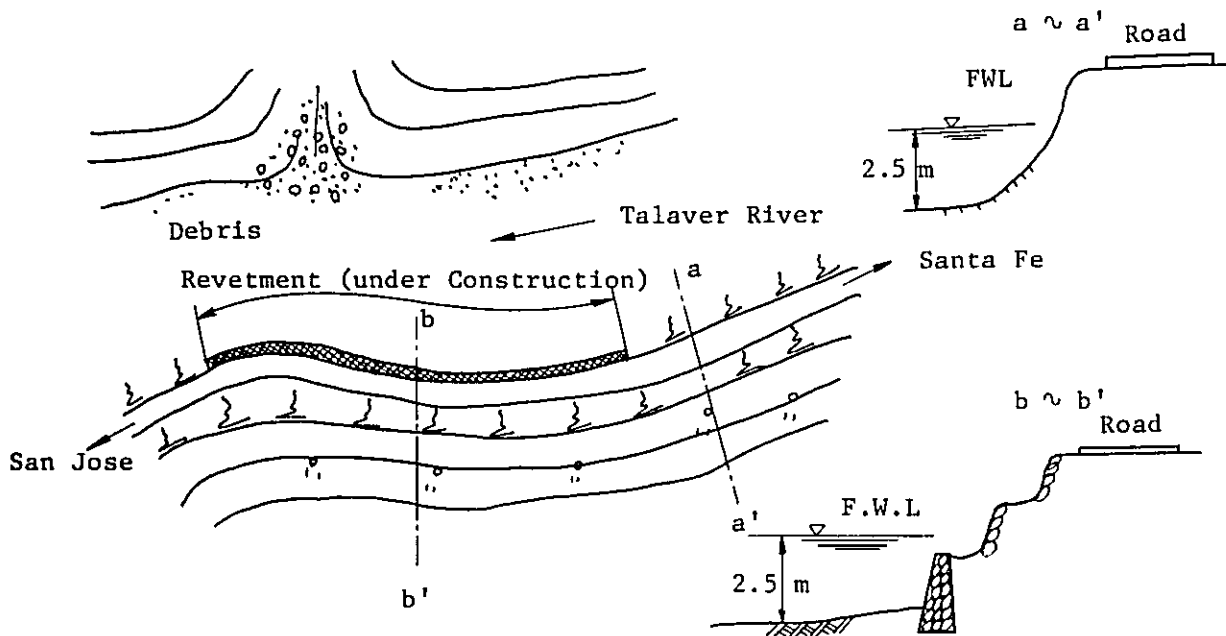
Figure II-1-41 Sta. 187 + 425 Situations

After Typhoon Didang, the road was shifted to cut slope side and revetment is under construction. As the toe of levee will be extremely scoured in future, foot protection works on the toe of revetment must be promptly installed. We recommend to use the foot protection having upward keys as shown on Figure II-1-42 to deflect the water flow, as the river curves continuously.

We also recommend to protect by revetment the natural levee about 100 meters upstream of construction site, because there will be predicted scouring by coming flood.

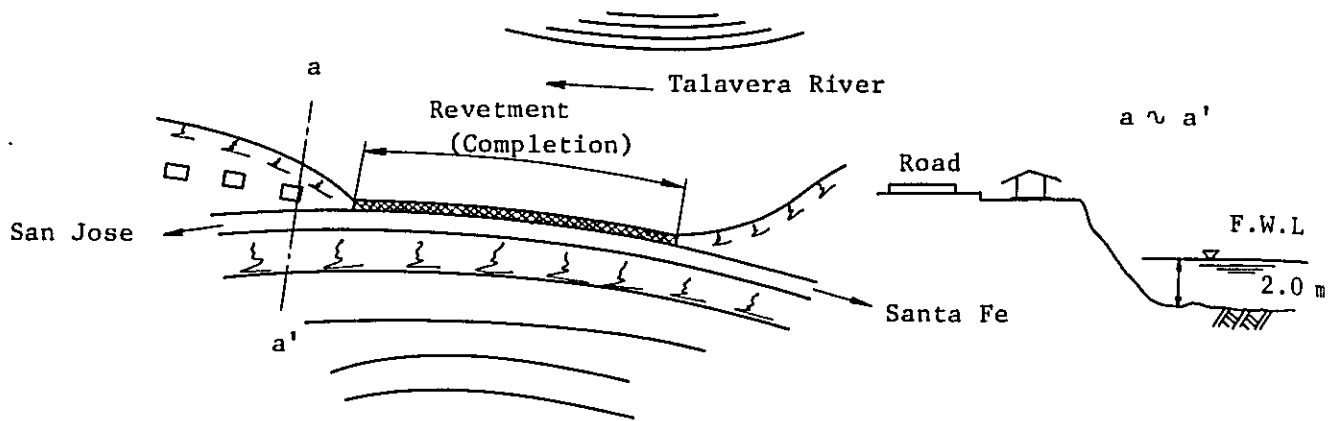
Figure II-1-43 Sta. 189 + 900 Situations

The revetment was already completed at the section which will be affected by levee scouring. The penetration of revetment is more than 1.5 meter deep. Also, levee scouring is not expected heavily judging from river conditions. Accordingly, this restoration is considered to be suitable. Additionally, we would like to recommend the protection of downstream levee of this section, because several households are behind the river and the road is close to the river.

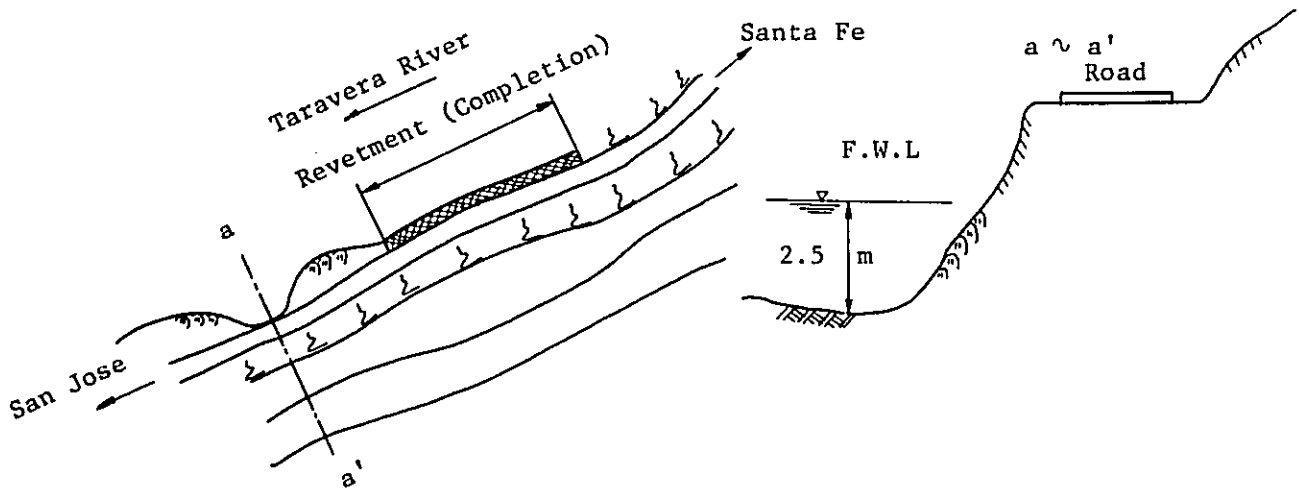
Figure II-1-45 Sta. 192 + 600 Situations

The installation of revetment was already completed at the most severely damaged section. As the both side of this section are dangerous and will be predicted the damages of road by coming flood. We recommend to protect the levee by revetment at both sections. For sometimes although the scouring of levee is not so important, foot protection works or spur dykes will be required in the future to reduce the river bed evolution.

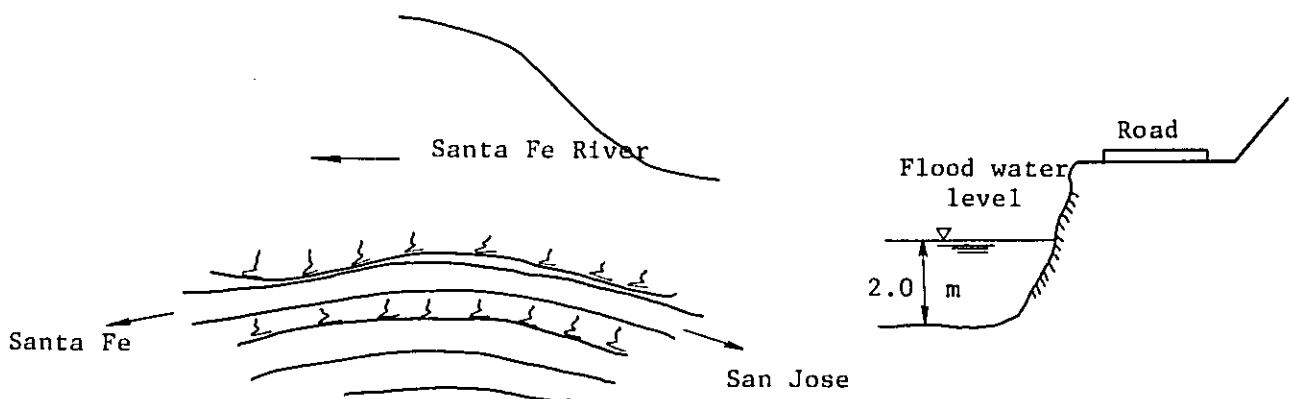
Figure II-1-47 Sta. 217 Situations

Damaged portion is the gentle curving section of the Santa Fe River. In immediately downstream, spur dykes are installed.

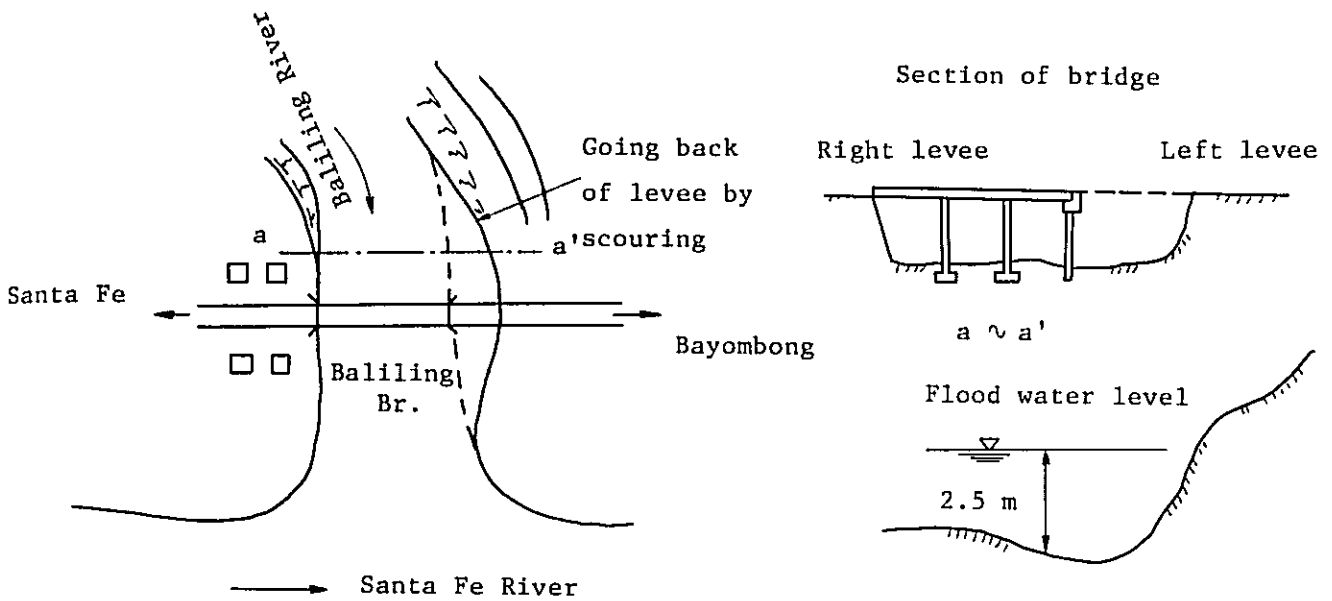
Figure II-1-49 Sta. 220 + 500 Situations

Damaged section locates just upstream of confluence of the Santa Fe River and the Baliling River. The left levee of the Baliling River curves toward road.

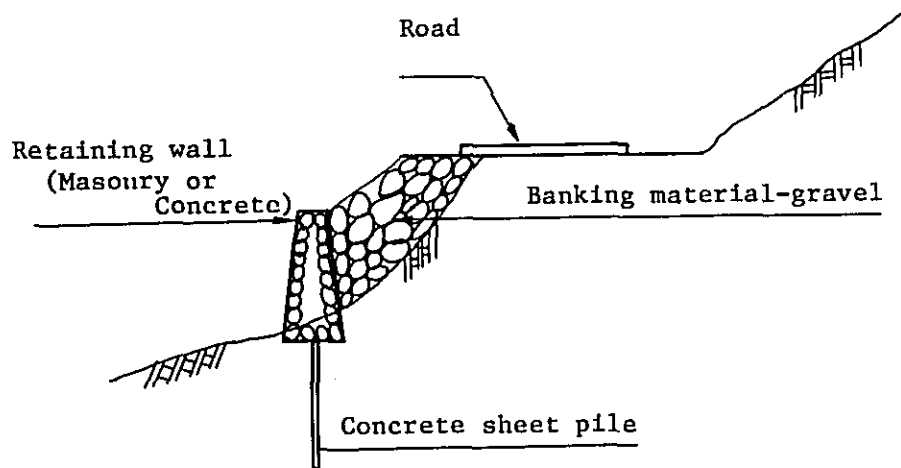
Figure 5-3

Damages of the road in the mountainous zone are observed at about seven parts of the total extension. In all instances, such damage appears to have arisen from softening of the fill-up base of road due mainly to precipitation over the slope face of the road and surface water from the road. Thus, the pattern of damage seems to be almost common and identical to all of seven parts.

Restoration work from damage is already finished up with built-up of stone masonry. Appropriate measures are taken, wherever deemed necessary, to be suited for the site condition, for instance, by use of concrete sheet pile for the base of masonry or by replacement of banking soil with gravel.
