SURVEY REPORT
ON
THE LONG-TERM MULTIPURPOSE DAM SCHEMES

APPENDIX II GEOLOGICAL SURVEY

JUNE 1978

JAPAN INTERNATIONAL COOPERATION AGENCY

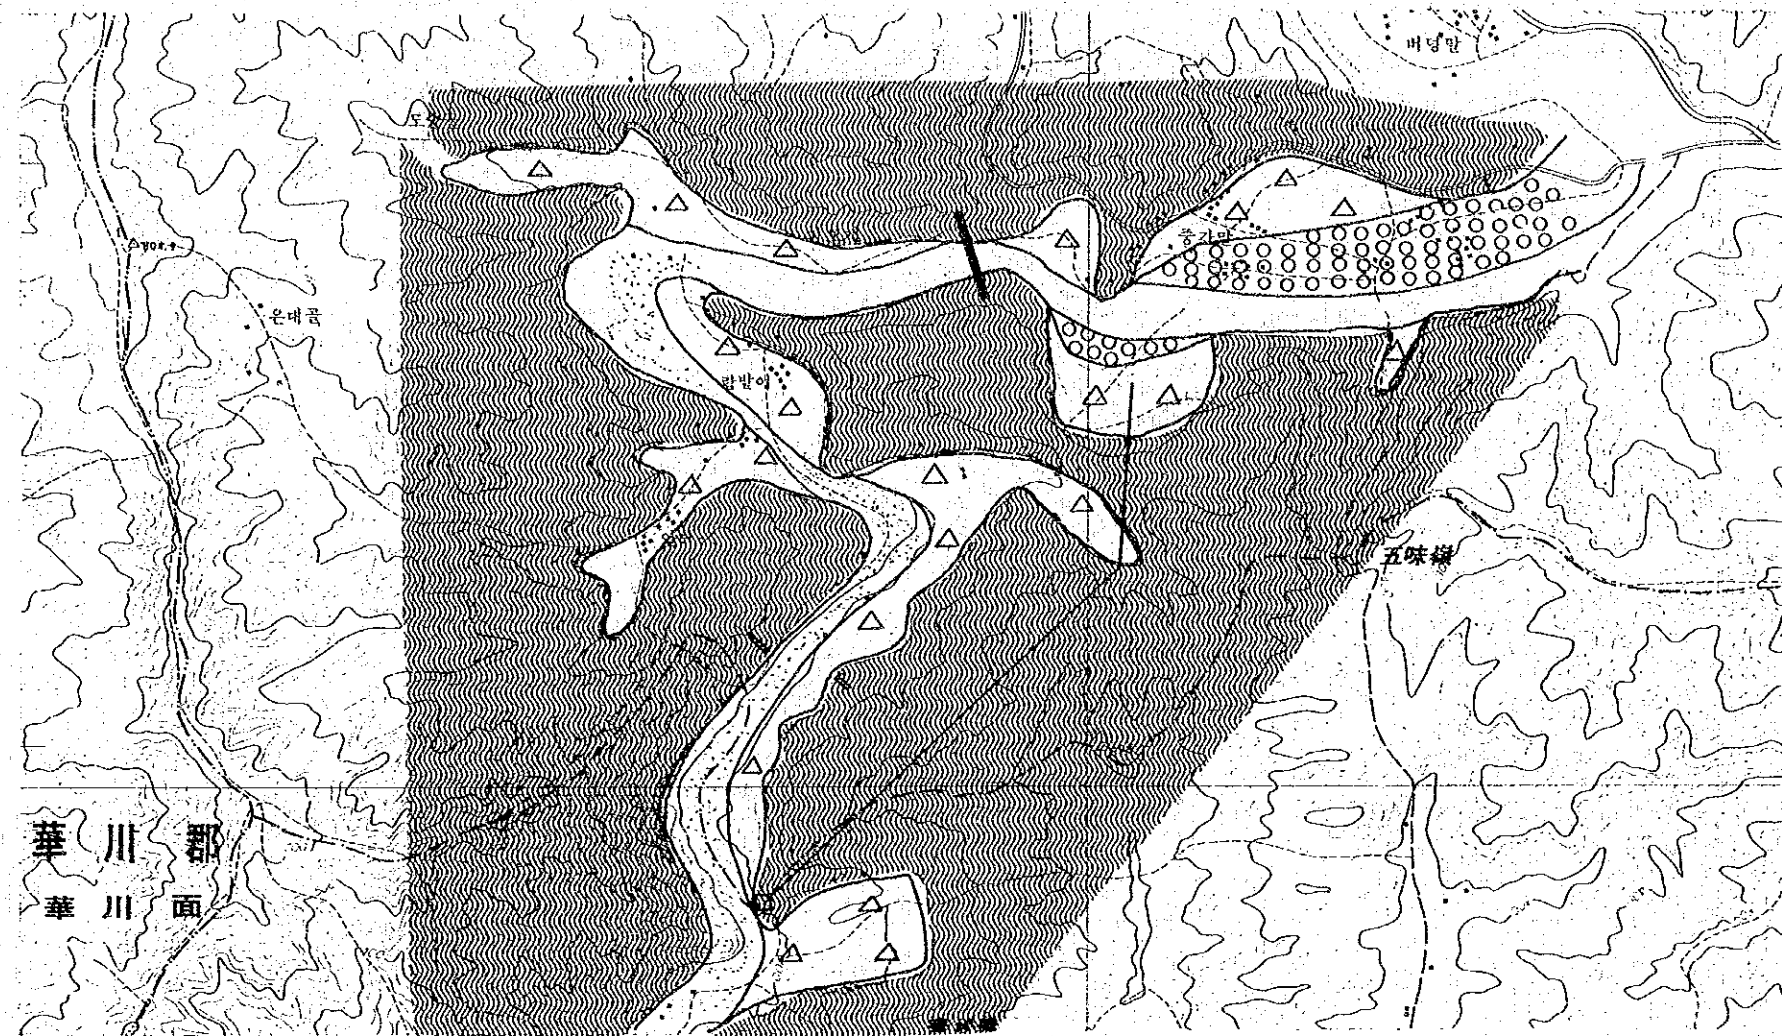
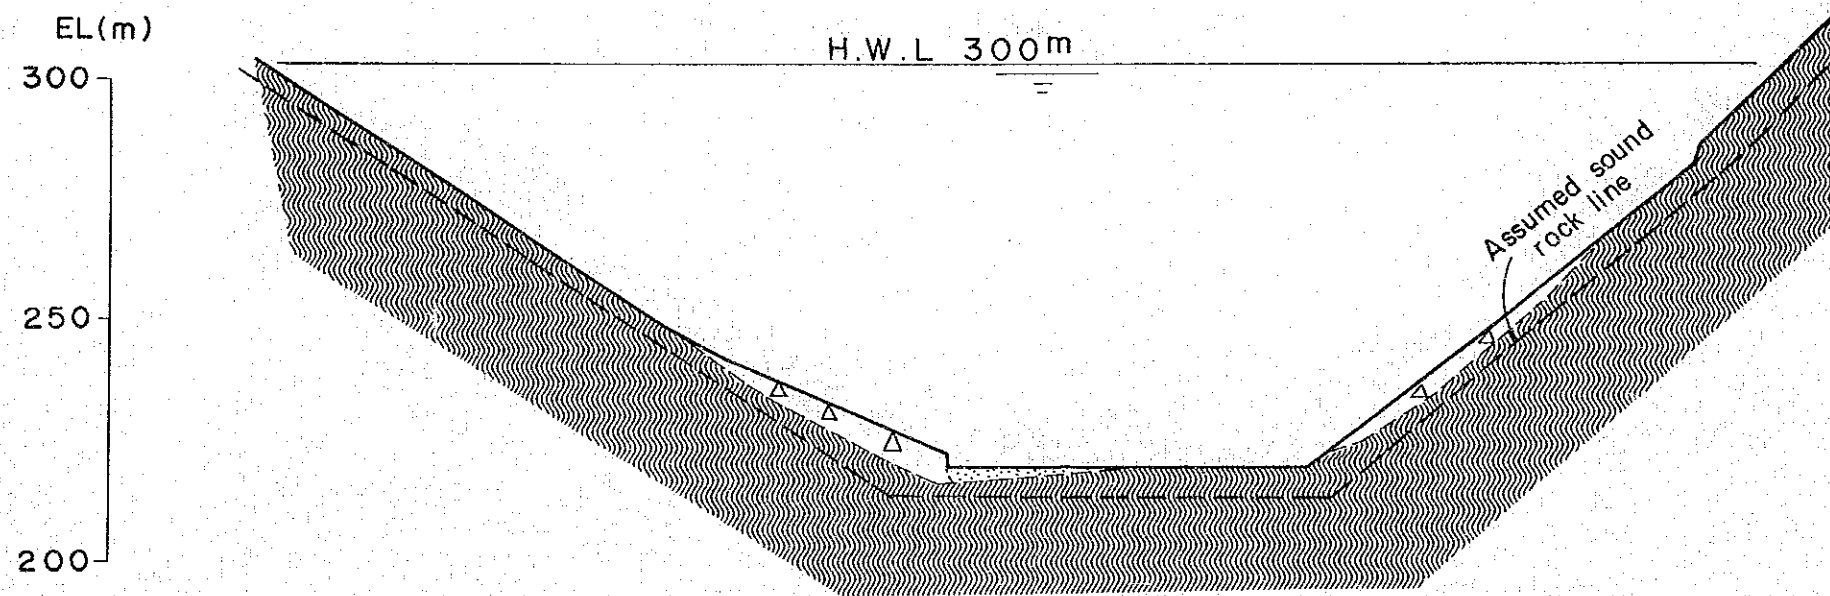
A damsite is selected at transition from valley plain to gorge channel. Left bank slope is a nose of hill ridge of 35°, with talus slope of 22° in its lower portion. The thickness of the talus increases at the downstream side. Left bank ridge is followed by a saddle ridge in its extension. High water level and the elevation of the saddle should be carefully studied for possible leakage of impounded water.

Steep slope on the right bank is mostly covered by surface soil. Base rock is exposed partly. Hard and fresh rock is available after thin excavation of the overburden. Big fault or fractured structure is not found around the site.

- A) River channel is meandered in flood plain in its upper reach and a damsite is selected at rocky gorge section at just end of the meandered channel. Left bank talus, on the other hand, increase its thickness in the downstream side. Layout of dam base is confined in narrow area. Design and layout of dam body should be carefully studied.
- B) Most important problem is to find out supply source of impervious material. A series of valley plains in the upper reaches should be surveyed again to find out suitable soil material. Another possible source can be expected in the weathered granite area, 5 km east of the damsite.
- C) A concrete gravity dam is also adoptable, if geological condition on the left abutment is favourable after detailed investigation.

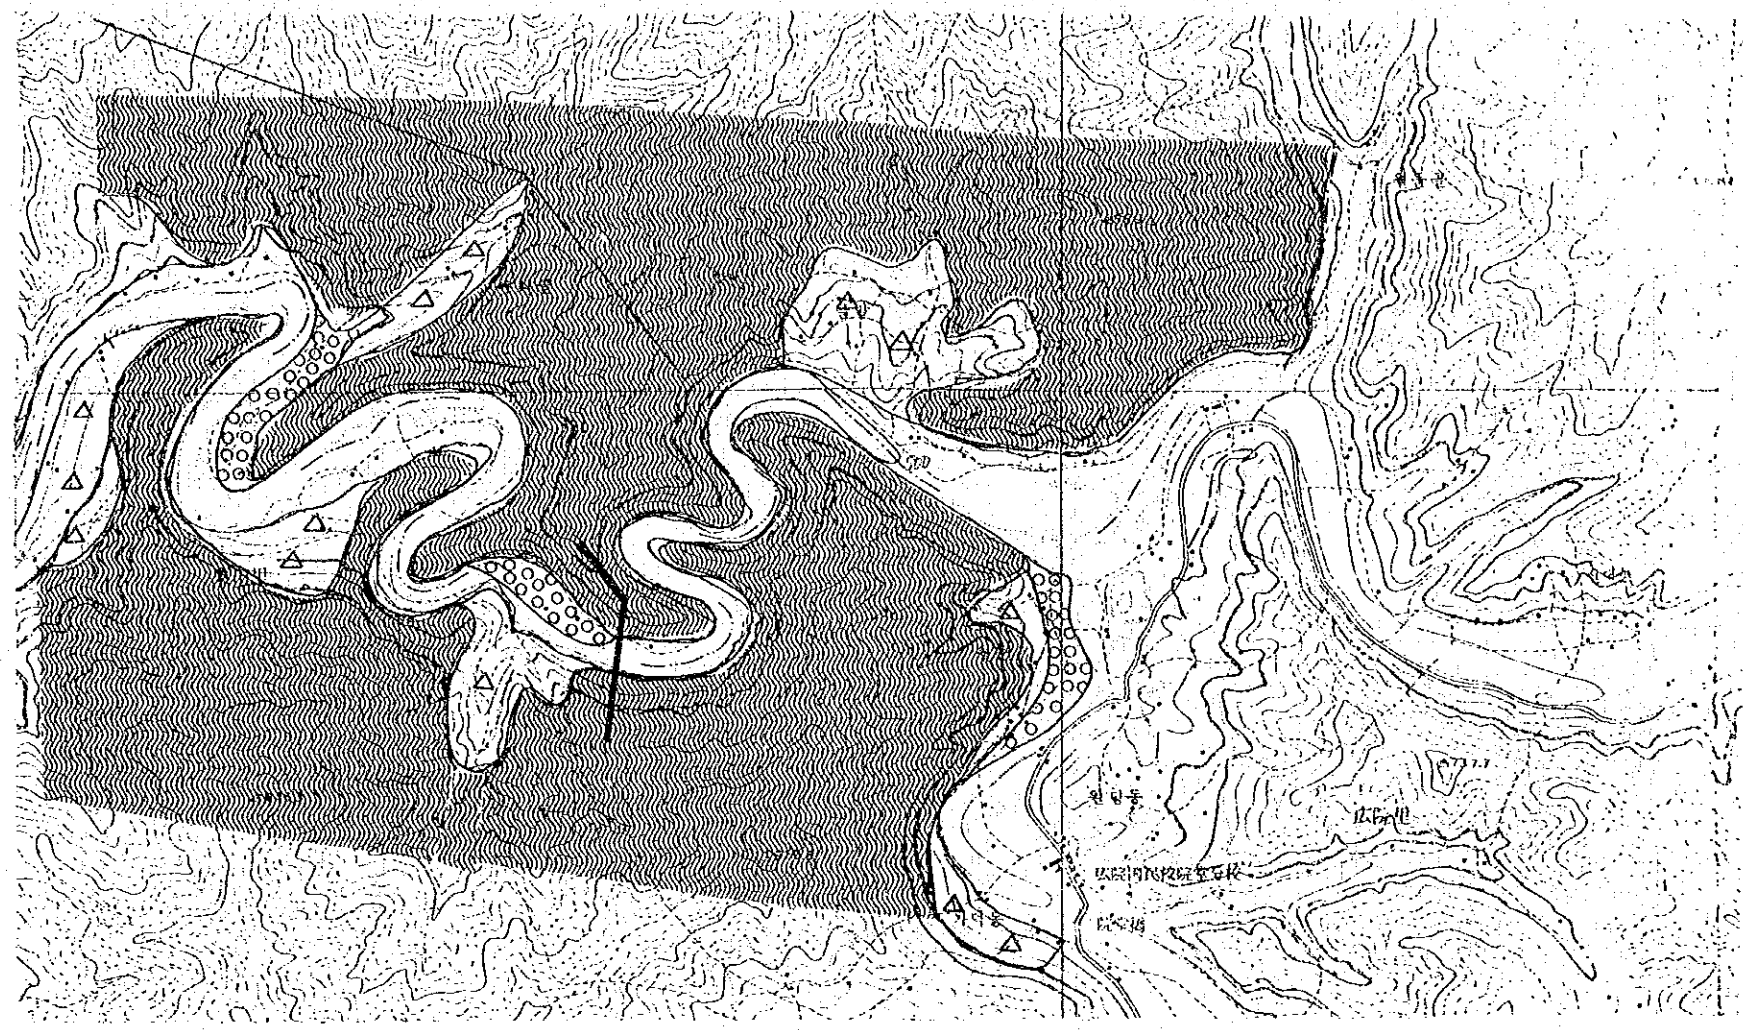
foundation for the dam. In the riverbed, rather thin deposits of gravel are covering hard and sound base rock of granite gneiss underneath.

Spillway: Spillway can be laid either on left bank or on right bank side from the geological point of view. However it is better to lay on the right bank side under the topographical conditions --- using the thin ridge as an overflow crest.

Tunnel: Tunnel of 11.5 km length is passing through granite gneiss mass on the right bank side. The gneiss is firm and sound. There may be no big fractured zone that may cause spouting of ground water.

- A) Base rock in the project area is a sound granite gneiss, providing firm foundation for all structures.
- B) Special investigation will be necessary on the thin ridge on the right bank side. Bearing strength and permeability on the ridge ground should be carefully confirmed.
- C) It is required that confirmation and selection of borrow pit for exploitation of impervious materials.

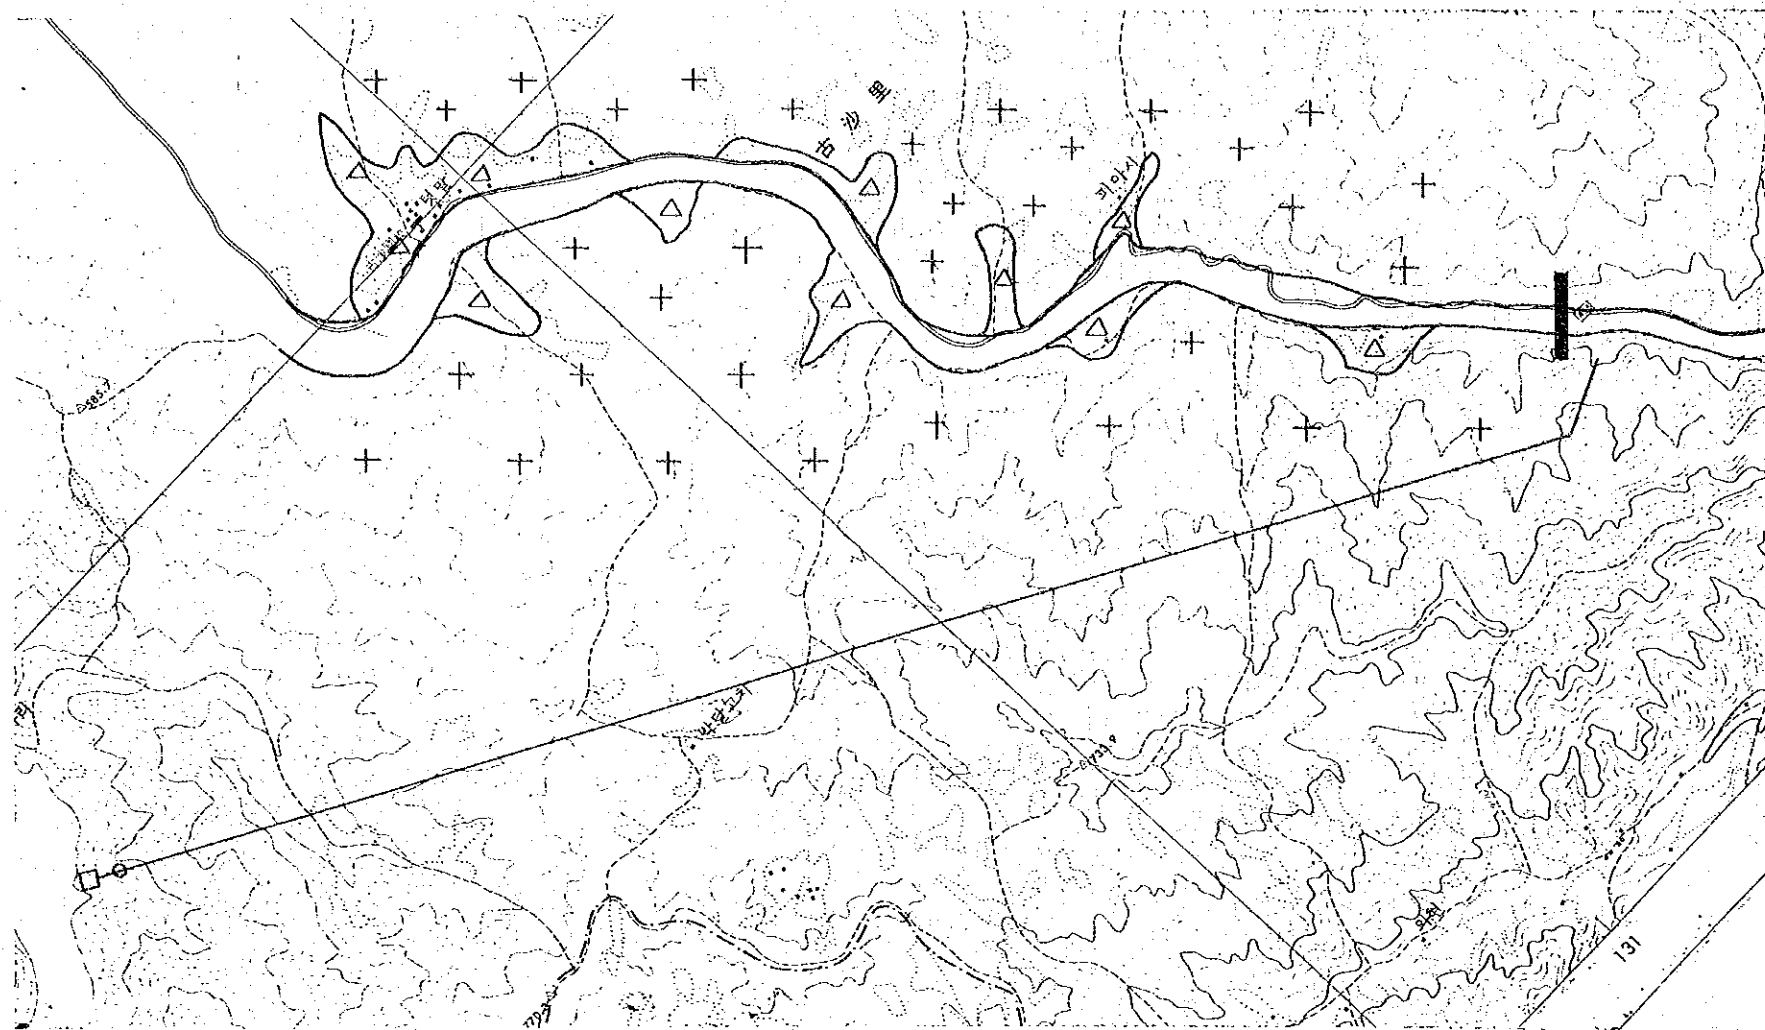
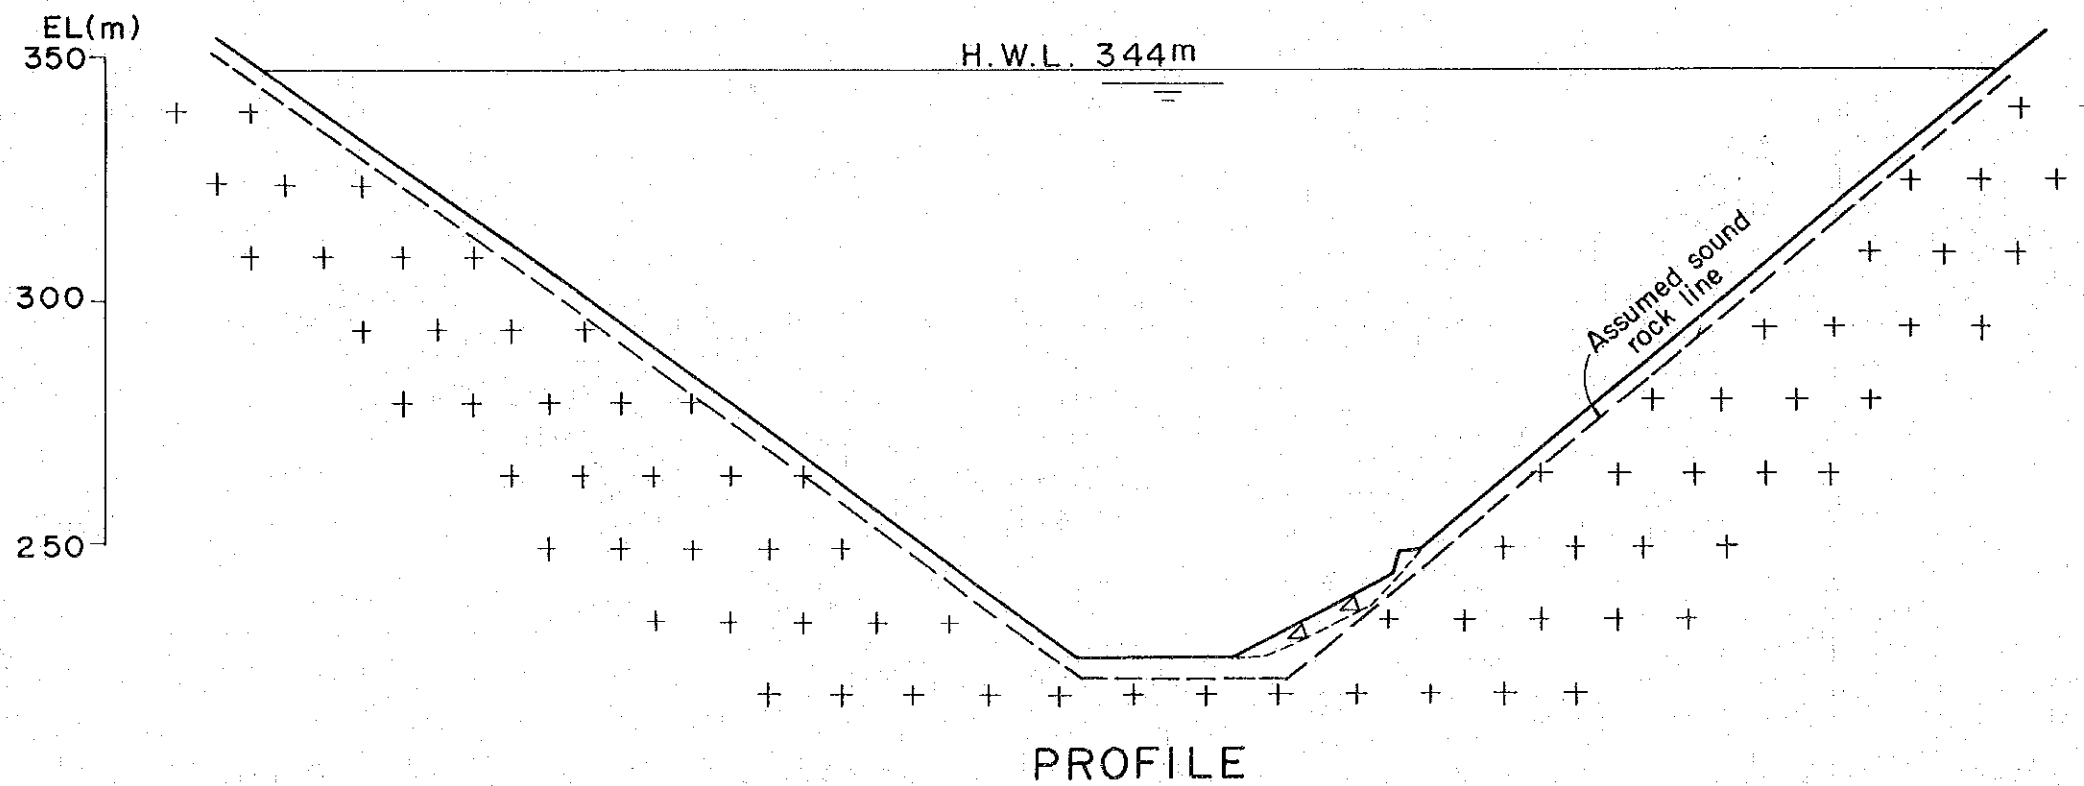
Base rock is generally composed of hard granite. Granite rock is exposed on most of the left bank slope. Surface weathered zone may be 3 - 4 m thickness. There may be some seepage through joints or cracks. Riverbed gravel sometimes contain big boulders. But firm and sound granite rock can be expected beneath thin deposits. Right bank slope

is covered by surface soil of 1 - 2 m thickness, and talus deposit at the foot of the slope, except granite exposure at water's edge and road cut portion. Dambody can be abutted directly on the fresh and sound granite after excavation of these overburden. There is no evidence of big fracturing or fault around the damsite.

Tunnel: Intake tunnel will be opened on the left bank just upstream of the dam. Tunnel of 5.2 km length is extended to the back water of the existing Soyanggang Reservoir. Tunnel route will pass through granite and granite gneiss. There may be some fractured zone encountered at the boundary of granite and gneiss in the middleway of the route. Tunnel driving through the fractured zone will accompany some troubles such as groundwater spouting or cave-in.

Penstock and Power station: Penstock line will be laid on the rocky slope of granite gneiss which will provide firm and sound foundation of anchoring the pipe line. Power station will be built on the riverside slope which had submerged by the backwater of the Soyanggang Reservoir. A large excavation of rock is required to prepare the building space. High cut rock face behind the station should be carefully protected against rock fall.

- A) Hard and fresh rock of granite distributed extensively exposed around damsite, providing favourable site. Selection of dam axis on the rugged valley wall should carefully be done after detailed study of topography and geology.
- B) Possible leakage through joints and cracks at the left abutment should be carefully studied.
- C) Location of impermeable core material in case of rockfill dam is not established yet. Wide area survey to find out suitable borrow area for the material is urgently needed.

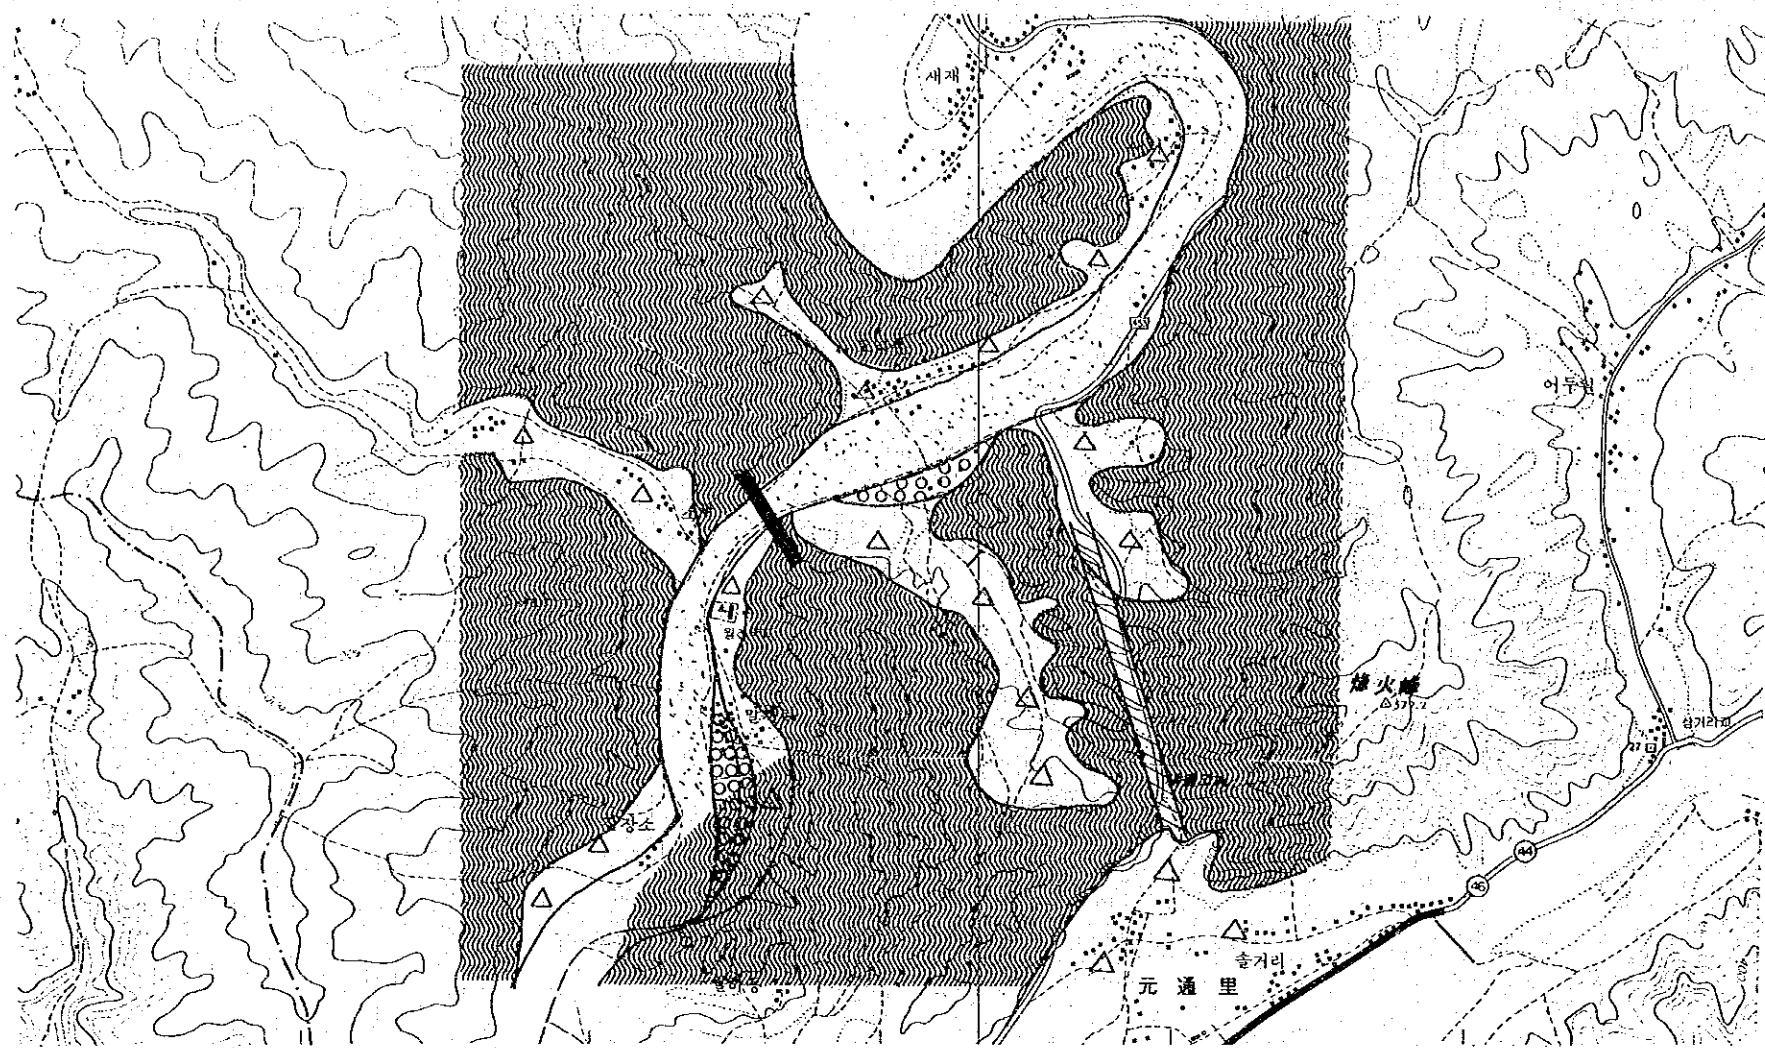
The southern slope of the path (saddle) is 30° in gradient and water table seems to be low at present. When impounded, leakage through the sheared zone will probably cause landslide on the southern slope, therefore, the countermeasures against leakage should be needed based on the detailed investigation.

The left abutment is formed of a low terrace field, a talus slope and a hill slope in ascending order. The terrace gravel is overlain with the base rock of granite gneiss with thickness about 10 meters. The talus deposit covers the said terrace gravel at the hill foot with about 10 meters thickness in maximum. The hill is formed of granite gneiss covered with top soil. The weathered zone of granite gneiss is assumed to be about 5 meters. Talus deposit, terrace gravel and weathered rock should be dug out at the foundation of the impervious core of the dam.

Penstock and power Station: The penstock is to be constructed at the left bank formed of granite gneiss. On the slope of the hill. The firm foundation will be found beneath the weathered zone, however, at the slope end, deep excavation of talus deposit will be needed to reach the foundation. The power station will be placed on the terrace ground where the firm foundation exists deeply.

- A) The saddle, where a great sheared zone occur, will give a serious problem of leakage at the left bank of the reservoir. It is better to lower the high water level.
- B) Talus and terrace deposits will be thick at the left abutment. Detailed geological investigation will be needed to confirm a suitable firm foundation.
- C) Topographically, the proposed dam axis will be acceptable at the present surveyed line.

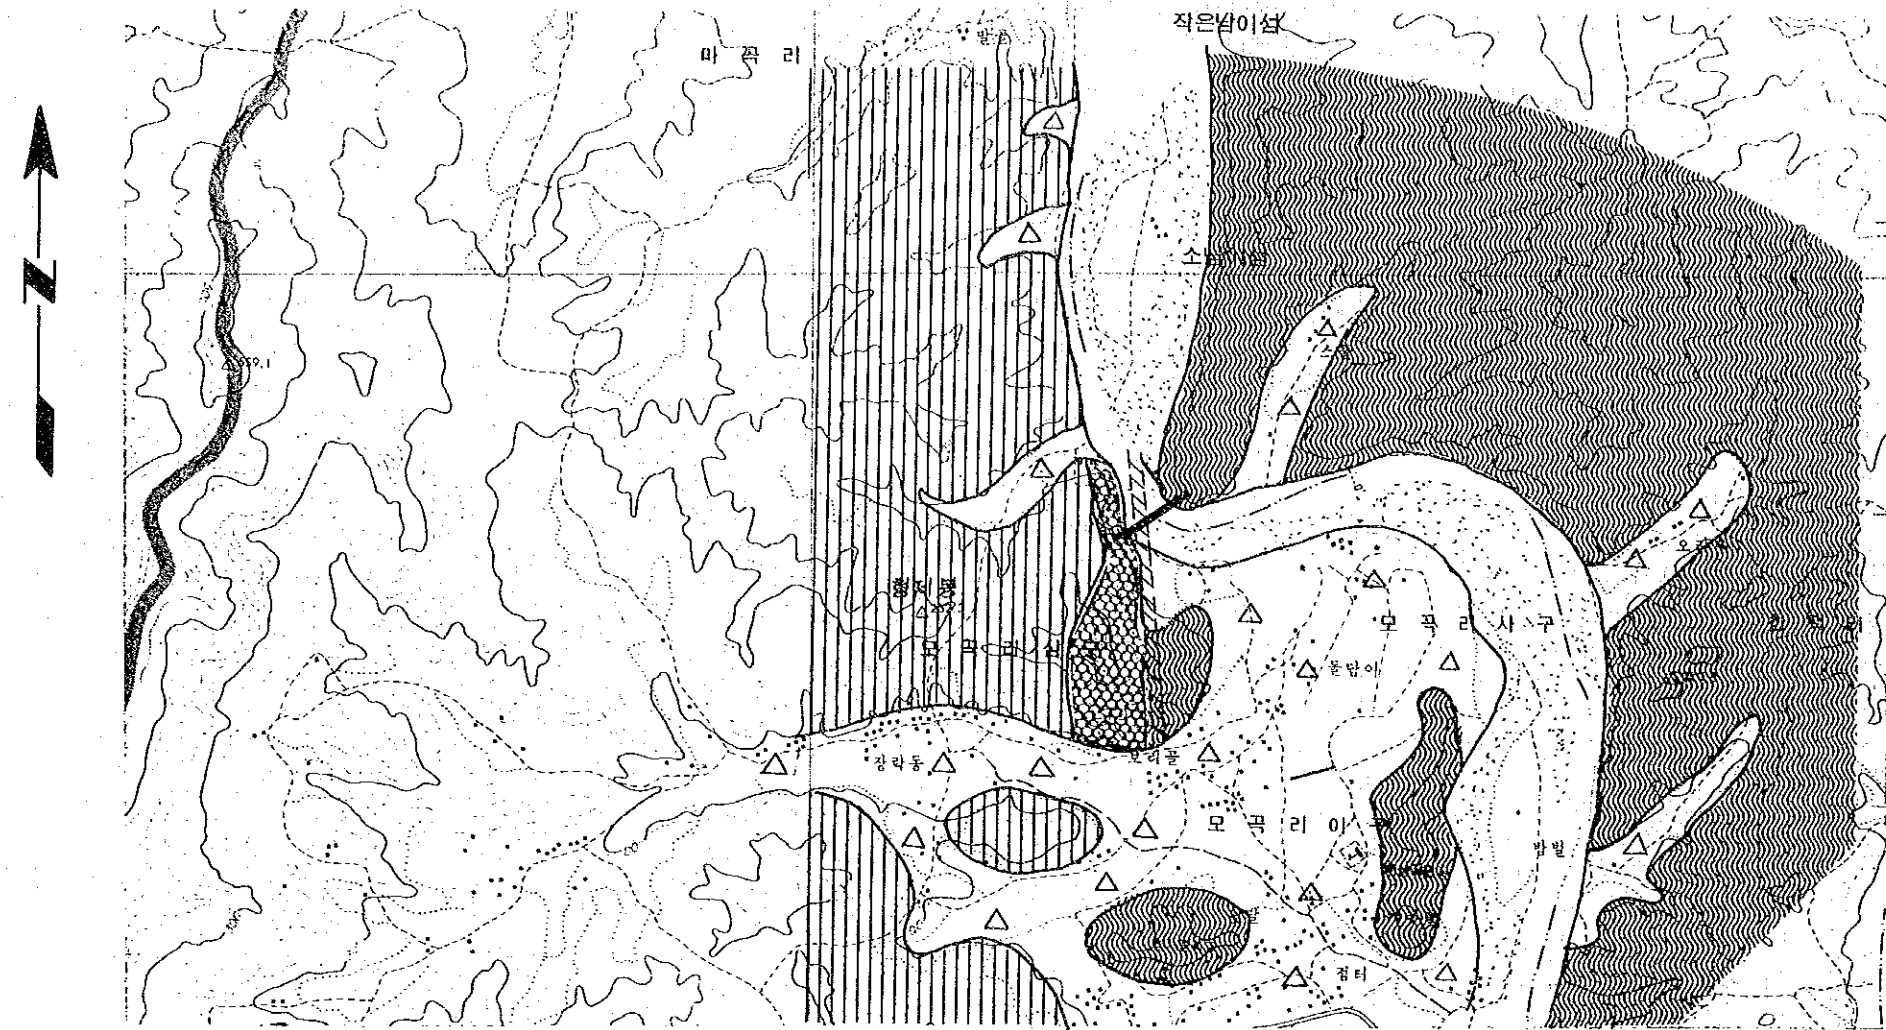
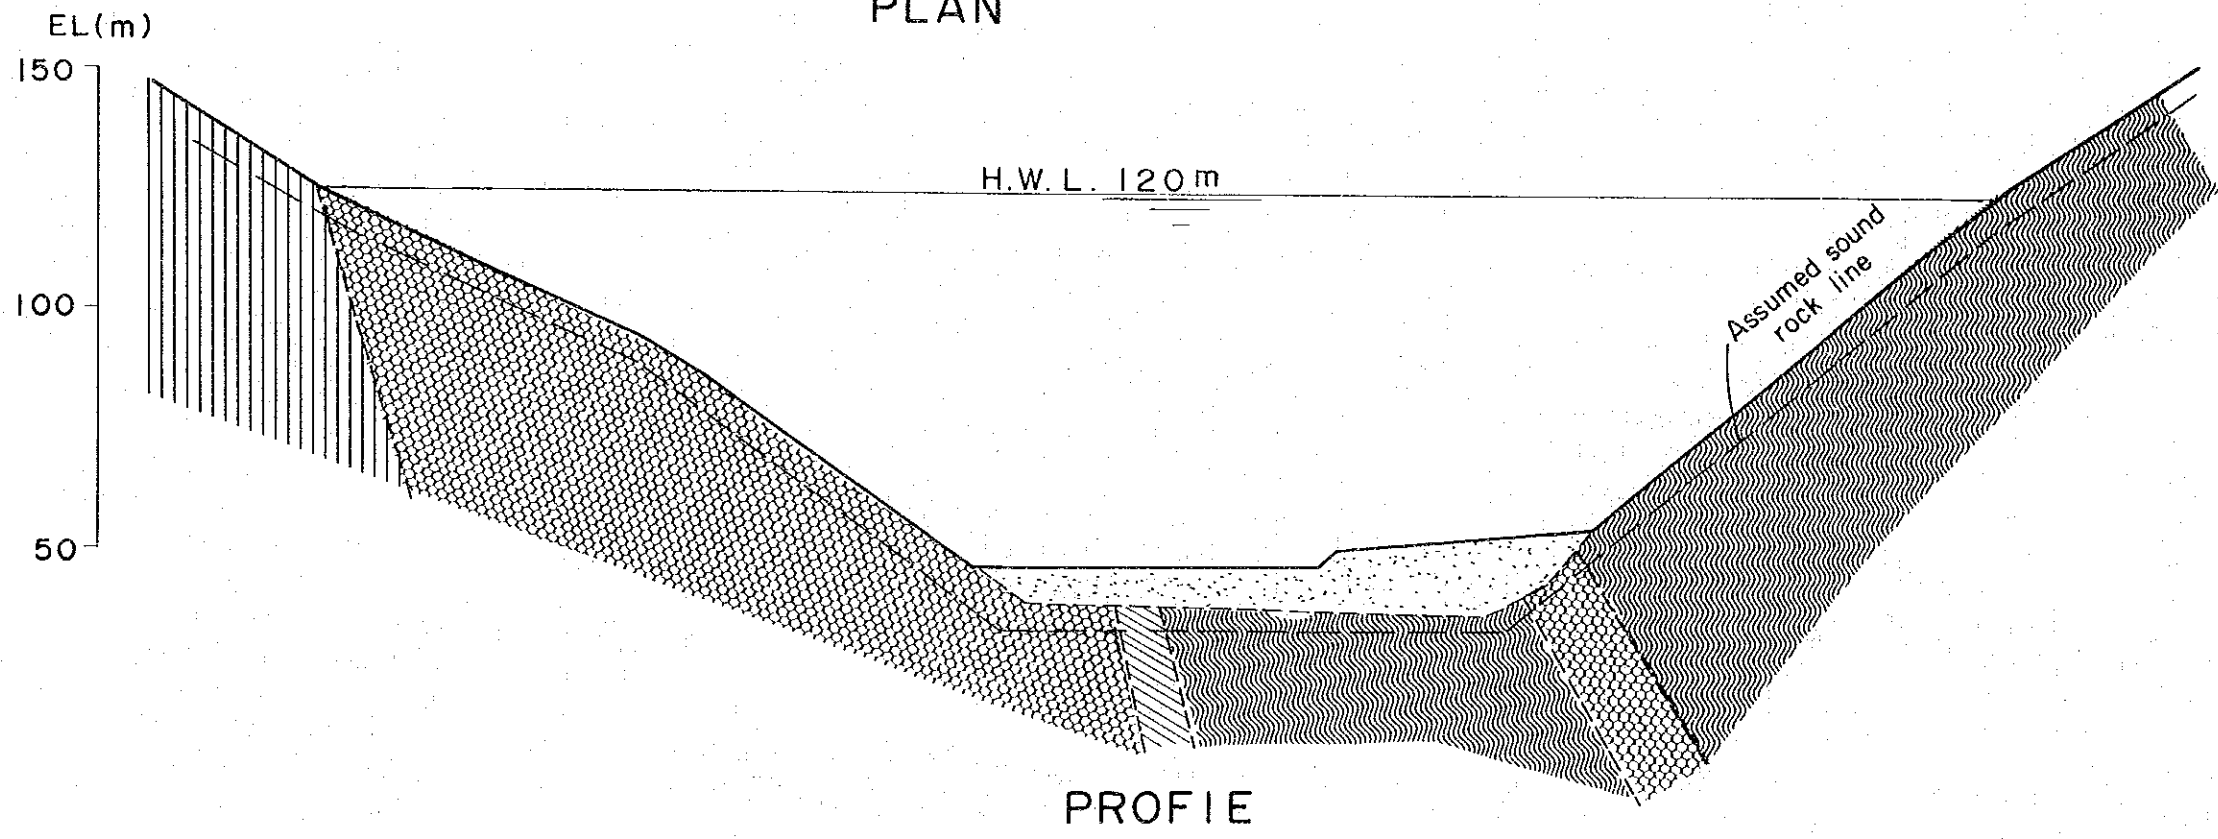
A small gully on the left bank just upstream side is burried with debris. The gully may possibly be a small fractured zone of N75E direction.

Riverbed is filled with sandy deposits. Its thickness cannot be confirmed yet at present. It may be supposed 10 m thickness. Under these sandy deposits biotite gneiss may be expected, though 10 m thickness of intercalated chert in gneiss (N20W, 50W) is found on the right bank. Extension of the intercalated chert expose again in riverbed at 350 m downstream of the dam axis. Dips and strikes of the chert and gneiss are not coincid each other. Chert and gneiss are likely contacting with fault as shown in the geological map of 1/50,000.

Long north-south ridge on the right bank comprises of gneiss with thin covering of slope wash of less than one meter and weathered zone of 2-3 m thickness. Talus debris in the skirts on right bank slope seems to be an extension of small-scale fractured zone found at the downstream toe on the left bank. Thus, a series of northsouth fractured zone of small-scale is presumably running along the river channel. Nevertheless, there is no fault or fracture crossing the right bank ridge. The ridge will have no leakage after impound of the reservoir.

- A) The Hongchon damsite is only one favourable site all along the river course.
- B) Selection of dam axis is also limited in narrow range because of its characteristic topography.
- C) Major geological problems in this project are thickness of riverbed gravels, fault or fractured zone underneath the gravel deposits and leakage problem through long ridge on the right bank side. Further investigation should include seismic exploration, test borings and permeability tests to study the above mentioned problems.

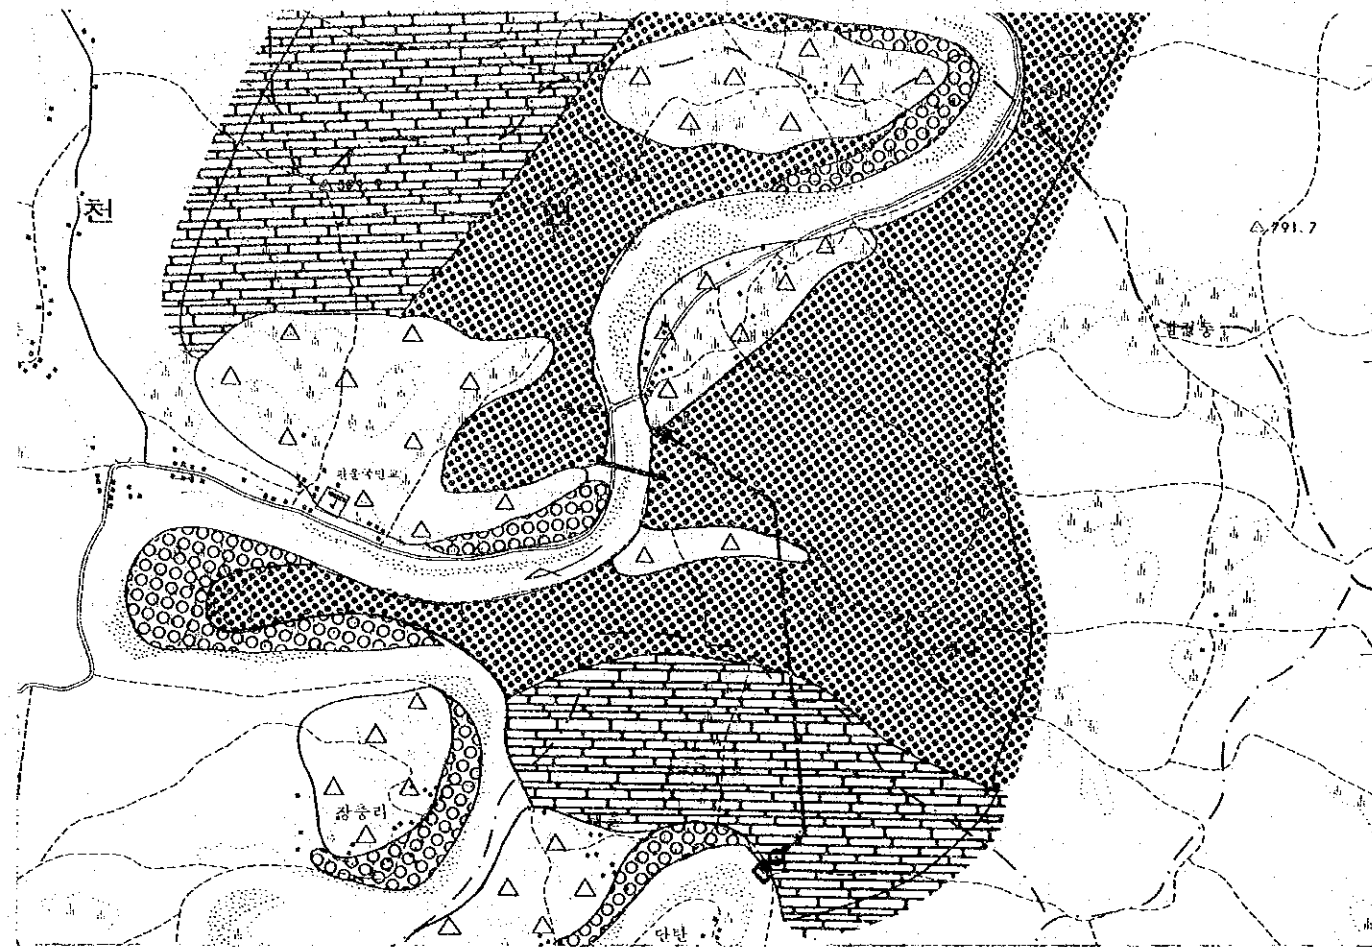
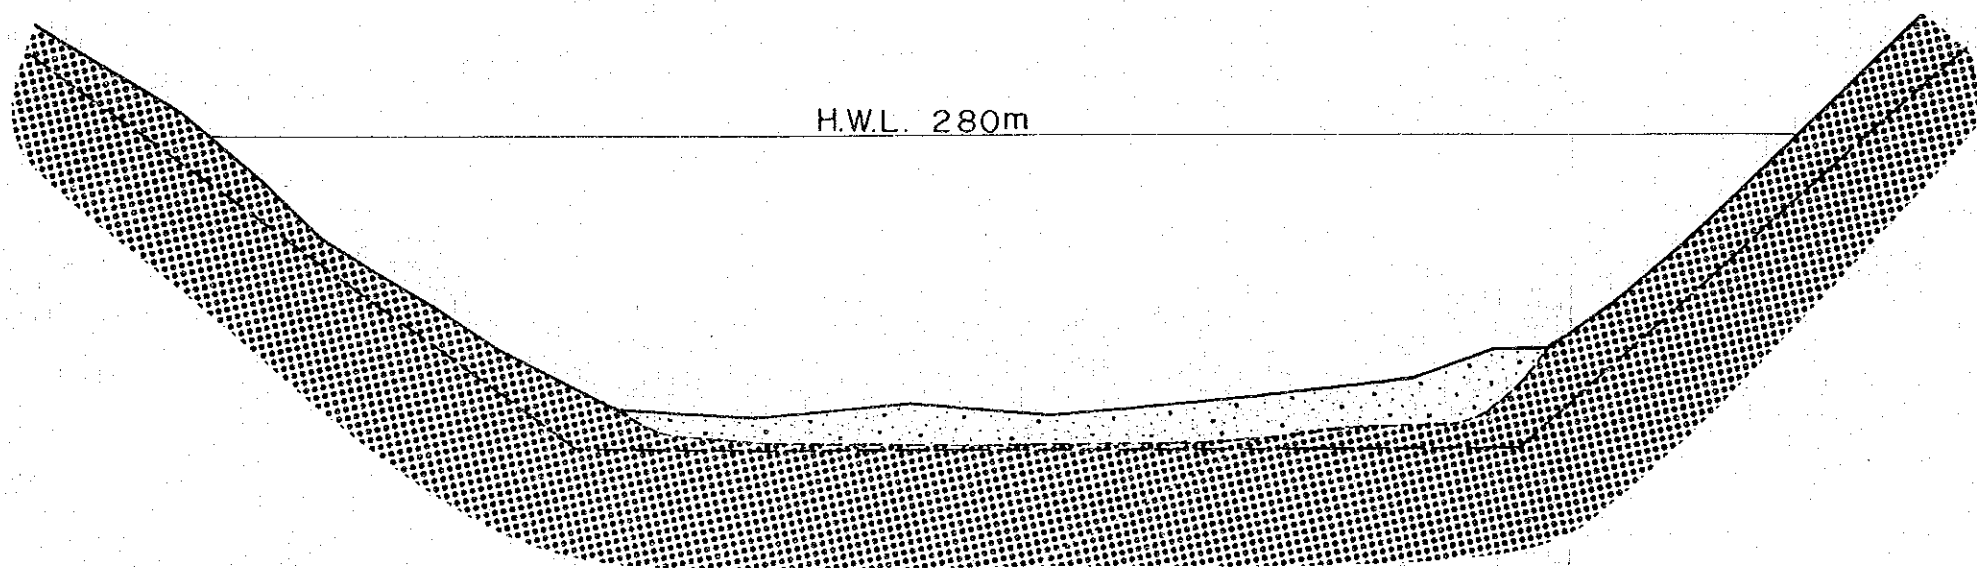
- A) The foundation rock of the site is sufficiently good as the foundation for the proposed dam.
- B) Limestone of the Yeongweol Group is distributed in this reservoir area. Since the limestone mass is surrounded by non-calcareous rocks (Gyeonggi gneiss complex, granite and Yeoryang Group -- sandstone and slate), it is thought there will be little possibility of leakage to outside the reservoir. However, detailed geological investigations should be made inside the reservoir using topographical maps of at least 1/10,000 to 1/25,000 scale in regard to the limestone distribution area. In such case, it will be necessary for investigations of the rock fall areas inside the basin to be made at the same time.

- C) Since weathered cracks are numerous in the foundation rock of the damsite, it will be necessary for drill holes with the purpose of investigating the degree of development of cracks and permeability of each abutment, and for drill holes to investigate the thickness of the sand-gravel at the riverbed to be provided.
