**REPORTS OF GEOLOGICAL SURVEY
FOR
CIVIL ENGINEERING WORKS**

REPORTS OF GEOLOGICAL SURVEY FOR CIVIL ENGINEERING WORKS

Reports of Geological Survey for Civil Engineering Works compiled by Kazuji Uno, Expert on Engineering Geologist dispatched by the Japan International Cooperation Agency (JICA) to the Republic of Indonesia under the Colombo Plan Technical Cooperation Scheme (dispatched duration: from July 1974 through July 1980).

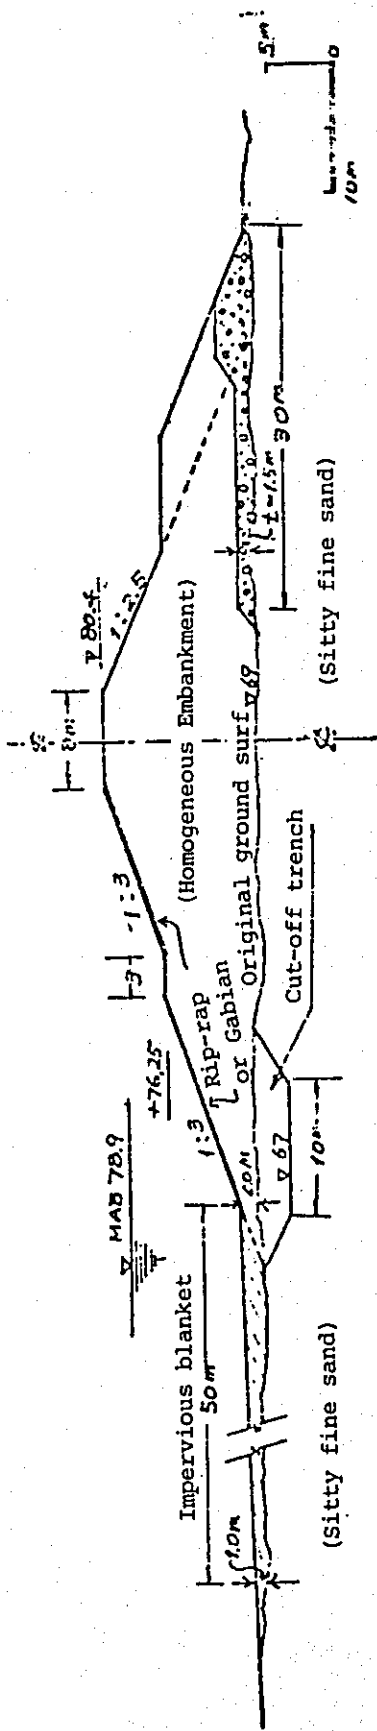
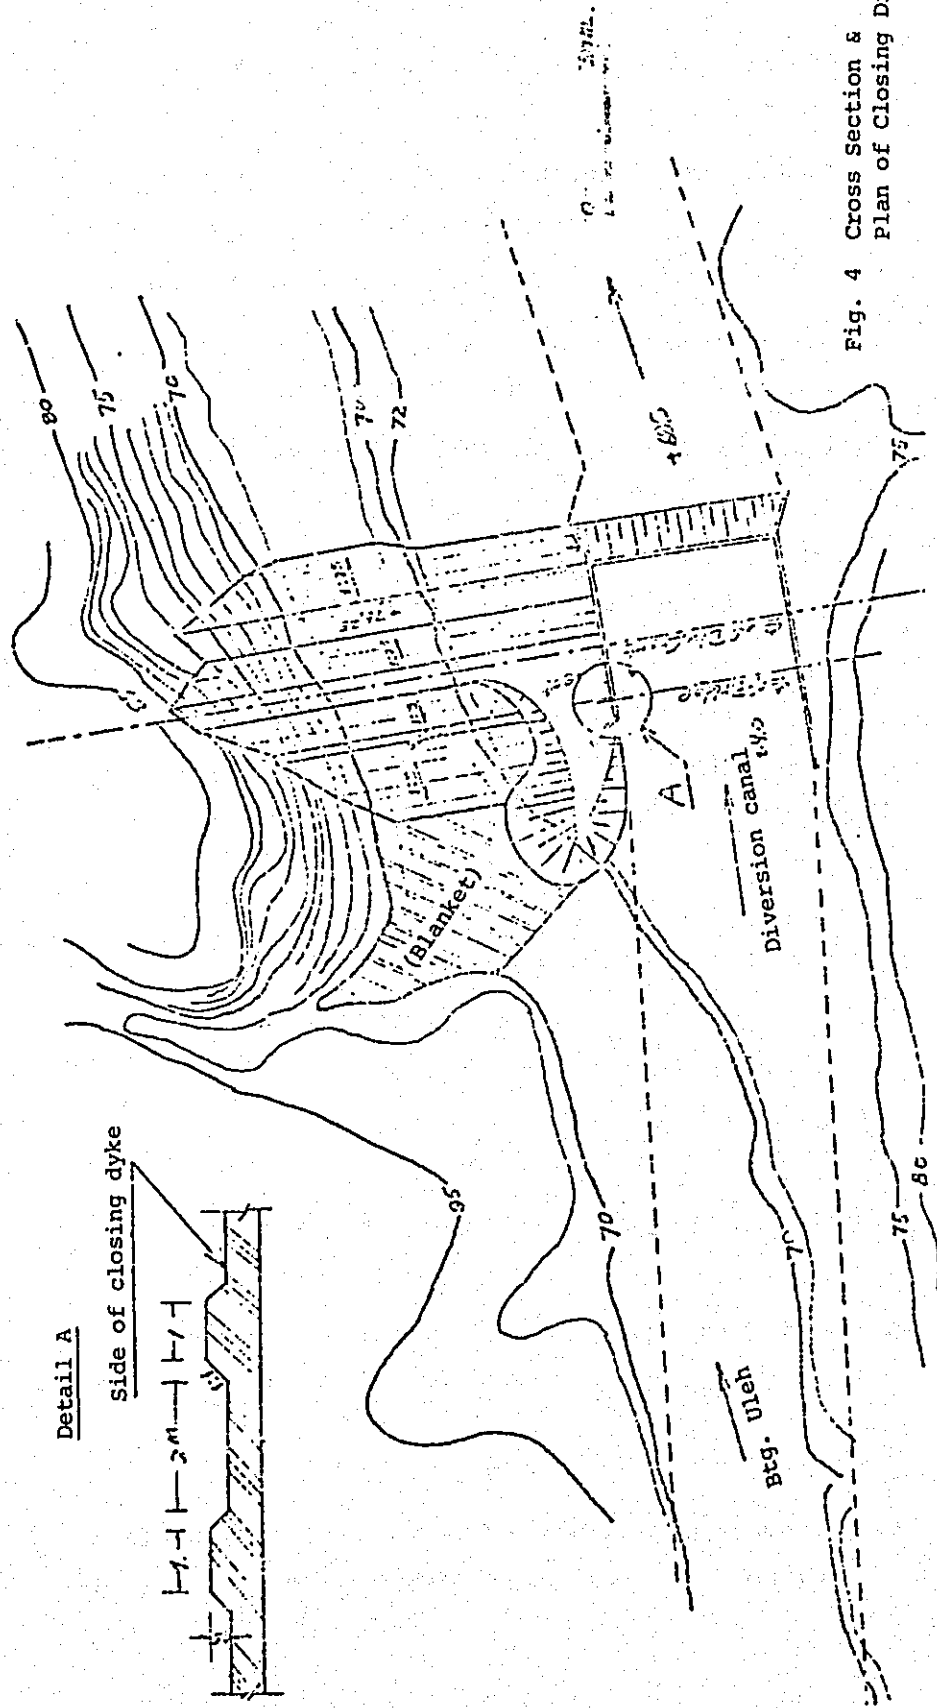
Fig. 4 Cross Section & Plan of Closing Dike

According to the probe test (Dutch one ?), the bearing capacity of fine sandy gravel layer is more or less 200 kg/sq. cm. It is strong

enough for the increased stress due to embankment, which is derived by Asterberg's Theory as shown in the Report.

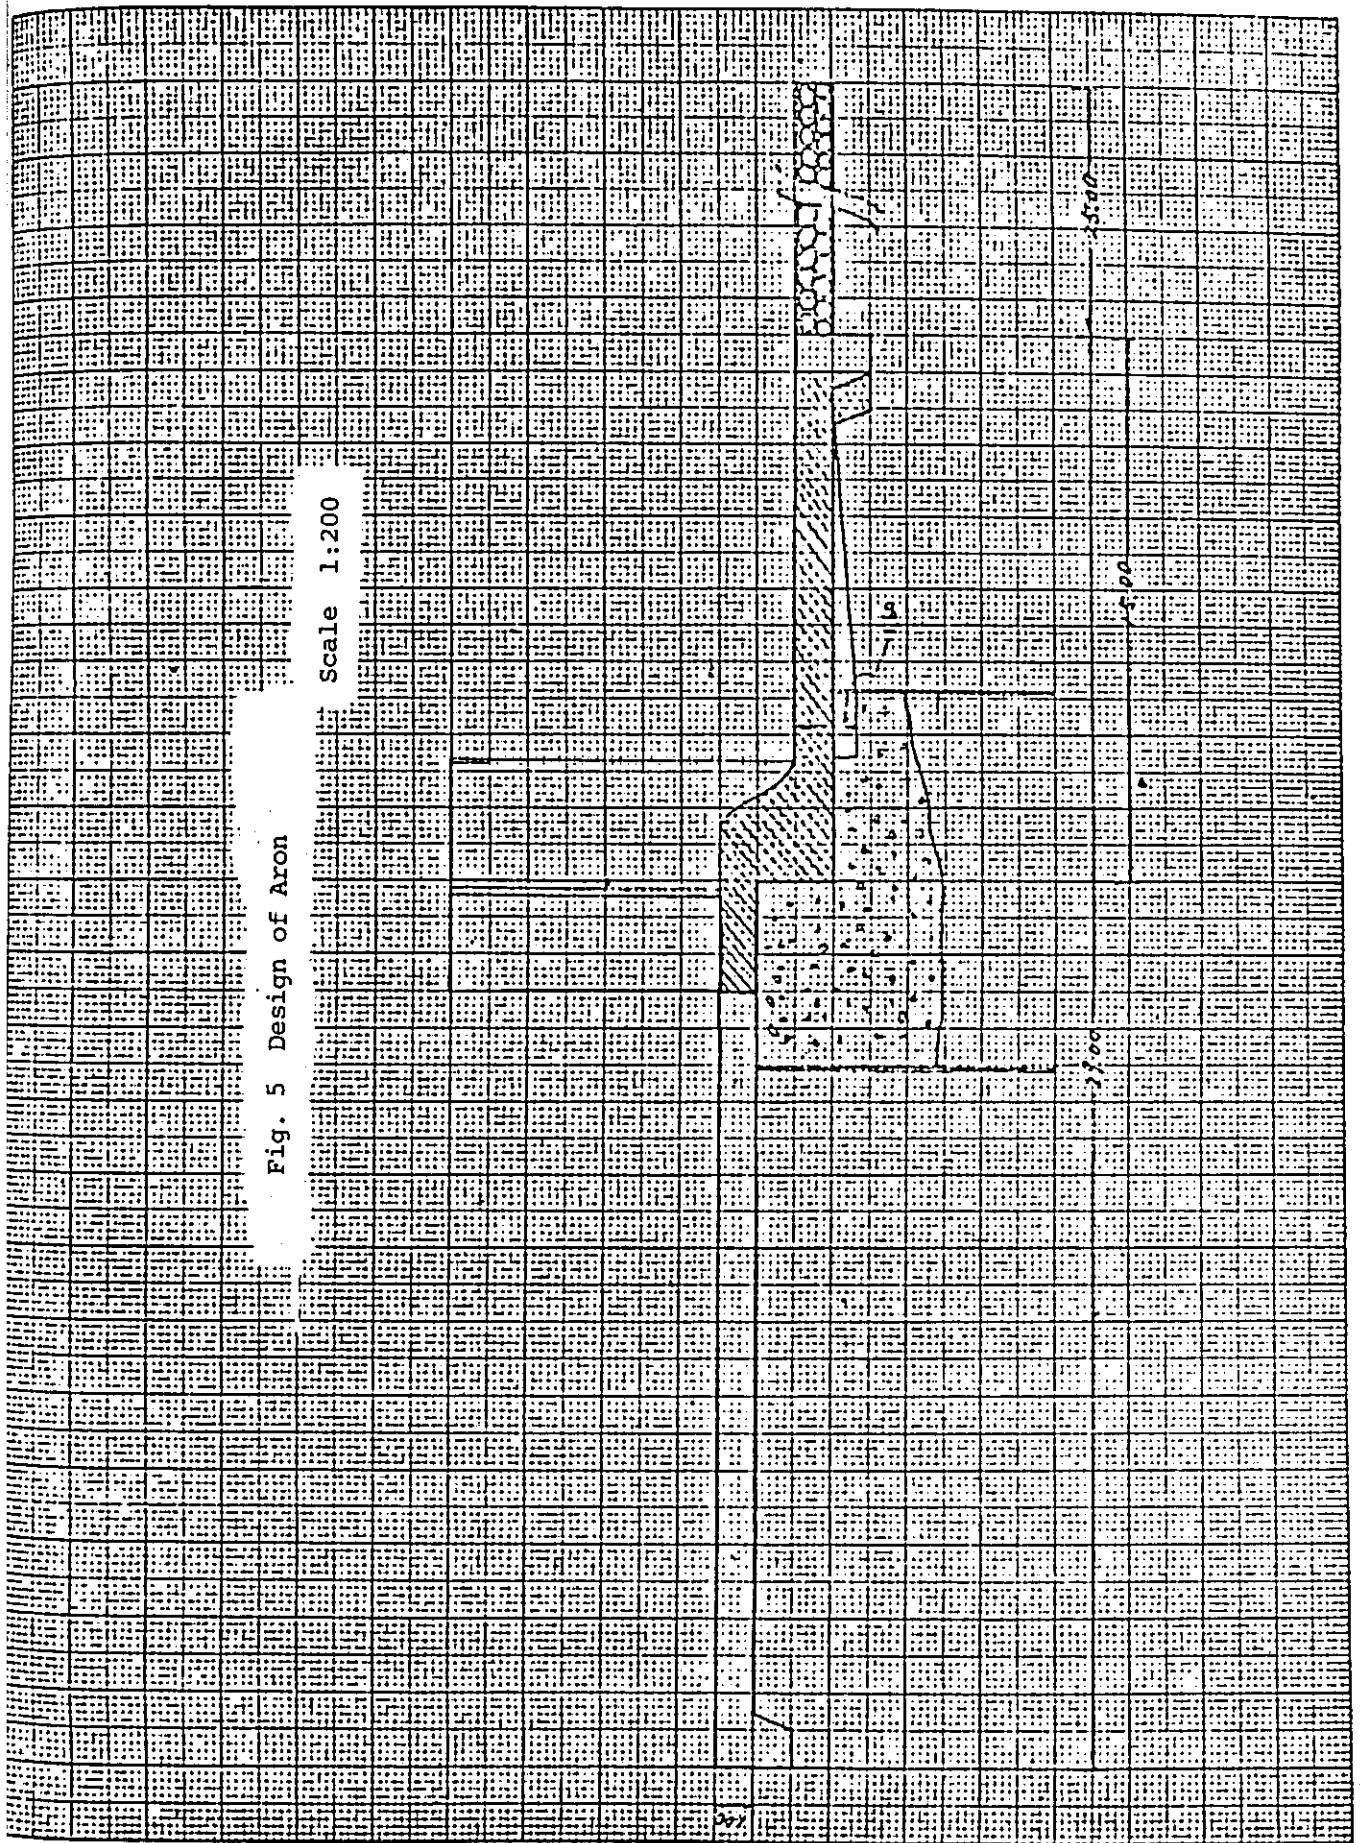
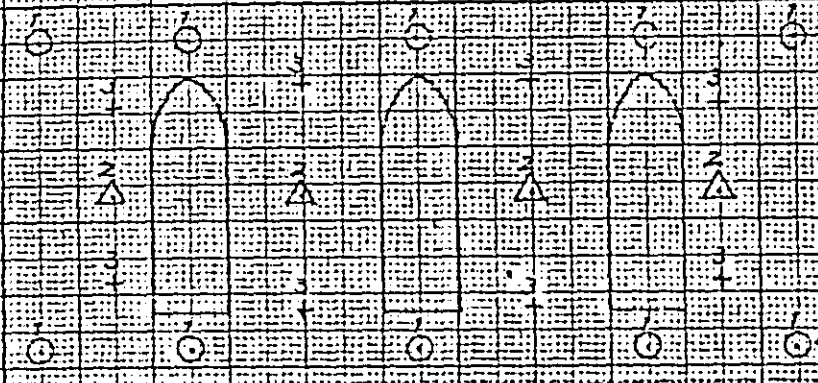
Fig. 7 Grouting

- (3) The disposition of grout holes can be considered by several way. One example is shown in Fig. 7 (a). Groutings are operated in order from 1st group and, 2nd group and so on and injected at their middle point between previous ones. The grouting pattern may be modified sometime from the result of grouting.

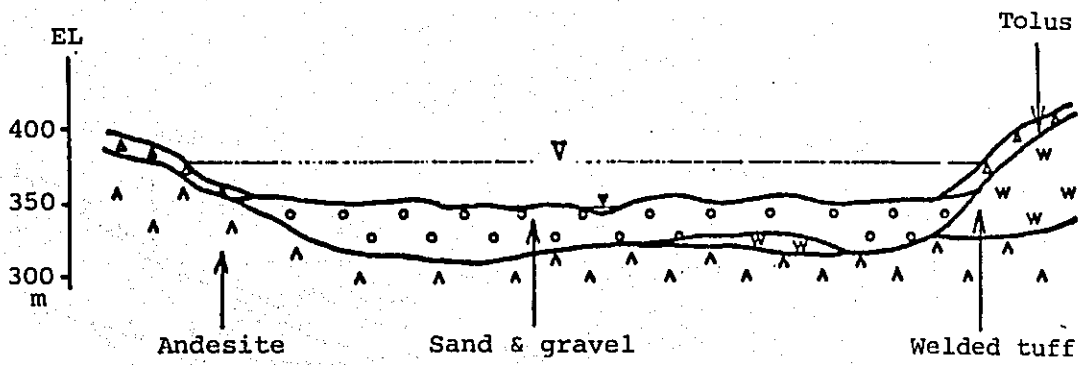
Fig. 1 Chubetsu Dam

In case of talus, alluvium or Masa, if the depth to base rock is shallow, it's enough to exclude the underpart of core. If not, must be taken some measure for leakage or differential settlement. Generally speaking, settlement of base of fill dam is smaller than consolidation of dam body, therefore usually there's no problem. But in case of concrete cut-off wall connected with asphalt facing, sharp change of base slope or uneven distribution of poor ground, precaution must be taken to prevent cracks on dambody. (see Figure 1, 2)

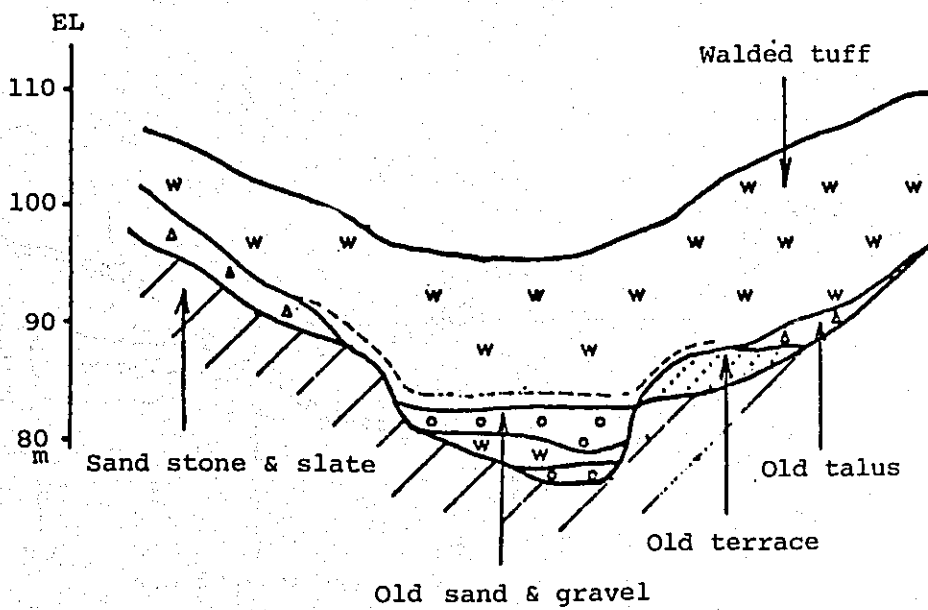
Fig. 2 Nagayoshi Dam

In case of lava or welded tuff, the bearing capacity may be enough but sometimes they have many cracks in themselves and confined aquifer underlie them, therefore treatment for leakage is often required. Counter measure may need much money for leakage control in shirasu or volcanic ash and lapilli, and such rocks also need the examination for piping and liquefaction in saturated condition. (see Figure 2, 3)

cases, weak layers such as old soil, weathering zone or sand and gravel is often sandwiched between older and younger stratum and causes trouble needing treatment. (see Figure 2, 4)

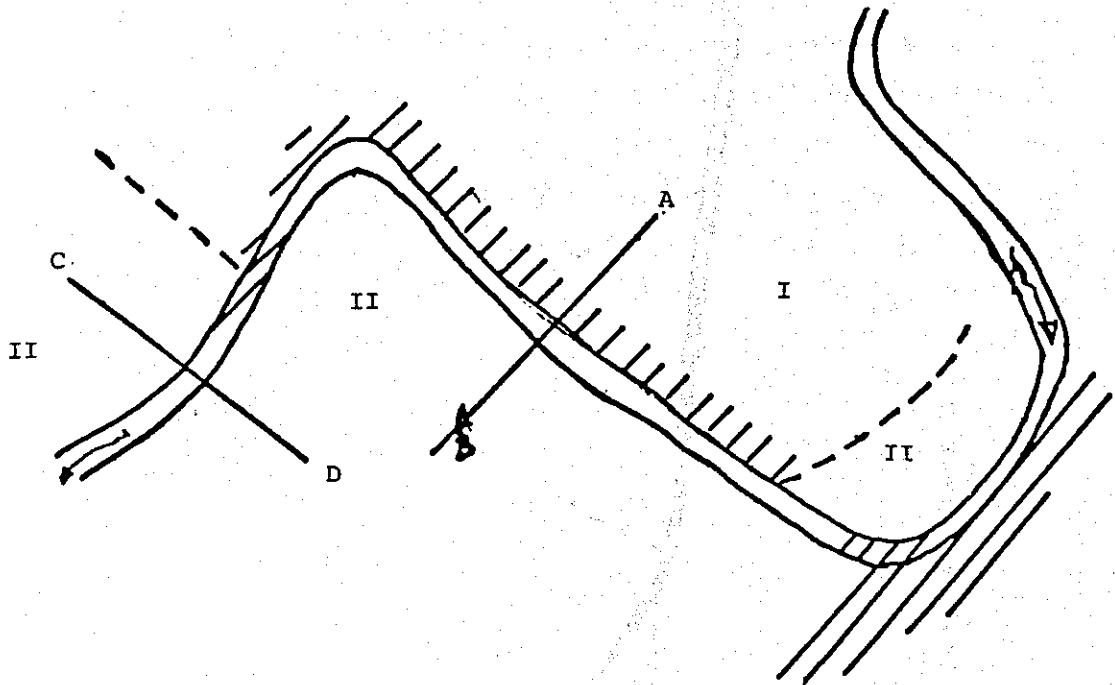
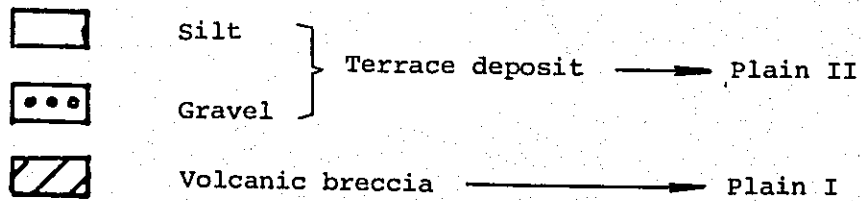
Fig. 2 Geological Map and Anticipated Profile
(Sketch)

Route of channel is not decided yet, then accurate site of aqueduct is not determined. For planning on design of aqueduct and channel, it seems useful to have a conception of general geology and geomorphology about this area. (See Fig. 2)

Volcanic breccia is enough and gravel layer is perhaps enough as bearing layer. If there is no need to select the channel route for special construction, its enough to examine the form and strength of foundation at the very spots.
