REPORT ON THE STUDY ON ENERGY CONSERVATION PROJECT IN THE KINGDOM OF THAILAND VOL. 1

-CERAMICS/GLASS AND PAPER FACTORY-

JANUARY, 1983

JAPAN INTERNATIONAL COOPERATION AGENCY

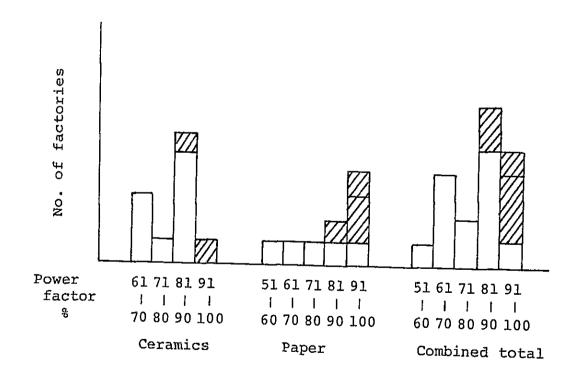
Fig. 3 Distribution of Power Factor by
Branches of Industry

of capacity, as well as to install condensers. It is desirable to adopt an incentive system that may encourage such rationalization effort and investment. Due care should be taken, however, before installing condensers as some factories surveyed were found to have suffered from the leading power factor due to excessively large condensers provided. The power factor varies according to loads. Shown in Fig. 3 are the data on the power factor obtained by the diagnosis of the factories.

Factories where condensers are installed.

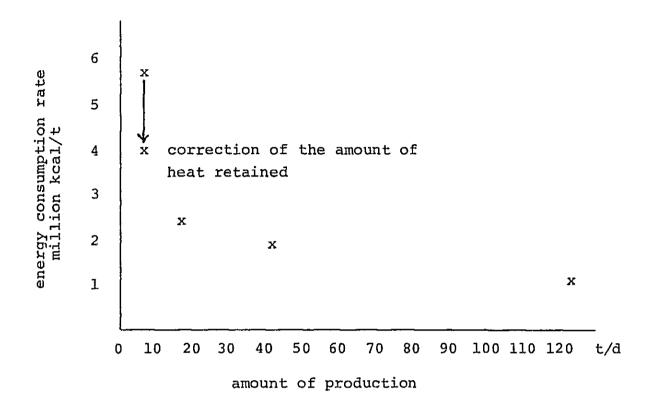
Fig. 6 Consumption Rate of Energy for Melting

C. Of all, energy used for melting shows the highest percentage, and its consumption rate per unit of production is as shown in Fig. 6. The energy consumption rate, as discussed later, is affected by a number of factors; in general, this figure is low with a large furnace and high with a small one.

It should be pointed out, however, that the smallest furnace has some designing problems and differs from the others in terms of operation.

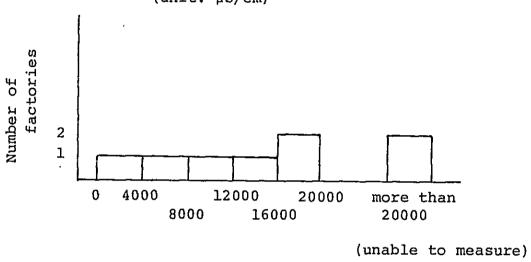
Fig. 13 Conductivity of Water in the Boiler (unit: μ s/cm)

Shown in Fig. 13 are the results obtained by measuring the conductivity of water in the boiler. These results indicate that blowing was not adequately made. Inadequate blowing may produce scale, resulting in a drop in the heat-transfer coefficient as well as the deterioration of boiler tubes.

The Japanese standards (on the cylindrical boiler with the evaporation rate of 30 kg/m²h or less) specify that the conductivity of water in the boiler should be kept below 6,000 μ s/cm.

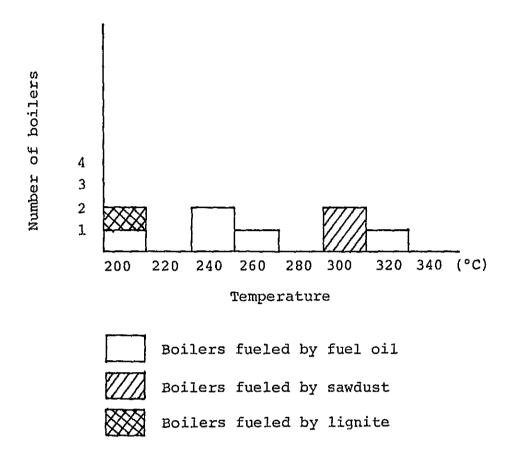
Fig. 14 Temperature of Exhaust Gas from Boiler

The temperature of an exhaust gas from the boiler

comes within the range shown in Fig. 14 below.

Since the exhaust gas from a boiler burning fuel with the high sulfur content causes corrosion, it is rather difficult to lower its temperature down below 200 to 250°C.

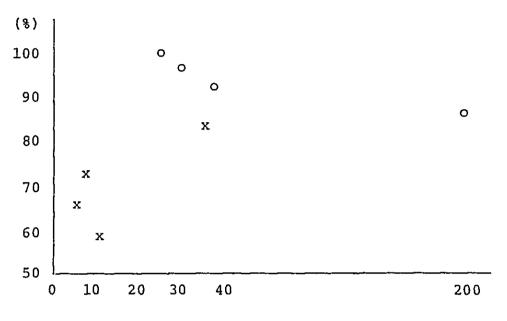
Fig. 15 Power Factor

g. Fig. 15 shows the results of the power factor measurement.

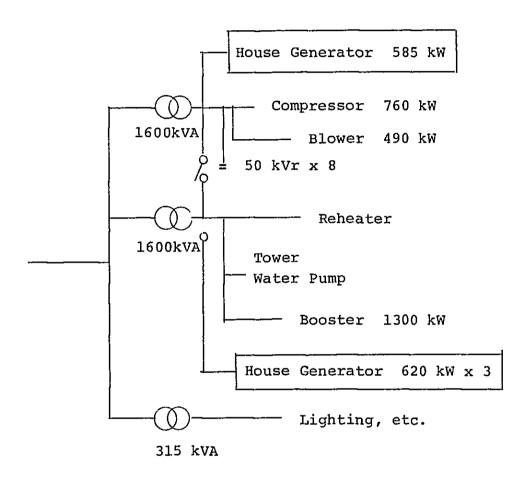
(2) One-line diagram

Power-receiving installations are situated near electric equipment, at the center of the factory. Two transformers with the capacity of 1,600 kVA were operated independently; the loads on both transformers were almost balanced, but their load factors stood below, 50 percent. A total of 400 kVr condensers were provided to improve the power factor, which was kept

at 90 percent.
