SECTION 5

MAE MOH FACTORY
REHABILITATION PLAN

Section 5 Mae Moh factory rehabilitation plan

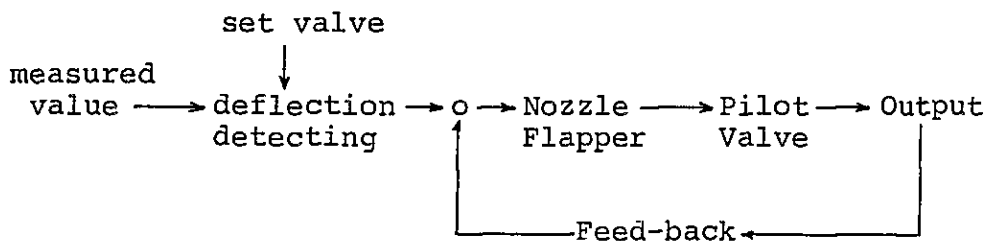
(Pneumatic Controller)

Overhauling was performed for 35 units of controllers, being 50% of whole controllers at Mae Moh Factory, and there were found five cases of clogging at nozzle, which are excessive numbers. This means that the instrument air is not suitable and its countermeasure shall be taken immediately.

Through the checking of proportional + integral + differencial control action at the time of overhaul, two mal-functioning case of differencial control action were found and were repaired under our supervision, controller and regulator are plug-in type and sealed with "O" rings.
