APPENDIX VI

CONDITIONS OF PAST DISASTER AND DAMAGE

APPENDIX VI
CONDITIONS OF PAST DISASTER AND DAMAGE

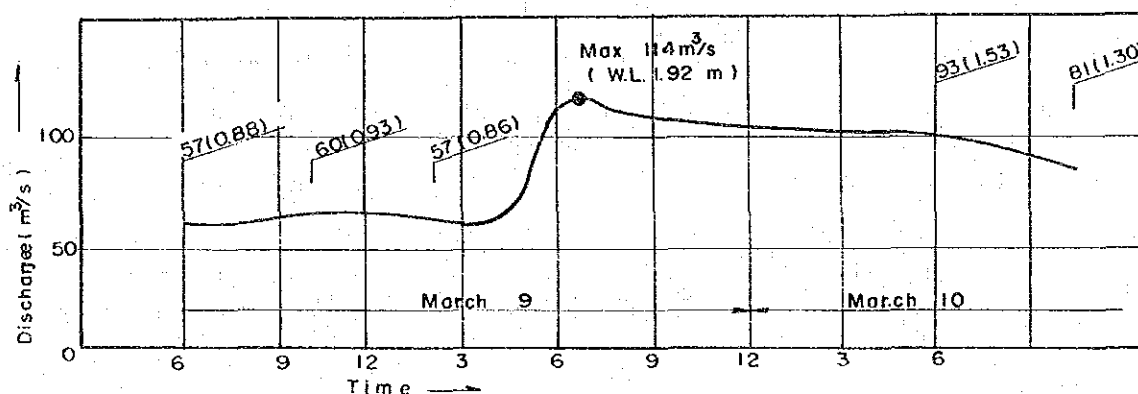
The run-off record on March 9 was obtained at only Chosica gaging station which is located at the downstream stretch of the confluence of Rimac river and Sta. Eulalia river. The water level as well as discharge in the main stream did not vary until the early afternoon on March 9 but suddenly increased in the late afternoon as seen in the figure below.

The sudden increase would be more remarkable in the downstream stretch of Chosica town as some disaster Quebradas are located in the downstream stretch of the Chosica gaging station.

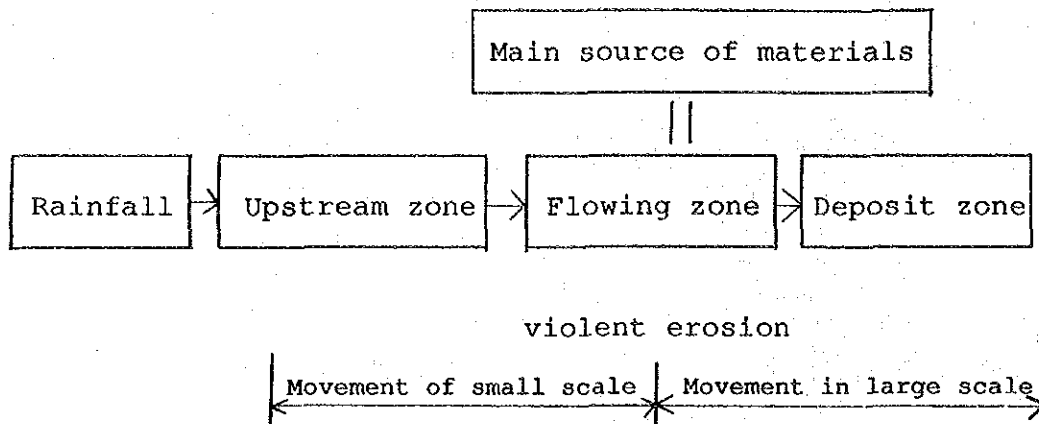
Flow Chart of Debris Flow Process

It is considered that the debris flow is the movement by flow action rather than gravity action though the characteristics are different as follows:

- (a) Erosion action of flow (velocity, discharge, resistance of materials against erosion, etc.)
- (b) Mix proportion of debris and mud
- (c) Grading of mixed materials

It seems that the flow coming from the upstream stretch into the flowing zone more or less contains rocks and earths. The upstream zone has some small tributaries which join each other on the way of flowing. The damming-up seems to be occurred in these small tributaries especially at the confluences, at the time of debris flow. Then the scale of disaster becomes bigger. In some quebradas, it was informed from the inhabitants that the flow was temporarily disappeared or got muddy just before the coming of debris flow. The phenomena possibly were caused by damming in the upstream tributary.
