APPENDIX III

Inspection Report on
Damaged Flood Embankment of
Demonstration Unit of
N-N Irrigation Project

DEMONSTRATION UNIT OF N-N IRRIGATION PROJECT

T. AMANO
Irrigation and Drainage Planning
JICA Basic Design Study Team
for N-N Irrigation Project
(Block A-1)

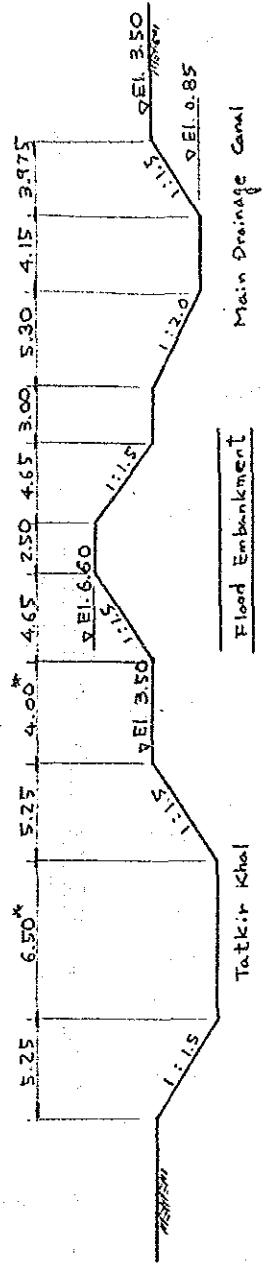
Cause of breaching: It is judged that the direct cause of breaching is piping failure due to the rat holes barrowed into the embankment.

Situation : The embankment has been settled through a height of about 1.2 m and the innerside of the embankment has almost been eroded and washed away. If (A) portion has not been broken down, this portion must have been breached.

Situation : Serious slope failure along the entire length of the portion was witnessed. The cross-section of the embankment above the flood water level seemed to be half of its original size and the top width of the embankment has

(1) The phreatic line became somewhat horizontal due to the presence of rat holes inside the embankment and the honeycomb made by rat holes made the embankment extremely weak. As a result of these, the downstream slope of the embankment was failed. Such failure can be found along the entire length of the embankment.

- (A) 4.3 km point (l = 72 m)
- (B) 5.7 km point (l = 15 m)
- (C) 6.5 km - 8.4 km (l = 1.9 km)
