## 5.6.2. Results of Field Investigation

Fig - 5.1  
 THE AMBUKLAO DAM REHABILITATION PROJECT  
 DAM CREST ALIGNMENT  
 Alignment - 1  
 Alignment - 2  
 SCALE 1:4000    DATE  
 THE JAPAN INTERNATIONAL COOPERATION AGENCY

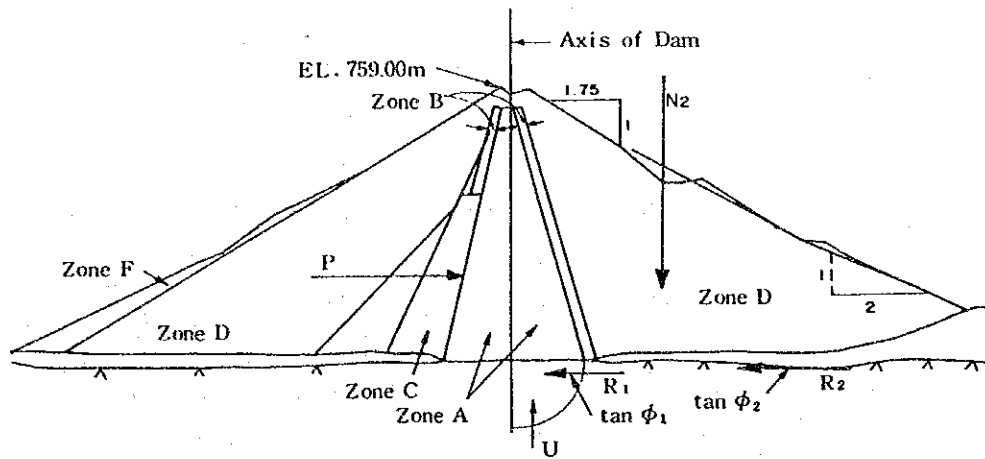
Fig- 8.3 Sliding Wedge Analysis

However, there is no description in the above Report of the magnitude of the earthquake coefficient used in the calculations and the basis for its determination. By making back calculations using formula (8-4) as applied to the dam geometry shown in Fig.-8.3, an earthquake coefficient of  $K = 0.15$  was determined. As the uplift pressure was not considered in stability calculations of the dam for the case of maximum water level in the reservoir with earthquake, the earthquake coefficient of 0.15 is considered to be quite appropriate.

The steep slope caused by the construction of the access road on the downstream face of the dam is considered not to have any relation with the design slope of the dam. (See Fig.-8.3 and Fig.-8.4(b))

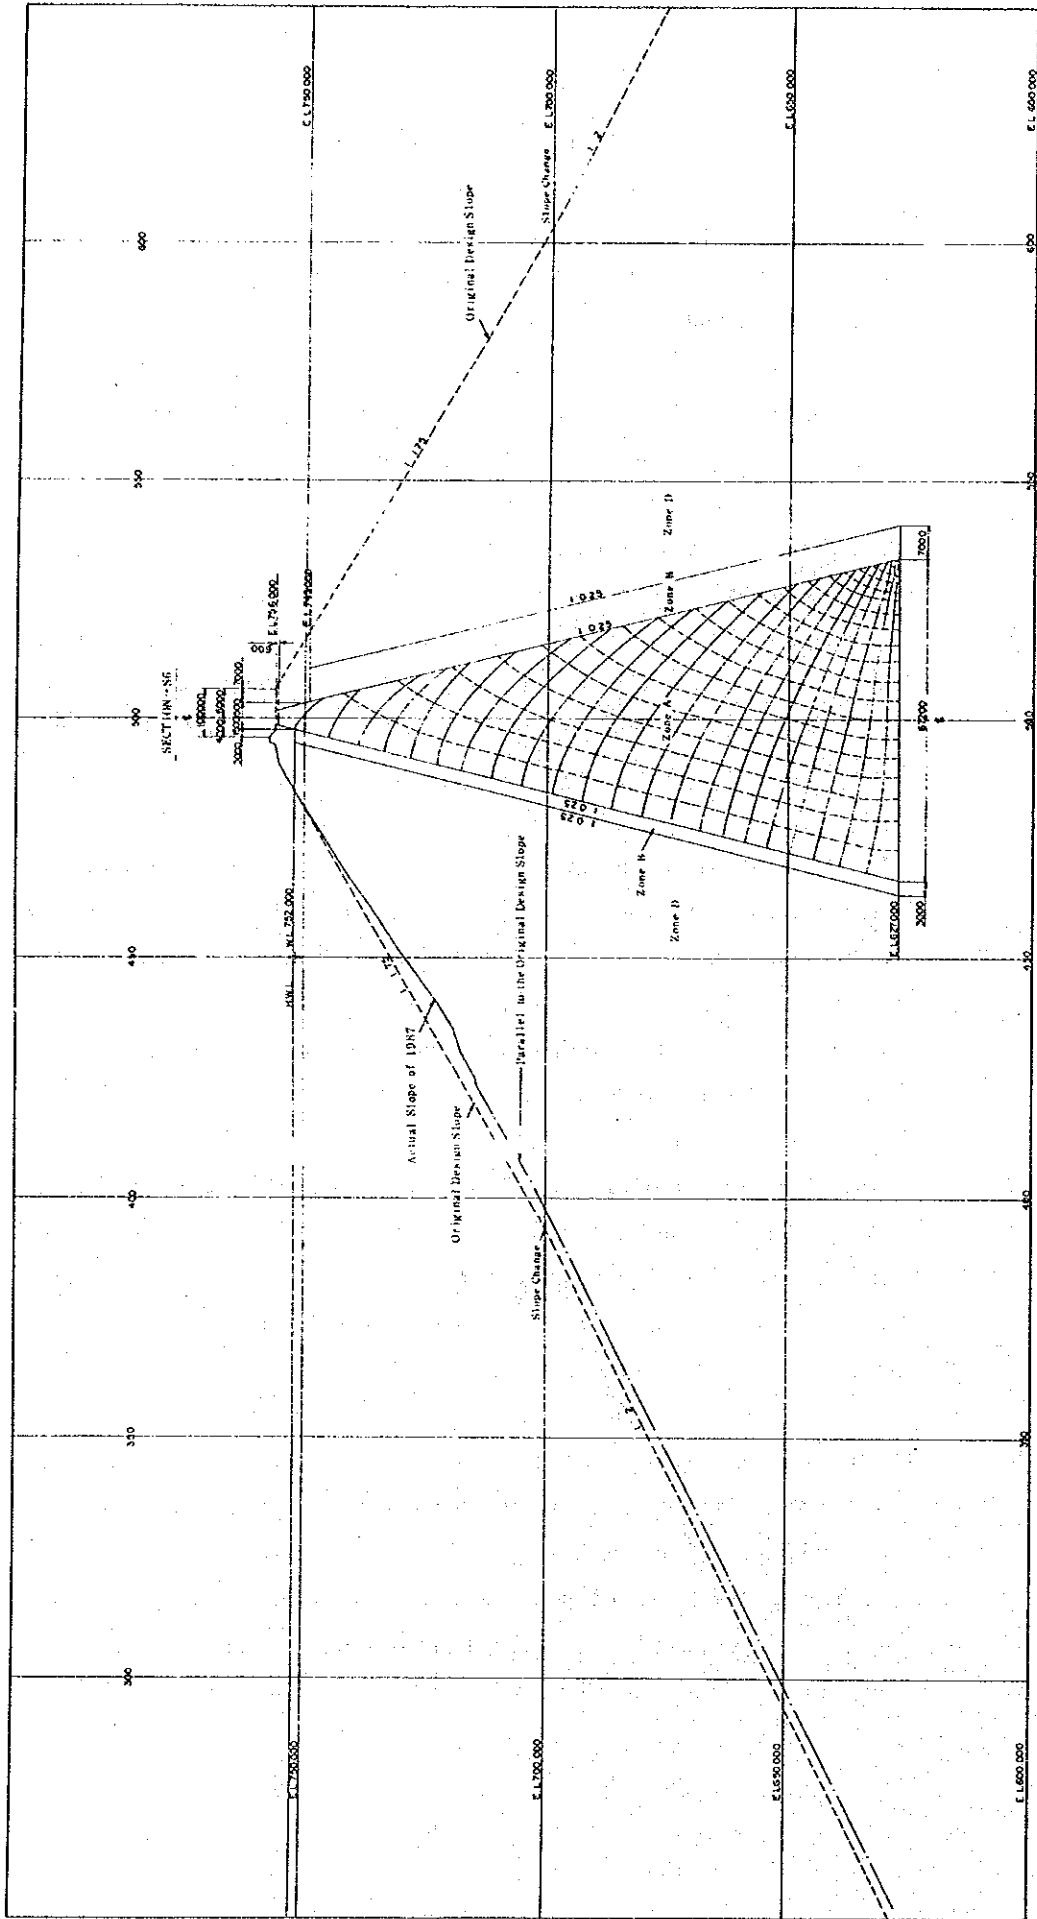
Fig - 8.5 Dam Profile and Flow-Net Applied for Stability Analysis

Section S6 with the steeper average upstream slope was selected for analyzing the cross section of the dam for stability. For analyzing surface sliding, however, section S16 was selected as a section with steepest partial slope (1 vertical to 1.32 horizontal). The flow net of the core zone, shown in Fig.-8.5, drawn on the basis of a

As indicated on Fig.-8.5, the original design slope was 1:1.75. As of 1987, however, it has not been exactly kept in all the sections of the dam probably due to settlement of the dam having occurred for a long period of time after the construction.

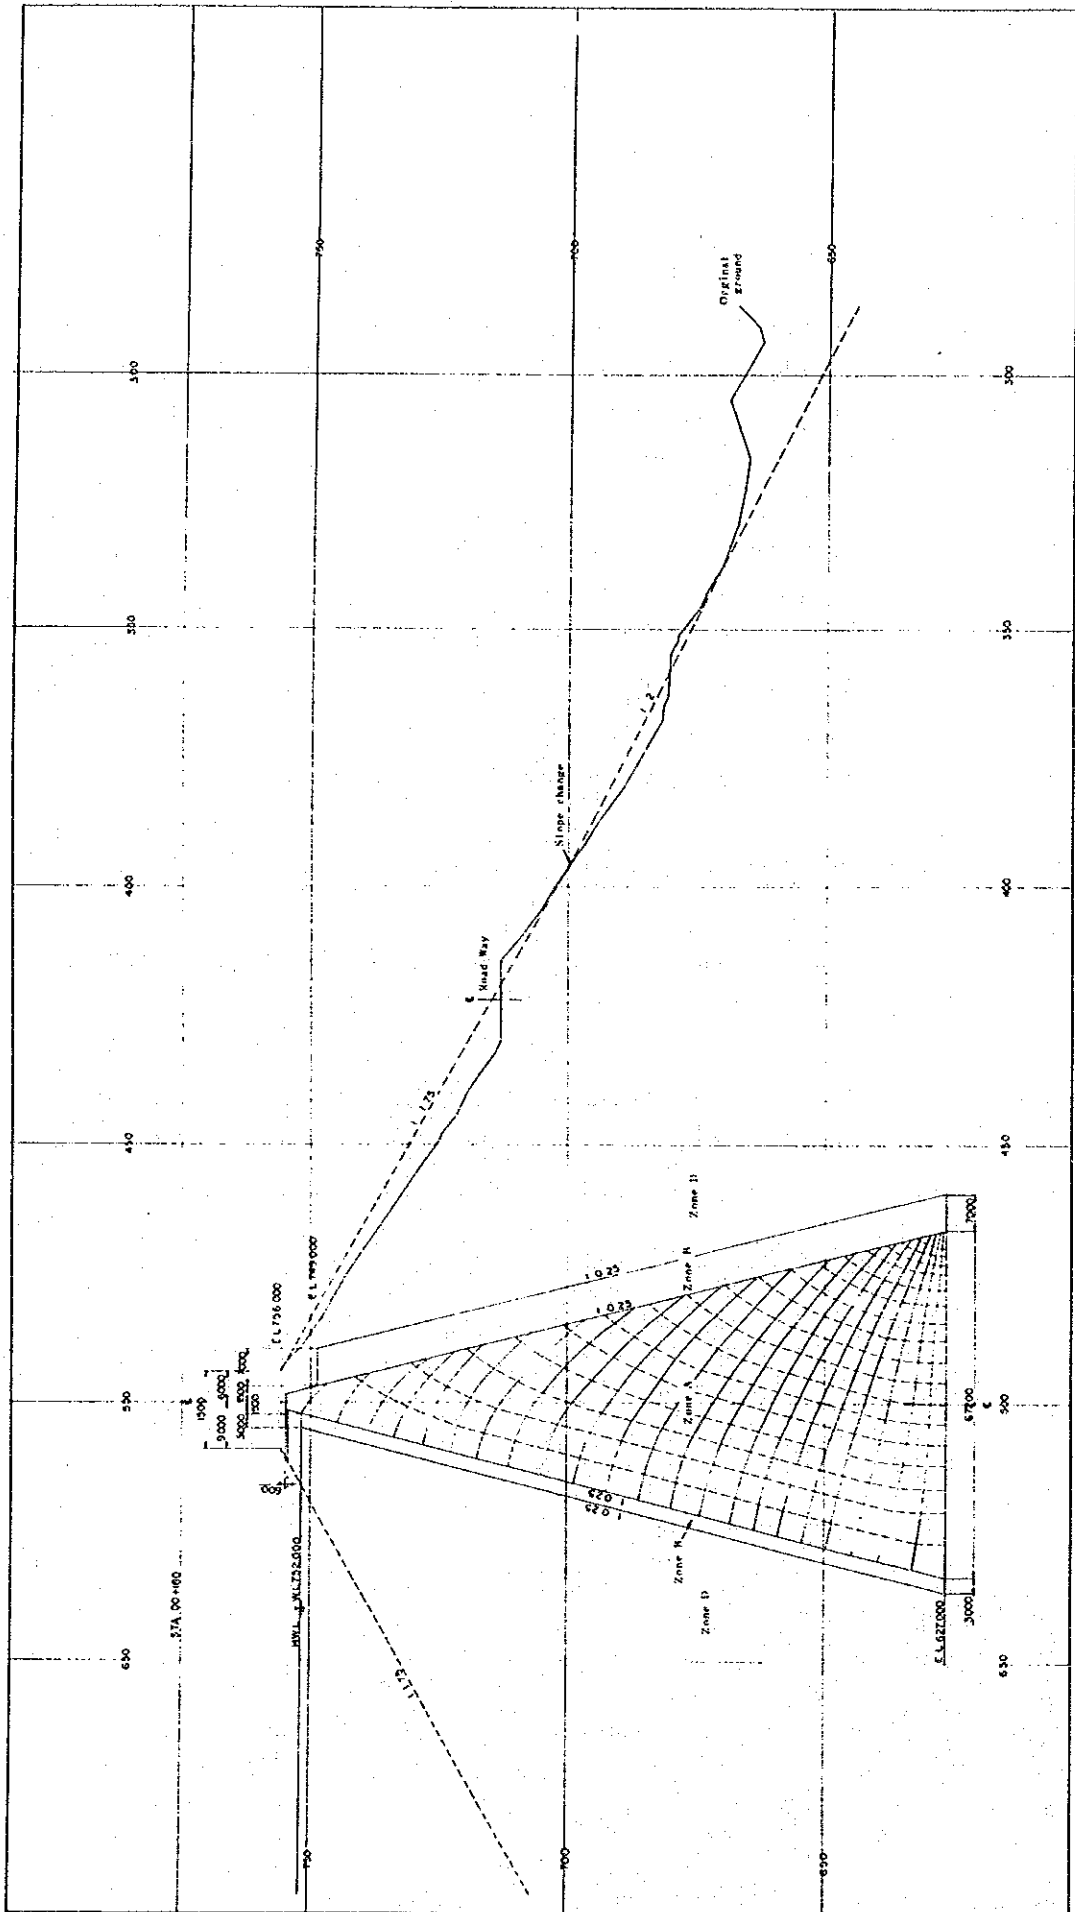
Fig - 8.7 Dam Profile and Flow-Net applied for Stability Analysis

The cases analyzed are shown in Table-8.6. The locations of the sections for which the analysis was made are DA10, and Sta.00 + 180 based on the survey conducted in 1985. The sections are shown in Fig.-8.7. The flow-net adopted for the analysis of the upstream face and shown in Fig.-8.3., was also used for the downstream face.

The results of the analysis for Cases 1 and 3, both without seismic effects, show safety factors of 1.347 and 1.396, respectively. These values are regarded to be

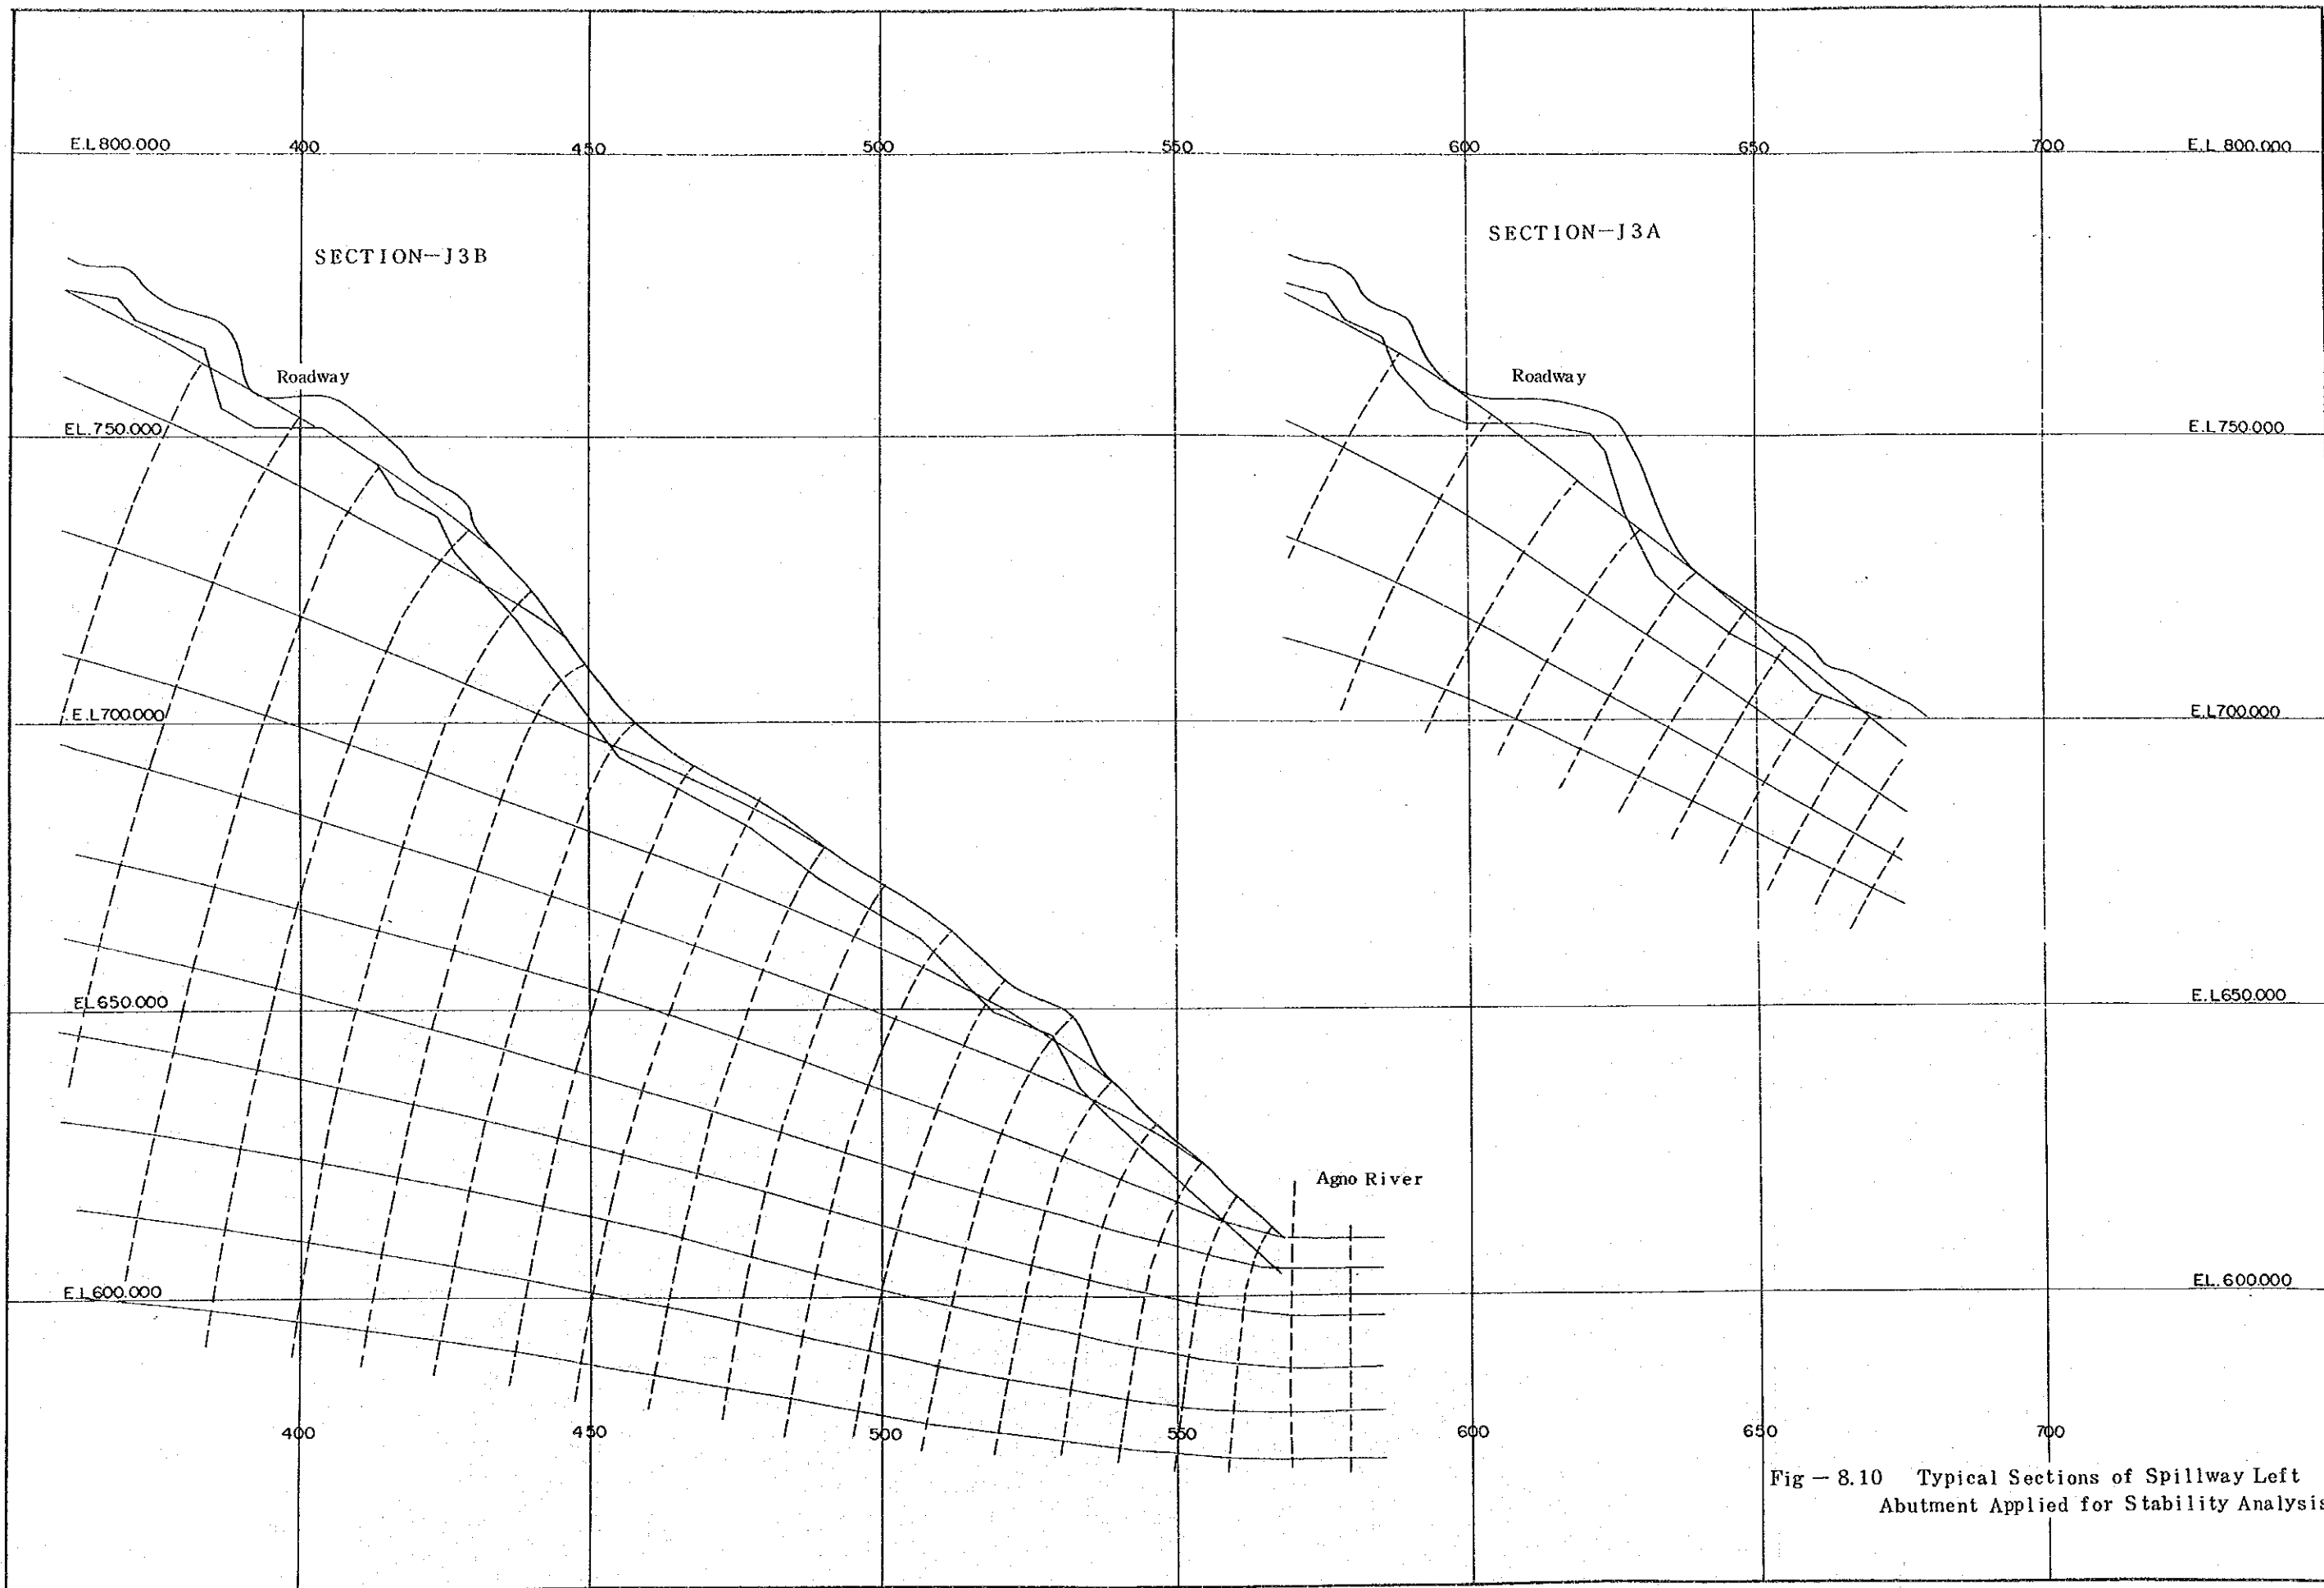
Fig - 8.10 Typical Sections of Spillway Left Abutment Applied for Stability Analysis

The cross sections to be analyzed were selected on the basis of a ground survey carried out in 1987. Two basic sections were selected. They were (1) a cross section of a very steep slope representative of a relatively shallow steep slope in a limited area, and (2) a cross section of a steep slope representative of a larger area of the abutment. The former is designated Section J3A and is shown in Figs.8.9 and 8.10, and the latter is Section J3B and is also shown in Figs.-8.9 and 8.10. The above two cases are representative of a shallow and a deep seated slides, respectively.

For the analysis, as described above, consideration of ground water conditions was required. For the analysis of the shallow sliding, Section (1) above, the underground water conditions were not considered due to the existence of a very steep slope and the drainage mechanism on the surface. Con-

sidering, however, the existence of a crack in the bedrock, the seismic effect was added.

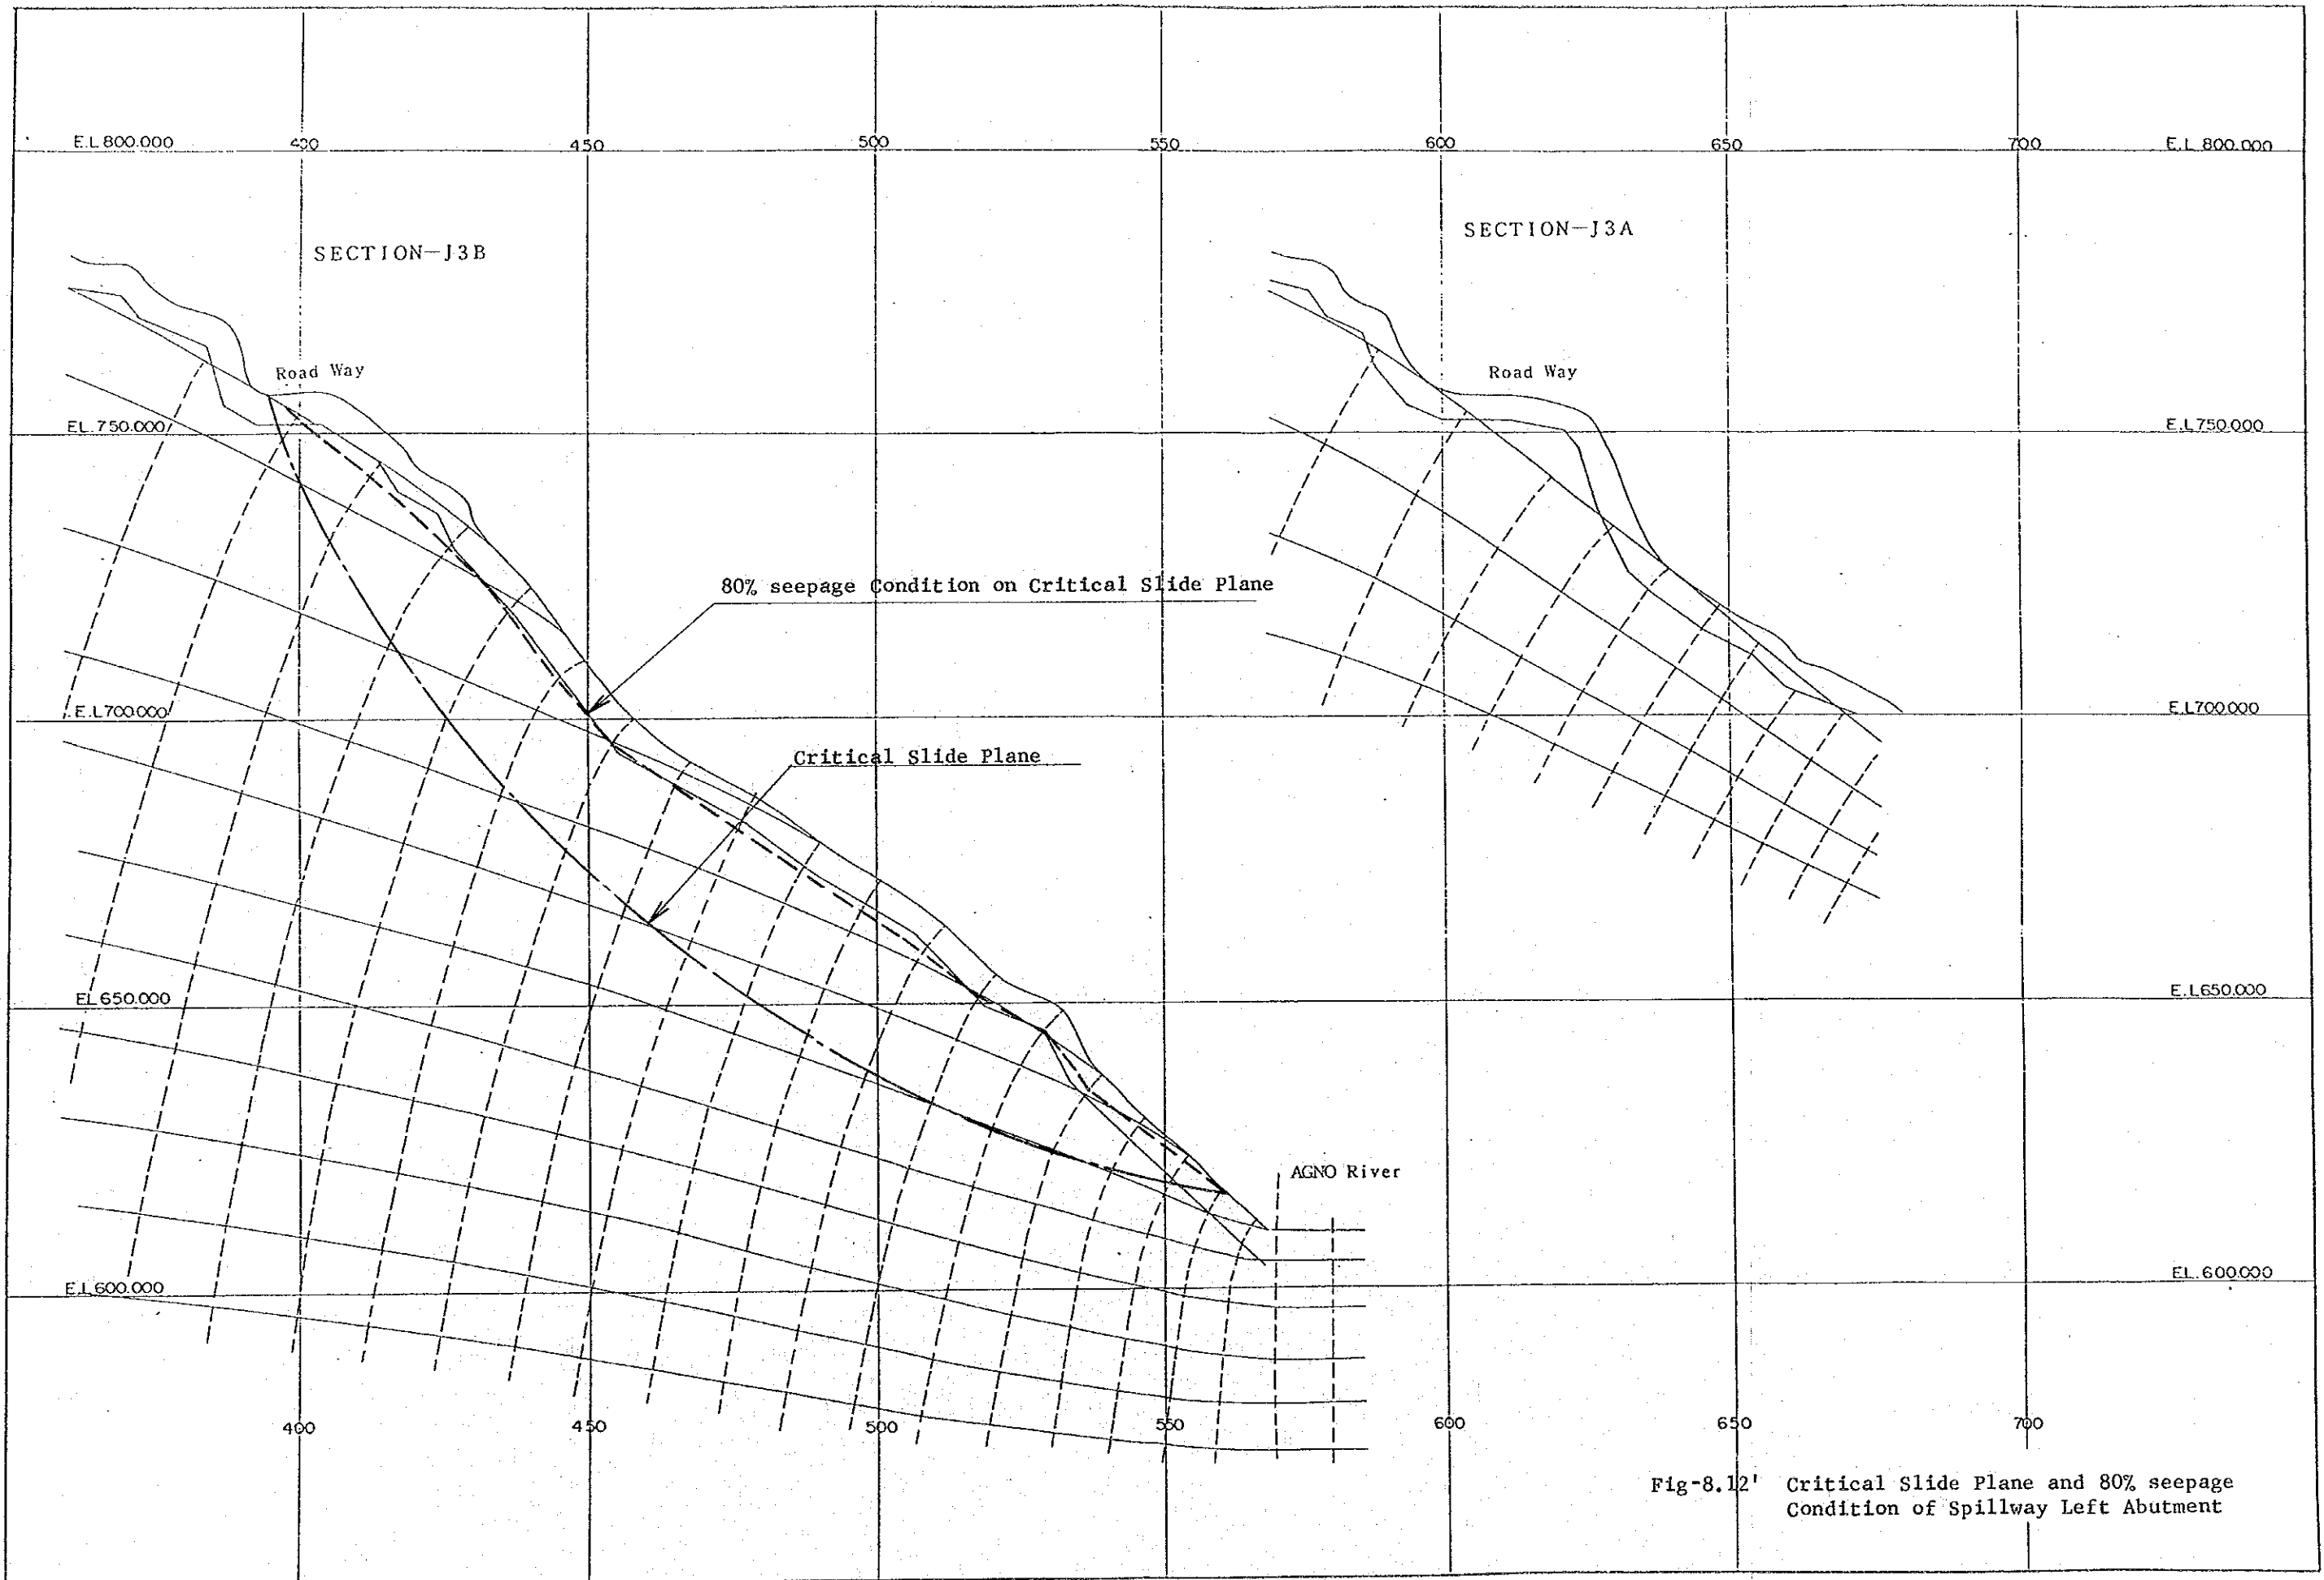
Fig-8.12' Critical Slide Plane and 80% seepage Condition of Spillway Left Abutment

\*3 Case 2 shall be critical condition and referring to Fig.-8.12'

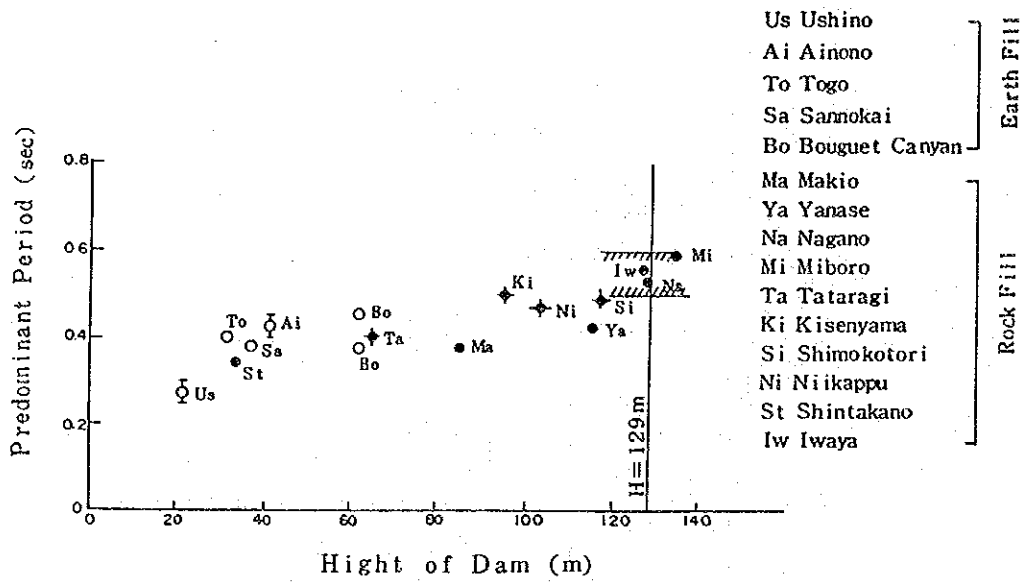
Fig - 8.19 Predominant Period of Fill Dams<sup>\*2</sup>

The periods of first shearing mode in the upstream-downstream direction for embankment dams due microtremor, vibration test by blasting, earthquake observations, etc., are shown in Fig.-8.19. The value of  $T = 0.65$  or  $0.68$  sec., for the Ambuklao Dam, based on the above data (see Fig.-8.19<sup>\*2</sup>) appears to be appropriate. This further reinforces the view that value of  $T = 3.23$  sec. is something out of the ordinary, and, therefore, it thus should be reevaluated.
