BASIC DESIGN STUDY  
ON  
THE PROJECT FOR REHABILITATION  
OF  
N-N DEMONSTRATION UNIT  
IN  
THE PEOPLE'S REPUBLIC OF BANGLADESH

MAY, 1988

JAPAN INTERNATIONAL COOPERATION AGENCY

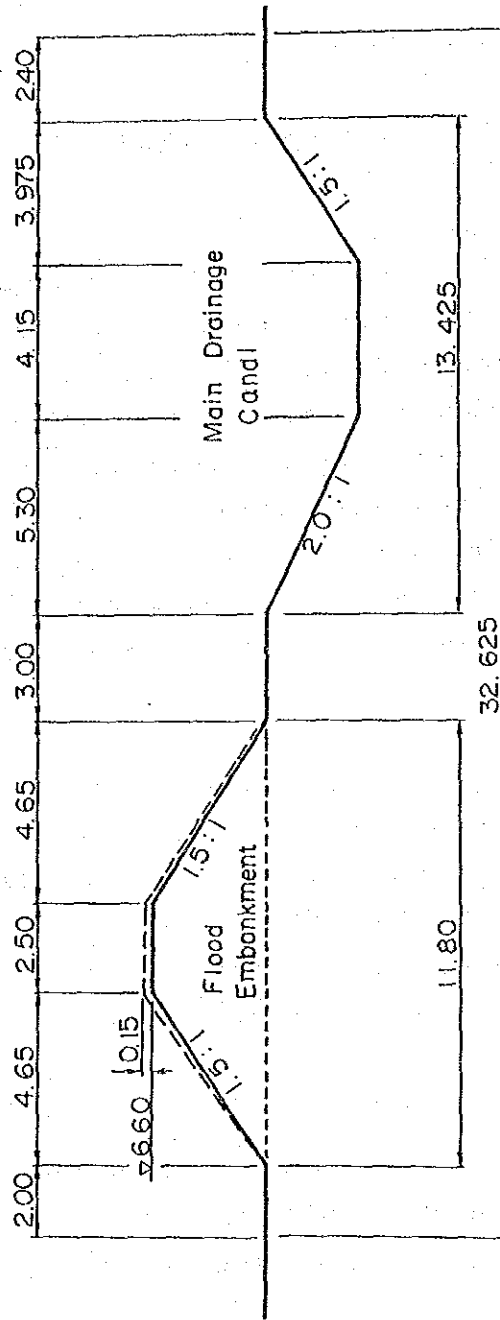
Fig. 5-1-1 Original Design of Flood Embankment

The subject flood embankment occupies an important position in the Demonstration Unit which was designed as a pilot model for the N-N Irrigation Project. In the original design, the estimated high water level was set at HWL 6.20 m, corresponding to a 10 years return period, and the crest elevation of the flood embankment was determined at EL 6.60 m with a free board of 0.40 m. The embankment was so designed as an integrated structure in combination with the main drainage canal as to be provided with the typical cross-section illustrated in Fig. 5-1-1.

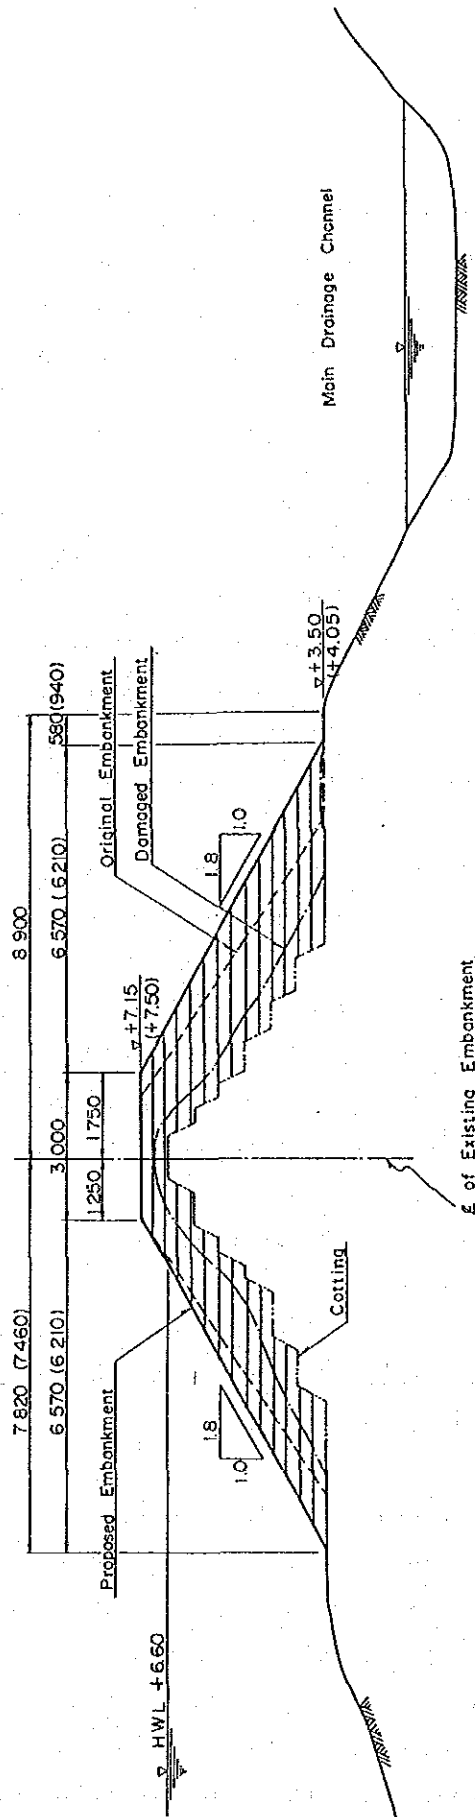
Fig.5-1-2 Typical Cross Section of Emergency Work

The emergency rehabilitation work commenced during the recent dry season (1987/1988) with Japanese grant aid cooperation to protect the heavily-damaged sections from flooding during the next rainy season. For the slightly-damaged section between the pumping station and the 4.0 km point, the BWDB is conducting its own emergency rehabilitation work with IDA funds in conformity with the work on the Japanese side. Fig. 5-1-2 shows the typical cross-section of the embankment body subject to the Japanese emergency rehabilitation work, which is finalized by the completion of this work. An extensive impervious blanket is being applied to the river side of the embankment body at the breached section to prolong the path of percolation beneath the embankment body.

The emergency rehabilitation work is, however, being implemented with a short-term objective to prevent flooding in the 1988 rainy season due to constraints in the construction period and the resultant workability of the earth work. As a result, the sectional form of the rehabilitated embankment is slightly inferior to those of many other flood embankment in Bangladesh. It is, therefore, essential to take radical reinforcement measures for this Project.

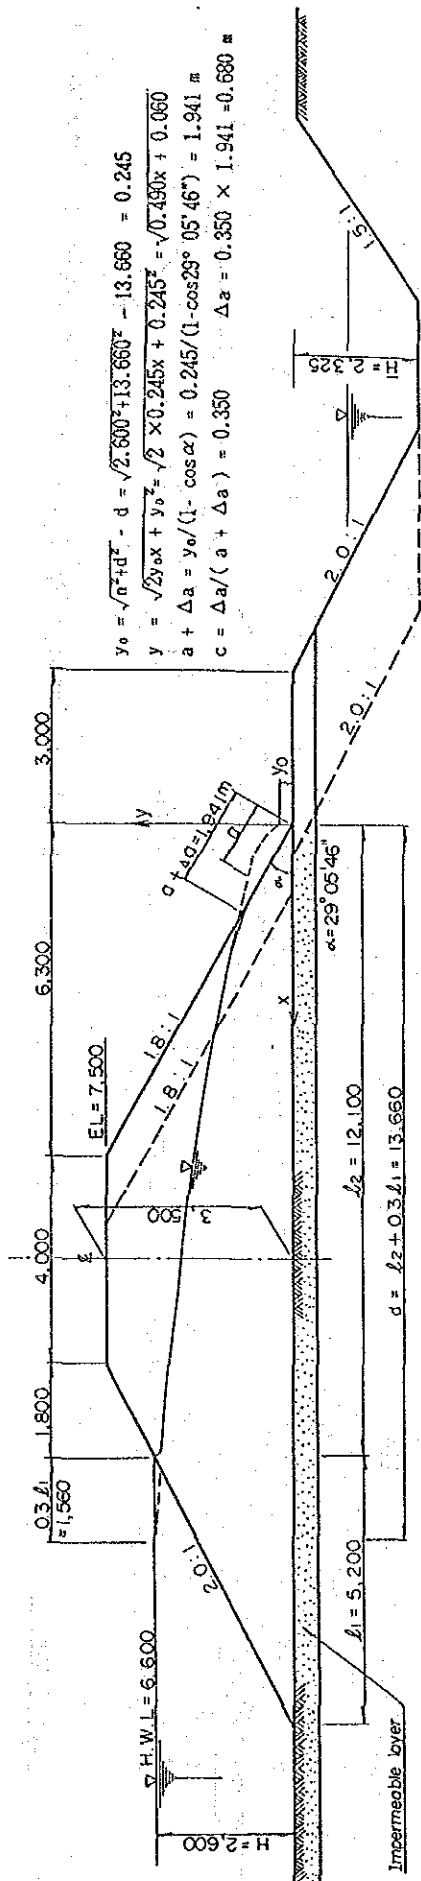
Fig. 5-4-1 Result of Seepage Analysis ( without Special Measures )

Sequent on the soil study and permeation analysis, the stability of both the land side and river side slopes was analysed for two cases, i.e. ① where no embankment reinforcement measures are taken and ② where the level of the seepage face is lowered by the construction of a core-wall. The design water level was identified with the high water level, but the case of the low water level was
