THE RAMA VI BRIDGE CONSTRUCTION PROJECT

SUPPLEMENTARY REPORT

**Strengthening and Rehabilitation
for Krung Thon and Krung Thep Bridges**

MARCH 1982

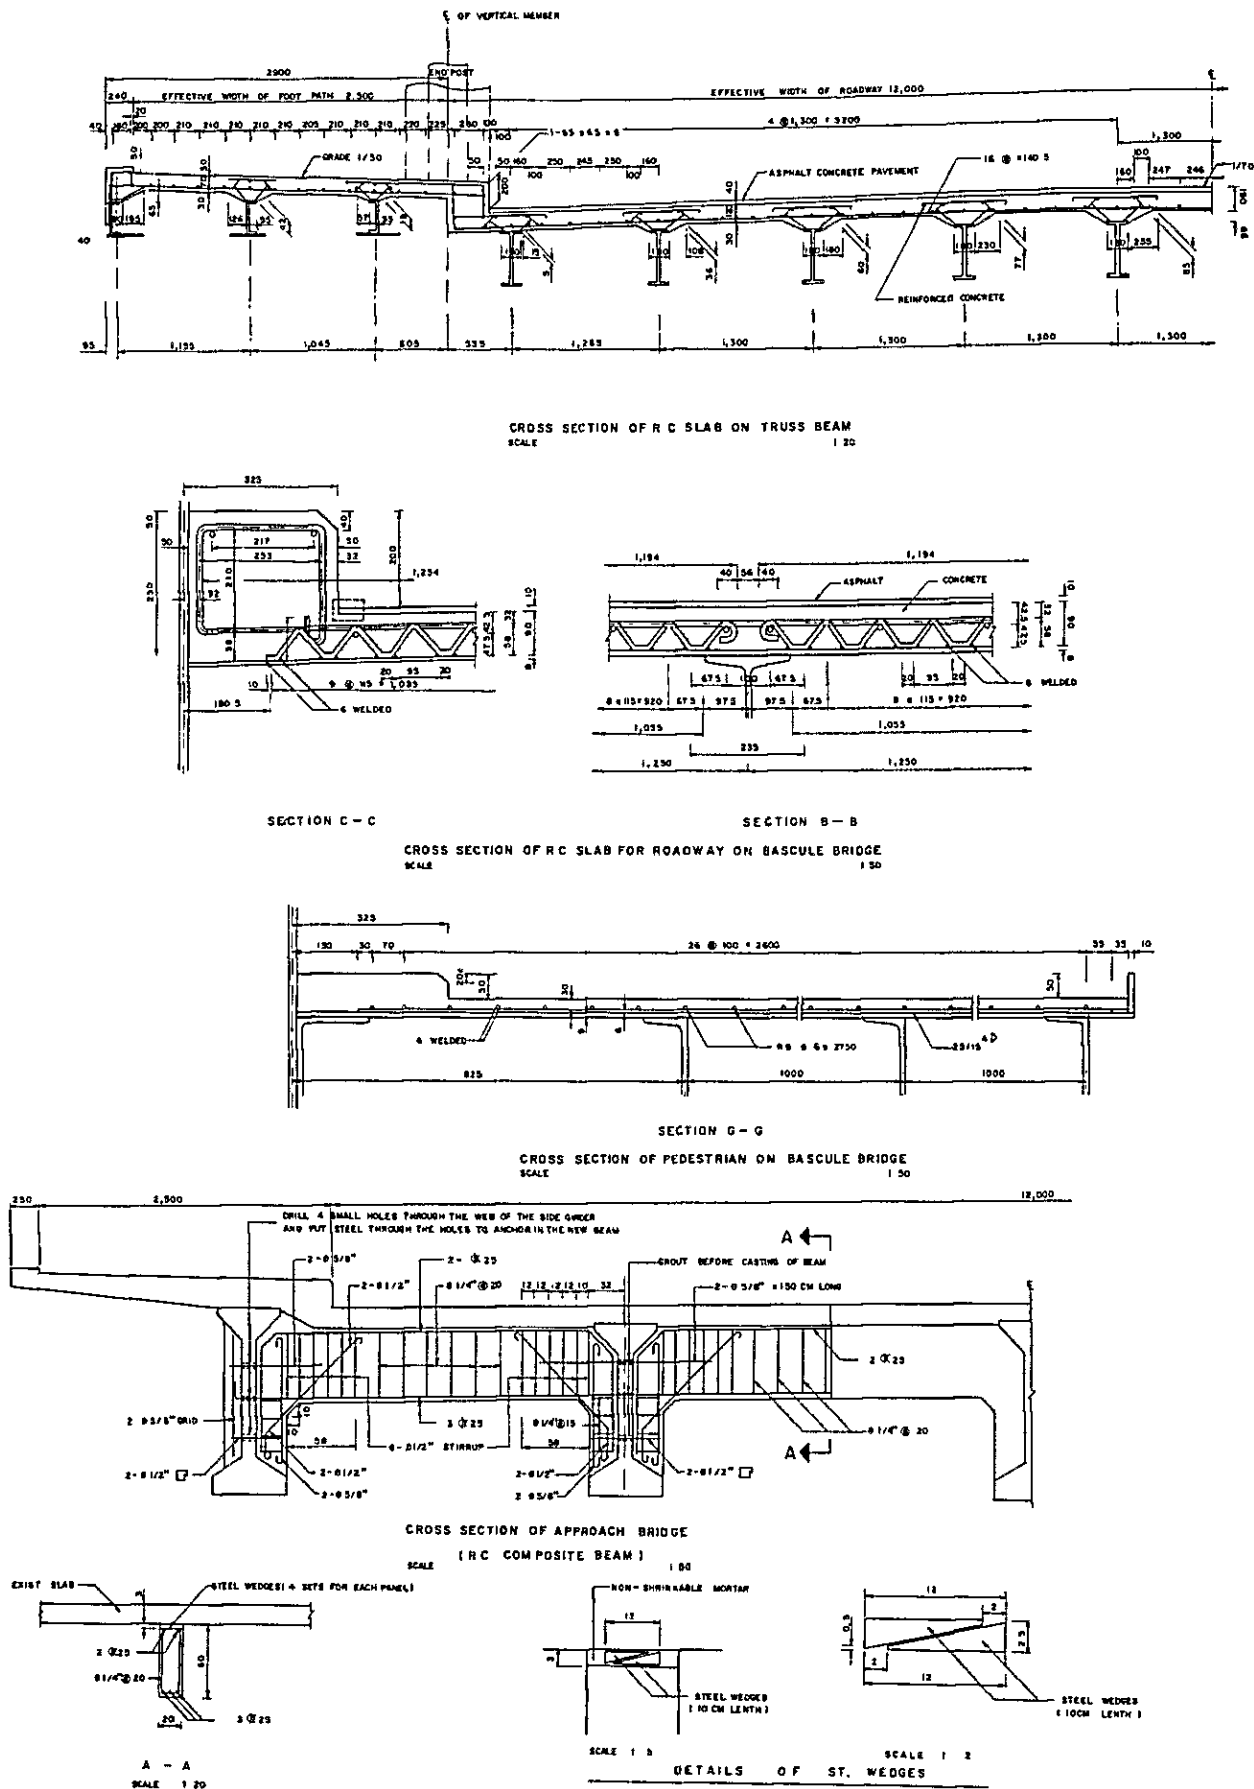
Fig. 3-3.1 EXISTING FLOOR SLABS ON THE TRUSSED BEAM, BASCULE BRIDGE AND PC COMPOSITE BEAM OF THE APPROACH BRIDGE

As shown in Figure 3-3.1, in the Trussed Beam Section, a 15 cm thick RC floor slab is continuously supported with stringers arranged at intervals of 1.3 m.

The results of the examination of the cracks taking place in these RC slabs are shown in Figure 3-3.4. The fine "net" of cracks has developed particularly at the 1st span at both sides for about 13 years. Accordingly, as shown in Figure 3-3.1 and Figure 3-3.4, cross beams have been provided between the originally existing cross beams,

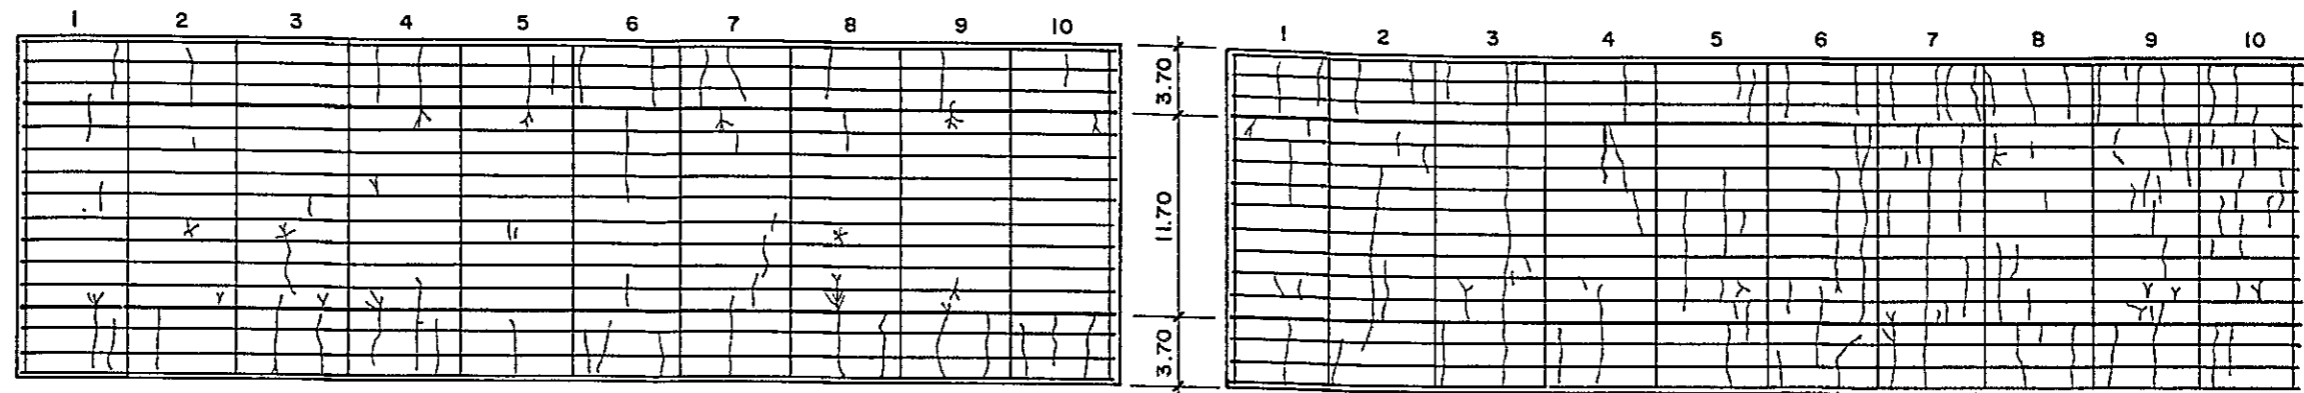
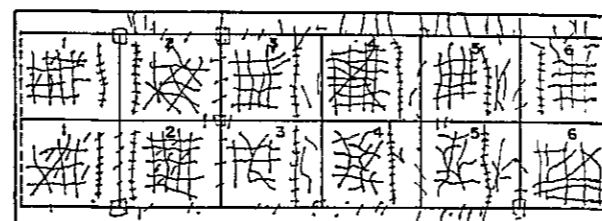
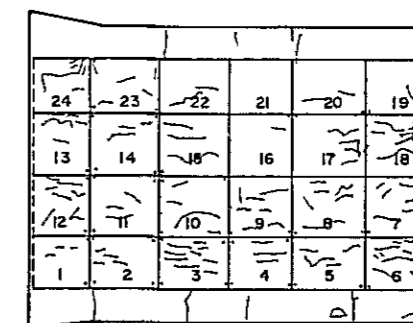
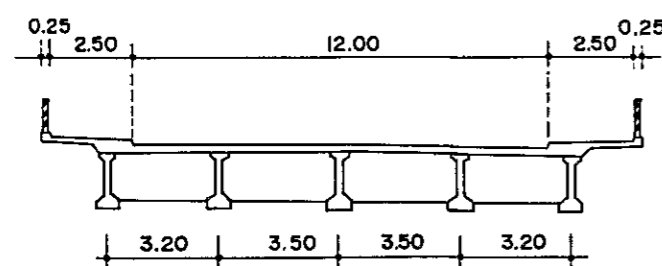
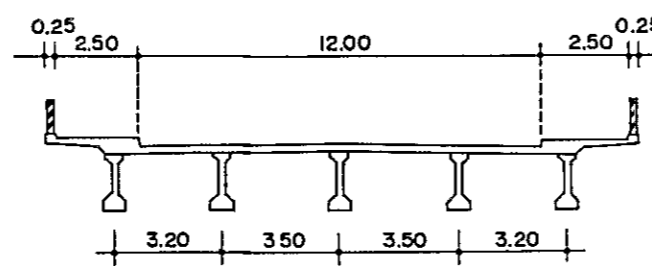
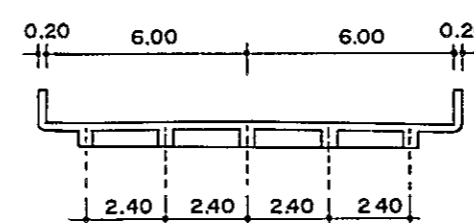
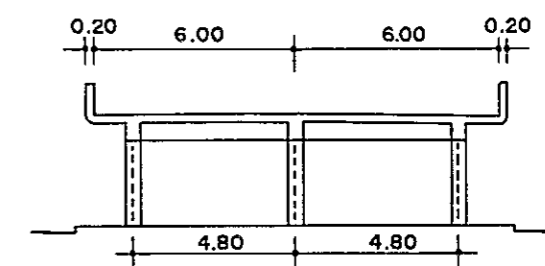
Fig. 3-3.2 CRACKS DEVELOPED ON THE CONCRETE FLOOR SLABS OF THE
MAIN AND APPROACH BRIDGE — KRUNG THON BRIDGE

As shown in Figure 3-3.2 through Figure 3-3.5, the concrete block pavements on the footpath of the KRUNG THON Bridge and KRUNG THEP Bridge present cracks everywhere, but they do not cause hindrances to the pedestrian flow. (Refer to Photo 3-1.3 through Photo 3-1.6).

The results of examination of the cracks taking place in these RC slabs are shown in Figure 3-3.2 and Figure 3-3.3.

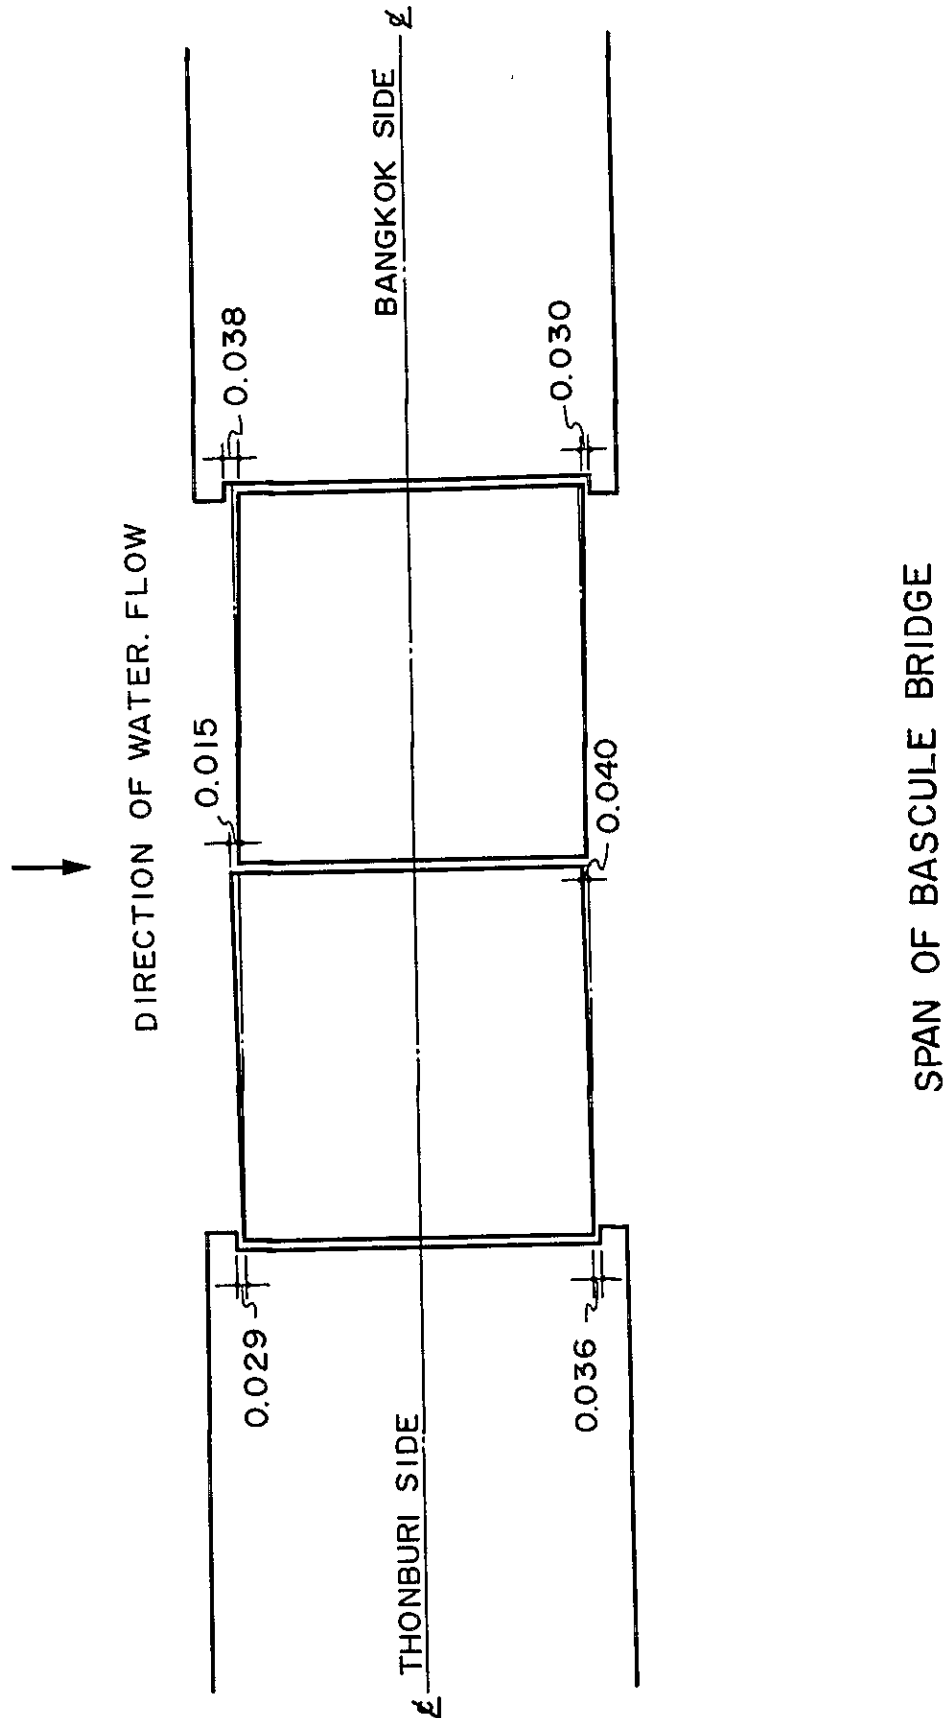
Fig. 3-6.1 PLANE SHIFT VALUES AT THE EACH POINT WHEN THE BRIDGE IS CLOSED

However, the shear key located at the span center presents the eccentricity as shown in Figure 3-6.1.

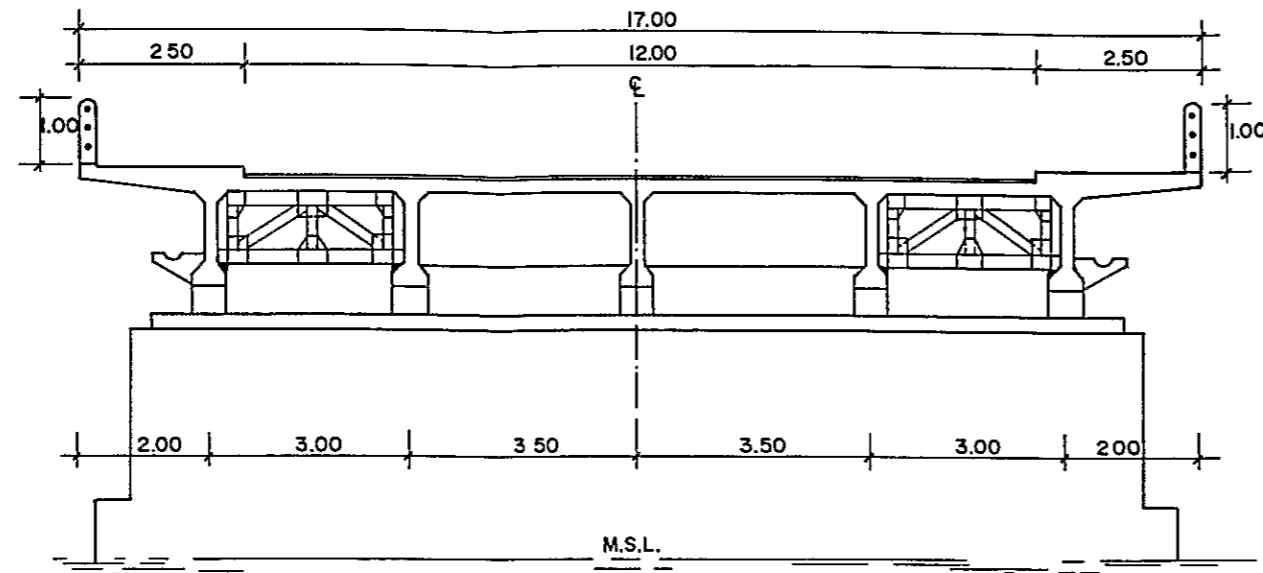
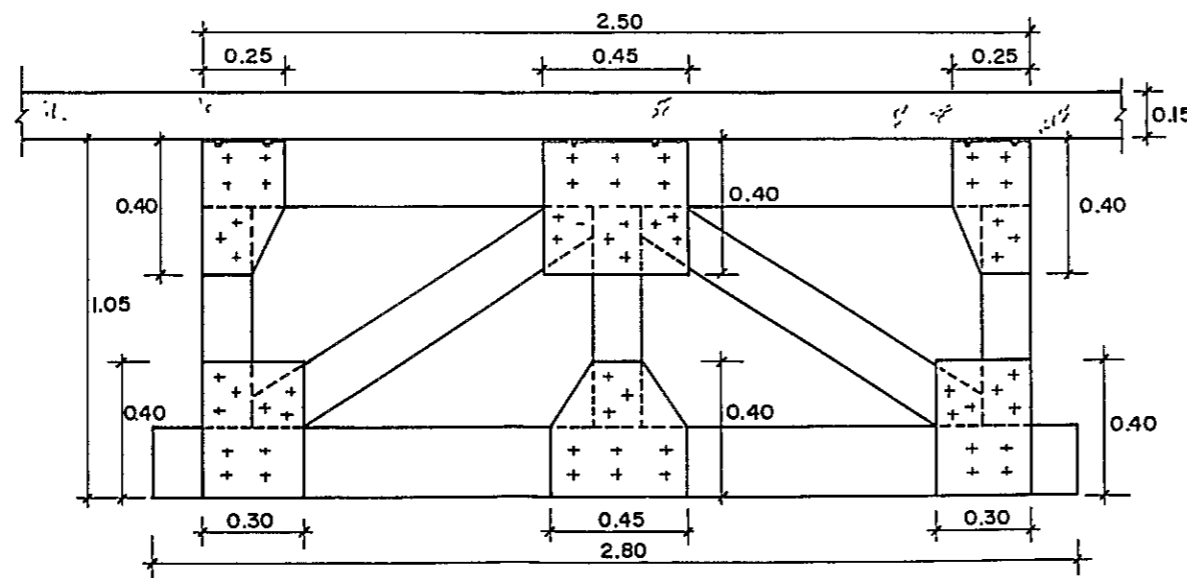
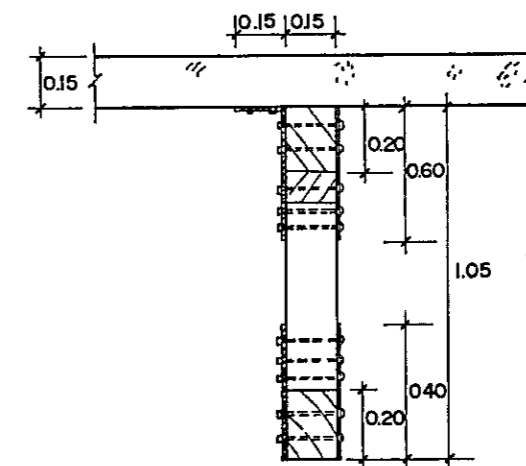
Fig. 3-8.3 THE TIMBERING ADOPTED TO STRENGTHEN THE CONCRETE FLOOR SLABS OF THE APPROACH BRIDGE — KRUNG THON BRIDGE AND KRUNG THEP BRIDGE

in order to support the floor slab. In addition, temporary supports have been constructed everywhere, aiming at preventing the floor slab peeling off and falling off as shown in Fig. 3-8.3. (Refer to Photo 3-8.7 through Photo 3-8.10)

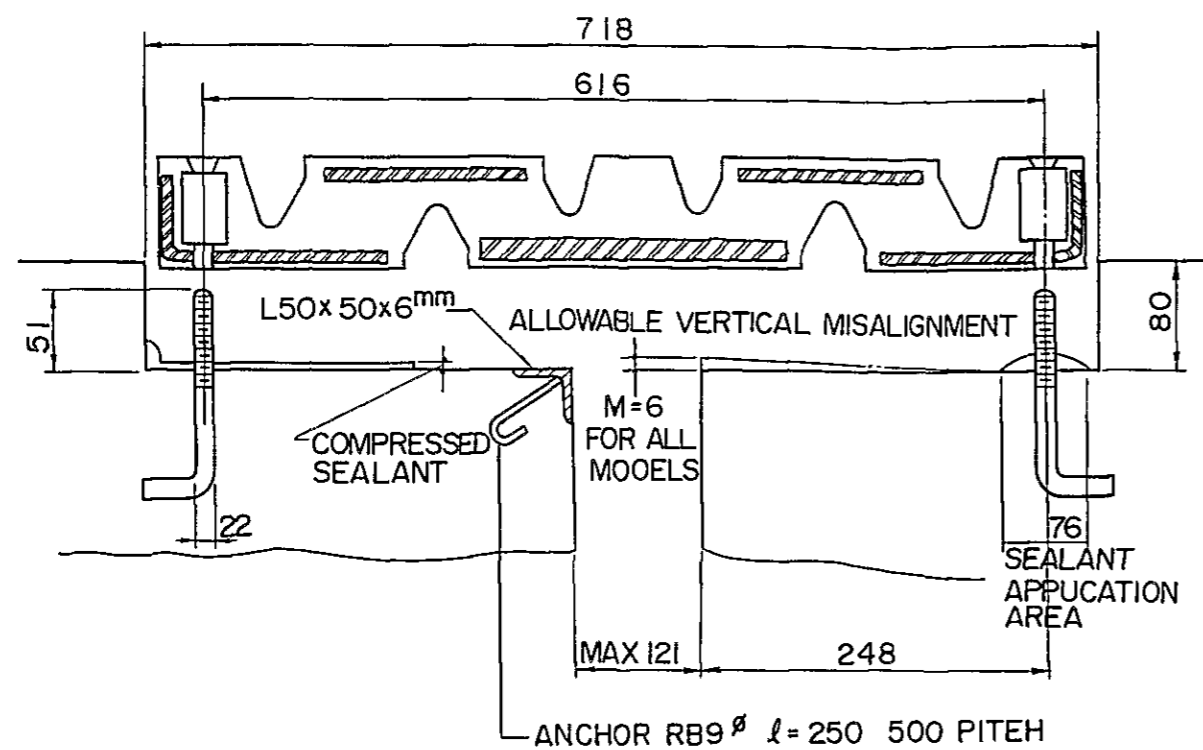
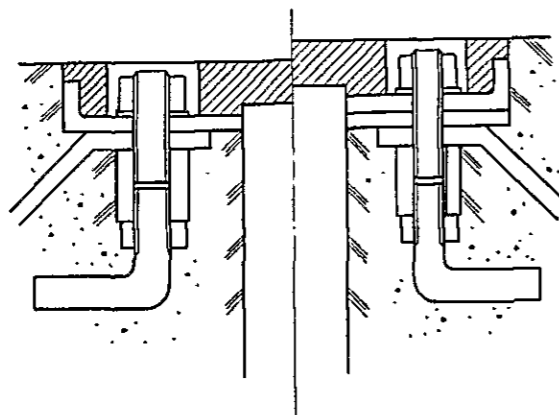
Fig. 6-2.1 IMPROVEMENT OF EXPANSION JOINT

On the other hand, with regard to the members located under the floor slab, there is serious formation of rust caused by rainwater, etc., near the expansion joints and construction joints of the RC slab. The said rust is so serious that it could damage the durability of the steel bridge.

- 1) Execution of the repair of the unevenness of the RC slab of the KRUNG THEP Bascule Bridge and execution of the asphalt covering as wearing course.
- 2) Execution of the improvement of the construction joints in the RC slabs of both bridges.
- 3) Replacement of the RC slab located on the PC composite beams of the approach sections.
