**ANGAT DAM REHABILITATION PROJECT**

**SUMMARY**

**MARCH 1989**

**JAPAN INTERNATIONAL COOPERATION AGENCY**

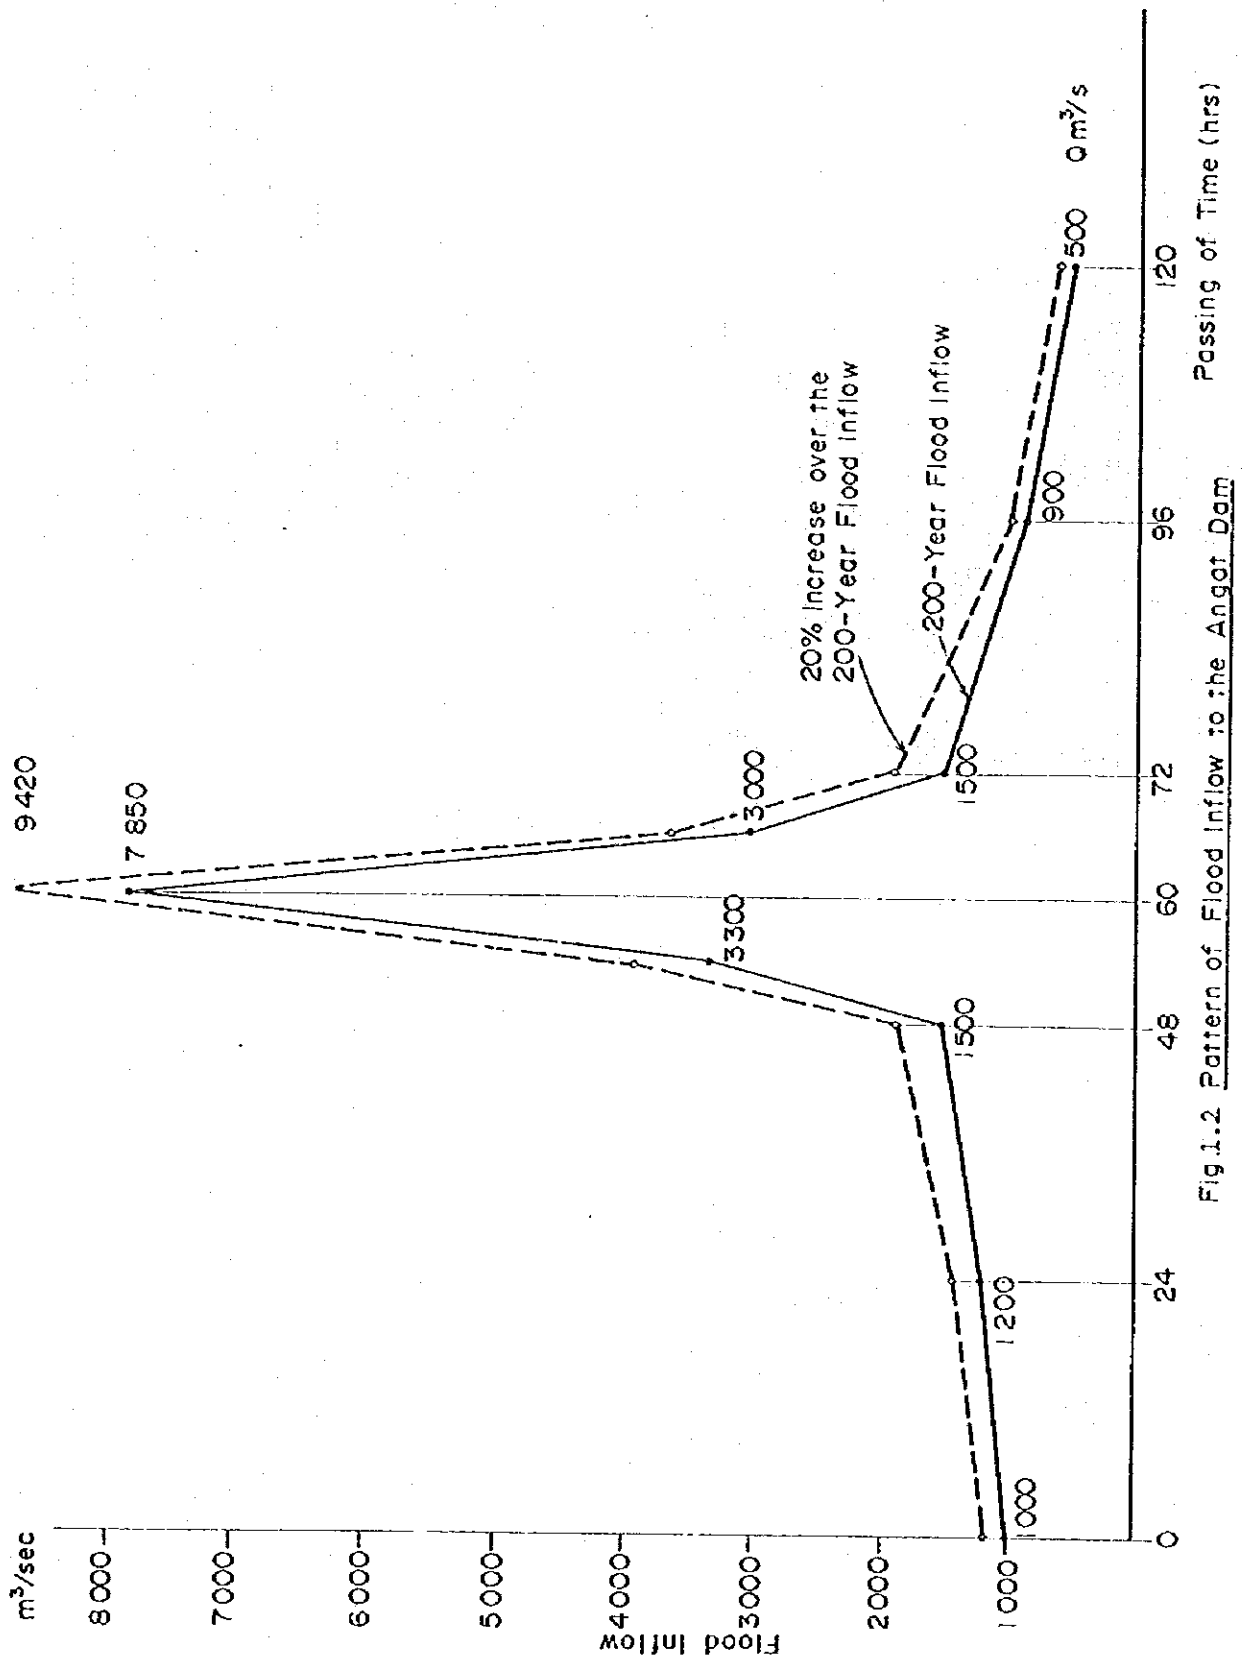
Fig.1.2 Pattern of Flood Inflow to the Angot Dam

The 20% increase over the 200-year flood inflow with such inflow patterns as above was applied to the case of the Angat dam as the design flood inflow, and the maximum permissible water level at this particular flood inflow was assumed to be at EL.218 m, with the high water level (HWL) set at EL.212 m, taking into account the height of wave above the reservoir water surface due to winds, and the minimum required freeboard of 1.5 m for fill type dam. (Refer to Fig. 1.2.)

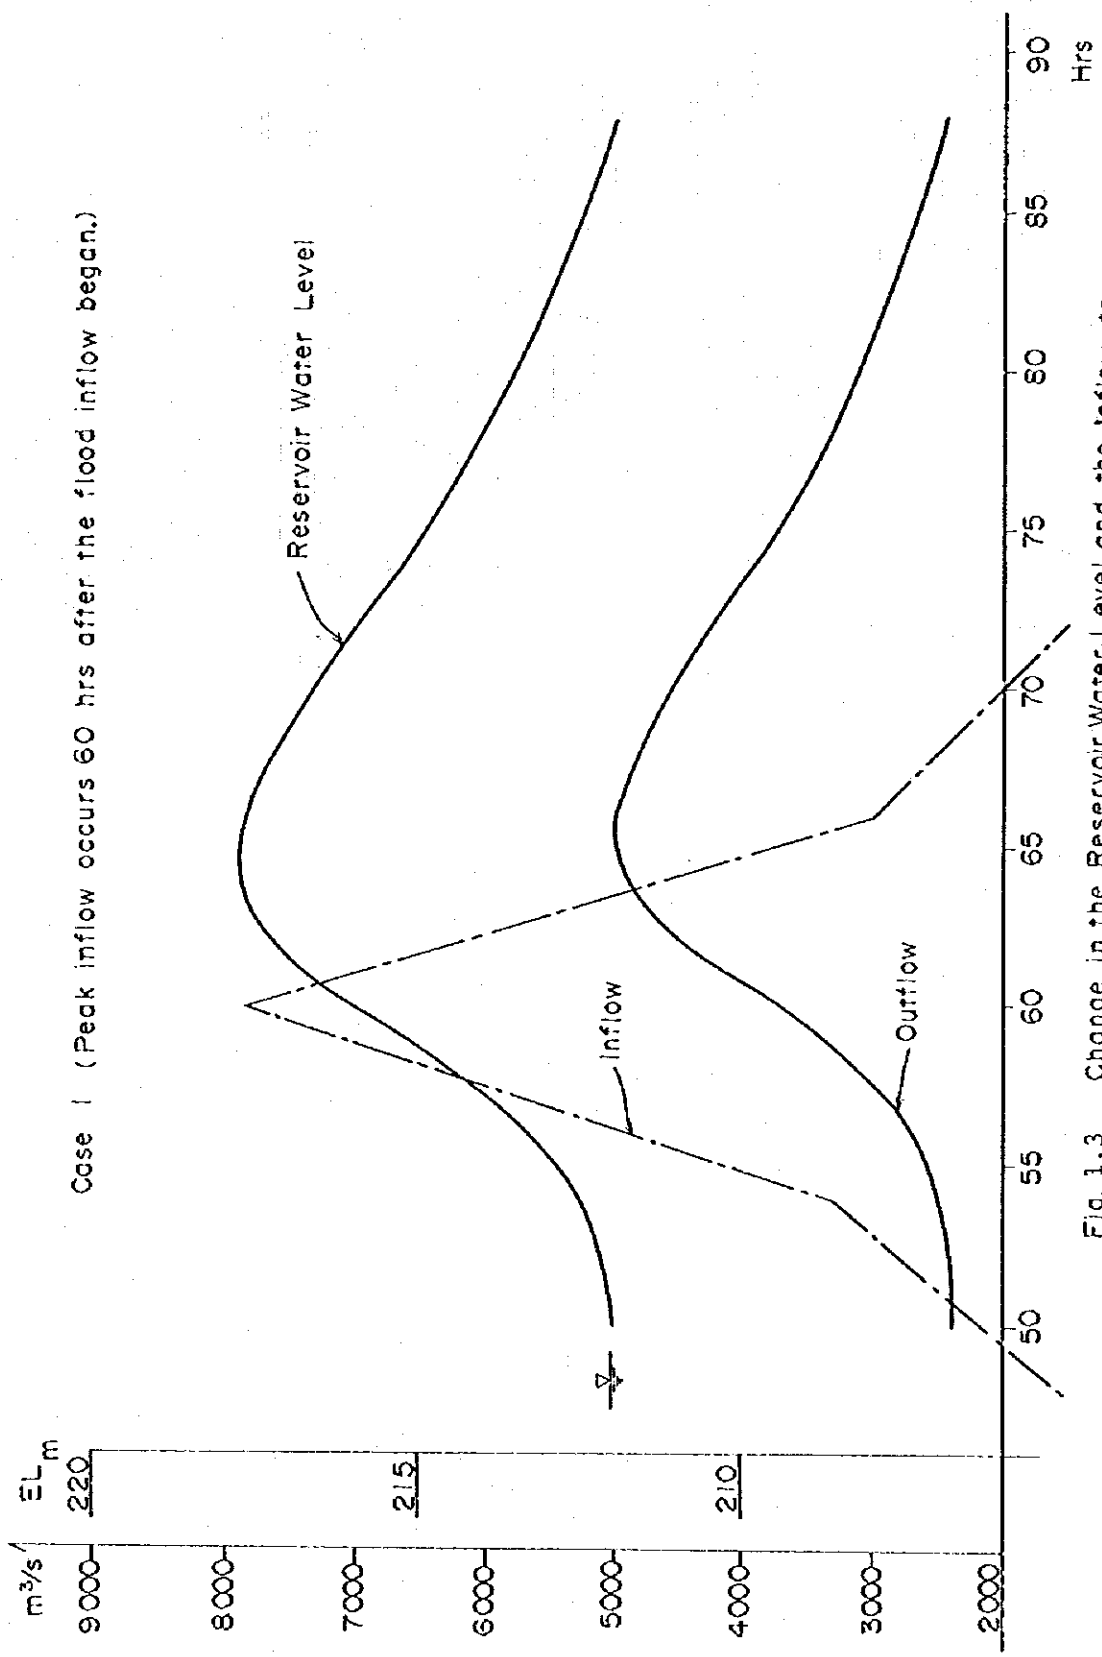
Fig. 1.3 Change in the Reservoir Water Level and the Inflow to and Outflow from the Dam during the Flood with a 200-Year Return Period Multiplied by 1.2

The results also indicate that, even if the water level is kept at EL.213.0 m, and the gate operation is done in such a manner as the flood inflow be discharged in free flow condition at full gate opening after the flow rate exceeds  $2,800 \text{ m}^3/\text{sec}$ , the water level would rise only to EL.218.12 m. This is a little over the maximum permissible limit of EL.218.0 m, but this much of excess may not pose any particular problems in dam operation. (Refer to Fig. 1.3. and Table 1.1.)

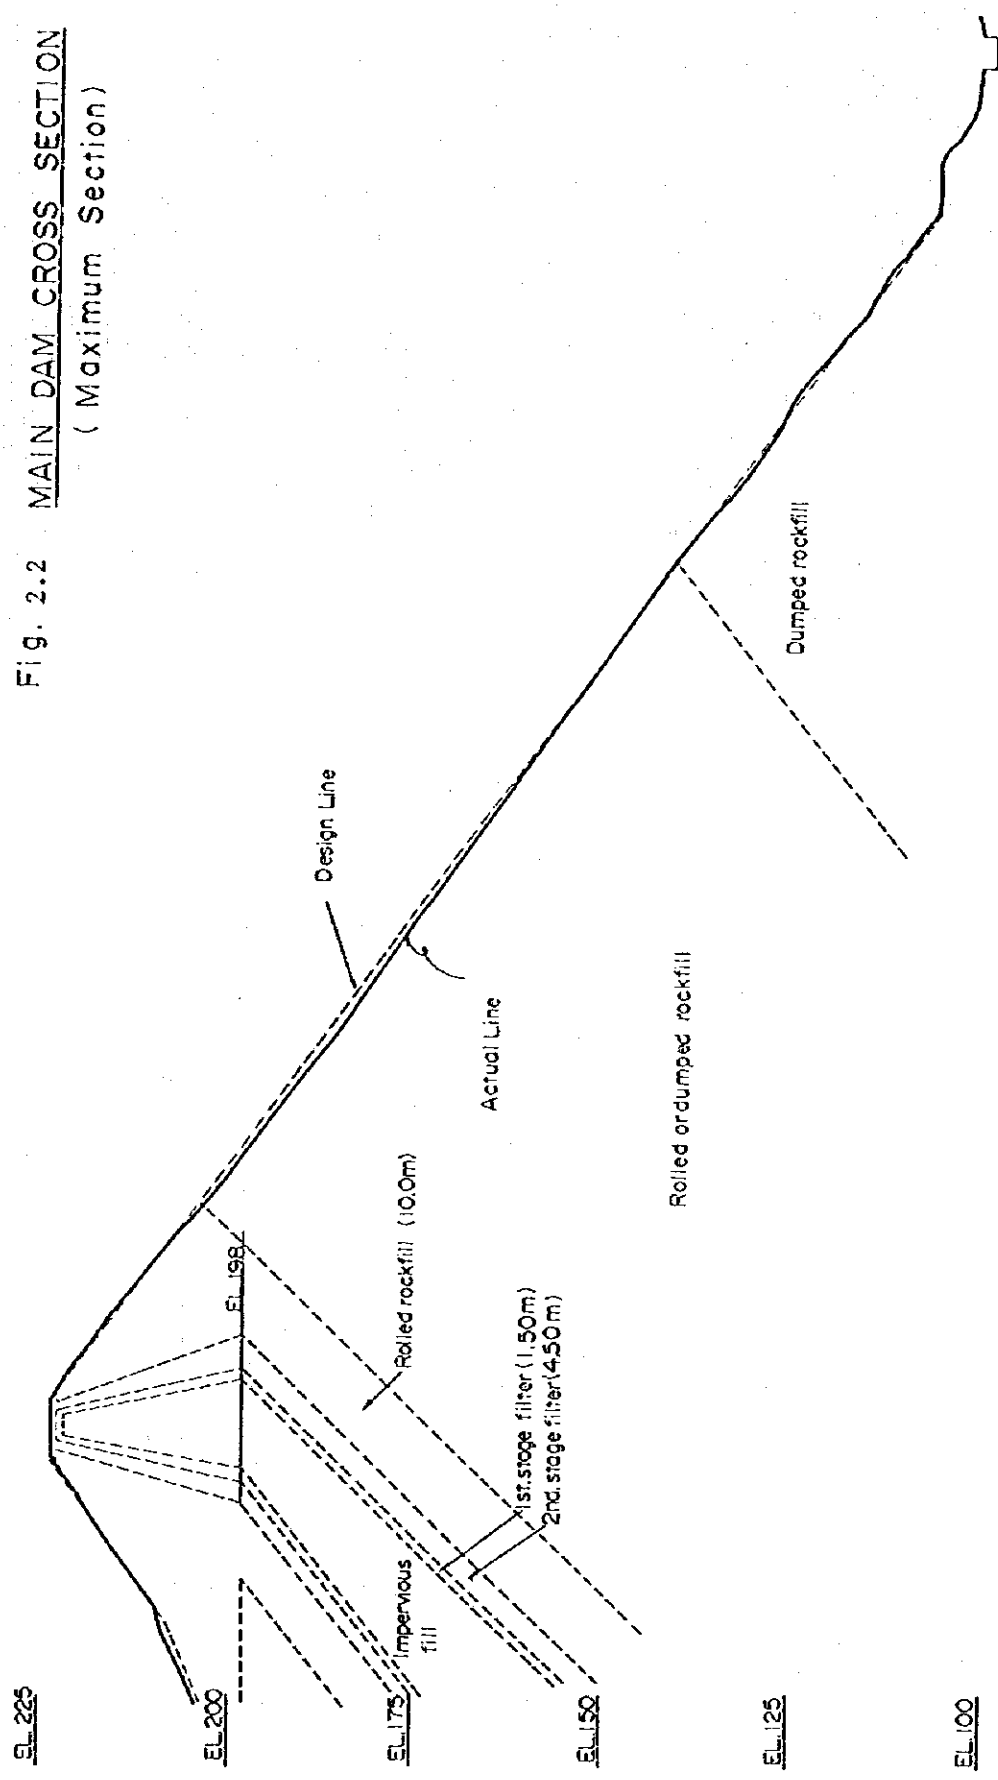
Fig. 2.2 MAIN DAM CROSS SECTION  
( Maximum Section )

With regard to the downstream face slope of the dam, it appears that no changes have taken place on the dam since its completion from the fact that the measured gradient of 1:1.4 is identical with the design drawing. (Refer to Figs. 2.2 and 2.3.)

The safety factor against sliding of the downstream face slope would be larger than 1.2 in static condition, when assuming  $\phi$  value of the rockfill materials is  $43^\circ$ , but would come down to 0.964 or smaller than 1.0 under the loading conditions with the earthquake with  $K_h$  of 0.15 g. The sliding, if happened, however, would be limited only to the portion close to the slope surface of the dam. Though it may not necessarily be said that the slope is absolutely safe against any large earthquake, the occurrence of such earthquake may not lead to a disruption of the dam. The stability analysis of the slope profile after removing the earth slidden due to the earthquake indicates that the safety factor against further sliding would be 1.0 in static condition. (Refer to Fig. 2.4.)

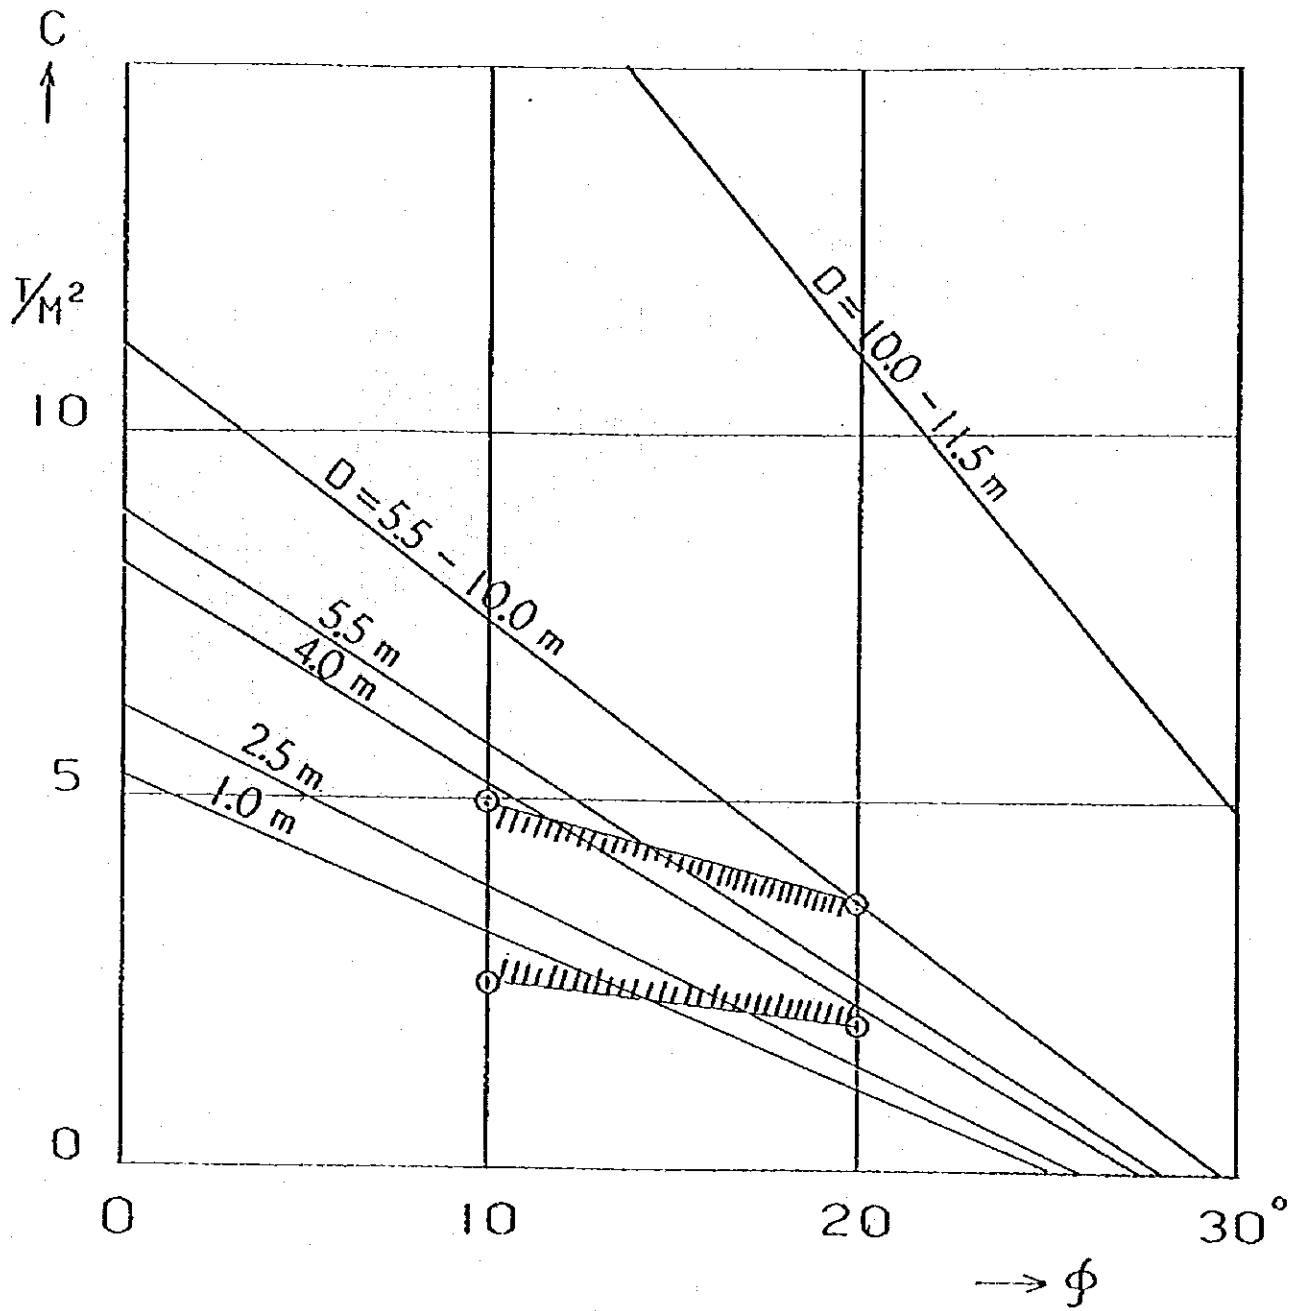
Fig. 3.1 Relation Between C and  $\phi$  Values for Analyses on the Possibility of Landsliding

if  $\phi$  value is assumed to be  $20^\circ$ , in so far as the mountain masses are at the elevations higher than EL.180 m. (Refer to Fig. 3.1.)

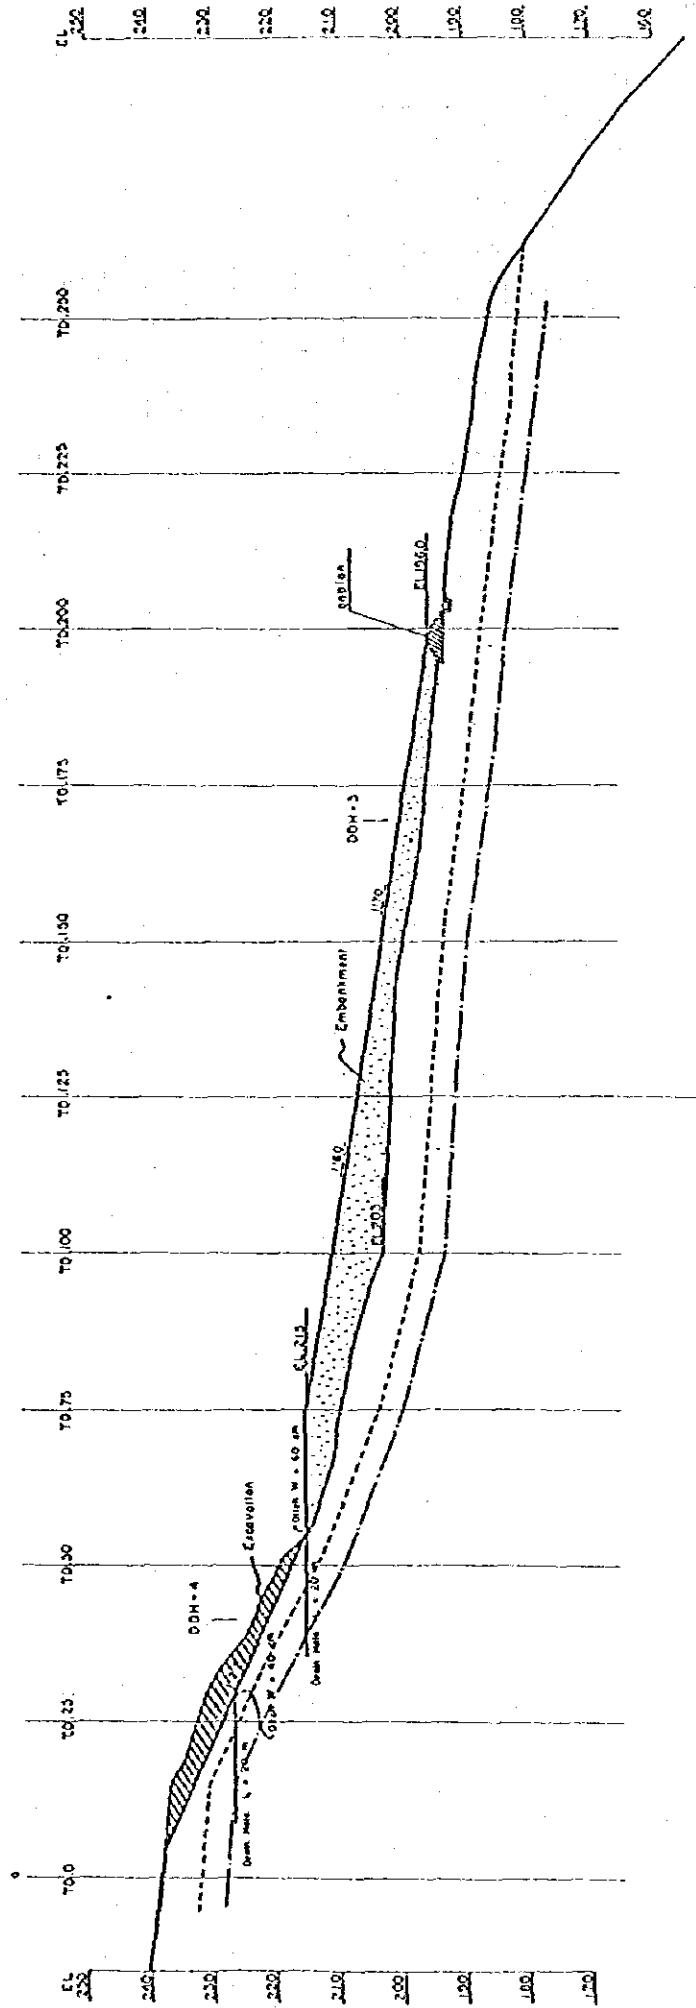
Fig. 3.4 Longitudinal Profile after Slope Reformation (Cross Section A-A)

It was also confirmed that the solution (b), if implemented in such manner as to cut the ground at elevations higher than EL.215 m to make the slope gentler, and to fill up the ground at elevations lower than 215 m to keep it from sliding, will ensure the safety of the slope, even in an extreme case where an earthquake with  $K_h$  of 0.15 g would occur at any time when the ground is impregnate with water up to the surface due to heavy rainfall. (Refer to Figs. 3.3, 3.4 and 3.5.)

It is also recommended to provide drain holes, each with a diameter of 75 mm, at the elevations of EL 215 m and 225 m, and surface drain ditches, in order to reduce ground water level and to protect the surface from erosion by rainfall, so as to make doubly sure of the safety against sliding.
