RESULTS OF VISUAL INSPECTION OF 52 BRIDGES (5/11)

DIAGNOSTIC RECORD OF THE 22 EXISTING BRIDGES (2/22)

DIAGNOSTIC RECORD OF THE 22 EXISTING BRIDGES (13/22)

DETAILED SURVEY OF DETERIORATION AND DAMAGES (1/3)

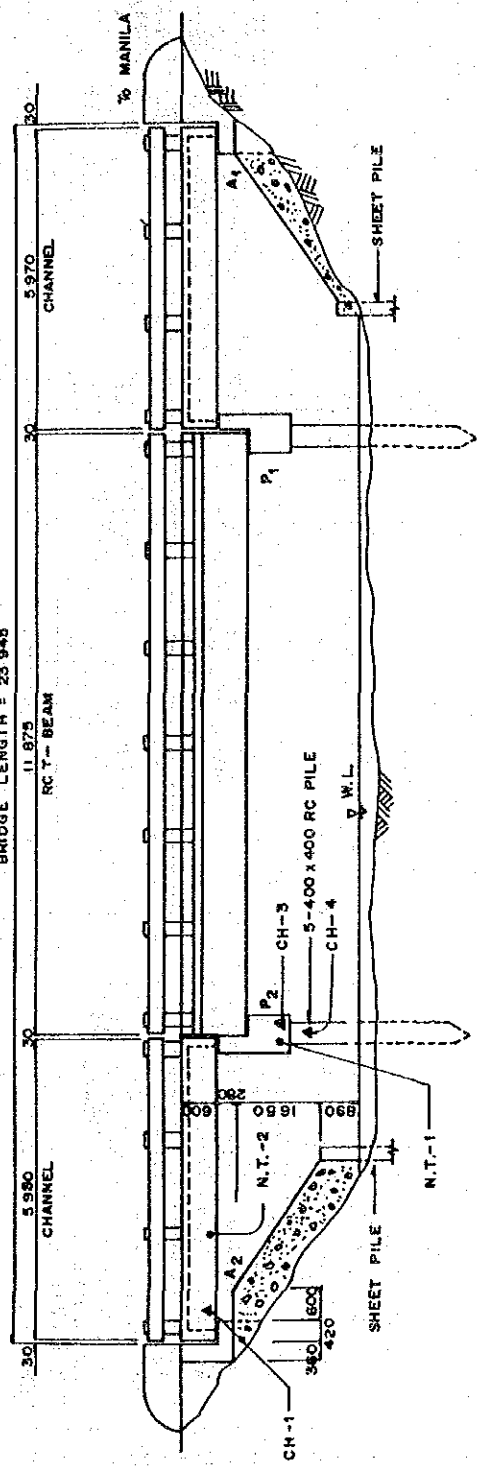
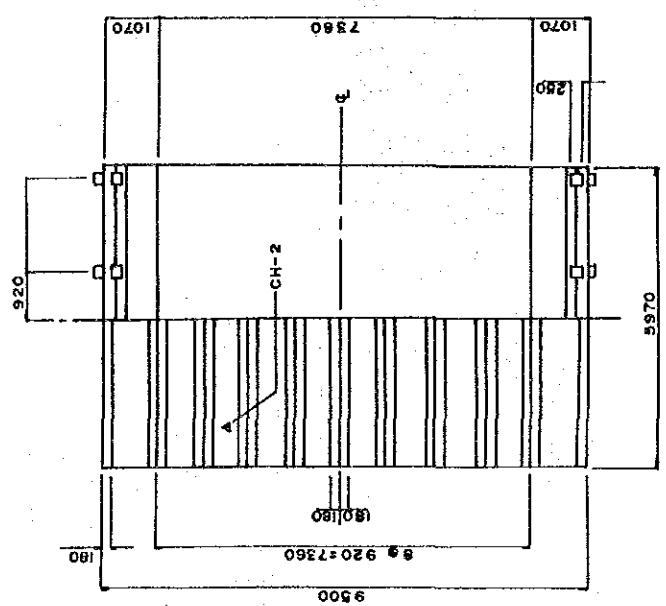
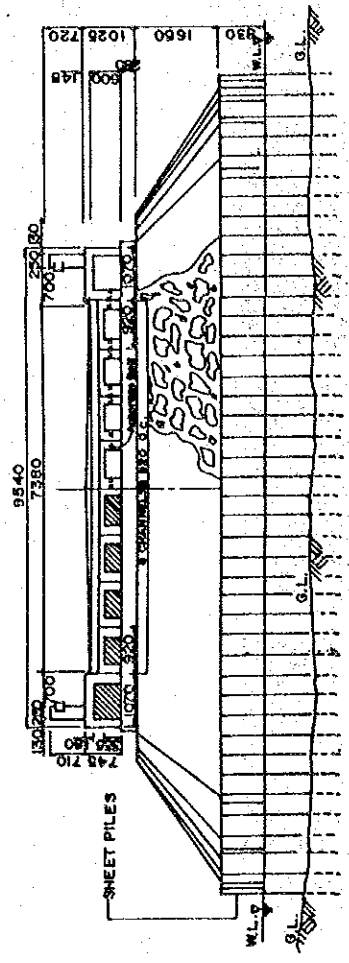
PROFILE MEASUREMENT OF BRIDGE ELEMENTS

- N.T. - NEUTRALITY TEST
- N.T.-1, NON CORROSION OF REINFORCING STEEL. NEUTRALITY DEPTH 0mm.
- N.T.-2, REINFORCING STEEL NOT VISIBLE. NEUTRALITY DEPTH 0mm.

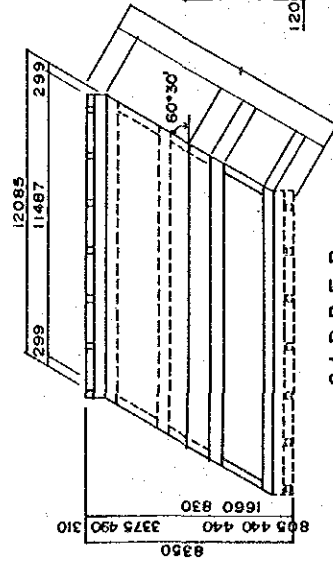
PLAN  
SCALE: 1:200

NOTE:  
1. CONCRETE HAMMER TEST (CH)  
CH-1 PIER 1 420 kg/cm<sup>2</sup>  
CH-2 PIER 2 380 kg/cm<sup>2</sup>  
CH-3 GIRDER No.3 SPAN 400 kg/cm<sup>2</sup>  
CH-4 ABUTMENT 380 kg/cm<sup>2</sup>  
CH-5 GIRDER No.1 SPAN 380 kg/cm<sup>2</sup>  
2. NEUTRALITY TEST (N.T.)  
NT-1 GIRDER NEUTRALITY DEPTH 25 mm  
NT-2 PIER 1 NEUTRALITY DEPTH 20 mm

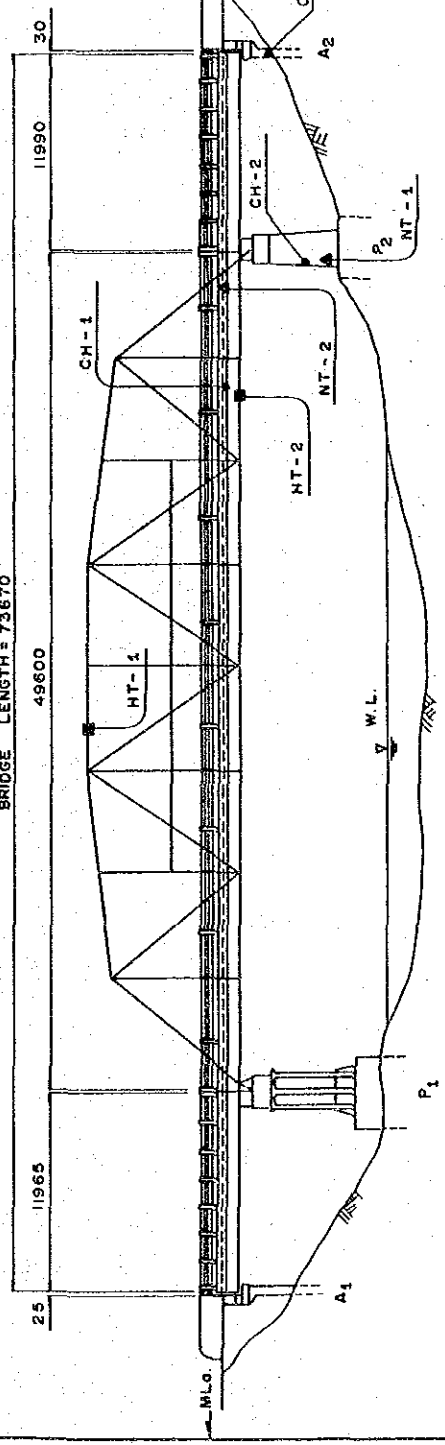
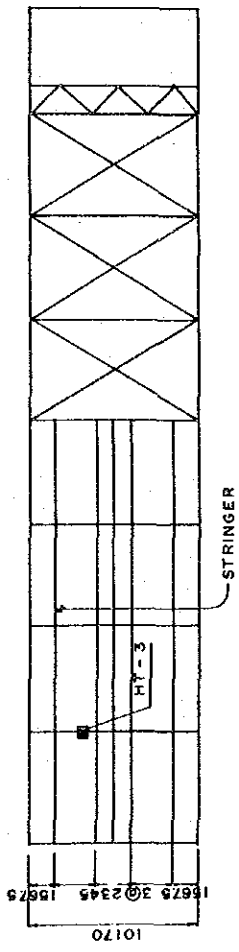
CROSS SECTION  
SCALE: 1:200

- HARDNESS TEST (HT):
  - HT-1 TOP CHORD 140 150HB (5200 kg/cm.)
  - HT-2 LOWER CHORD 130 HB (4800 kg/cm.)
  - HT-3 CROSS BEAM 160 HB (5500 kg/cm.)
- CONCRETE HAMMER TEST (CH)
  - CH-1 SLAB 470 kg/cm<sup>2</sup>
  - CH-2 P2 350 kg/cm<sup>2</sup>
  - CH-3 A2 360 kg/cm<sup>2</sup>
- NEUTRALITY TEST (NT)
  - NT-1 PIER 2 NEUTRALITY DEPTH 50mm
  - NT-2 SLAB NEUTRALITY DEPTH 20mm
