VI. STUDY ON THE GATE LEAVES AND RELATED FACILITIES

6-1-2 The Present Condition of Gate

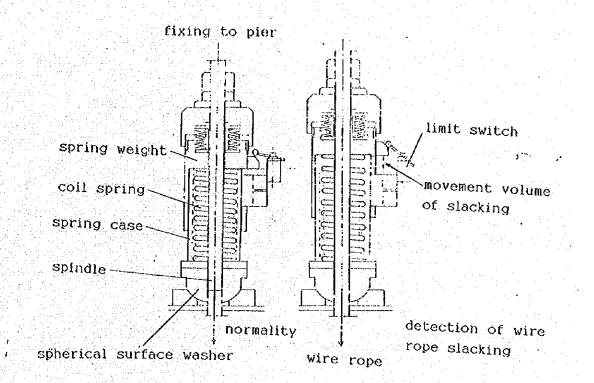
Detective device for wire rope slacking

In case of wirerope slackening, the spindle of the wirerope end will be raised by the coll spring.

Then the spring saucer will also be raised and at the same time sending signal to the motor by the limit switch which is at the side of the device and will stop the hoist automatically. The detection device for dislocation is installed for the protection of the metal fittings.

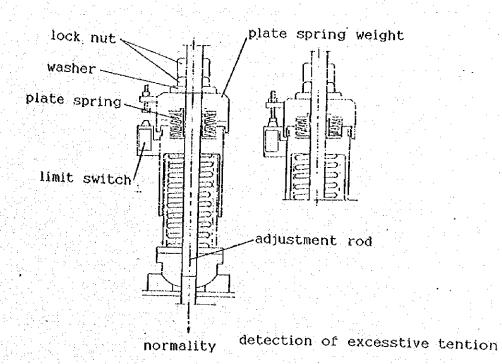
Detective device for excessive tention of wire rope

An overcurrent relay, torque limit detector, sliding clutch, shear pin, buckling protector, etc. are commonly used for a rope winding type, screw spindle type, and rack gear ype.

For a shear pin, cosideration should be given so that the gate leaf does not lower under its own weight even if the pin is broken. A relief valve is generally provided for a hydraulic cylider type and hydraulic cylinder wireropetype.
