**FEASIBILITY STUDY
ON
SMALL-SCALE POWER PLANTS
REHABILITATION PROJECT
IN
THE REPUBLIC OF COLOMBIA**

**PUENTE GUILLERMO HYDROELECTRIC
POWER PLANT**

MARCH 1990

Japan International Cooperation Agency

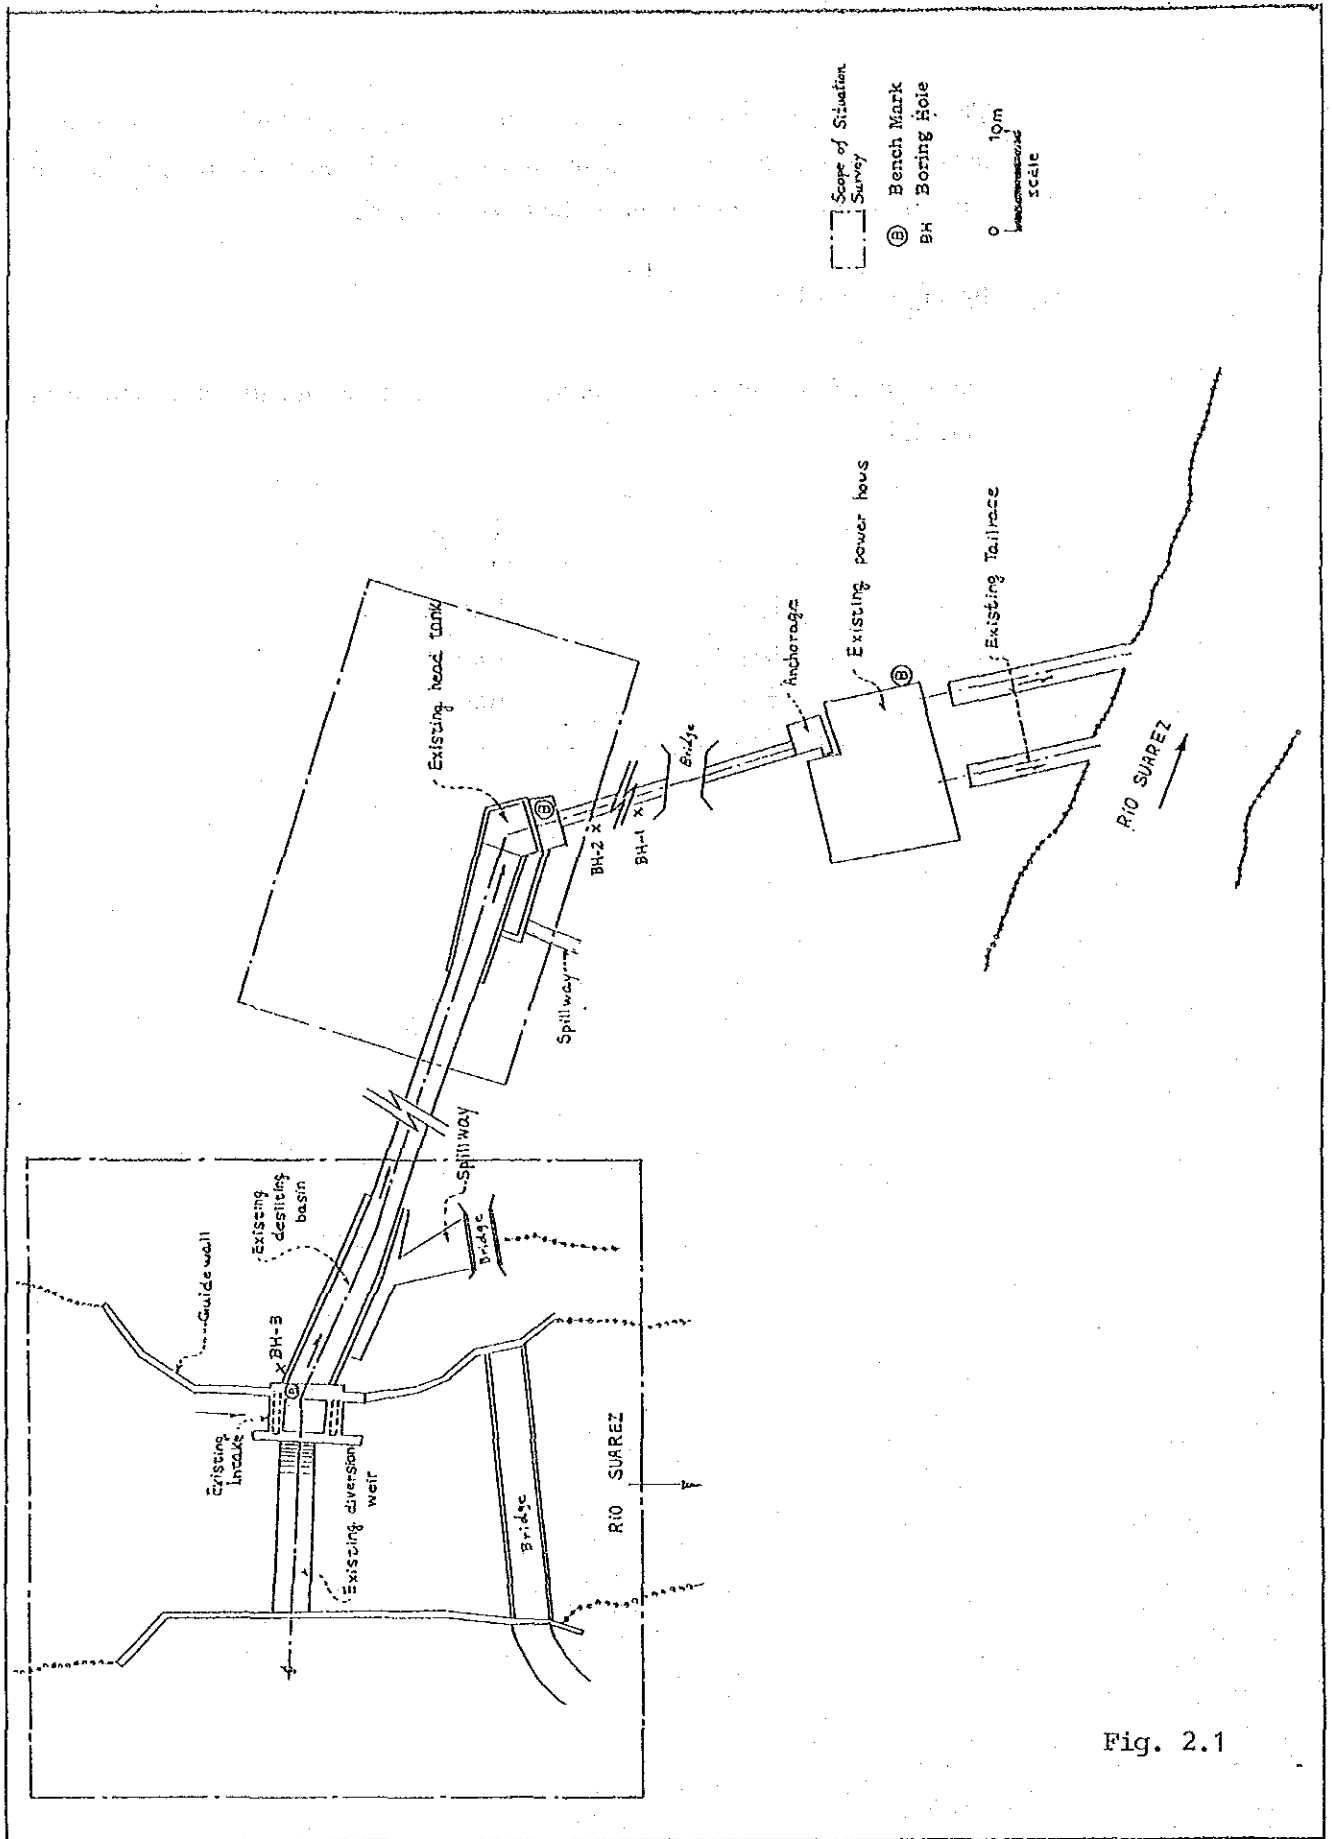
Fig. 2.1

The core boring survey was conducted at the three locations as shown in Fig. 2.1.

Depth
BH-1	12.5 m
BH-2	16.0 m
BH-3	10.0 m

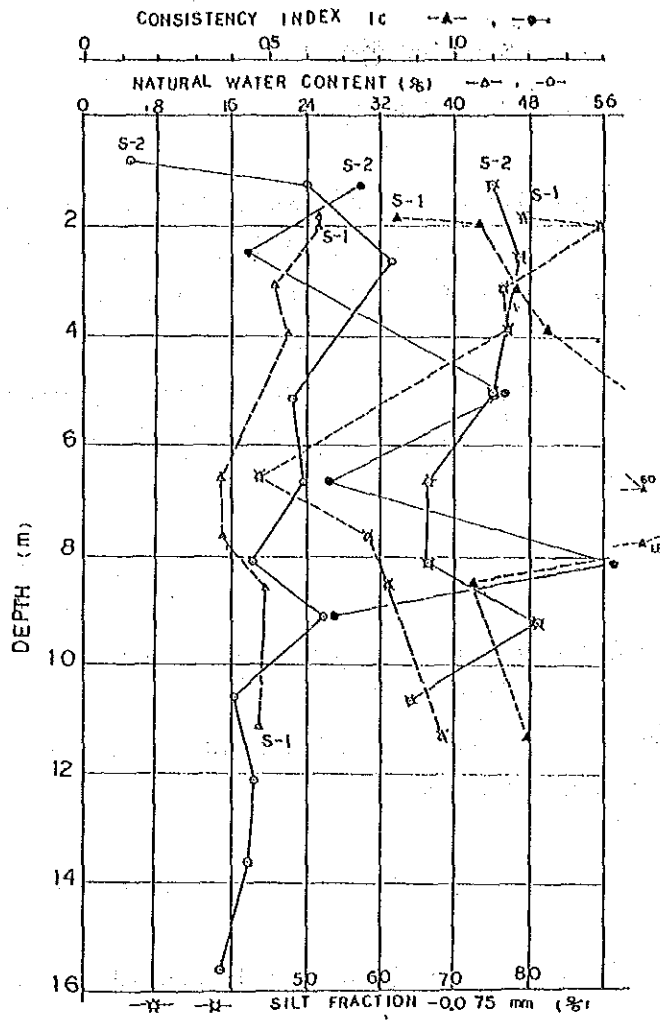
Fig. 4.1 Depth, Natural Water Content, Consistency Index and Silt Fraction 0.075 mm Content

The relationship among the core boring depth, natural water content, consistency index and silt fraction 0.075 mm content is shown in Fig. 4.1. From this figure, the following can be understood.

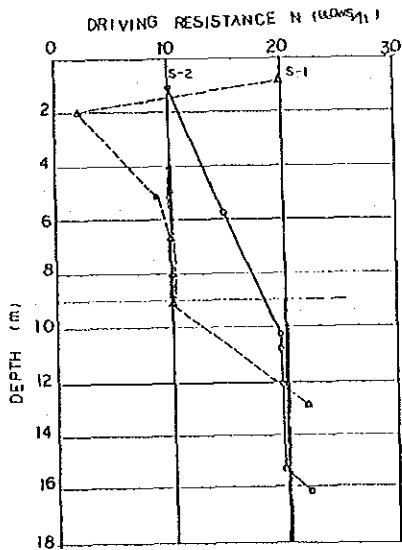
Fig. 4.2 Depth and N Value

Fig. 4.2 shows the relationship between the depth and N value. From this figure, the relationship between the bedrock depth and N value can be obtained below:

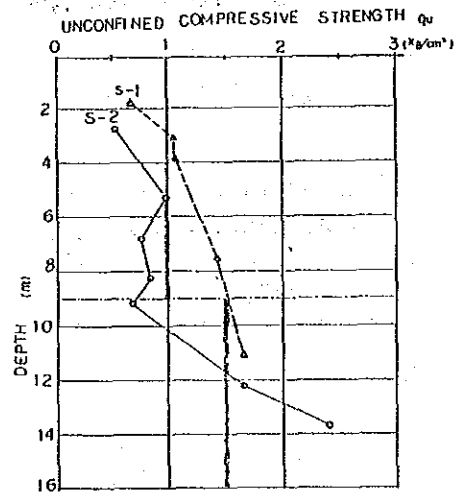
Fig. 4.3 Depth and Unconfined Compression Strength

Fig. 4.3 shows the relationship between the depth and unconfined compression strength. From this figure, the relationship between the bedrock depth and unconfined compression strength can be found below:

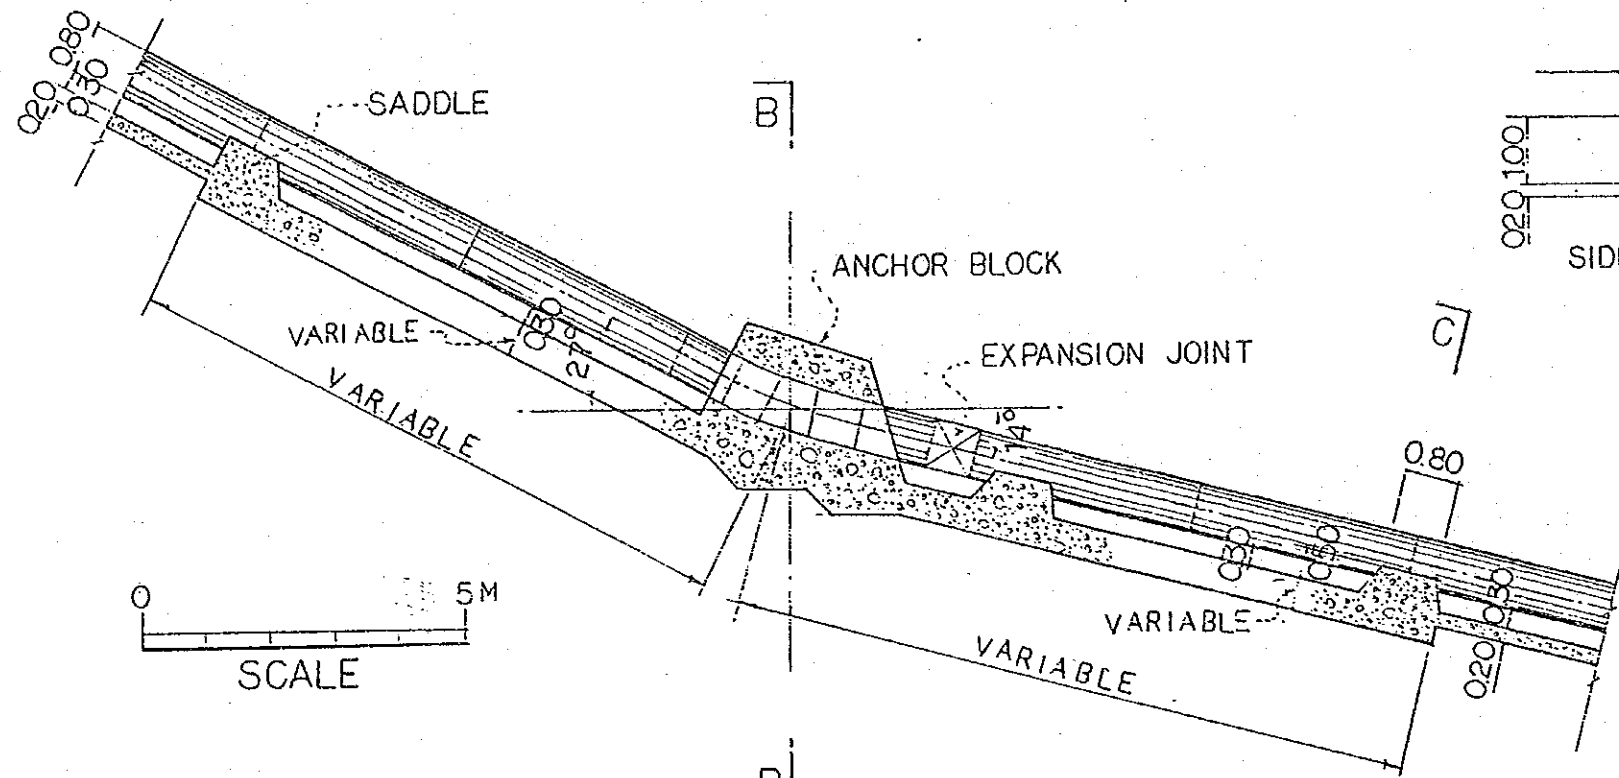
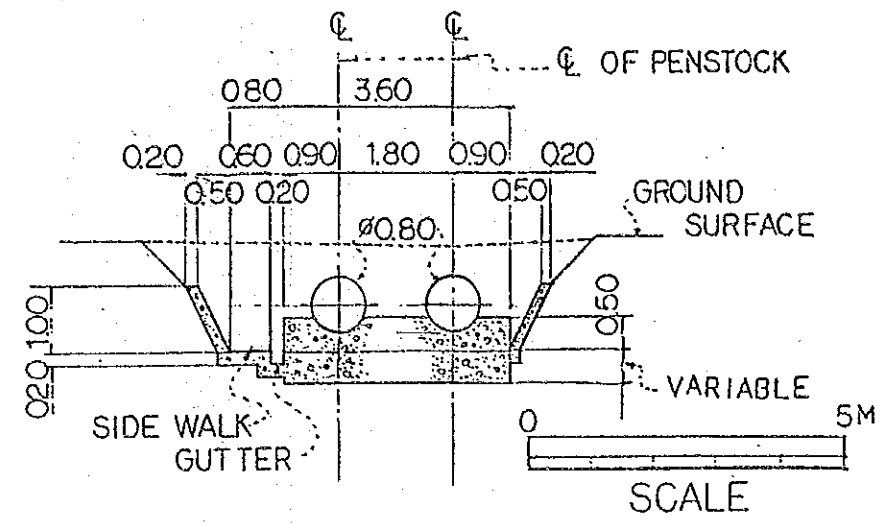
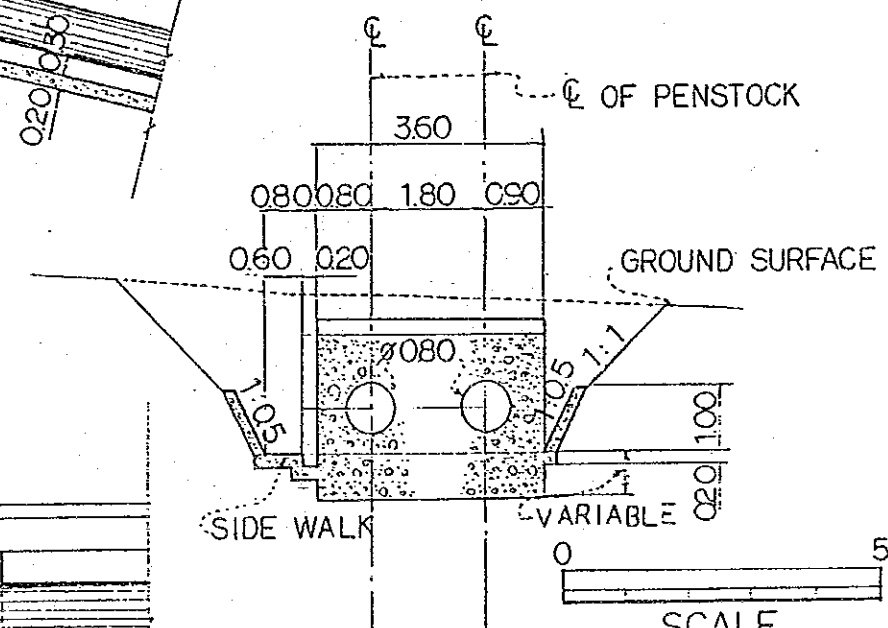
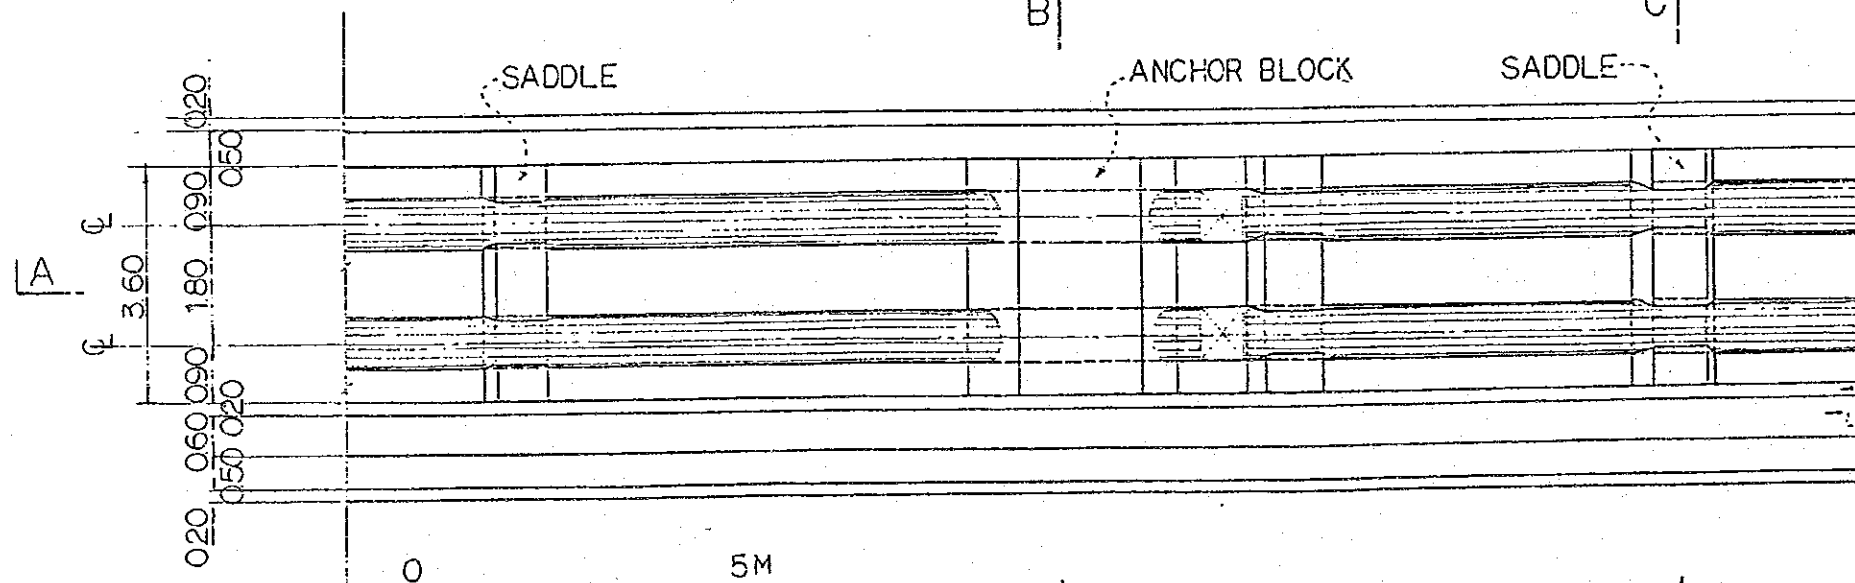
JAPAN INTERNATIONAL COOPERATION AGENCY (JICA)			
INSTITUTO COLOMBIANO DE ENERGIA ELECTRICA (ICEL)			
FEASIBILITY STUDY ON SMALL-SCALE POWER PLANTS			
REHABILITATION PROJECT IN THE REPUBLIC OF COLOMBIA			
PENSTOCK			
PLAN AND SECTIONS			
DRAWING NO.		PG-C-04	
SCALE		DATE

Steel conduit pipes (diameter: 0.80 m) are laid to construct the penstocks in two rows, with a total length of 180 m. The penstocks are supported by five concrete blocks, concrete and saddles. The penstocks built upstream were damaged due to the deformed bedrock.

Excluding two marshes, the headrace is built on the bedrock. The penstock is grounded in the talus deposits formed in the foundation of the marsh, except under the cliff section beneath the head tank.
