REPUBLIC OF THE PHILIPPINES
DEPARTMENT OF PUBLIC WORKS & HIGHWAYS

Feasibility Study
on
The Rural Road Network Development Project

FINAL REPORT (Volume 3)

APPENDIX

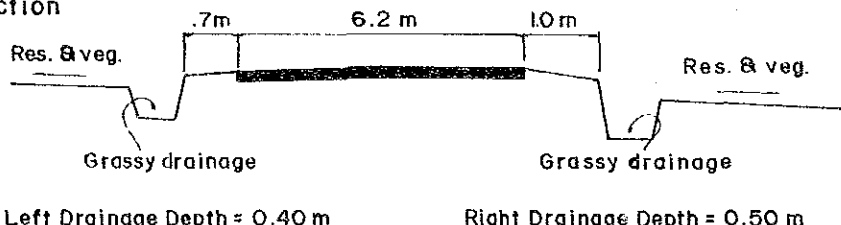
<p style="text-align: center;">Left Drainage Depth = 0.40 m Right Drainage Depth = 0.50 m</p>															
Pavement Cross-Section

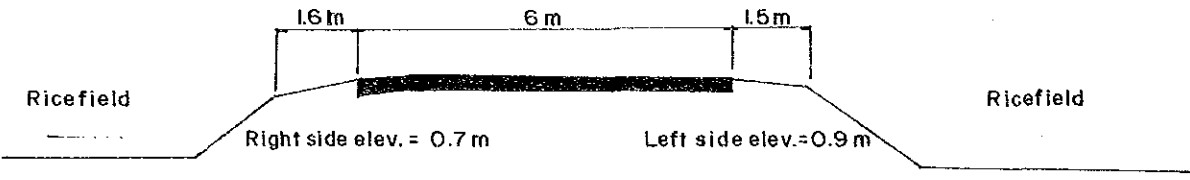
Road Cross-Section

Pavement Cross-Section Surface <input checked="" type="checkbox"/> DBST 16 mm Base <input type="checkbox"/> 12 cm Subgrade		Environmental Condition Ricefield both side Fill section	
Subgrade Soil Soil Classification W (n) Max. size mm = 19 0.075 mm pass % = 43 LL = NP PL = - PI = NP Soaked CBR = 11		Drainage Condition Bad due to grassy side ditch is no longer effective	
		Water Table Did not noticed	
		Remarks Water at ricefield rise about 40 cm during rainy season

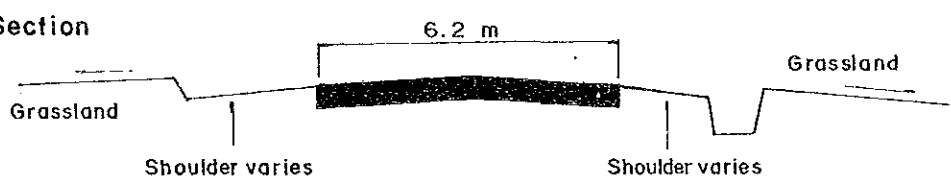
Road Cross-Section

Pavement Cross-Section <table style="width: 100%; border-collapse: collapse;"> <tr><td style="border-bottom: 1px solid black; width: 60%;">Surface</td><td style="width: 20%;">AC</td><td style="width: 20%;"></td></tr> <tr><td style="border-bottom: 1px solid black;"></td><td>80 mm</td><td></td></tr> <tr><td style="border-bottom: 1px solid black;">Base</td><td>12 cm</td><td></td></tr> <tr><td style="border-bottom: 1px solid black;">Subgrade</td><td></td><td></td></tr> </table>		Surface	AC			80 mm		Base	12 cm		Subgrade			Environmental Condition Both side is grassy pasture land ; Hilly terrain																															
Surface	AC																																												
	80 mm																																												
Base	12 cm																																												
Subgrade

Subgrade Soil Soil Classification <table style="width: 100%; border-collapse: collapse;"> <tr><td style="width: 15%;">W (n)</td><td style="width: 15%;"></td><td style="width: 15%;"></td><td style="width: 15%;"></td><td style="width: 15%;"></td><td style="width: 15%;"></td></tr> <tr><td>Max. size</td><td>mm</td><td>=</td><td>37.5</td><td></td><td></td></tr> <tr><td>0.075 mm pass</td><td>%</td><td>=</td><td>59</td><td></td><td></td></tr> <tr><td></td><td>LL</td><td>=</td><td>54</td><td></td><td></td></tr> <tr><td></td><td>PL</td><td>=</td><td>38</td><td></td><td></td></tr> <tr><td></td><td>PI</td><td>=</td><td>16</td><td></td><td></td></tr> <tr><td>Soaked CBR</td><td></td><td>=</td><td>4</td><td></td><td></td></tr> </table>		W (n)						Max. size	mm	=	37.5			0.075 mm pass	%	=	59				LL	=	54				PL	=	38				PI	=	16			Soaked CBR		=	4			Drainage Condition Good due to underground water level is low
