**REPORT OF JAPAN DISASTER RELIEF TEAM
ON
EARTHQUAKE AT SPITAK, ARMENIA, USSR**

FEBRUARY 1990

**JAPAN INTERNATIONAL COOPERATION AGENCY
(JICA)**

JICA (Japan International Cooperation Agency), on behalf of the Japanese Government, dispatched a JDR (Japan Disaster Relief Team) from 18th to 28th December, 1988, to conduct a survey of the damage of Spitak Earthquake and to advise engineer and officials of Armenia SSR and USSR the technical know-how for the rehabilitation and restoration measures to be taken in the damaged area.

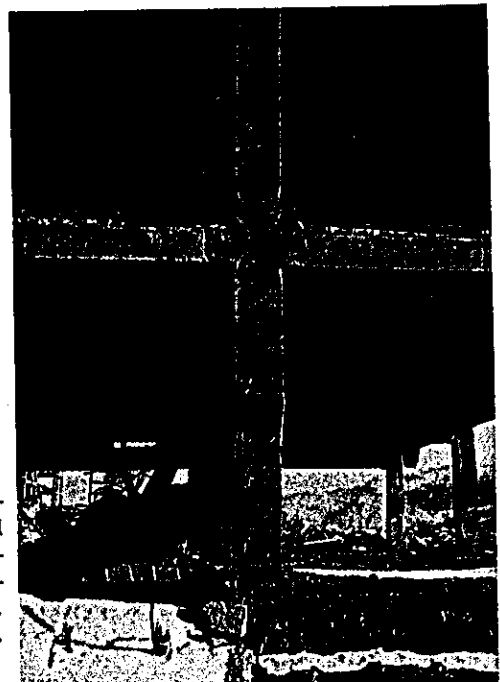
Photograph 1.6.4
 Precast void slab used as floor material in RPC building heavily destroyed during construction. Each end is supported on the beam and cast-in-place concrete is laid on the support portion. The span is about 5m in most cases. (Spitak)

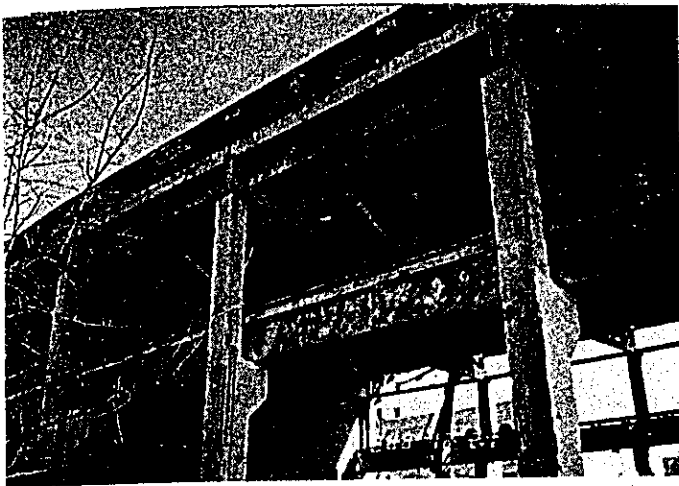
Photograph 1.6.5

Ribbed precast panels used for roofing of laboratory building of precast reinforced concrete. Braces were used in some portions of this building, but its external masonry walls were destroyed almost completely. (Leninakan)

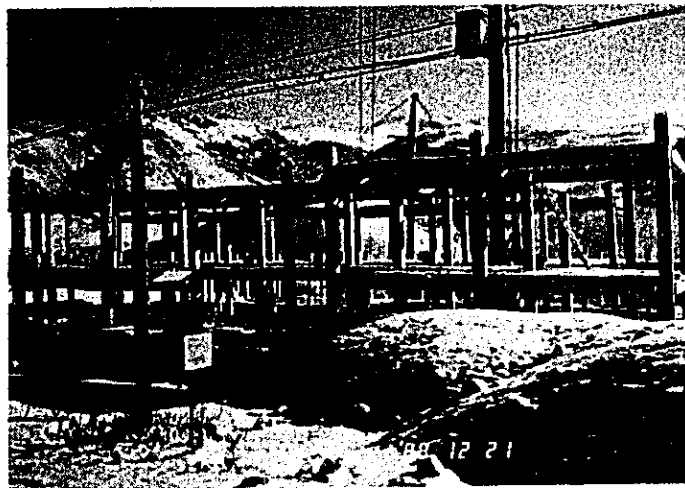
Photograph 1.6.8

Framework of rigid-frame precast reinforced concrete (RPC) building damaged during construction. This example has beams in two directions, though buildings with unidirectional beams account for a much larger part. (Suburb of Spitak)

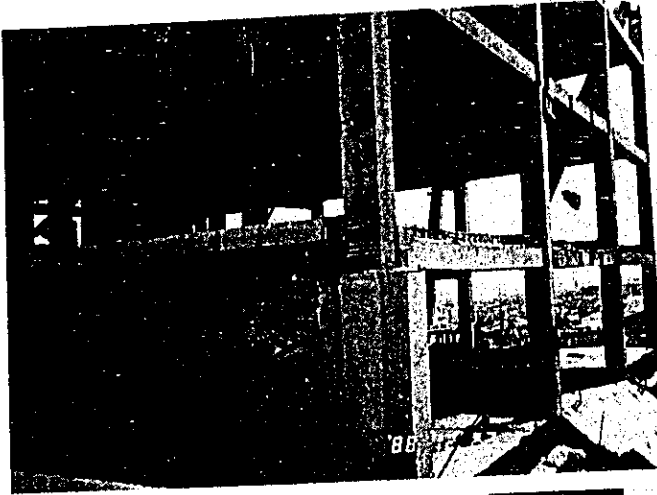
Photograph 1.6.9
 Framework of RPC building under construction, as in the previous photograph. Unlike the previous example, beams are provided only in one direction. Precast plates and masonry walls are provided in the direction perpendicular to the beams. (Spitak)

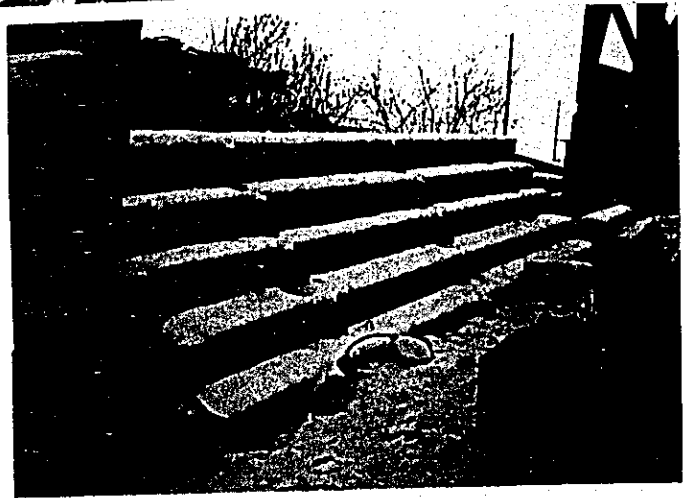
Photograph 1.6.10
 Precast pillar members left on construction site of RPC building destroyed during construction. One member covers two stories. Exposed main bars are provided at each end for pillar to pillar joint, and a pair of bars and steel angles are provided at two points between the ends for pillar-beam joint. (Leninakan)

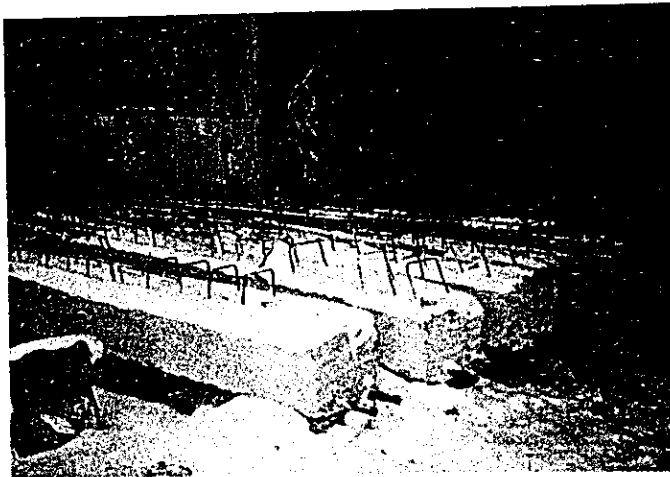
Photograph 1.6.11
 Precast beam members left on construction site of RPC building, as in the previous photograph. A member covers one span. Top of the beam reinforcing bars is exposed at a portion where cast-in-place concrete is to be laid for connection with a floor panel. After assembling beam members, two main bars are provided at the two solid steel angle portion of the reinforcing bars, and then the main bars are welded, followed by placing of concrete. (Leninakan)

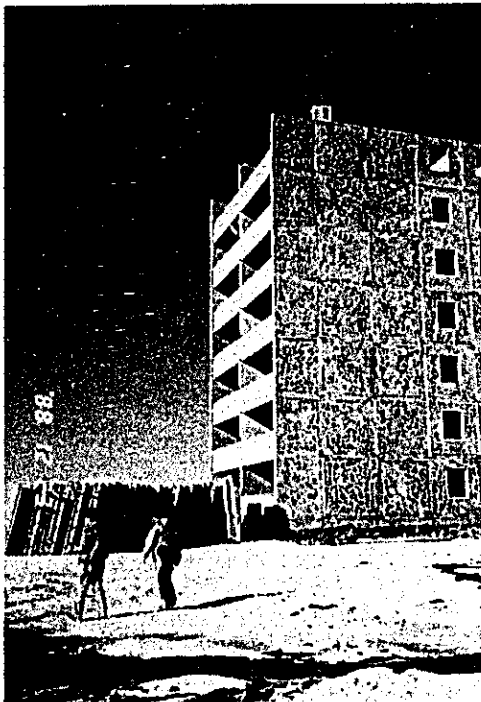
Photograph 1.6.15

Construction site of nine-storyed apartment house comprising large precast panels of reinforced concrete (WPC method). Seven stories had been completed at the time of the earthquake. The damage was limited to the fall and collapse of the PC floor panels of the eighth floor. Precast exterior walls incorporating tuff as external finish material are seen beside the building. (Suburb of Leninakan)

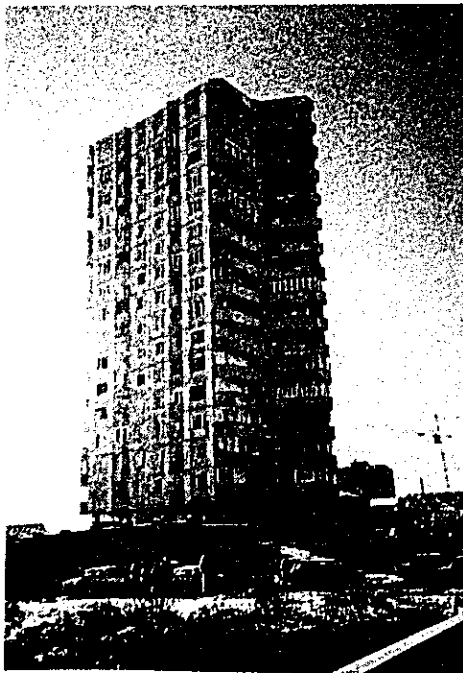
Photograph 1.6.19

The only high-rise building (sixteen storied) in Leninakan. Precast material is used for pillars and floor slabs in the peripheral portions while cast-in-place concrete is used for anti-earthquake walls installed in core-like arrangement in the middle portion of the building. The core anti-earthquake walls suffered heavy damage, causing most of the horizontal bars to bend. The damage was so severe that it seemed impossible to assure the safety of the building under normal load. Later, the building was pulled down completely.

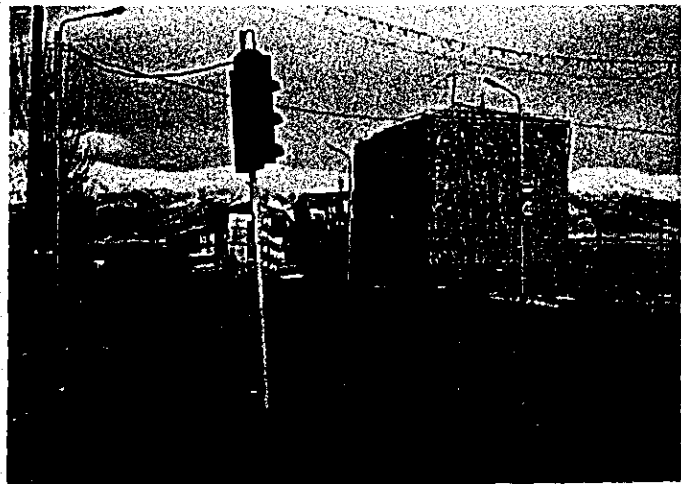
Photograph 3.1.4

iv. Area II-1: Most of the five-storied RMS apartment houses and stone residences suffered considerably heavy damage (Photograph 3.1.4).

Damaged RMS apartment houses along street in southeastern Spitak. There are many partially or heavily destroyed buildings.

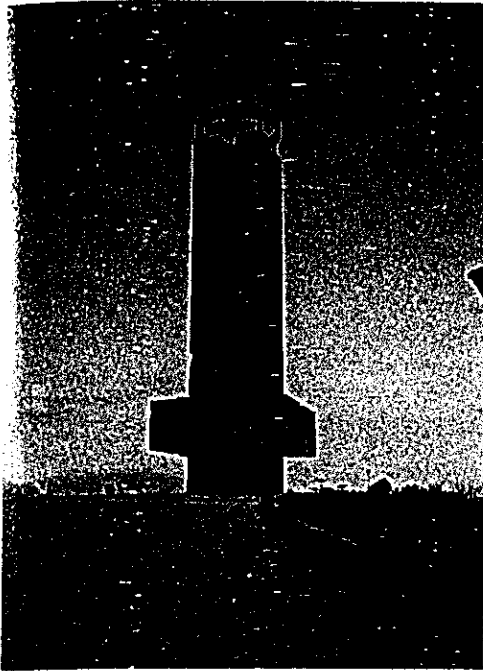
Photograph 3.1.9

Fig. 3.1.2 shows the degree of damage to major structures including the memorial tower on the hill (slightly damaged; Photograph 3.1.9) and large silo (partly destroyed; Photograph 3.1.10).

A stone monument at the top of the hill at center of southern area of Spitak. The monument as a whole is considerably or slightly damaged, except for part of the projected stone member in the middle partially broken and fallen.

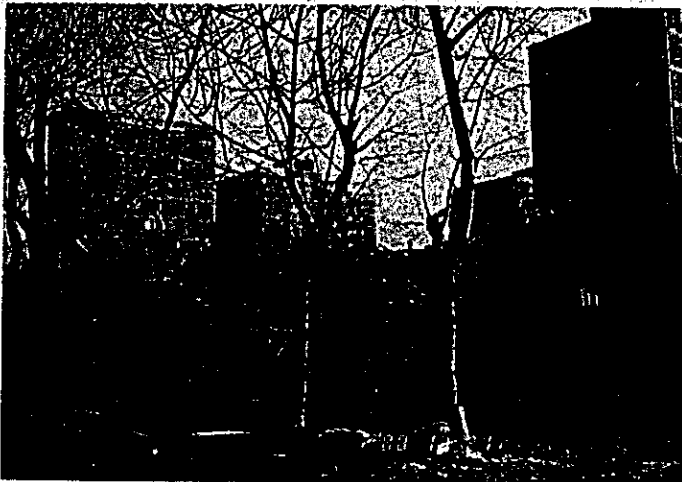
Photograph 3.1.11

Completely destroyed nine-storied RPC apartment houses in housing development located northwest part of Leninakan. All apartment house narrowly remaining standing were also destroyed heavily.

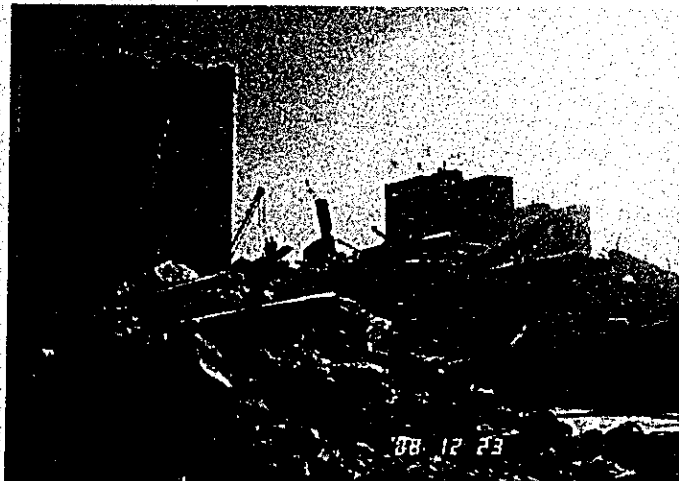
Photograph 3.1.12

Same site as above. PC floors and PC pillars almost free of rupture are found among the debris of buildings.

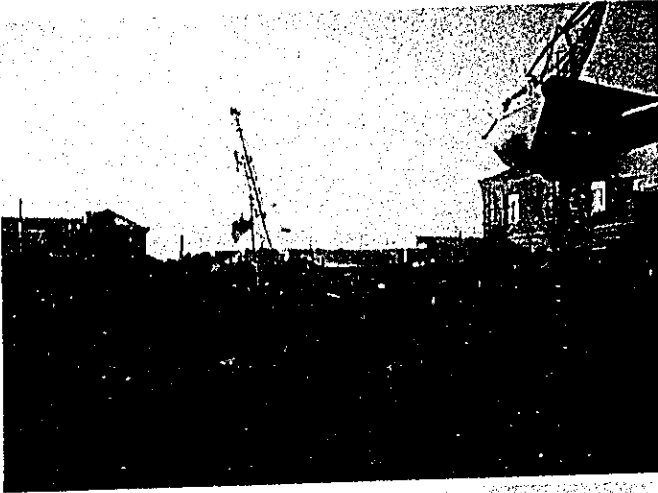
Photograph 3.1.13

Completely destroyed RMS apartment houses among old stone buildings in central part of Leninakan. They were completely reduced debris, leaving a huge number of rubble heaps of tuff used as wall material.

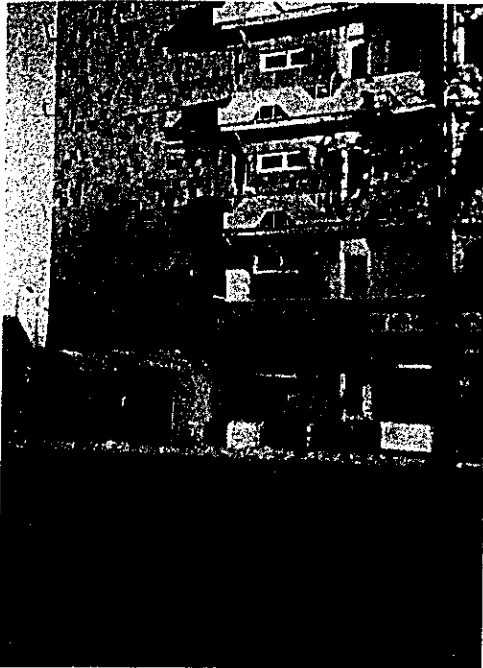
vi. Area III-2: Nearly 10 five-storied apartment houses of (apparently) RPC construction stood along the street coming from the Yerevan area into Leninakan. When viewed from outside, these apartment houses, nearly free of broken windowpanes, did not appear to have significant damage, except for uniform cracks formed diagonally along the edges of wall panels which were located at the ends of the buildings and had small openings (Photograph 3.1.17).

Photograph 3.1.17
 Damaged outer wall with small openings of five-storied, (probably) RPC apartment house standing on a road coming from the south into Leninakan. Similar damage was seen in all other buildings along the road, though they were almost free of other types of damage.

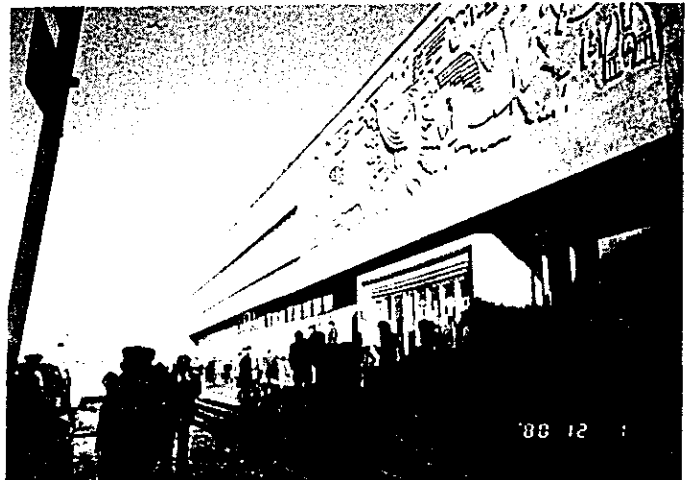
Photograph 3.1.23

The left part of a five-storied RMS apartment (remaining right part seen in photograph) in Kirovakan was completely destroyed. It was pulled down and removed. There were many similar apartment houses in this area, but many of them were reported to have suffered only slight damage.

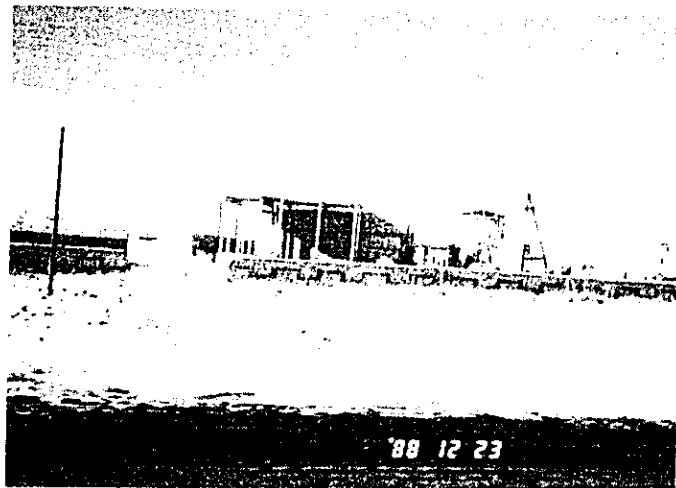
Photograph 3.1.28
 A suburb of Maralick located about 25km south of Leninakan (about 40km to the south-southwest of the epicenter). There were factory buildings comprising thin RPC pillars and one- to two-storied stone-built residences, which seemed to remain undamaged.

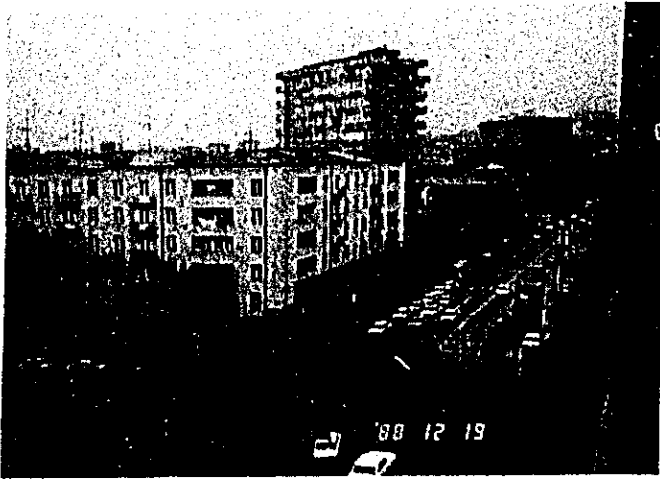
Photograph 3.1.29

Buildings in downtown Yerevan, a city with a population of 1,000,000 about 80km to the south of the epicenter. The only one set of strong motion data currently available was obtained on the first floor of the Institute of Architecture located in this city. The maximum acceleration was 62 gals. Yerevan contains a variety of buildings including twelve-storied RPC apartment houses. Most of them seemed to remain undamaged.

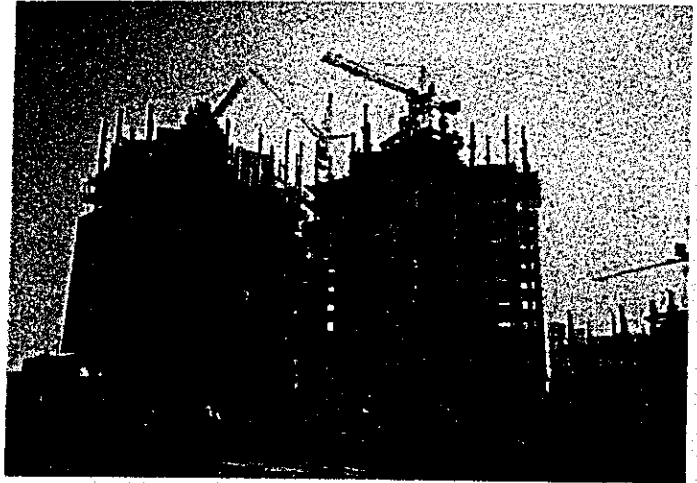
Photograph 3.1.30

A large housing development comprising mainly mixed PC/RC high-rise apartment houses, which are under construction in a northern suburb of Yerevan (about 70km to the south of the epicenter). They appeared to remain undamaged.

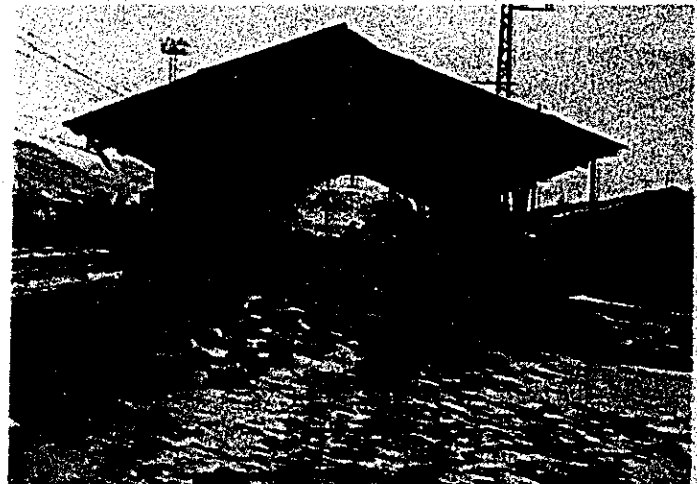
Photograph 3.1.32

Railroad station with wooden roof in Spitak. Masonry walls and pillars of the railroad were destroyed. Gables and corners were also destroyed in the two-storied house behind it. Mortar containing clay is used.

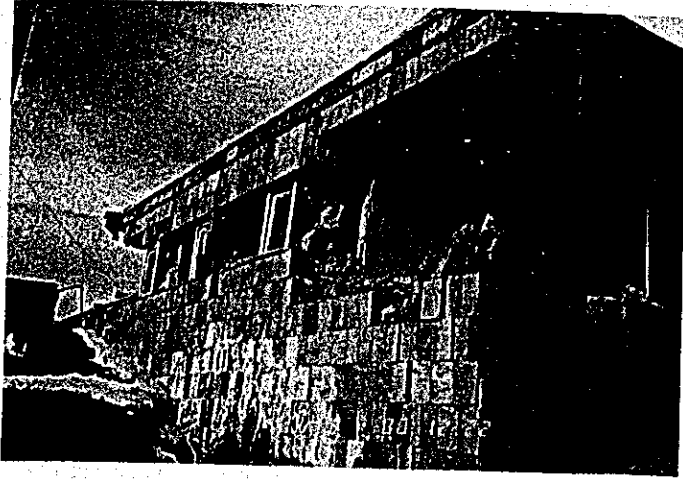
Photograph 3.1.33
A damaged one-storied stone house along railroad slope in Spitak. The walls are of concrete-filled type and with thickness of 30cm. The piers on either side of the window were heavily destroyed.

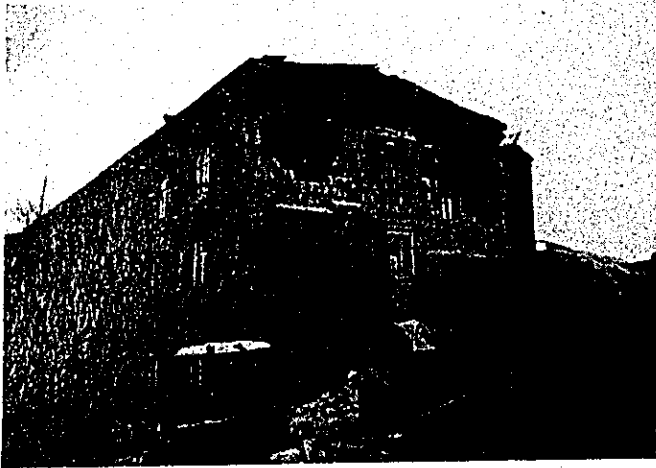
Photograph 3.1.37

Damaged gables at the third level of a three-storied filled-type stone-built apartment house. Void slabs are used as floor material in this building, but the roof is of wood. No members such as anchoring bars are seen between the top of the wall at the third level and the horizontal decorative member in the building (Leninakan).

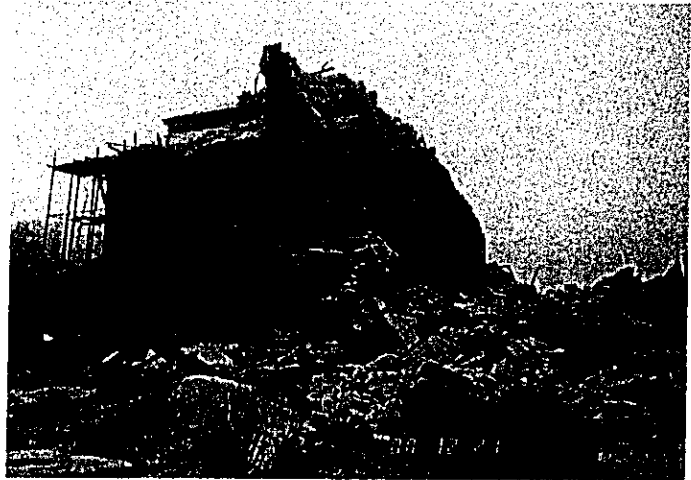
Photograph 3.1.38

A destroyed stone-built church which stood looking towards the Central Square in Leninakan. Many other churches suffered damage including the loss of spires. The roof is of wood and no reinforcing bars are seen in the debris, suggesting that the structure is not reinforced.

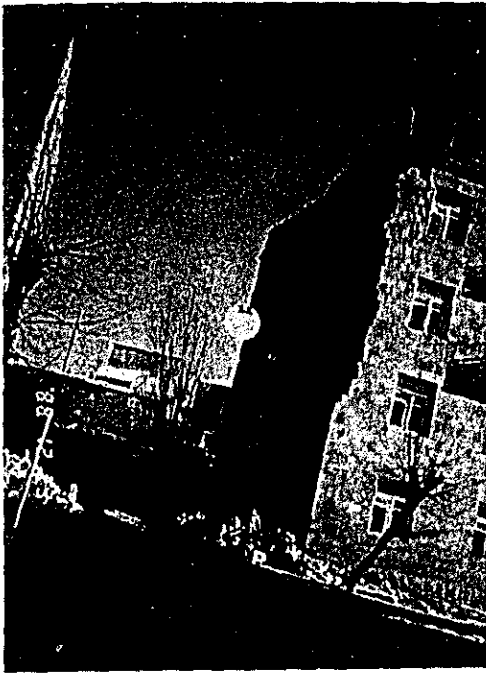
Photograph 3.1.41

A four-storied reinforced stone apartment house with damaged gable. This is an old-type building, in which reinforcement is not used in large amounts though the wall volume is large (Leninakan).

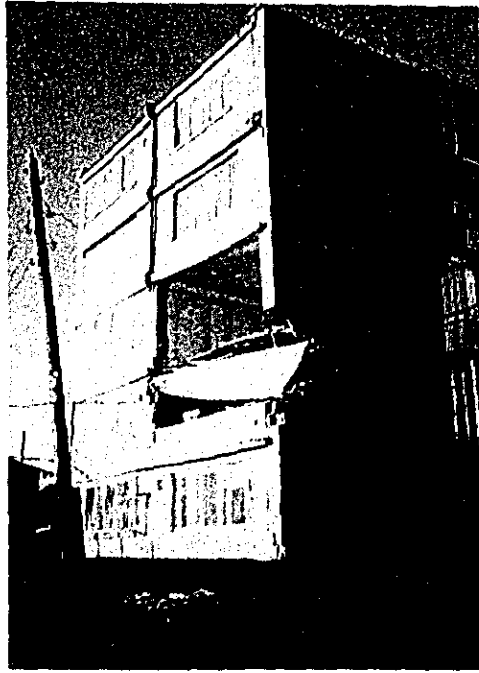
Photograph 3.1.42

A five-storied apartment house suffering from local damage to intermediate stories. The walls are of filled-type, but no reinforcement is seen in the wall at the edge of the shorter face (Spitak).

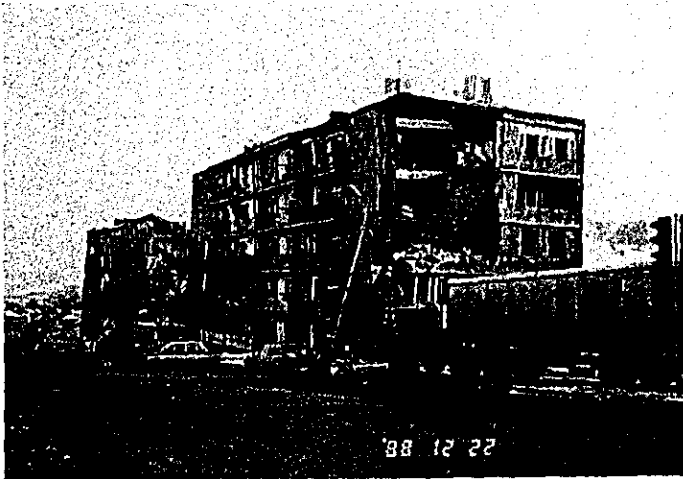
Photograph 3.1.43

A filled-type stone-built apartment house suffering from heavy damage to corners of higher stories. In the longer face, walls are provided only at the edges. In the shorter face, the gable has large openings and there are no walls of the edges (Spitak).

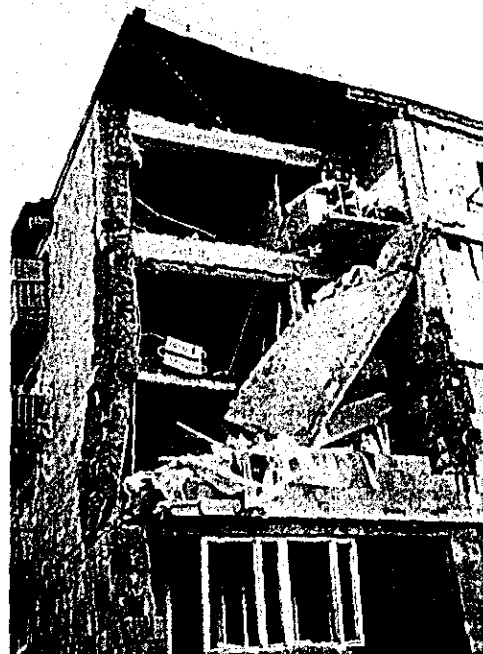
Photograph 3.1.44

A detailed view of the damaged part of the same building as above. Reinforced concrete is seen at the edge of the wall in the longer face. Beams connecting to an RC portion is seen in the fifth story and roof. The slabs used in the building are of precast type though not of void type. Anchoring bars probably used for connection are seen in the shorter side but not in the longer side (Spitak).

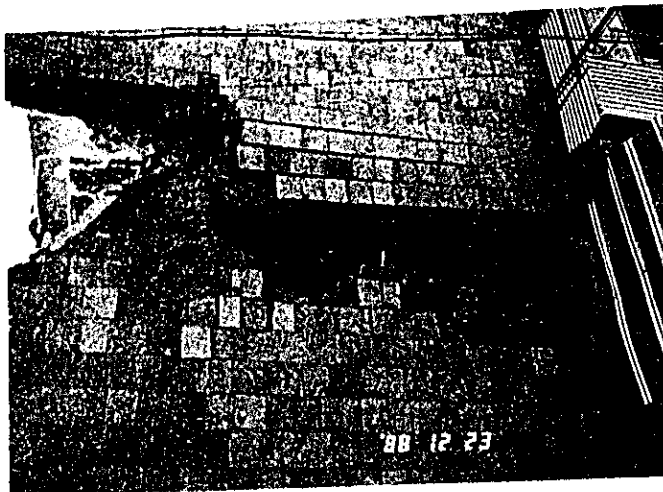
Photograph 3.1.45

A detailed view of a damaged portion in the same building as in Photograph 3.1.42. Vertical members of reinforced concrete is seen at two portions in the damaged filled-type stone wall, but the horizontal members probably provided for reinforcement are not connected to the vertical ones. Only vertical reinforcing bars and the horizontal ones are seen between them.

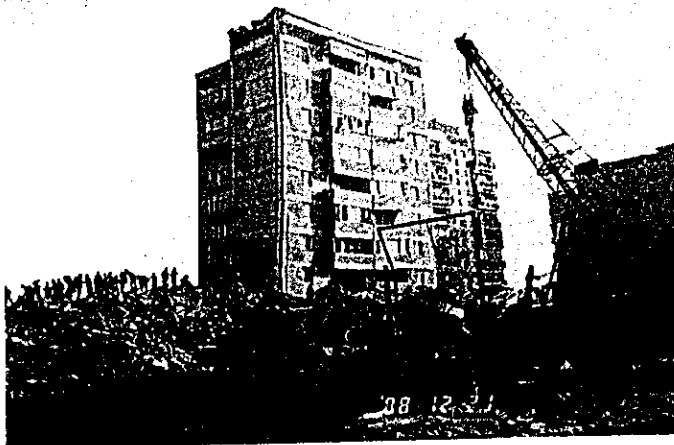
Photograph 3.1.46

Typical damage seen in a housing development comprising nine-storied RPC apartment houses. Most of the apartment houses were destroyed completely, and all of the remaining ones were also damaged heavily. The second and third story of the building in the photograph is so deformed that the portion as a whole appear to be expanded. A large number of victims still remained undiscovered (Leninakan).

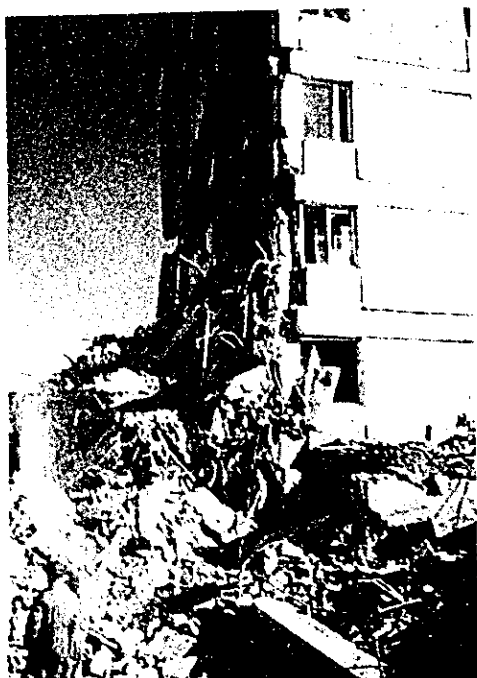
Photograph 3.1.47

A detailed view of the destroyed portion of a nine-storied RPC apartment house suffering from local damage to its central part. Non structural precast members are seen around the building. They did not suffer cracks. PC beam members hang from the building and all void slabs had dropped off (Leninakan).

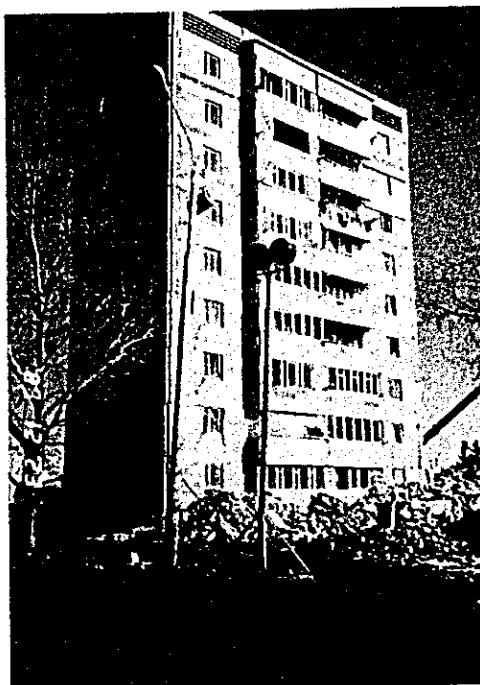
Photograph 3.1.48

A RPC apartment house narrowly remaining standing. The second and third stories suffered large cracks in the outer wall and damaged to their window panes (Leninakan).

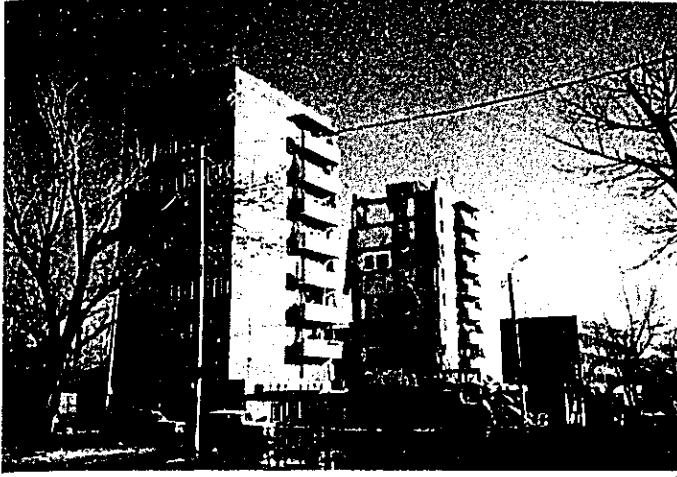
Photograph 3.1.49

An apartment house suffering the destruction of its middle portion, leaving the side portions undestroyed (overall view of the building in Photograph 3.1.47). As a rare case, the building was televised in a local TV program. The portions that appear to be pillars, beams or walls are broken sections of finishing material provided over structural members. The building is damaged in the span direction particularly in the second story. The four-storied building behind appear to be free of damage (Leninakan).

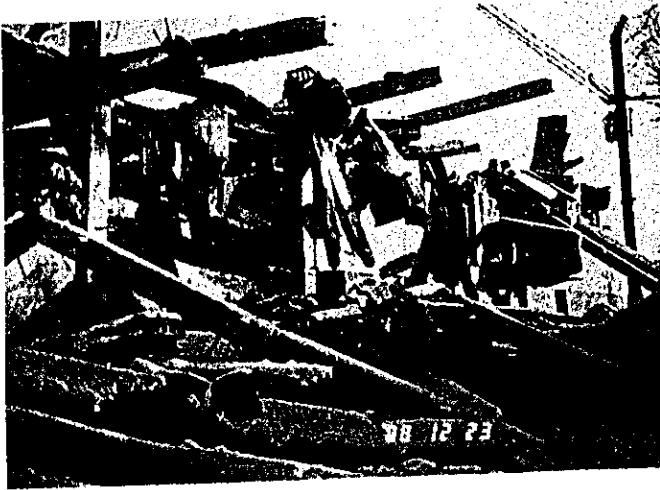
Photograph 3.1.53

An apartment house destroyed during construction. Some precast pillar members have fallen down in the same direction. Precast exterior material is attached to the outer faces of structural members. The building is estimated to have been a nine-storied one, but the cross-sectional dimensions of the pillar members are 40cm x 40cm even in the first story (Leninakan).

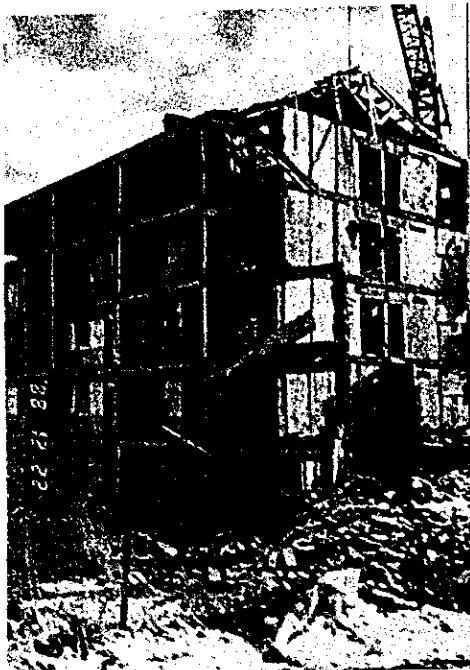
Photograph 3.1.55

A five-storied precast apartment house damaged during construction. It has beams in the long direction, but no PC pillars. A small PC wall panels are provided for each span, and the other parts are made of masonry walls. No beams are provided in the span direction, and many small PC wall panels are used instead. PC truss material is also used in the roof (Spitak).

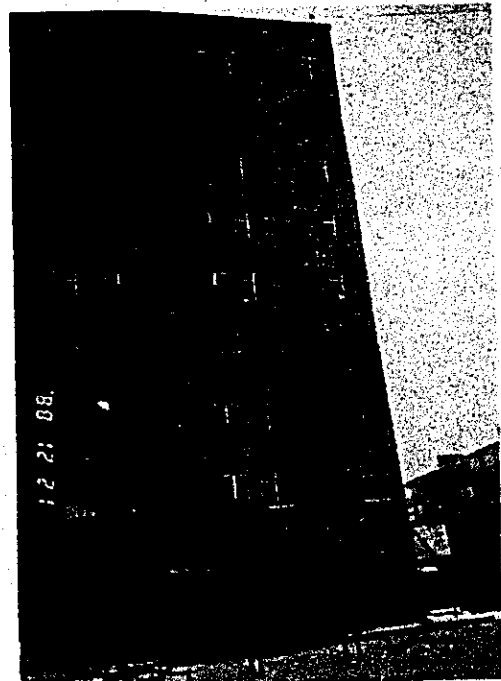
Photograph 3.1.56

An undamaged nine-storied RPC apartment house in Kirovakan. This building did not suffer even a crack in the outer walls though it was reported that 70 apartment houses of similar construction were damaged in Kirovakan.

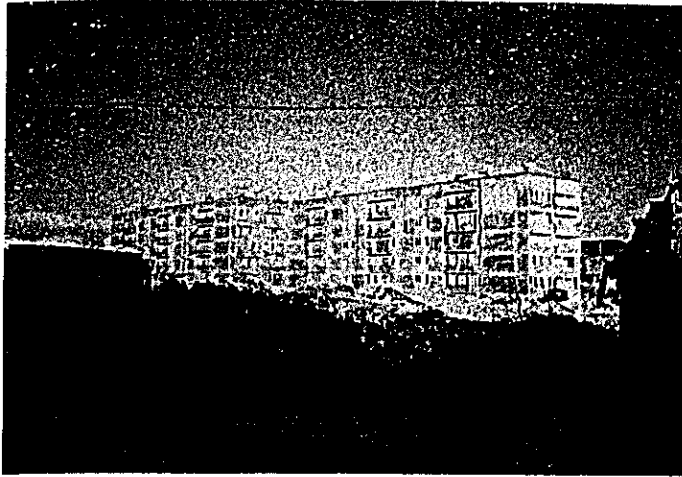
Photograph 3.1.57
 2 five-storied RPC apartment houses built near the construction site shown in Photograph 3.1.53. Though many walls are installed, pillars and beam forms are seen, which is a key feature indicating that these are not of WPC construction. No significant damage is seen except that, on the building in the foreground, the first-story portion of the gable appears to be deformed.

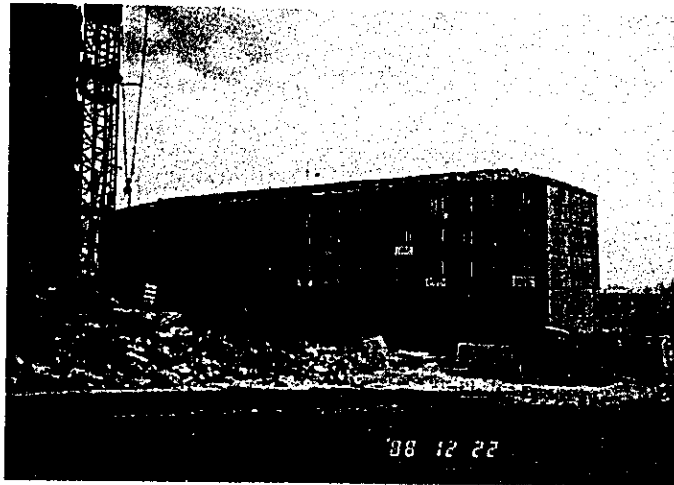
Photograph 3.1.58

An almost undamaged WPC apartment house suffering only the loss of some outer wall panels which stood among many completely destroyed five-storied RPC apartment houses in Spitak. The absence of pillars and beam forms is the key feature indicating that it is of WPC construction.

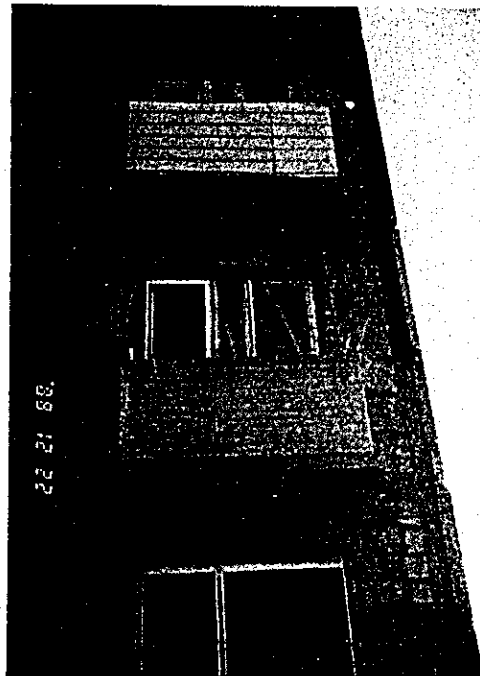
Photograph 3.1.60

Diagonal cracks formed in the outer wall panels on the five-storied WPC apartment house shown previously in Photograph 3.1.58. Cracks are seen in the wall on the right of the wall panels at the second-story level, but other panels and joints did not suffer cracking (Spitak).

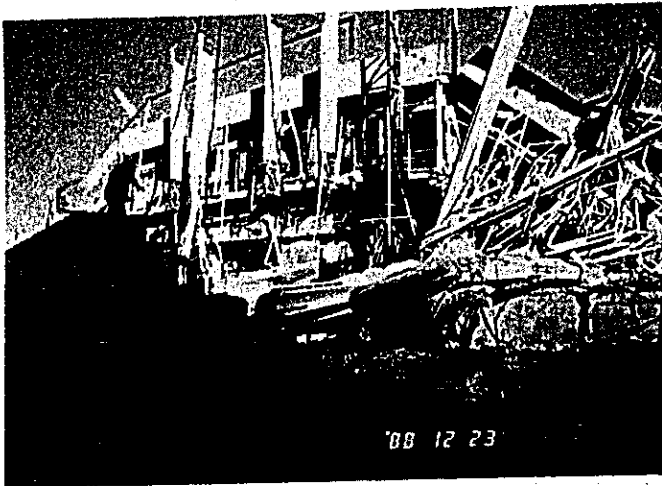
Photograph 3.1.61
 A completely destroyed four-storied RPC department store. The front part originally had three stories. The second story was destroyed and the third floor dropped (Leninakan).

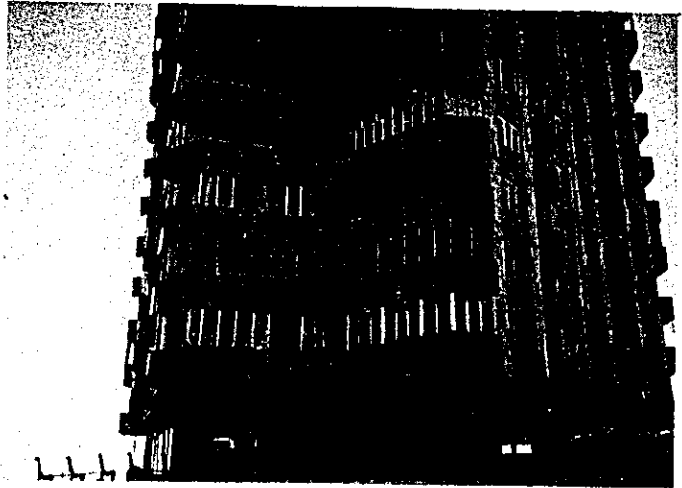
Photograph 3.1.66

The lower part of a sixteen-storied apartment house, which is the highest building in Leninakan. The core part is constructed of cast-in-place reinforced concrete, and the floor slabs, internal pillars and 12 external pillars at the four corners are of precast reinforced concrete. Pillars did not suffer significant damage though outer walls and partitioning walls were slightly damaged.

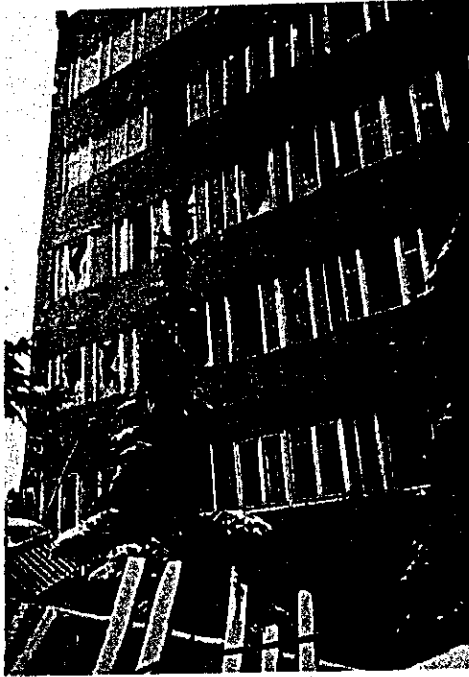
Photograph 3.1.69
When viewed at close range, many window-panes are broken and vertical members which appear to be reinforced concrete pillard suffered large cracks.

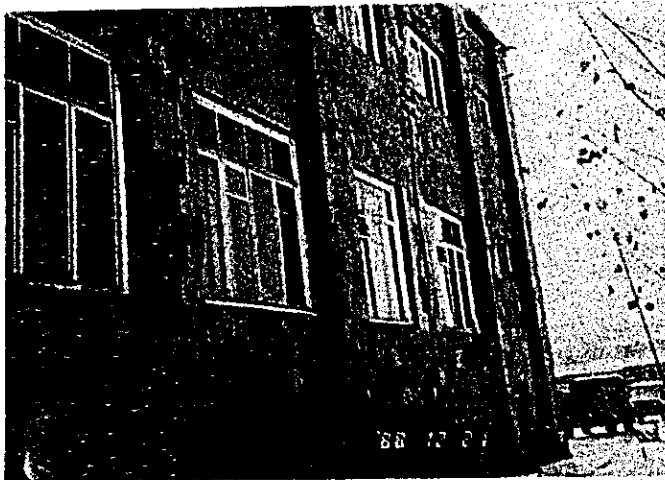
Photograph 3.1.71
A damaged building which appear to be of similar construction to the ones in the previous three photographs. Reinforcing members of reinforced concrete are seen in the destroyed stone pillar. Windows are large and the wall volume is small.

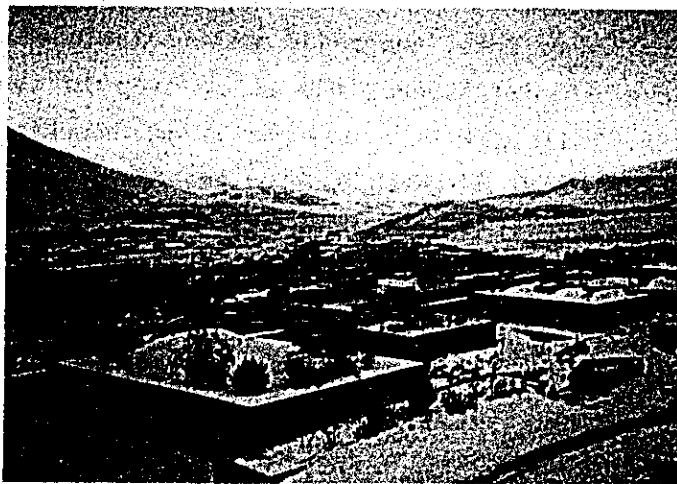
Photograph 3.1.74
A graveyard at the foot of a hill in
the south part of Spitak. Thin grave-
stones have not fallen down probably
because their bottom parts were
embedded in the ground.

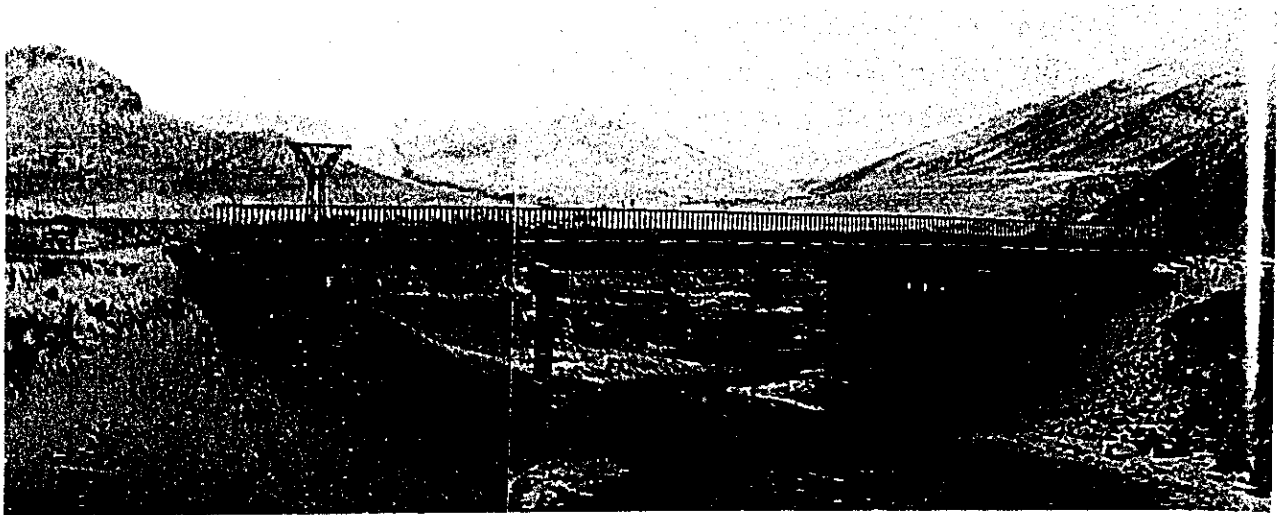
Photograph 3.2.1 shows an elevated bridge on a bypass currently under construction in a suburb of Spitak, the city closest to the epicenter. It consists of a three-span, simple-support, pretensioned girder supported on a RC frame. The lower structure consists of precast cross beams connected to precast piers at the site. The type of foundation is not known, but it may be of direct type.

The top and base portions of the piers suffered damage including the peeling of concrete as shown in Fig. 3.2.2. The cross beams have been slightly rotated and some piers have been inclined towards the bridge axis. Judging from Photograph 3.2.2.(b), the main bars, which are of deformed type, are about 25mm in diameter, and the hoops (deformed reinforcing bars) of about 9mm in diameter are provided at intervals of about 30cm. Ordinary type aggregate, rather than tuff, is used, but its strength appears to be low (roughly estimated at around 250kg). Compared to other bridges described later, this one obviously has a smaller cross section and there seems to be a large difference in design intensity.

Photograph 3.2.1: Elevated Bridge under Construction (Spitak)
 Cross beams are installed on precast piers to form a frame, on which pretensioned girders are laid. Some of the piers on the left are inclined irregularly. Of the bridges surveyed, this one had the smallest cross section.

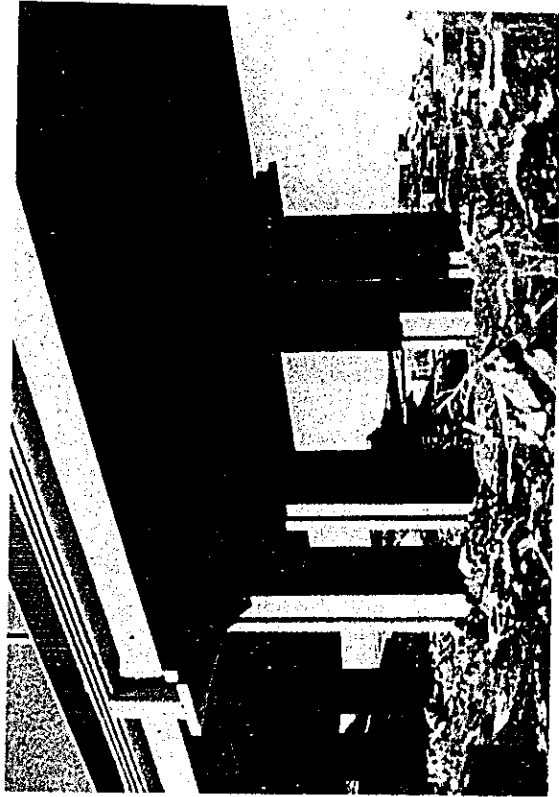
(b) Pier and Support

The design horizontal intensity may be least about 0.2 judging from the cross section of the piers. The piers and supports are free of damage.

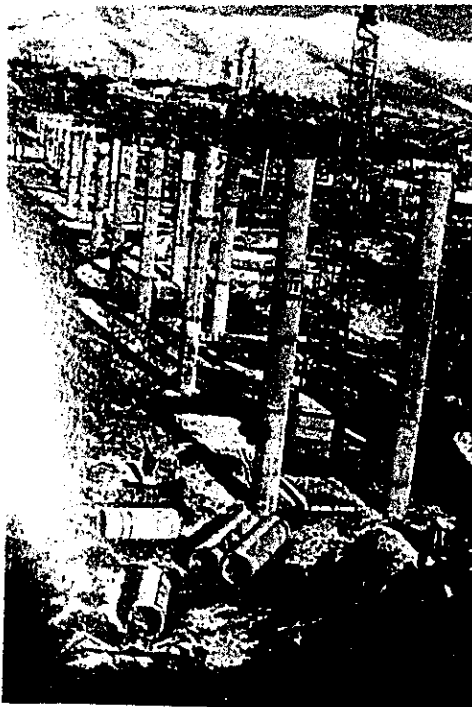
Photograph 3.2.5 depicts the piers (undamaged) for an elevated bridge being constructed on a bypass. It has 14 spans and its pier height is considerably large, 50m maximum. The span is approximately 30m. All piers and part of the cross beams had just been installed and become ready to accept some girders when the earthquake took place. The piers were constructed by connecting precast members at the site. Concrete had not been laid on the connecting portions, but the piers were fortunately free from damage because the upper structure had not been installed.

Photograph 3.2.5
Road Bridge under Construction

This large-scale bridge is planned to have 14 spans and to be about 40-50m in length and about 40m in pier height. The precast pier members (hollow) seen at the left bottom of the photograph will be connected to form piers. Cross beams will be placed on each pair of piers (some cross beams have already been installed on the piers at the farther end), followed by the installation of girders on them. Proper connection of precast piers is of key importance. The piers seem to have suffered no damage.

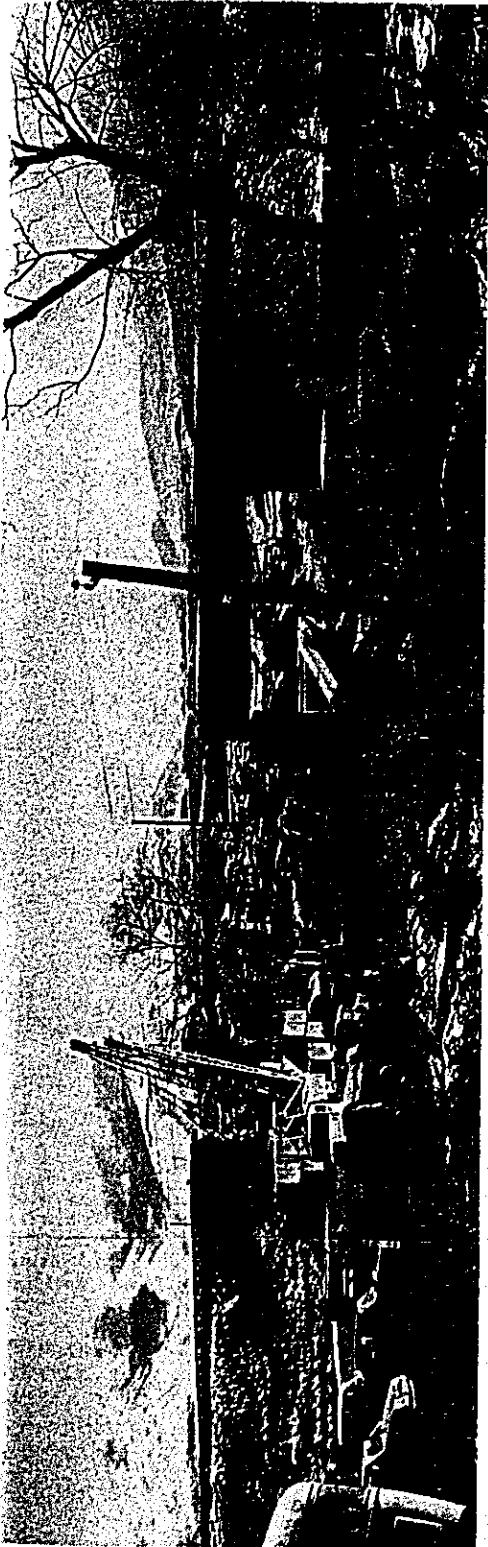
Photograph 3.2.12: Damaged Railroad Bridge

The left part of the two-span bridge has dropped while the right girder did not suffer damage. It was also reported that the girder was simply being replaced after being heavily damaged, instead of dropping in the earthquake. The cause of the damage is unknown. The piers in the central portion do not suffer from peeled concrete.

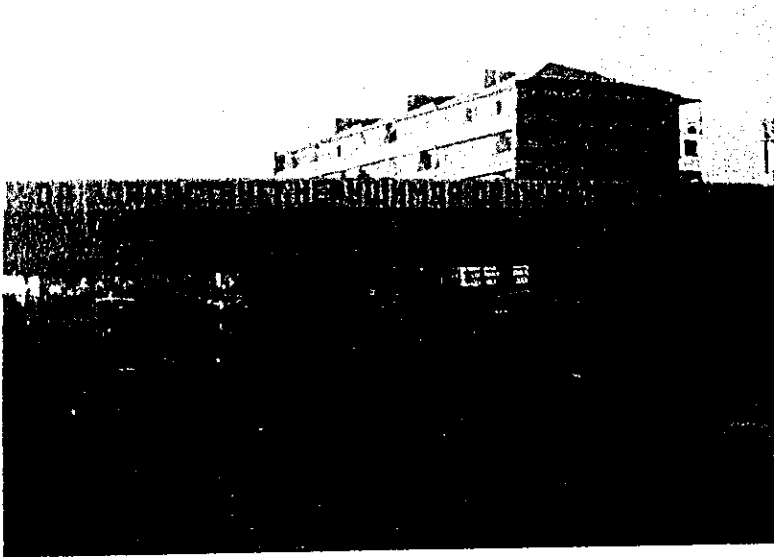
Photograph 3.2.14 Railroad Bridge (Leninakan)
 The bridge is undamaged. The piers are of rigid-frame construction and large in cross section, indicating that the performance of the bridge is largely different from that of the one in Photograph 3.2.1. The design horizontal intensity is roughly estimated at about 0.3.

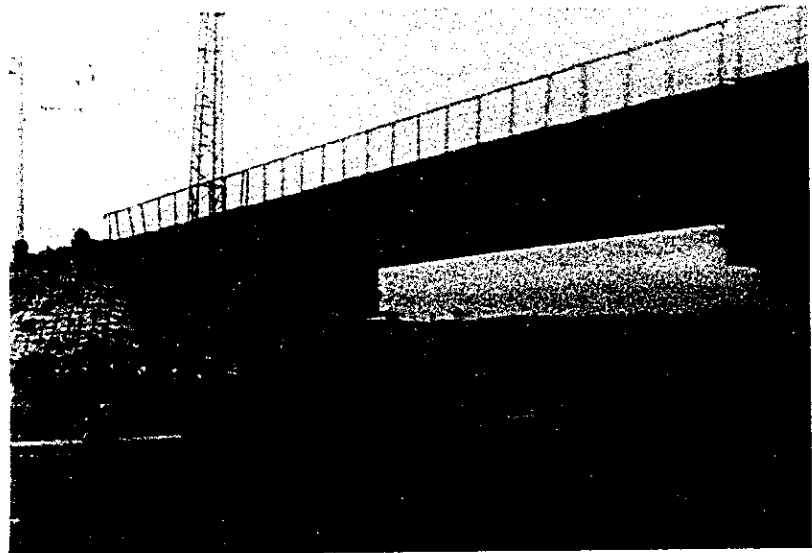
Photograph 3.2.15 Railroad Bridge (suburban Yerevan, undamaged)
 The bridge, which is undamaged, is located outside the disaster-stricken area. The piers are not very large in cross section, but they are of rigid-frame construction and estimated to have a sufficient rigidity.

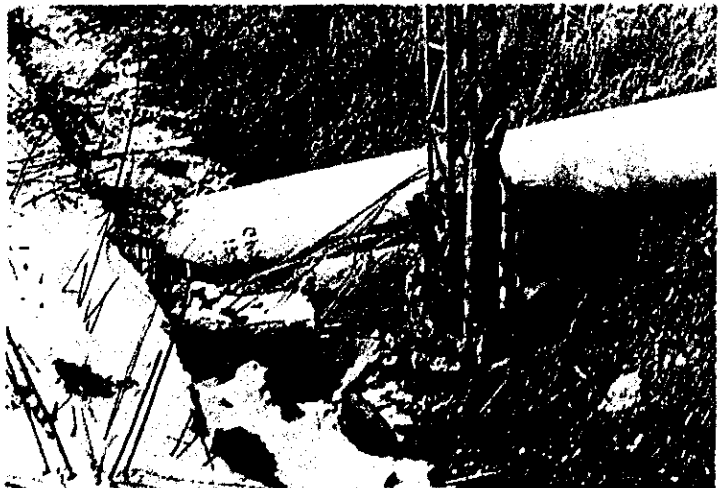
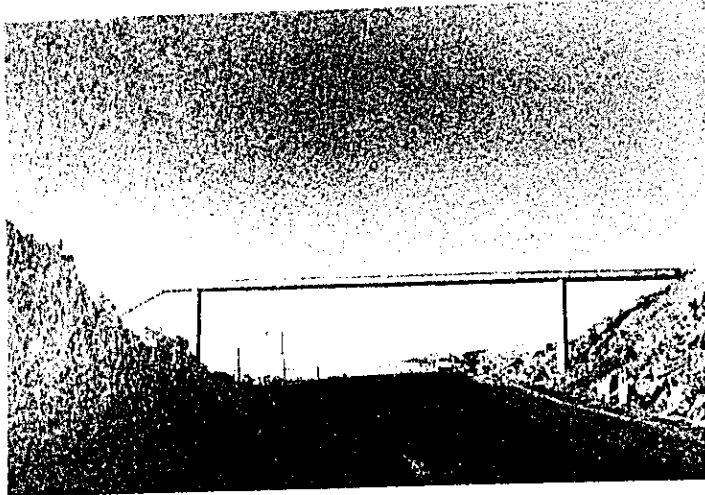
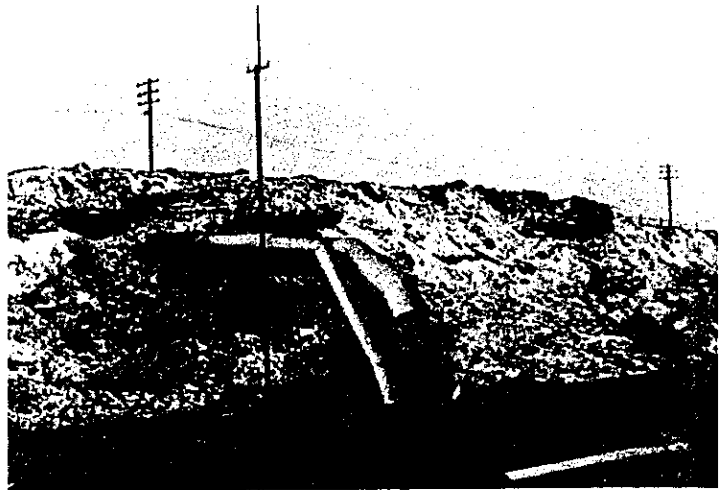
Photograph 3.3.1: Pipeline Across Road (steel pipe, probably for irrigation, undamaged). There are pipelines like this in many places, probably because the area is high in altitude and small in precipitation. Detailed information on their damage is not available.

Photograph 3.3.1 shows pipelines (undamaged) crossing a road in suburban Leninakan (found immediately before entering the earthquake-stricken area). Similar pipelines were seen in many places. They are considered to be used for irrigation or tap water supply, though details are unknown. In places other than roads, pipelines are installed directly on the ground surface or on a shallow level in the ground.

(a) A pipeline installed over a road.

(b) A pipeline crossing a road.
