**REPORT OF JAPAN DISASTER RELIEF TEAM
ON
EARTHQUAKE AT SPITAK, ARMENIA, USSR**

FEBRUARY 1990

**JAPAN INTERNATIONAL COOPERATION AGENCY
(JICA)**

JICA (Japan International Cooperation Agency), on behalf of the Japanese Government, dispatched a JDR (Japan Disaster Relief Team) from 18th to 28th December, 1988, to conduct a survey of the damage of Spitak Earthquake and to advise engineer and officials of Armenia SSR and USSR the technical know-how for the rehabilitation and restoration measures to be taken in the damaged area.

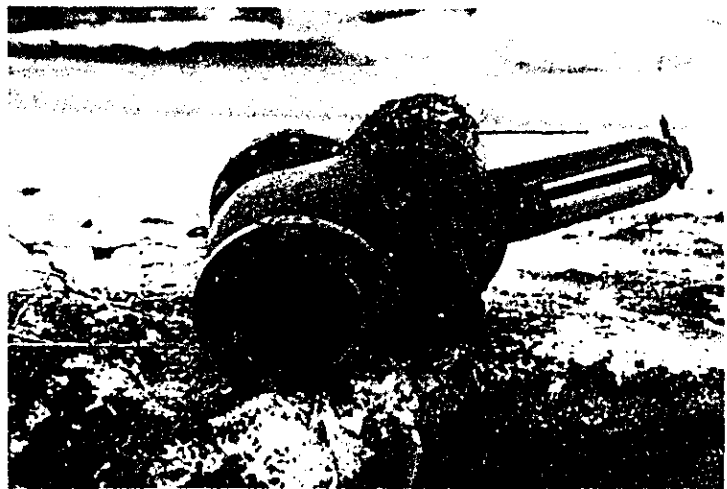
Photograph 3.3.3: Damaged Water Supply Pipe
It seemed that full-scale restoration had not started. Restoration work was seldom seen.

Photograph 3.3.3 shows a cutoff valve removed as a temporary measure to stop the leak from a damaged fitting in a water supply pipe in Leninakan.

(a) Temporary Treatment of a Fitting

(b) Cutoff Valve

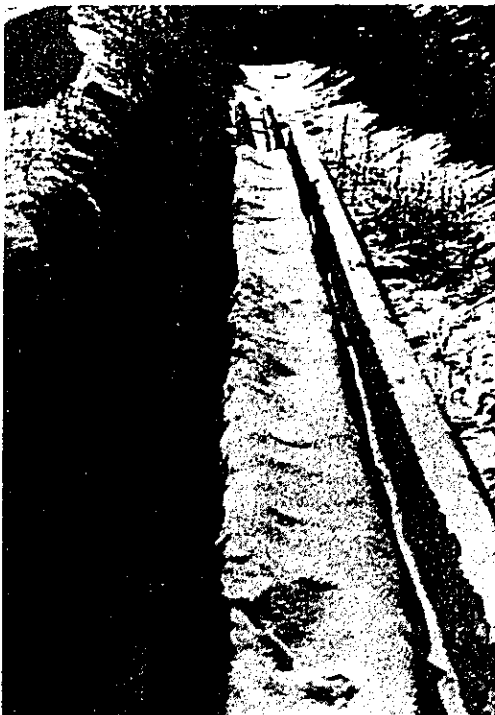
Photograph 3.3.4 shows a culvert being built near a building under construction in Leninakan, and a steel pipe installed in it. The use of the pipe is unknown. It seemed that the pipe laid in the culvert would be covered with reinforced concrete lids, followed by back filling.

Photograph 3.3.4: Steel Pipe (Probably for Water Supply) Installed in Culvert at Building Construction Site(Leninakan)
It appeared that RC lids would be laid, followed by back filling.

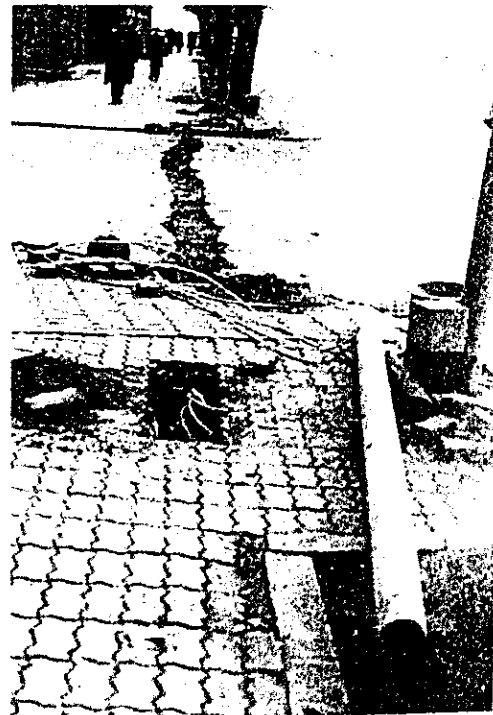
Photograph 3.3.5 depicts underground cables being restored. They appeared to be cables for control of traffic lights. They are passed through steel pipes and buried on a shallow level under the pavement.

Photograph 3.3.5: Restoration of Apparently Electric Cable under Pavement (Leninakan)

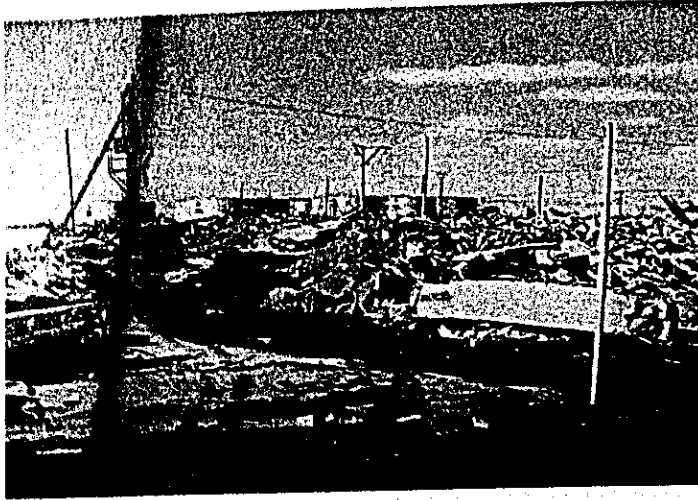
Photograph 3.3.6 shows tanks in an industrial complex in Leninakan. Whether they were damaged is unknown.

Photograph 3.3.6: Tanks in Industrial Complex (Leninakan)
When viewed from a distance, they did not appear to be damaged by fire, etc.

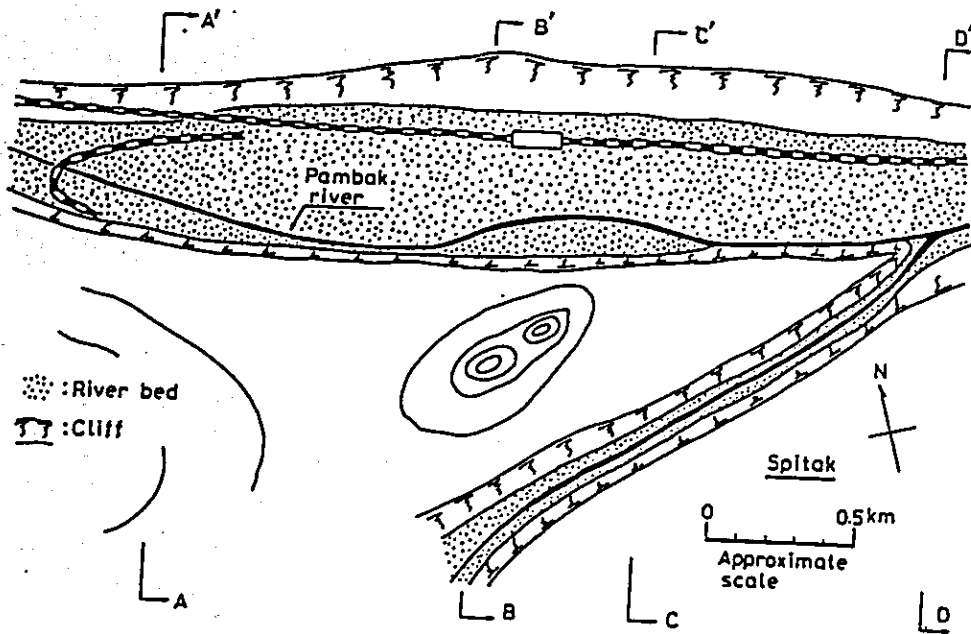
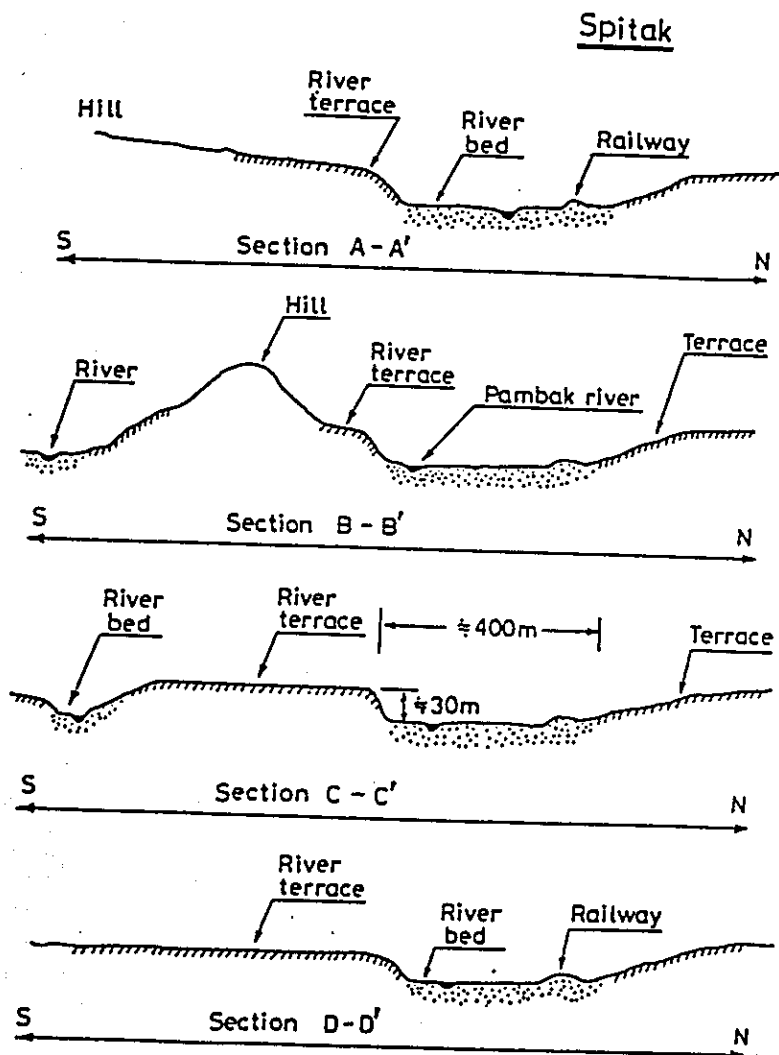
Fig. 2 (a) Plan view of Spitak

The city of Spitak develops in a widely opened area near the junction of the Pamback river and its tributary streams as shown in Fig. 2. The worst-hit city area consists of low-lying portion where the Pamback river flows easterly and of terrace portion on the north and south sides of the city center. No boring data is available in Spitak, but visual observation of the exposed strata

on the cliffs shows that the terrace is formed of the black-colored basaltic rock overlaid by layers of gravel-rich soils which appears to have been derived from the disintegration of the mother rock. The low-lying riverbed area appears to have been formed as a result of erosion by the Pamback river. The ground surface in this zone is predominantly covered by black-colored silt or clay with high plasticity. The strata below this surface soils consist of gravelley soils underlaid by the hard basaltic rock.

(4) In the city of Spitak, the terrace area above the cliffs appears to have suffered by far greater level of damage to buildings as compared to the damage in other areas in its vicinity.

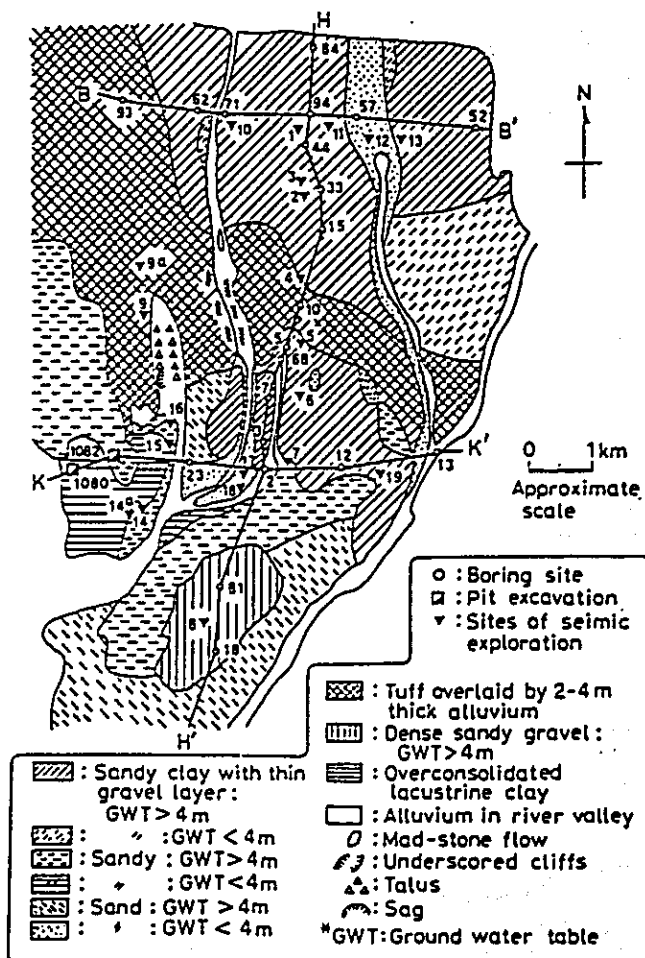
Fig. 3 Subsurface geology in Leninakan (Babayan et al. 1974)

may be seen that sand-rich deposits prevail generally in the southern part whereas gravelly deposits exist in the northern portion of the city. It is to be noted that the sedimentary tuff deposit 10 to 15 m thick extend toward southeast from northwest. In the south of the city, there exists dense sandy gravel deposit. The cross section in the east-west direction through the city center as indicated by k-k' in Fig. 3 is demonstrated in Fig. 4, where it may be seen that there exist layers of gravel-containing deposits of varying thickness to a maximum depth of about 20 m.

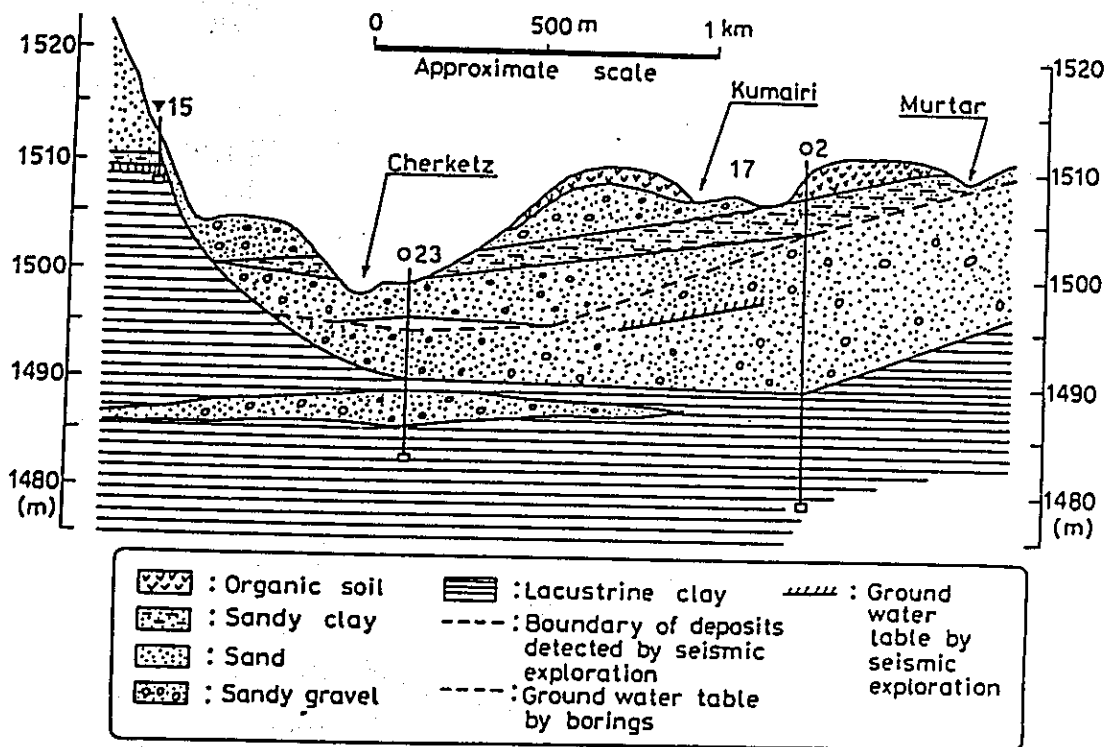
Fig. 4 Cross sectional view of soil profile in Leninakan (Babayan et al. 1974)

(3) The city of Leninakan lies on a buried lake having a distance of about 3 km in the east-west direction and a north-south distance of about 5 km. The western edge of the lake deposit outcrops on a hill just west of the Cherketz river (see Fig. 4). Therefore, the boundary between the lake deposit and the underlying rock at its western edge appears to dip sharply to the east. The presence of the inclined boundary as above might have acted toward concentrating the reflected waves in some particular section of the city.

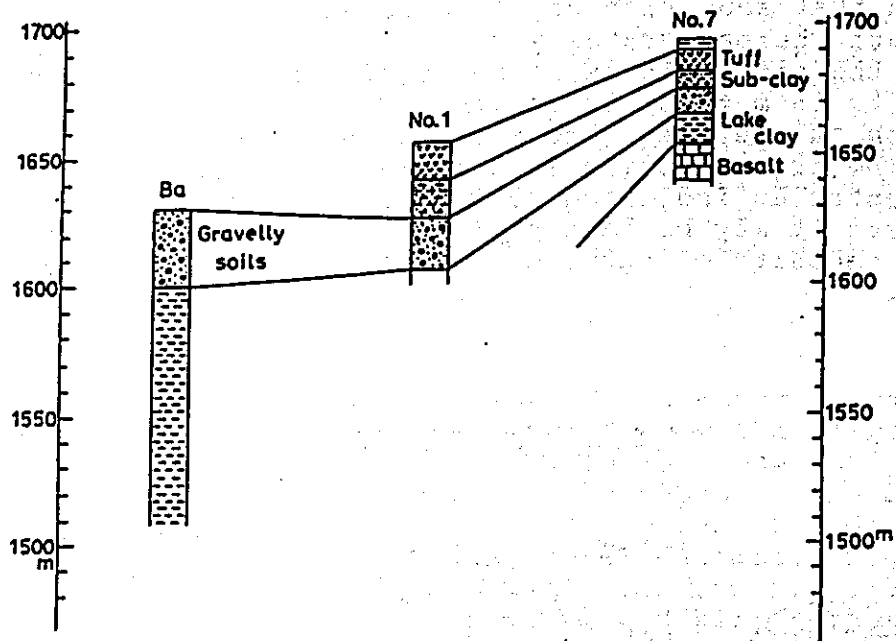
Fig. 5 Deep boring data in Leninakan

To see the soil profile to deeper deposits, data on deep borings were collected as summarized in Fig. 5. Individual sites designated by No. 1, No. 7 and Ba are indicated in Fig. 6. Fig. 5 indicates that the lake deposit pinches out as the ground elevation rises toward the north. It can also be seen in Fig. 5 that there exists the basaltic rock formation underlying the lake deposit.

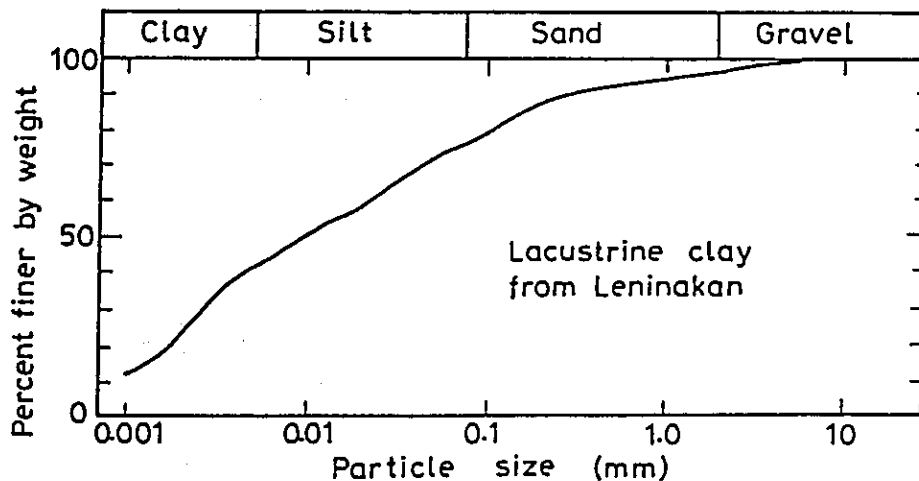
Fig. 8 Gradation curve of the lake clay

The test sample was secured from the bottom of the excavated pit and has a grain size distribution curve shown in Fig. 8. The clay is over-consolidated and cemented. The plasticity index is 34 as shown in Table 3. The void ratio of undisturbed samples are 1.45 and 1.18. The shear wave velocity, V_s , measured in-situ by the method of elastic wave refraction is reported by Babayan et al. (1974) to be 450 m/sec as indicated in Table 1, whereas the shear wave velocity measured in the laboratory by transmitting ultrasonic waves through undisturbed samples shows a value of 365 m/sec, and the V_s -value estimated from the q_c -value range between 300-400 m/sec, as indicated in Table 2. The values of shear wave velocity obtained from three different methods are summarized in Table 4 for comparison sake where it may be concluded that the shear wave velocity of the lake deposit in Leninakan does probably possess a value between 300 and 450 m/sec with a best estimated average of 350 m/sec.

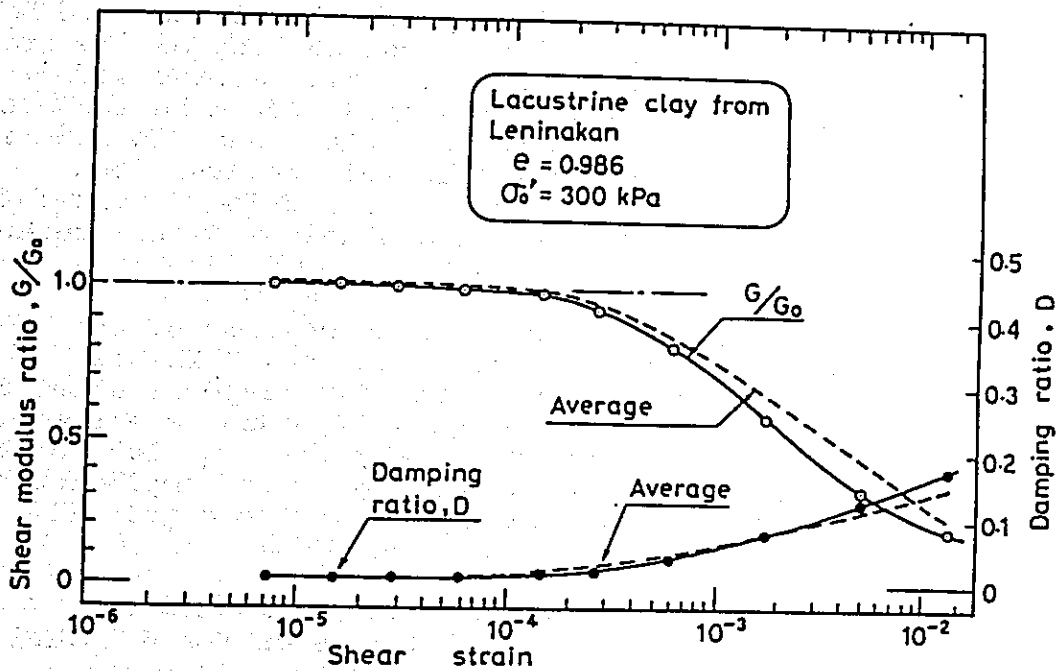
Fig. 9 Strain-dependent shear modulus and damping ratio for the clay in Leninakan

In addition to the above, a resonant column test was conducted on an undisturbed sample trimmed into a hollow cylindrical shape. The strain-dependent modulus and damping characteristics of the lake clay obtained in the test is demonstrated in Fig. 9, together with a typical average curve established thus far for clayey soils. In Fig. 9, the shear modulus, G , at a certain strain level is shown normalized to the shear modulus, G_0 , at a small strain of 10^{-5} . It is to be noted

that the shear wave velocity obtained at the lowest strain level in this test was 165 m/sec, a value much smaller than any value obtained by other methods listed in Table 4. This is probably because of the sample disturbance incurred during the trimming of the hollow cylindrical specimen. Thus, the data of shear wave velocity obtained in this test should be discarded. However, the strain dependency of modulus and damping as shown in Fig. 9 which coincide with the average curve from many other data on clays may represent actual behavior of the lacustrine clay undergoing the shaking during the earthquake
