*THE STUDY ON
LANDSLIDE PROTECTION PROJECT
IN PORT LOUIS*

*FINAL REPORT
EXECUTIVE SUMMARY*

NOVEMBER 1990

JAPAN INTERNATIONAL COOPERATION AGENCY

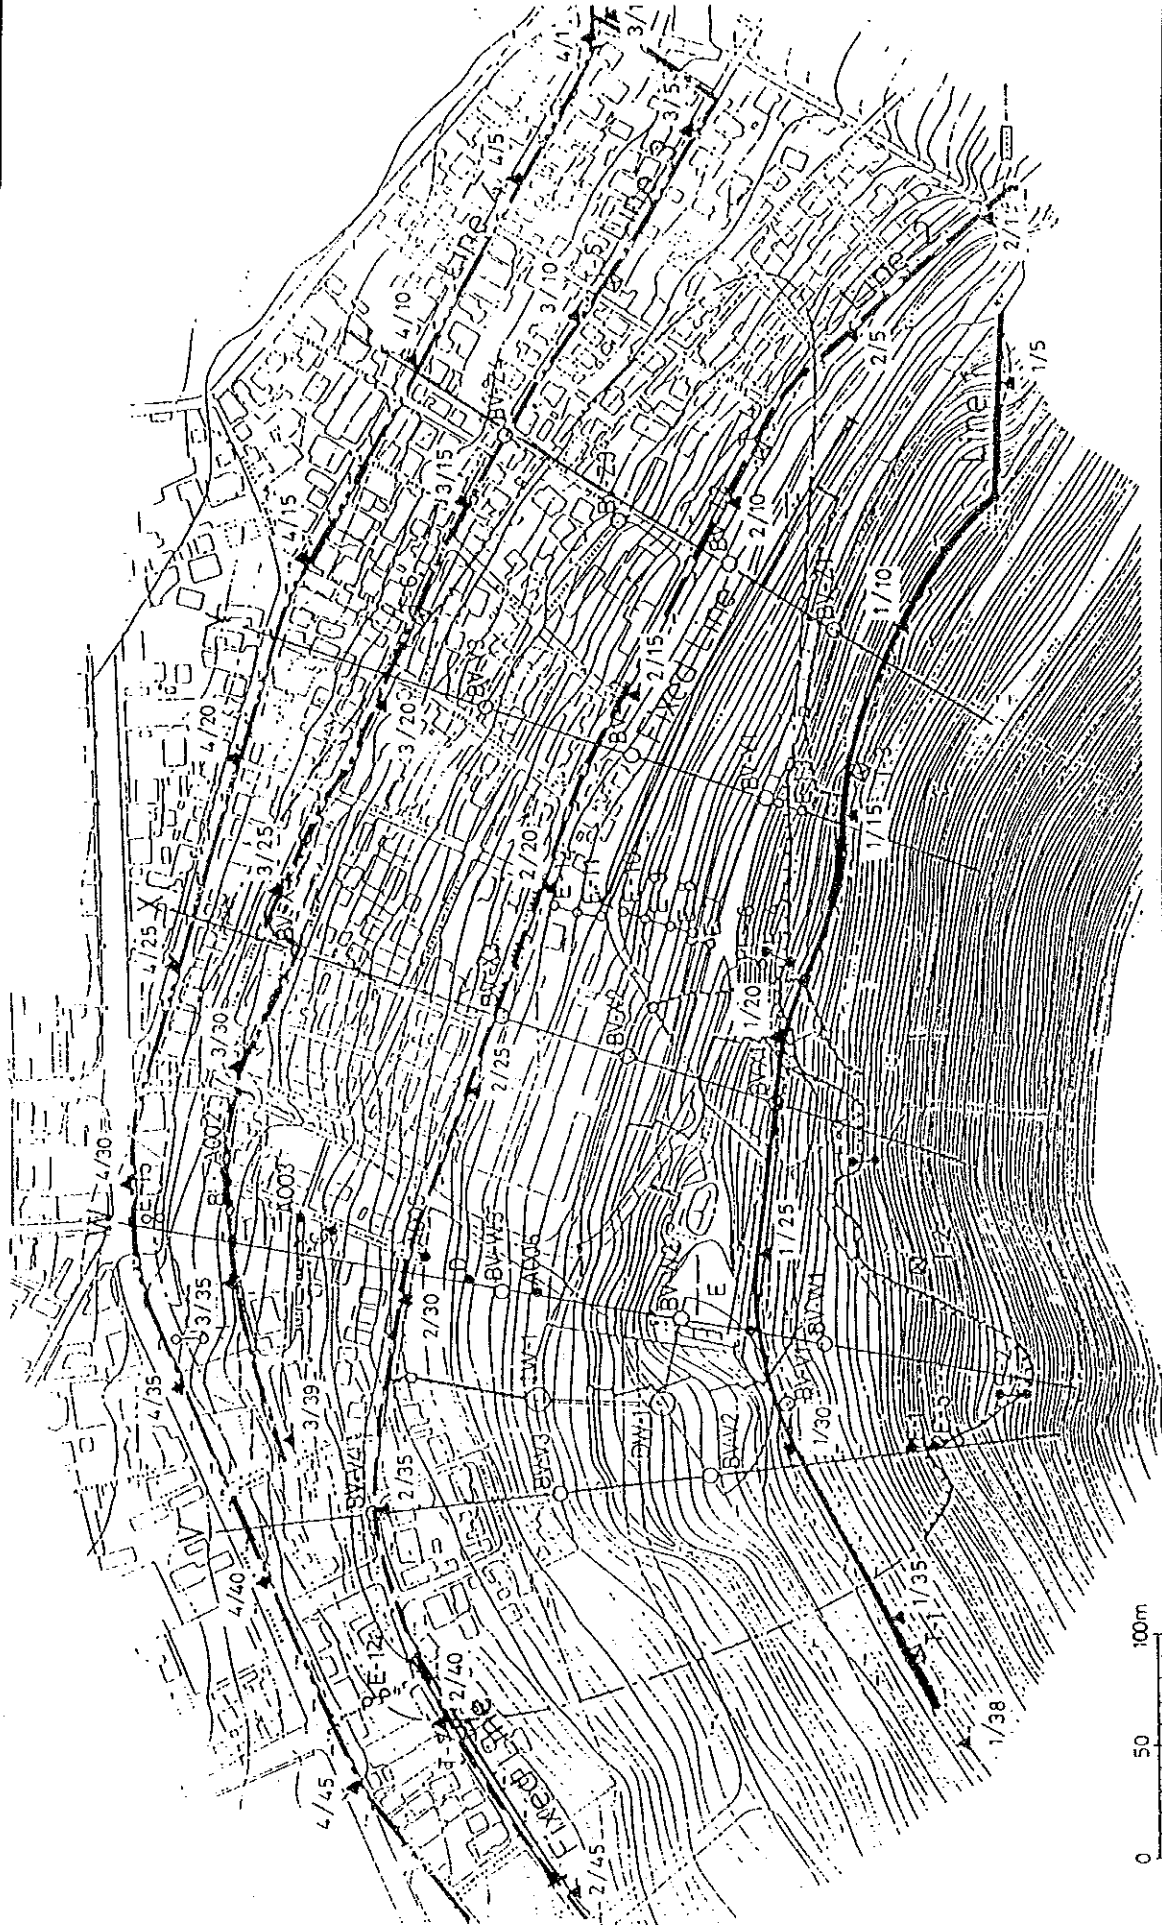
Fig. 2.2

More than 400 mm of subsidence of ground surface was measured along the leveling survey line-1 in the southwestern part of the landslide in May 1989. However, no further subsidence was measured in the following period which decreased rainfall. The location of leveling survey lines is indicated in Fig.2.2 and graphs of the subsidence is shown in Fig.2.3. Diminishing subsidence was believed to be due not only to decreasing rainfall but also to the effect of soil removal which was carried out as an urgent protective measure at the end of 1989.

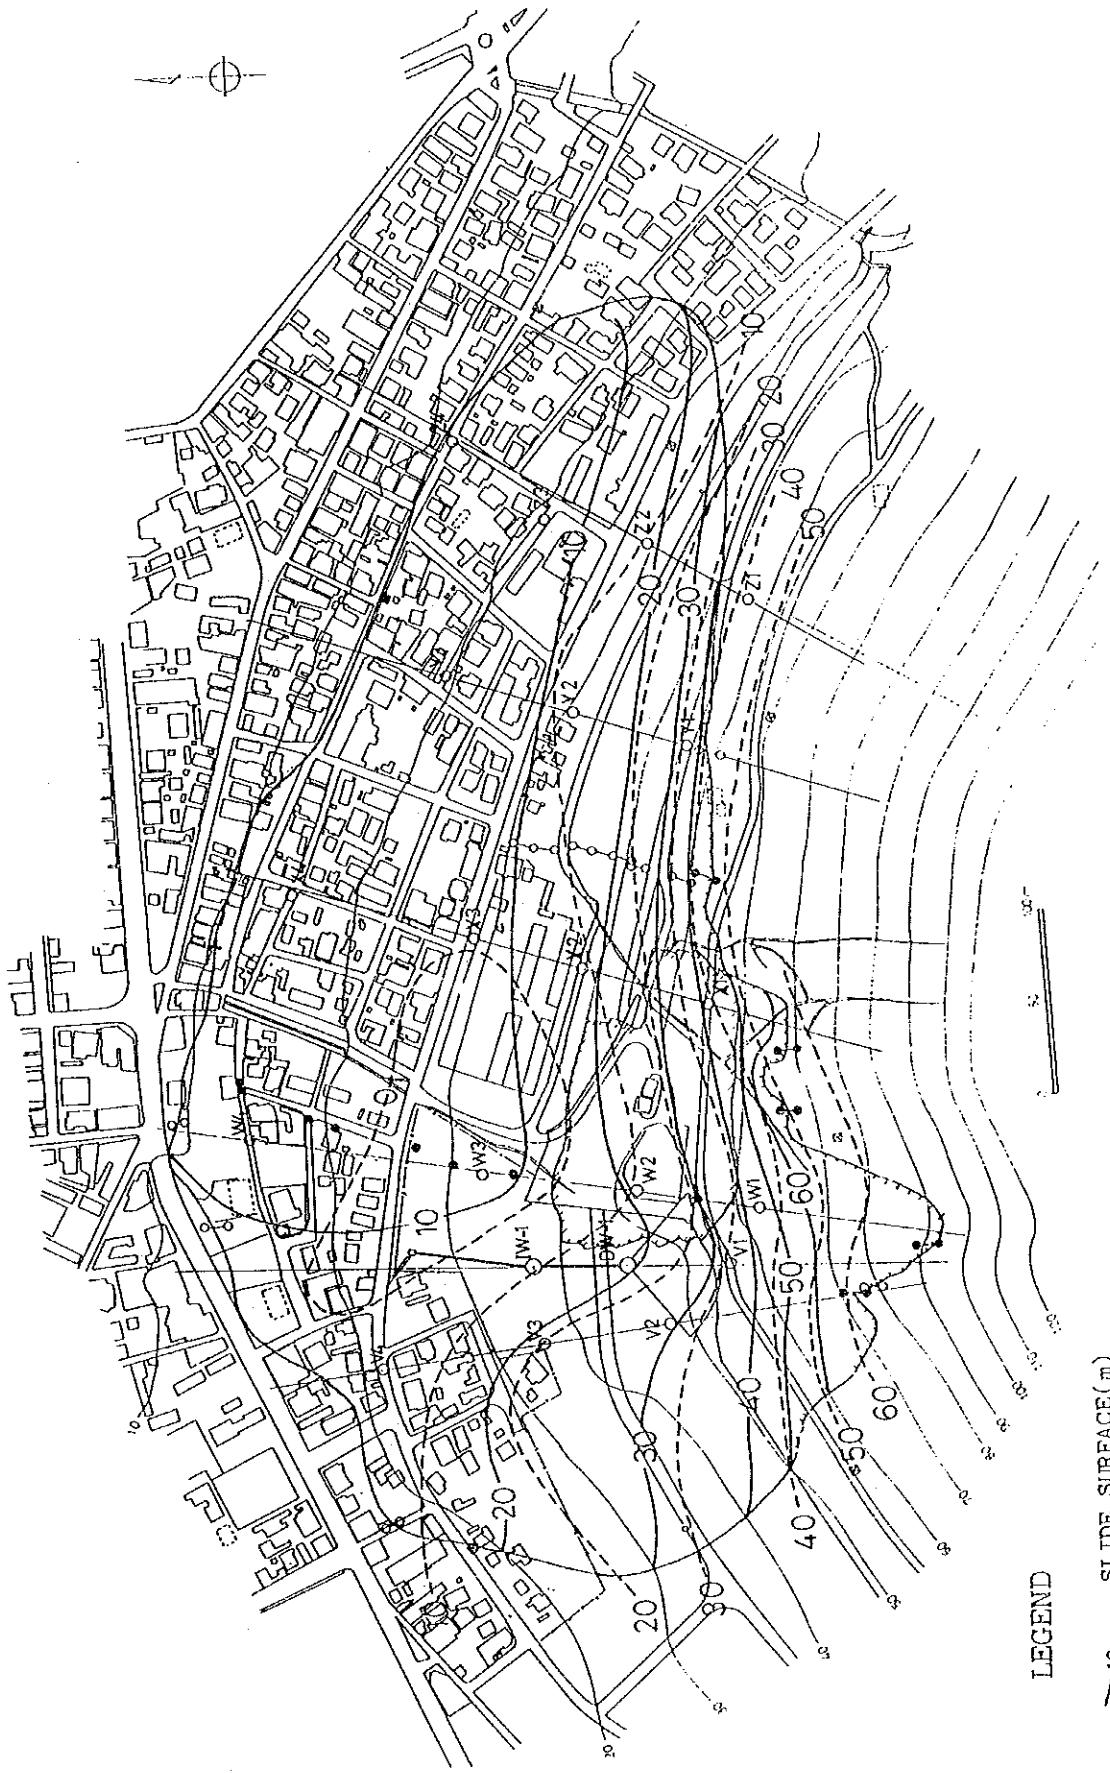
Fig. 2.4

The slide surfaces of the landslide are assumed be mostly among the scree deposits except for some parts where slide surfaces were estimated to touch the bedrock surfaces. The depth to the slide surfaces and the bedrock surfaces were assumed to be greatest in the central part of the landslide, and is assumed to be gradually decrease towards the outside. A contour map of the slide surface with the bedrock surface is shown in Fig.2.4, and geological profiles along the observation lines are given in Fig.2.5 to Fig.2.10.

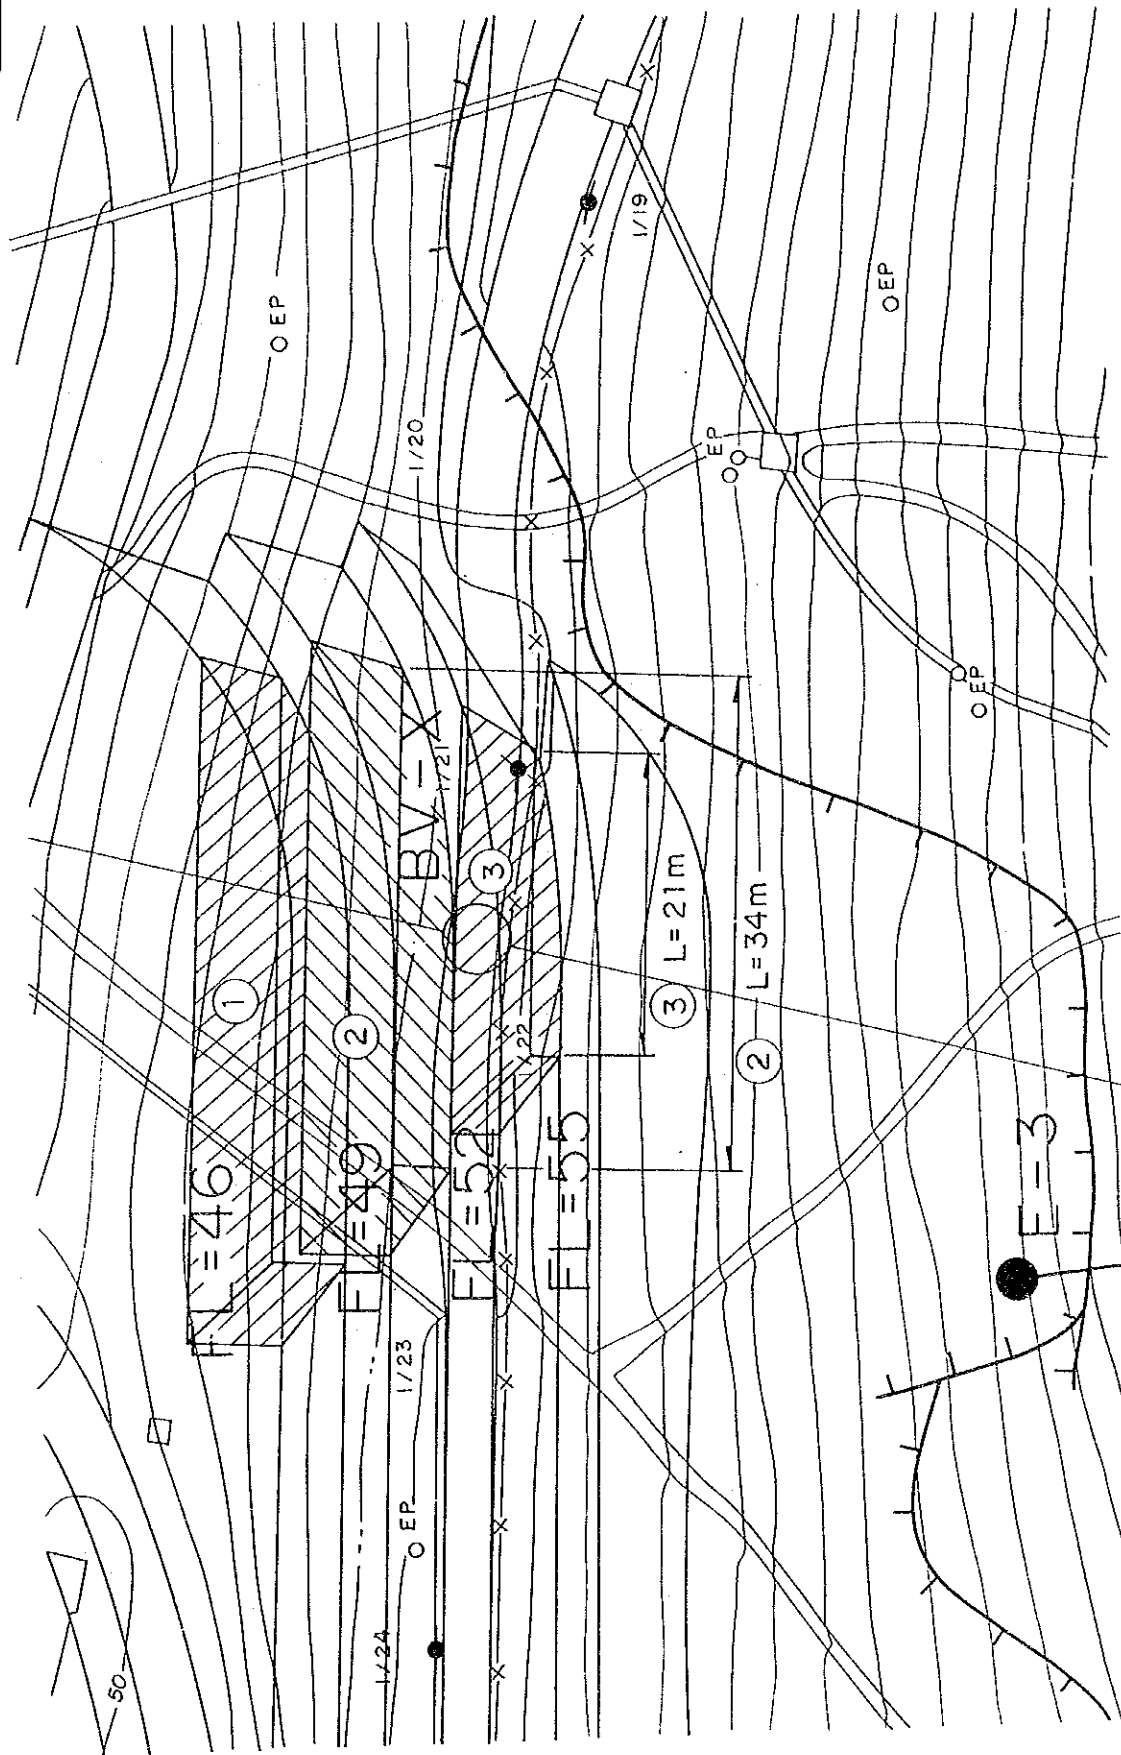
Fig. 3.4

However, the movement began again after relatively heavy rainfall in February. Displacements continued and was 200 mm between the middle of February and the beginning of March 1990. To check this movement, further counterweights were planned and implemented between the end of May and the beginning of June 1990. After providing these counterweights, movement gradually ceased in June 1990. The location and size of the counterweights are shown in Figs.3.4 and 3.5.

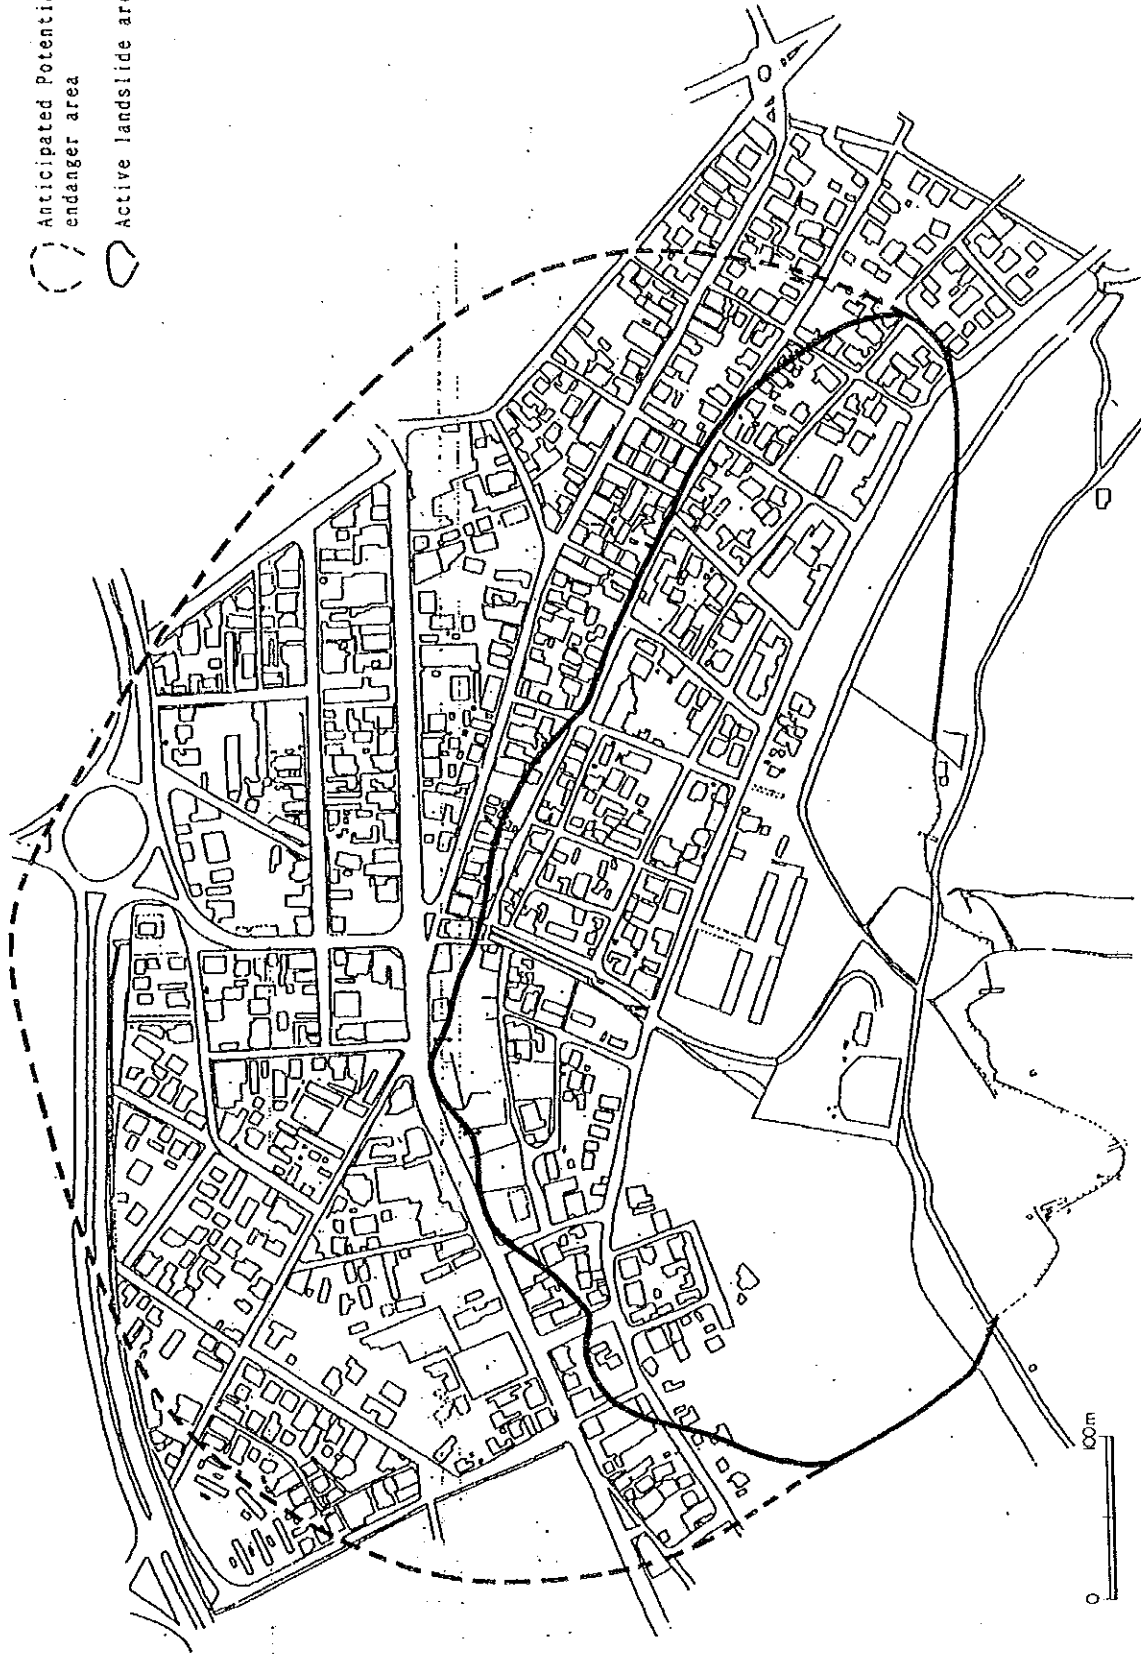
Fig. 4.5

Project evaluation started from estimation of the potential area at risk from landslide damage as shown in Fig.4.5. Project evaluation was then made on the with-project and without-project principle; that is, project benefits evaluated as potential damage which would be
