**REPORT ON EXPERT TEAM OF JAPAN DISASTER
RELIEF TEAM (JDR) ON THE EARTHQUAKE
IN PHILIPPINES OF JULY 16, 1990**

AUGUST 1990

**JAPAN INTERNATIONAL COOPERATION AGENCY
(JICA)**

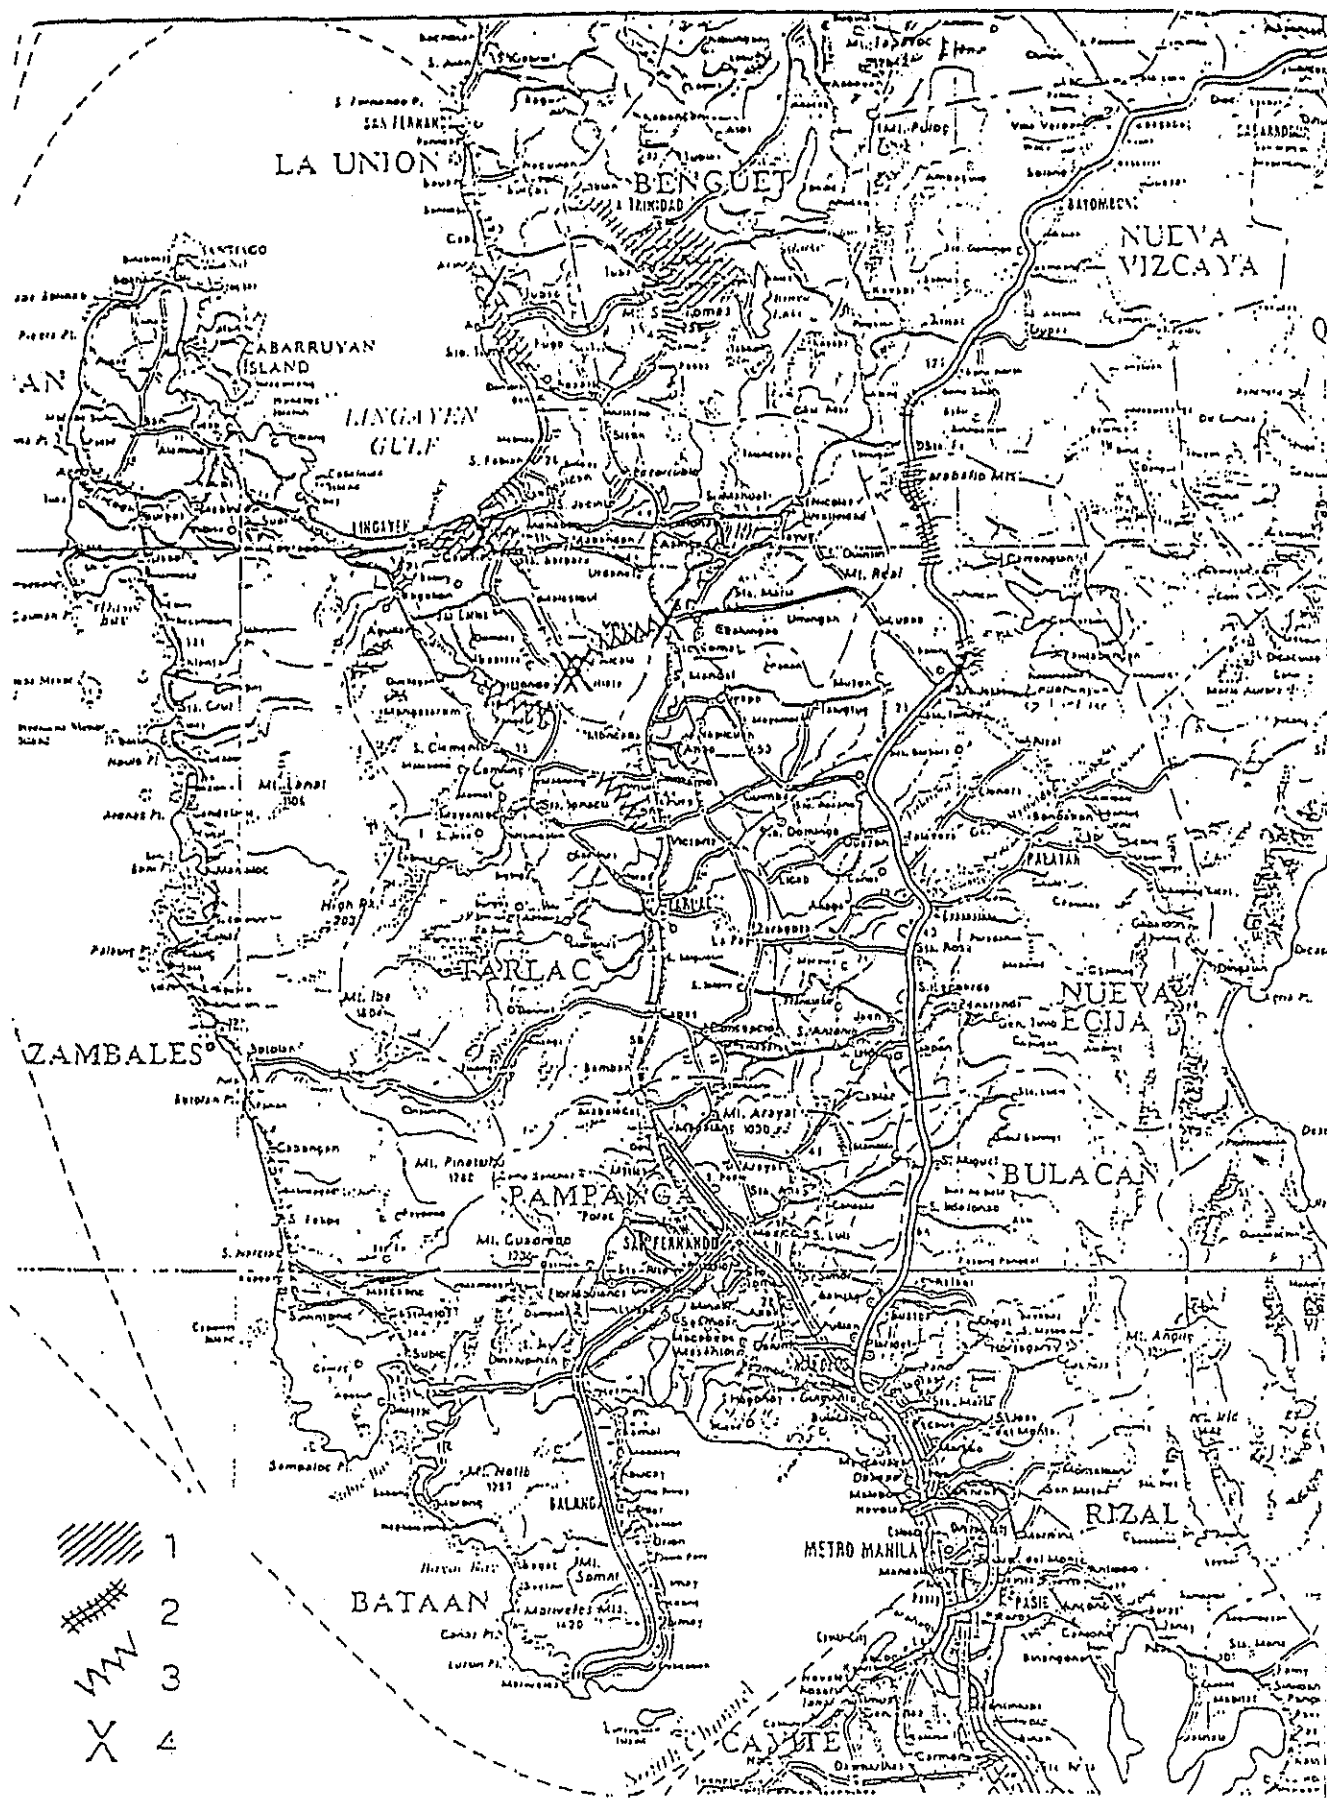
Figure 5.2.1 Approximate distribution of main damages
(see Chapter 7 for details)

- 1: Damaged buildings (areas where damaged buildings occurred frequently)
- 2: Damaged roads (ruinously disaster-stricken areas, such as those with impassability)
- 3: Damaged river facilities (damaged and broken embankments)
- 4: Damaged bridges (locations of fallen bridges)
