SWIM PROJECT PROFILE		File No. : 136
Regist. No. : Agency No. : BSWM-47	Name: SAN MARCOS SWIP	
Region: 2	Province: QUIRINO	Municipality: CABARRQUIS
Present Status: 1. Pre-F/S() ② F/S(1985) ③ D/D(1985)		
Purpose: Major : Irrigation Incidental : IF, FC, WM		
Project Feature:

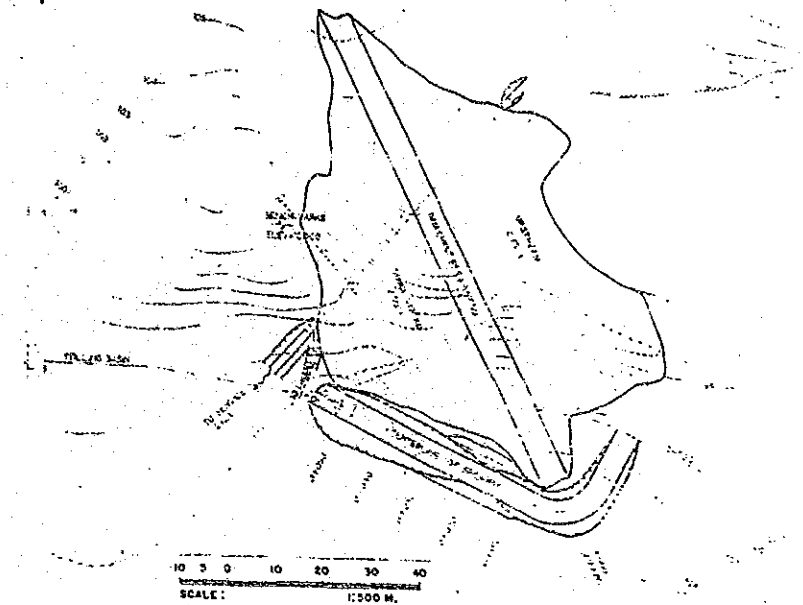
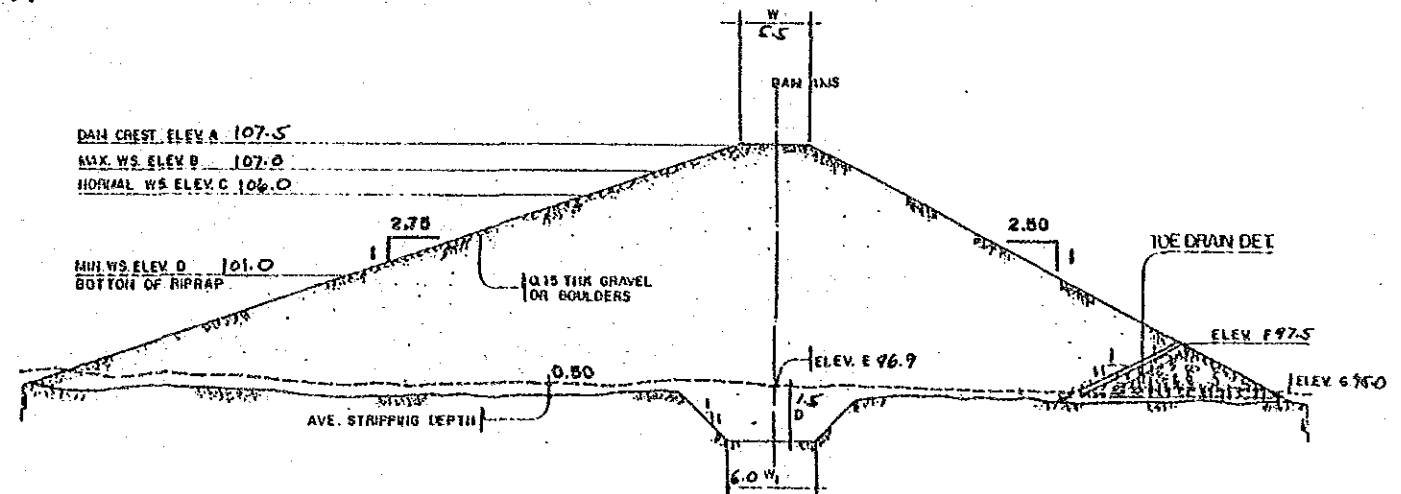
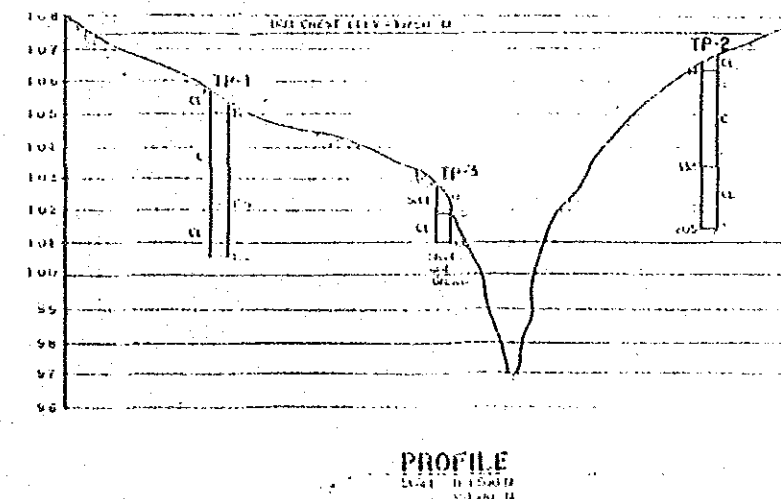
Note: silty clay with 2.0 m depth is piled up on the sand stone and shale.

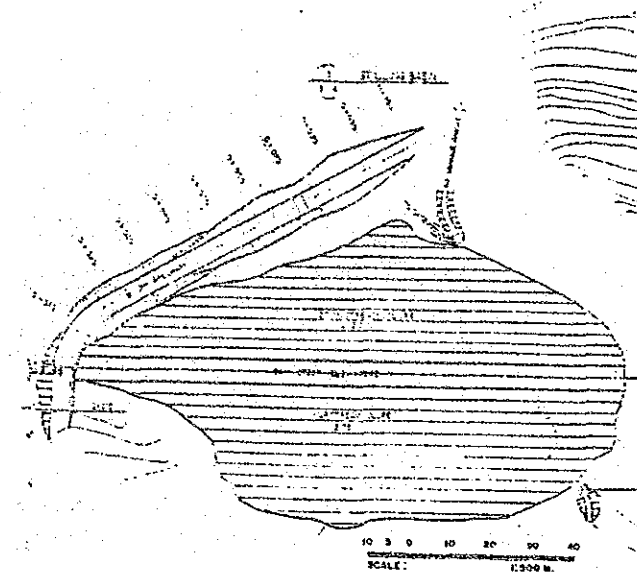
6. Inland Fishery	Annual Production	8 ton/year
Technical Assessment:		
1. Survey and Investigation: Topographic maps for reservoir site shall be prepared with 1 m contour at a scale of 1/2,000 or more. Depth of test pit or auger boring is not enough. Bearing capacity and permeability are not measured. Available volume for dam embankment shall be studied before construction.

2. Planning Environmental conservation plan is not formulated.		
3. Design Depth of core trench shall be modified during construction. Stability of upstream slope of the dam shall be checked. Freeboard is not enough. Weir shall be provided in the spillway. Center line of the spillway shall be shifted to left side.

Silty clay with 3.0 m depth is piled up on the sand stone and shale. Additional 0.5 m freeboard is necessary.

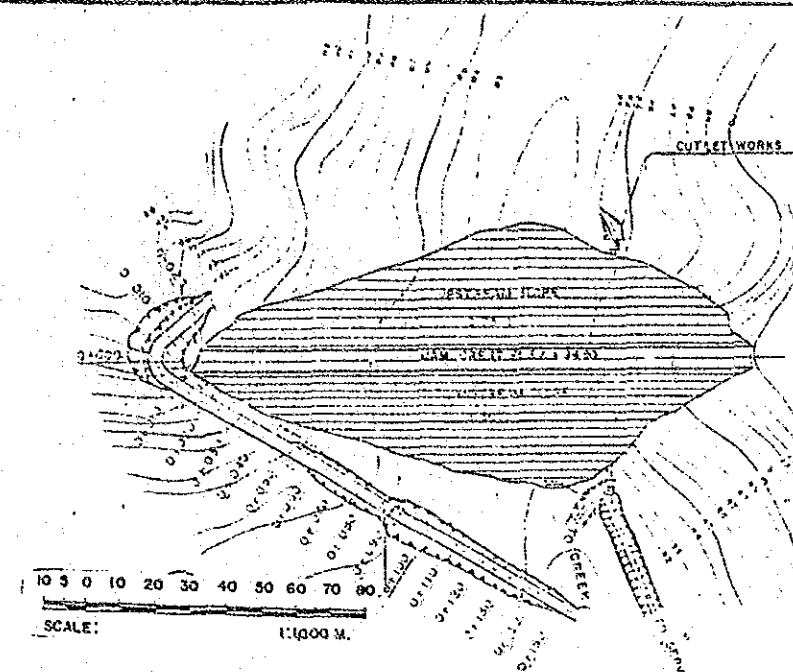
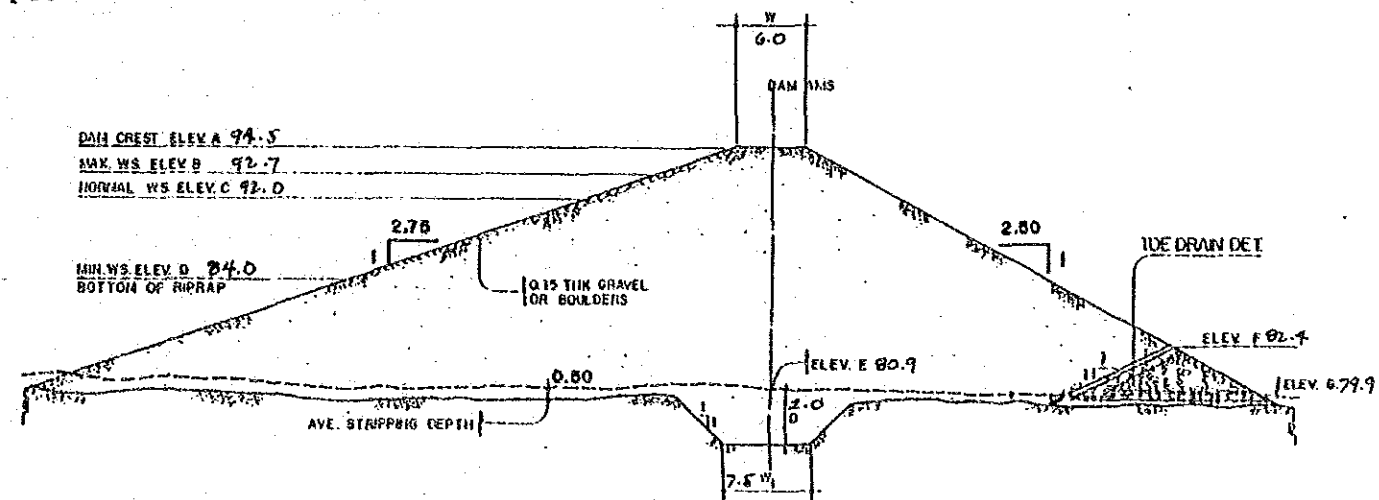
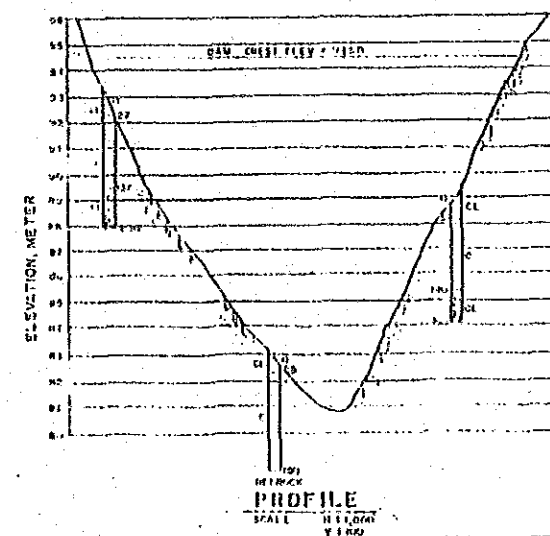
6. Inland Fishery	: Annual Production	: 16 ton/year
Technical Assessment:		
1. Survey and Investigation: Topographic maps for dam site shall be prepared with 1 m contour at a scale of 1/500 or more. Depth of test pit or boring is not enough. Bearing capacity and permeability are not measured. Available volume for dam embankment shall be studied before construction.

2. Planning Environmental conservation plan is not formulated.		
3. Design Depth of core trench shall be modified during construction. Stability of upstream slope of the dam shall be checked. Weir shall be provided in the spillway.

Note: silty clay with 2.0 m depth is piled up on the sand stone and shale.

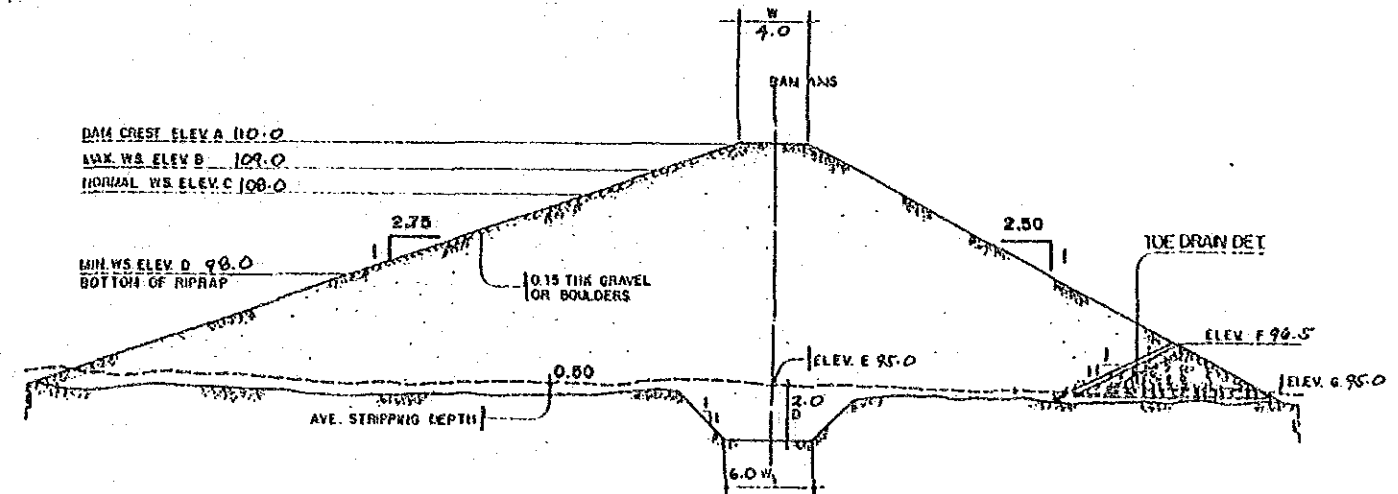
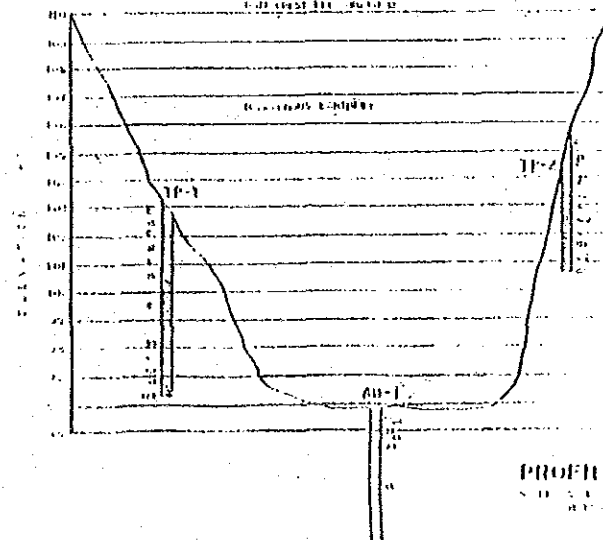
6. Inland Fishery	Annual Production : 13 ton/year	
Technical Assessment:		
1. Survey and Investigation: Depth of test pit or auger boring is not enough. Bearing capacity and permeability are not measured. Available volume for dam embankment shall be studied before construction.

2. Planning Environmental conservation plan is not formulated.		
3. Design Depth of core trench shall be modified during construction. Stability of upstream slope of the dam shall be checked. Weir shall be provided in the spillway.

Note: silty clay with 2.0 m depth is piled up on the sand stone and shale.

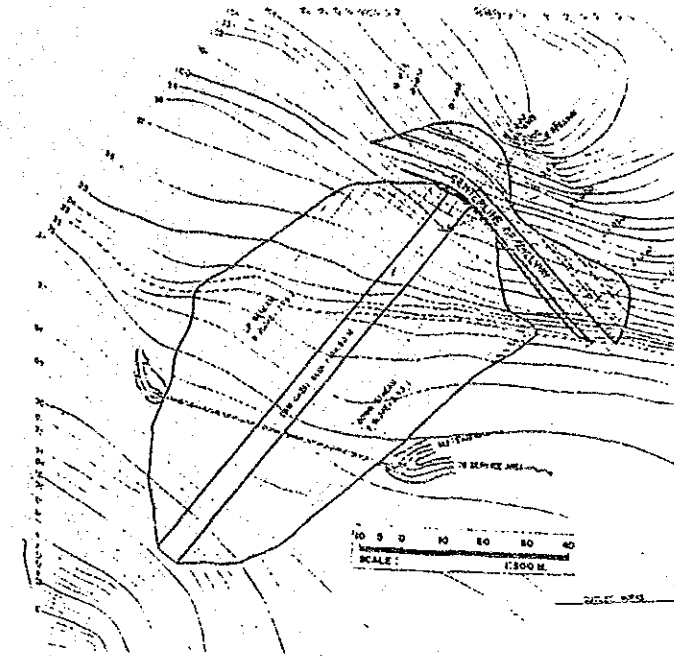
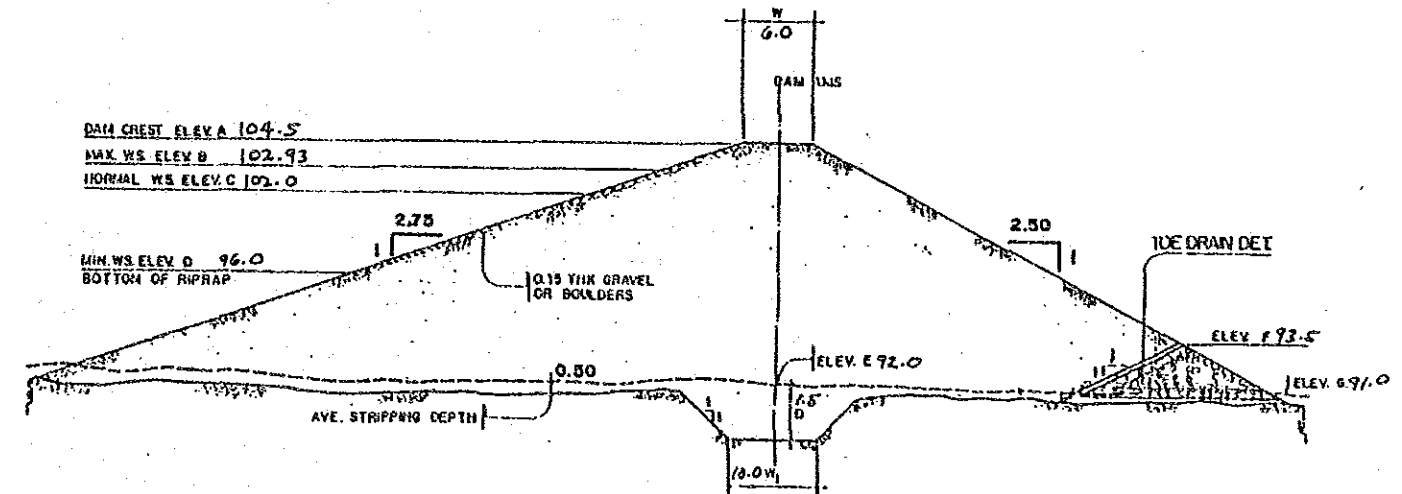
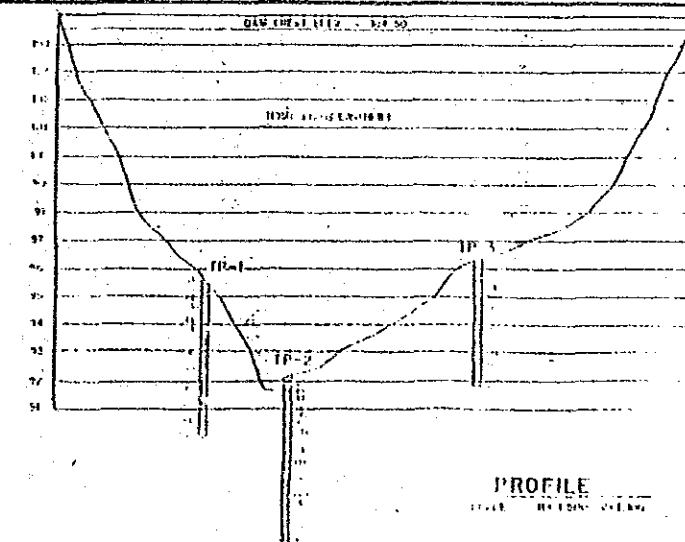
6. Inland Fishery	Annual Production :	6 ton/year
Technical Assessment:		
1. Survey and Investigation: Depth of test pit or auger boring is not enough. Bearing capacity and permeability are not measured. Available volume for dam embankment shall be studied before construction.

Note: Silty clay with 3.0 m depth is piled up on the sand stone and shale.

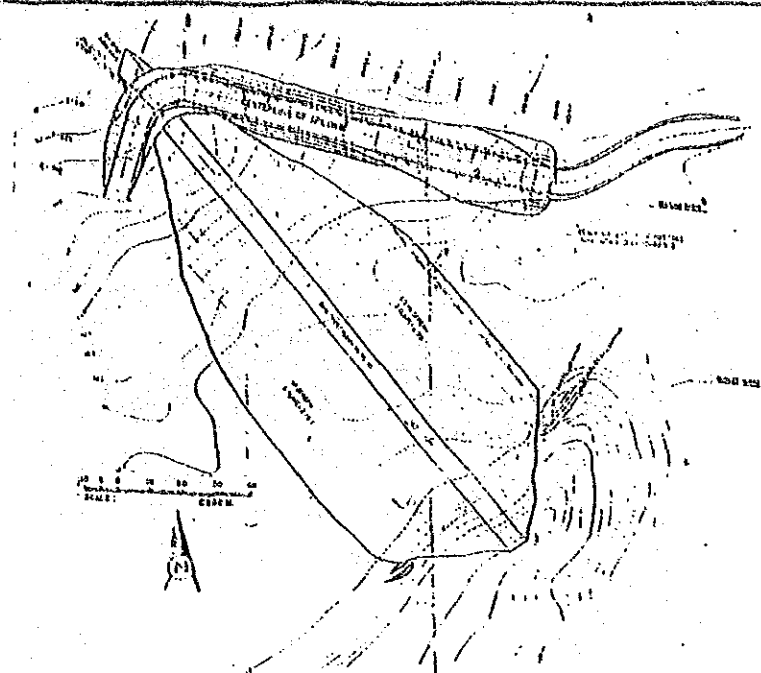
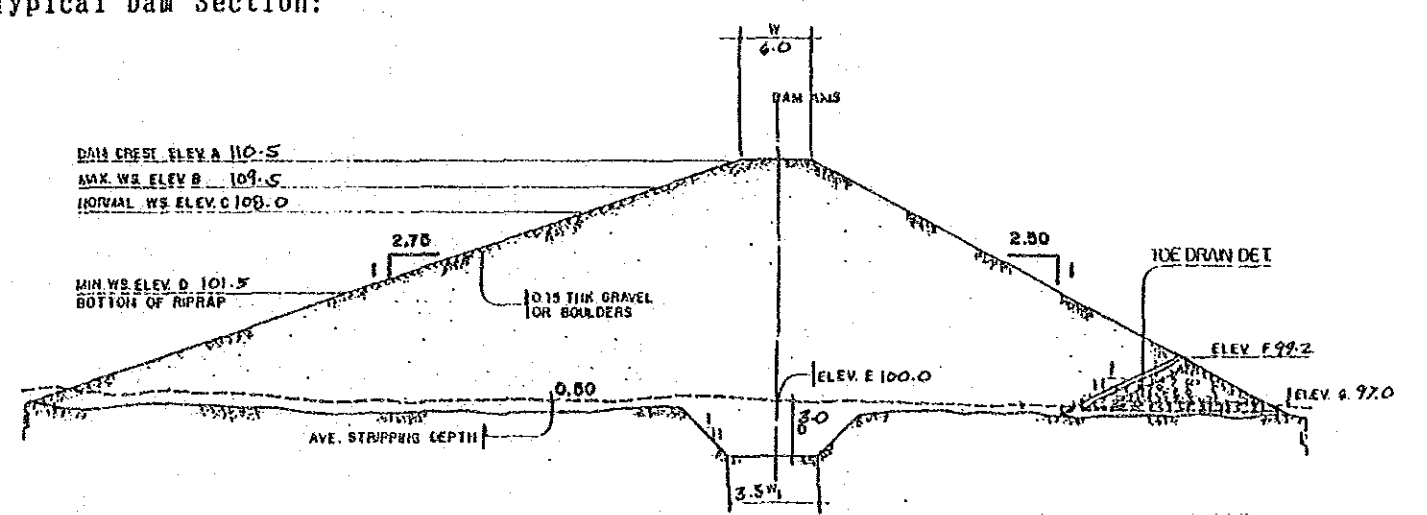
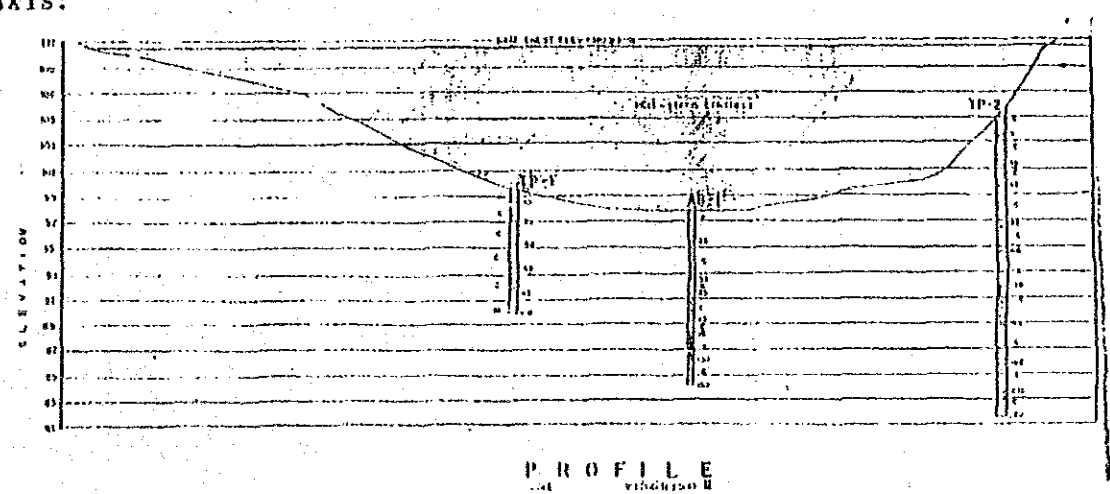
Note:
Silty clay with 2.5 m depth is piled up on the sand stone and shale.

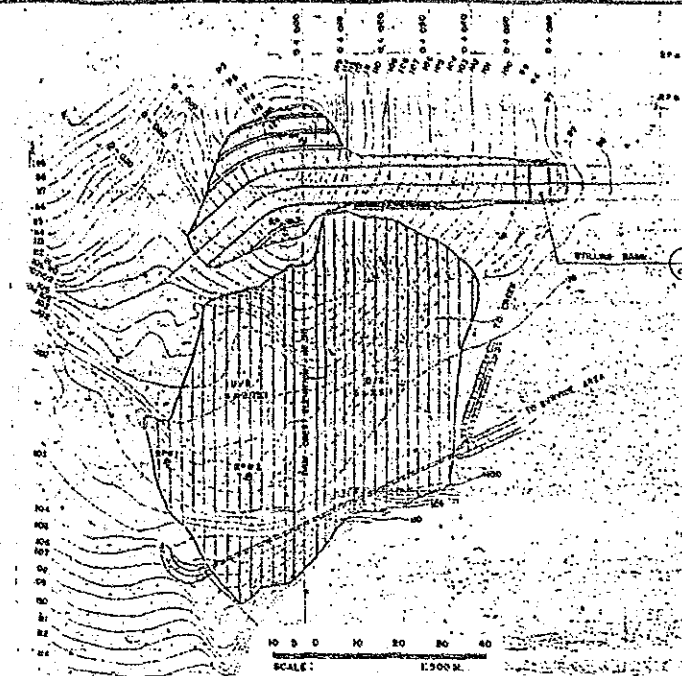
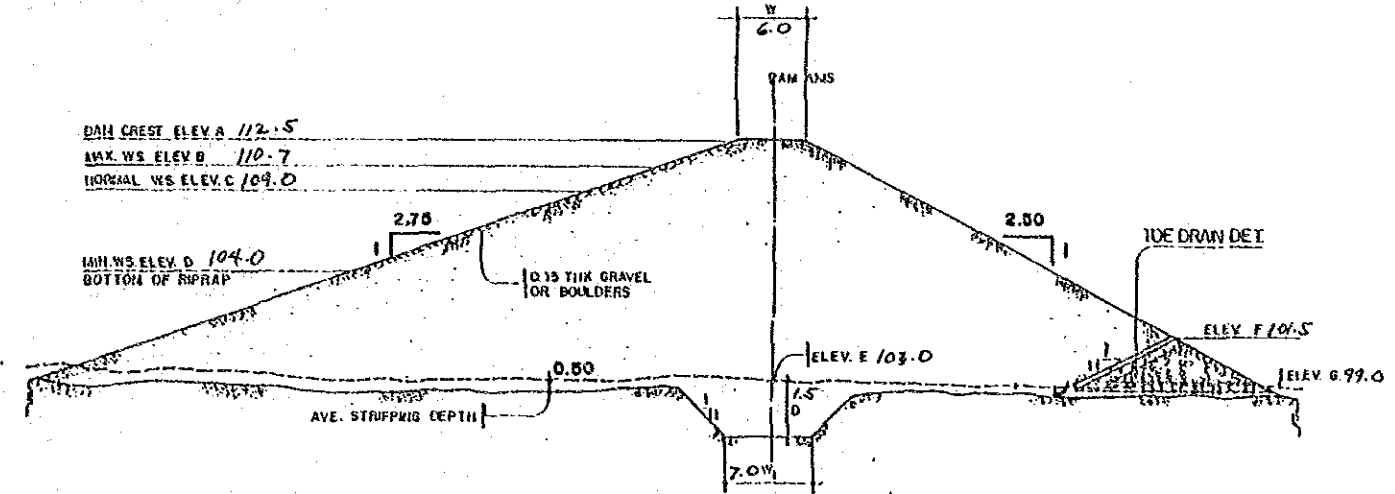
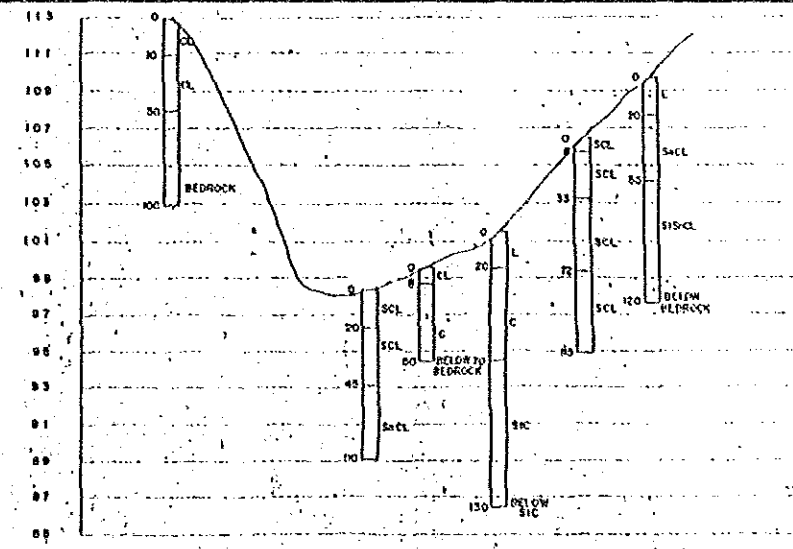
Basalt having minor joints, fractures and shares underlay clay blanket with 1.5 m depth.

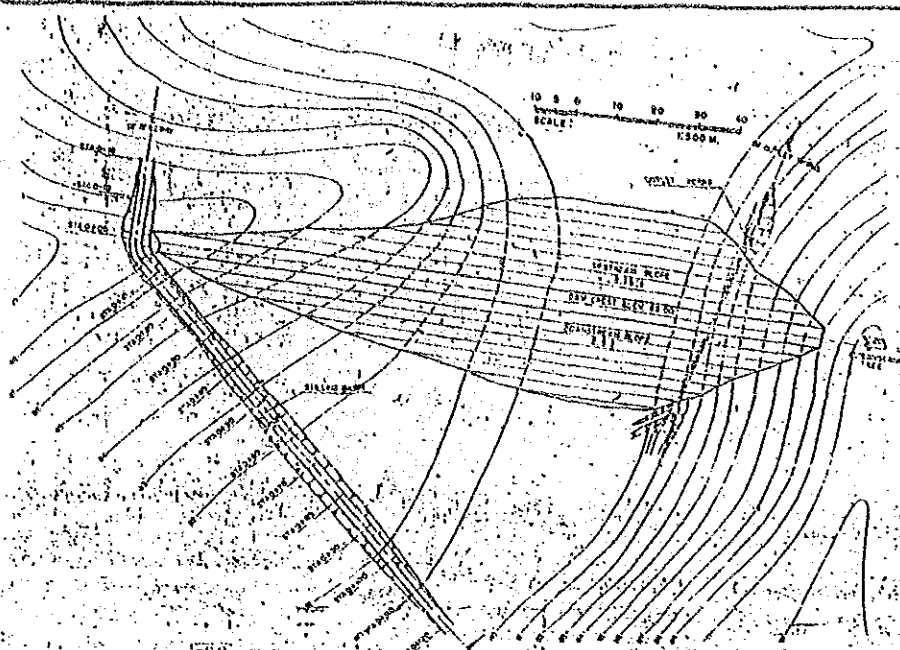
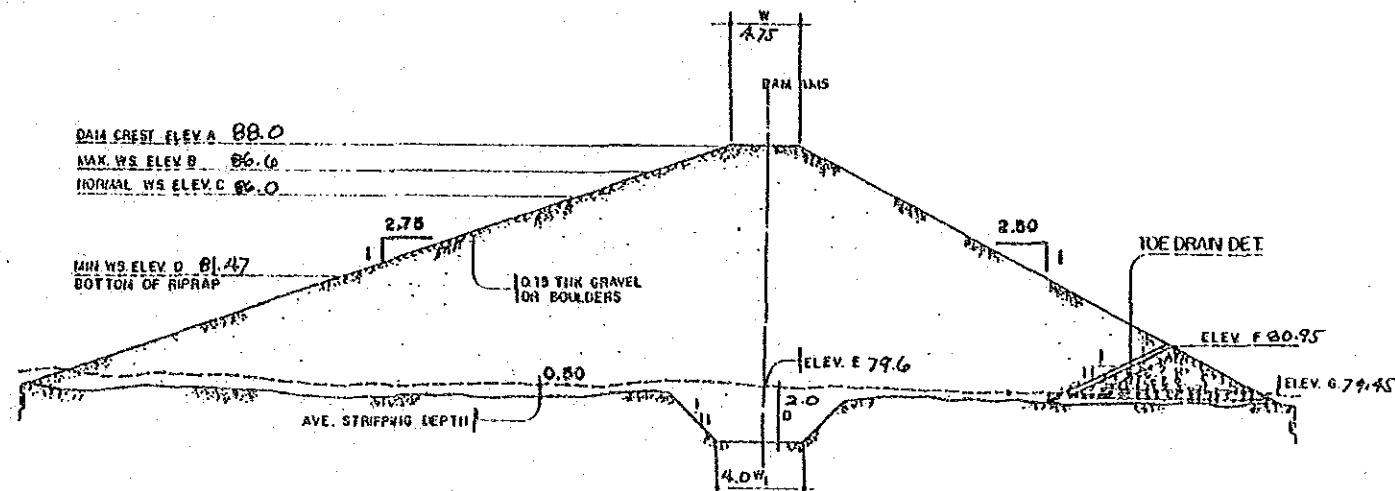
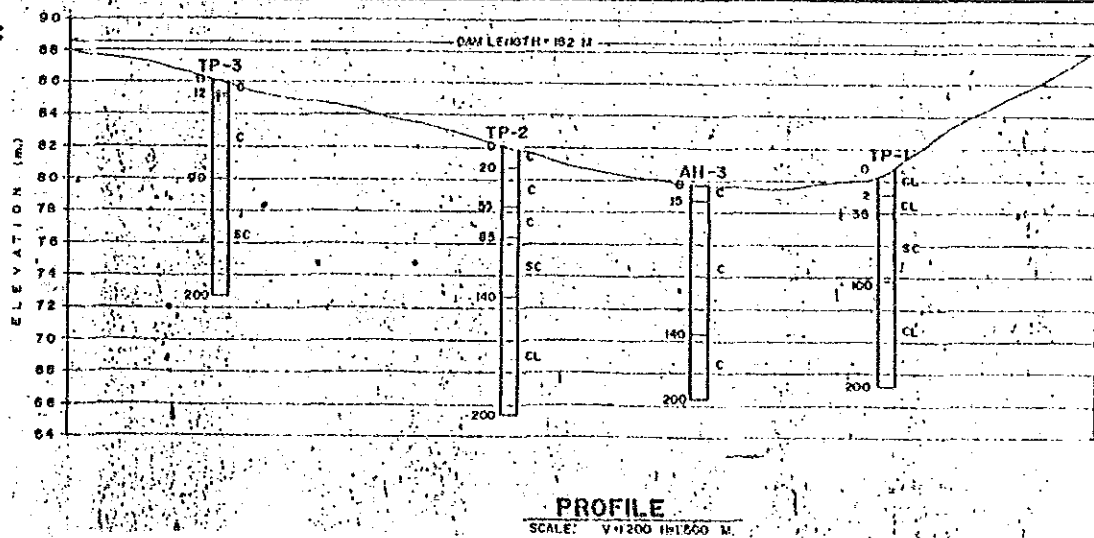
Note: Porous terrace gravel underlies 2.0-2.6 meter's depth clay layer. This clay layer functions as impervious blanket.

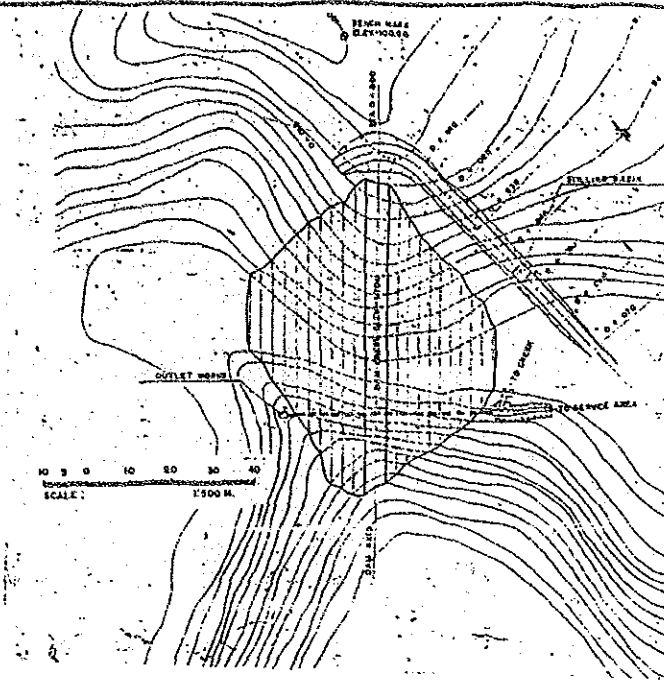
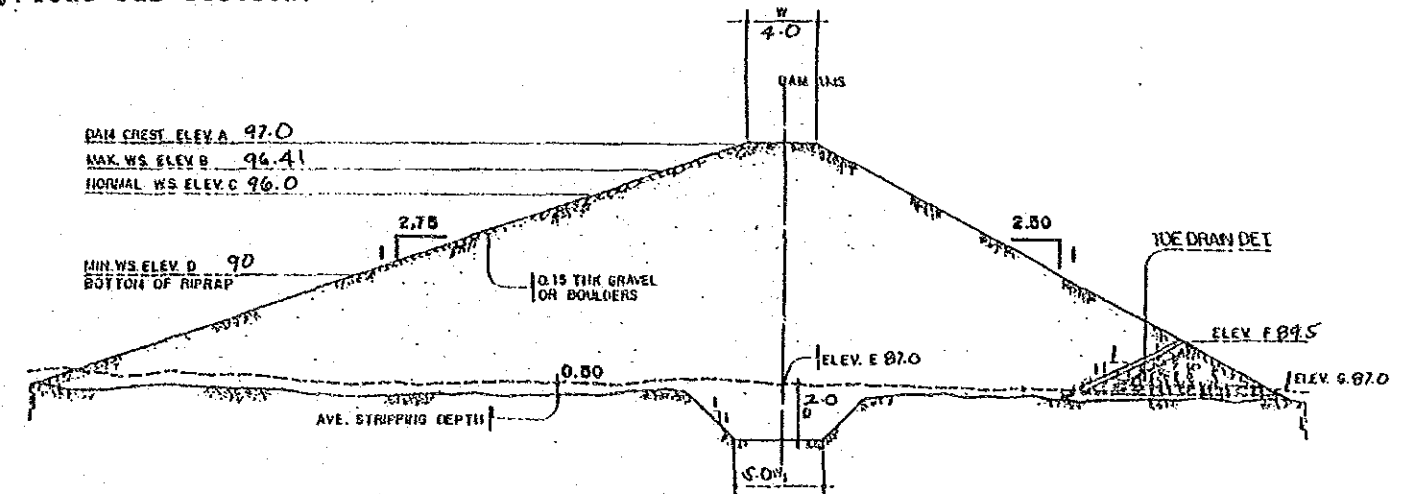
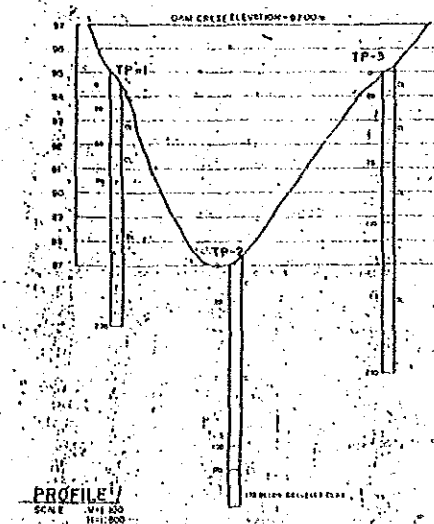
Clay blanket with 2.0 m depth is piled up on the sand stone and shale.

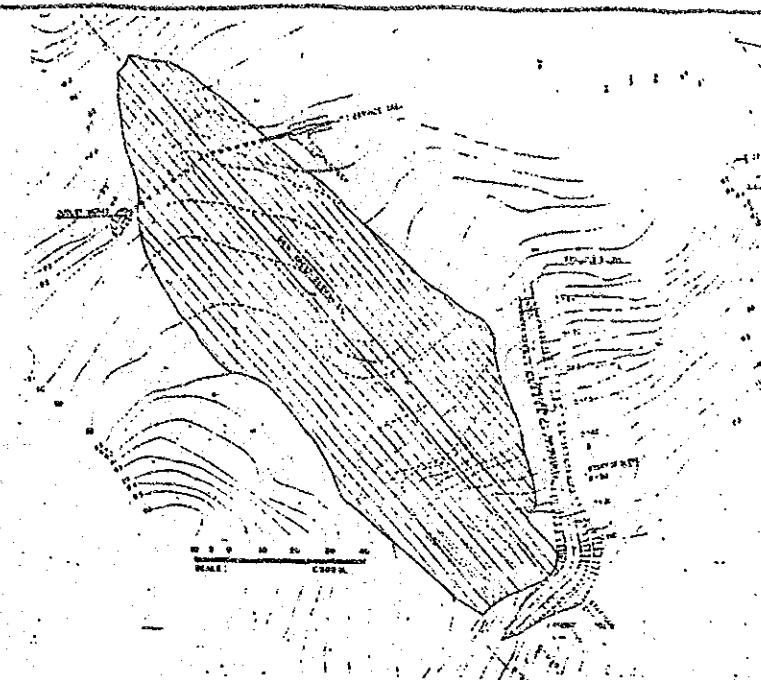
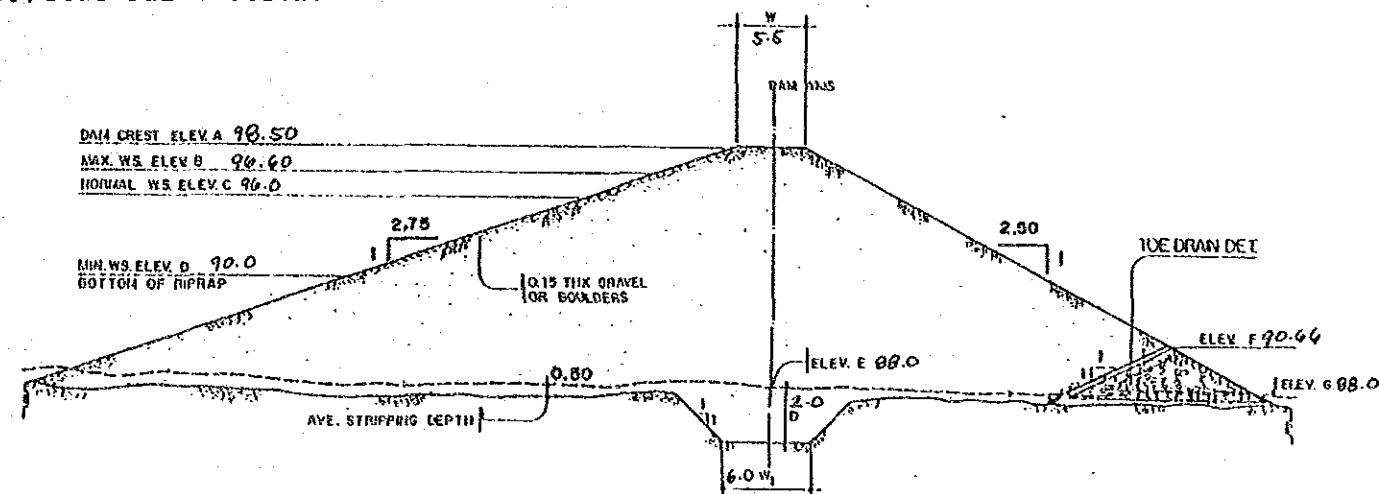
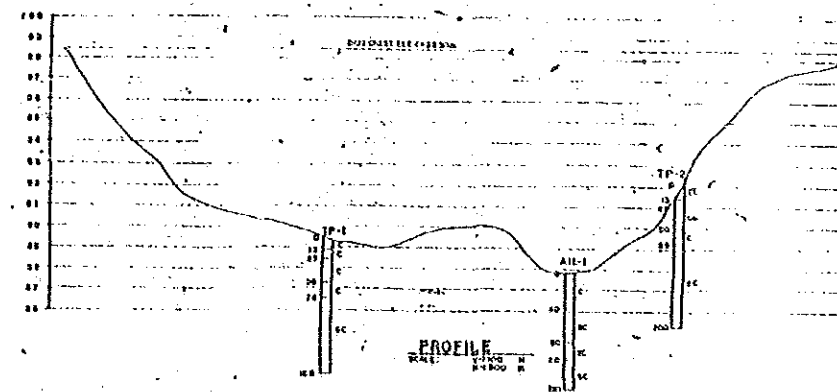
2. Planning		
Environmental conservation plan is not formulated.		
3. Design		
Depth of core trench shall be modified during construction.		
Stability of upstream slope of the dam shall be checked.		
Center line of the spillway shall be shifted to left side.		
Center line of conduit is recommended to be straight.

Note: Terrace gravel underlies clay blanket with 2.0 m depth. Its matrix is sand.

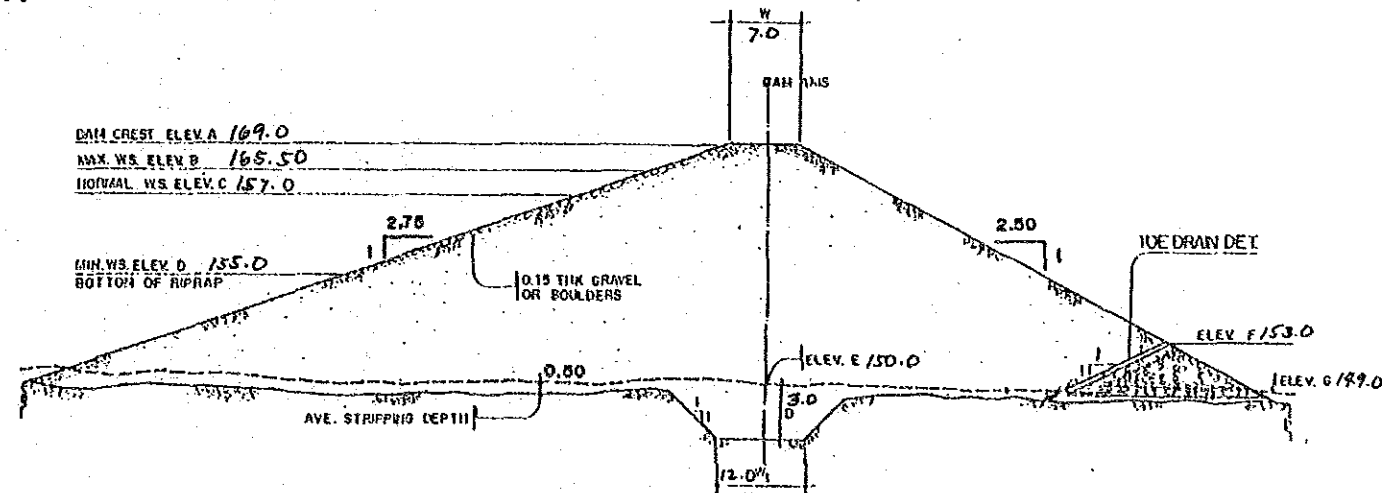
2. Planning Environmental conservation plan is not formulated.		
3. Design The seepage in the underlining metamorphic rock shall be studied. Stability of upstream slope of the dam shall be checked. Design discharge shall be estimated based on 100 year's flood or more. Center line of the spillway shall be shifted to right side. Weir shall be provided in the spillway. Center line of conduit is recommended to be straight.

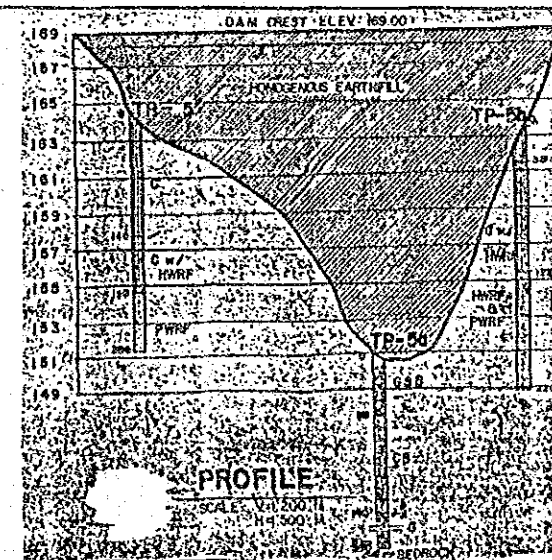
Profile of Dam Axis:

Note: The extent of sand and gravel with 1.4 m depth in riverbed shall be confirmed as well as the permeability in the underneath metamorphic rock.

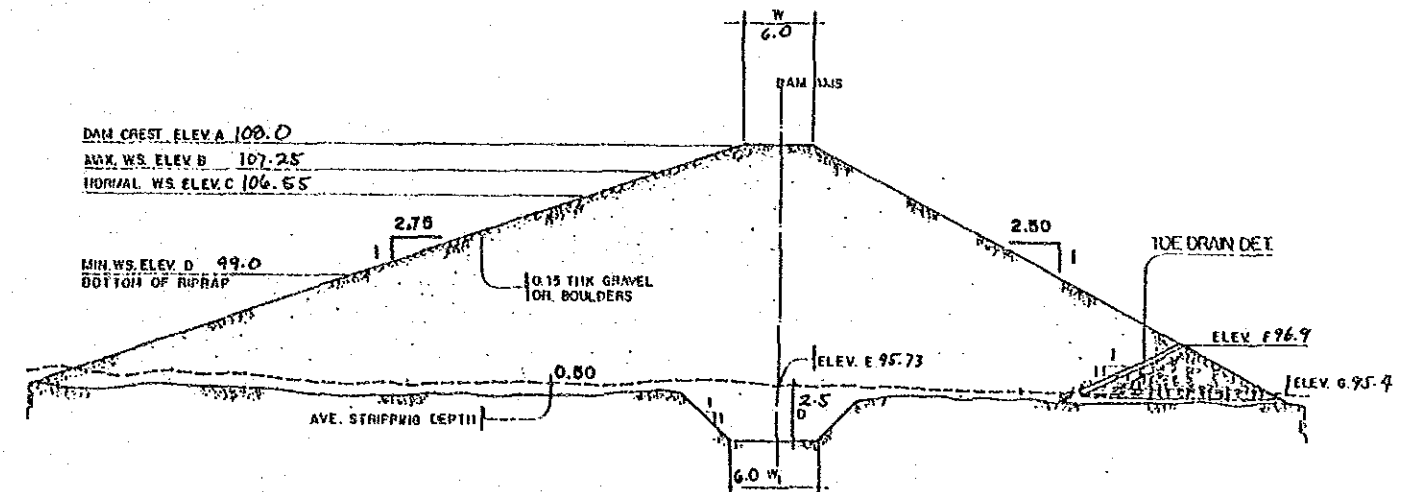
2. Planning		
Environmental conservation plan is not formulated.		
3. Design		
Depth of core trench shall be modified during construction.		
Stability of upstream slope of the dam shall be checked.		
Weir shall be provided in the spillway.		
Center line of conduit is recommended to be straight.

Note: Silty clay blanket with 2.0 m depth is piled up on the tufaceous sand stone.

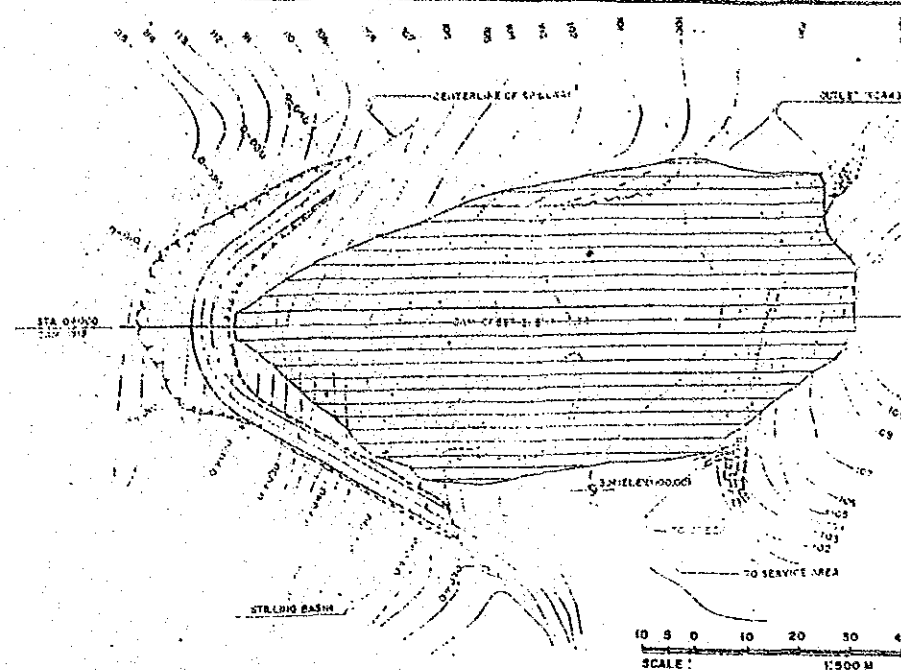
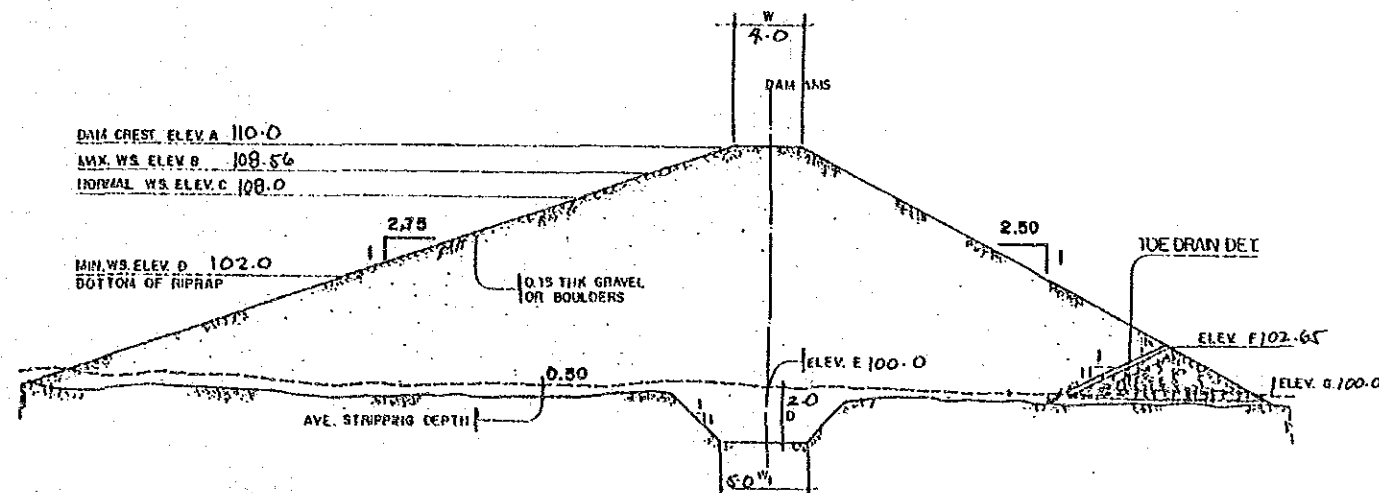
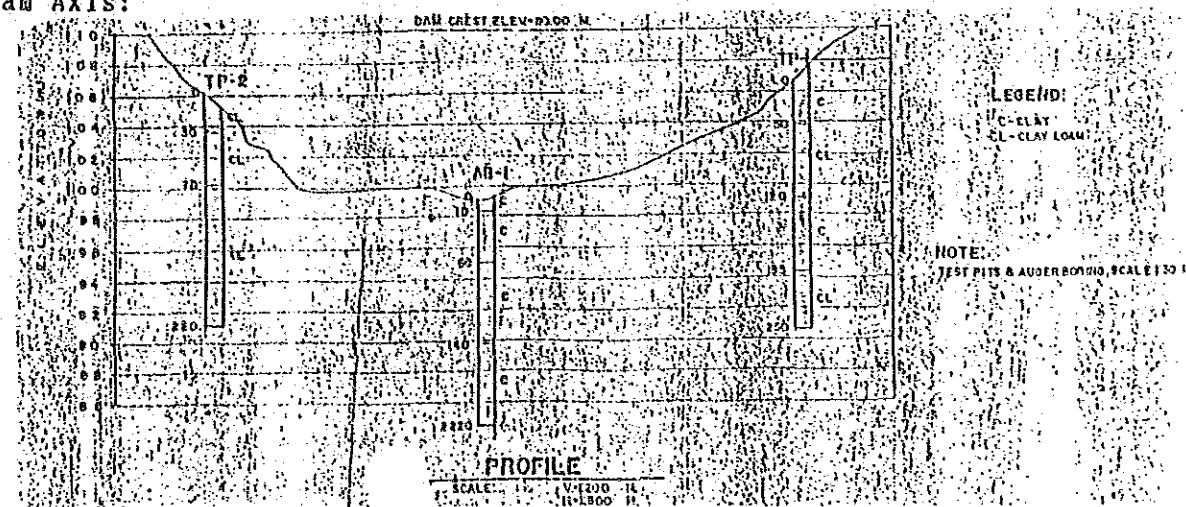
2. Planning		
Environmental conservation plan is not formulated.		
3. Design		
Depth of core trench shall be modified during construction.		
Stability of upstream slope shall be checked.		
Weir shall be provided in the spillway.		
Center line of conduit is recommended to be straight.

Note:

silty clay blanket with 2.0 m depth is piled up on the tufaceous sand stone, silty stone and shale.

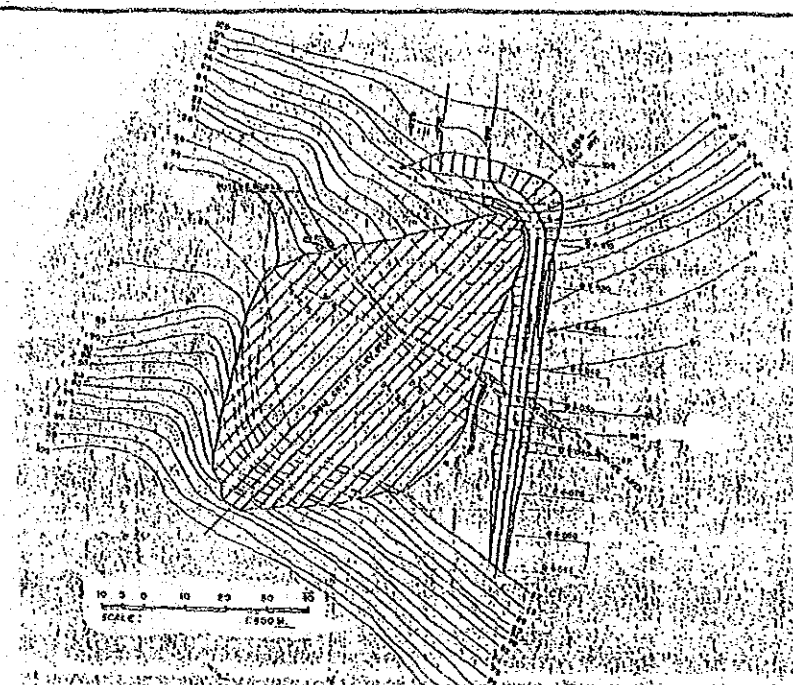
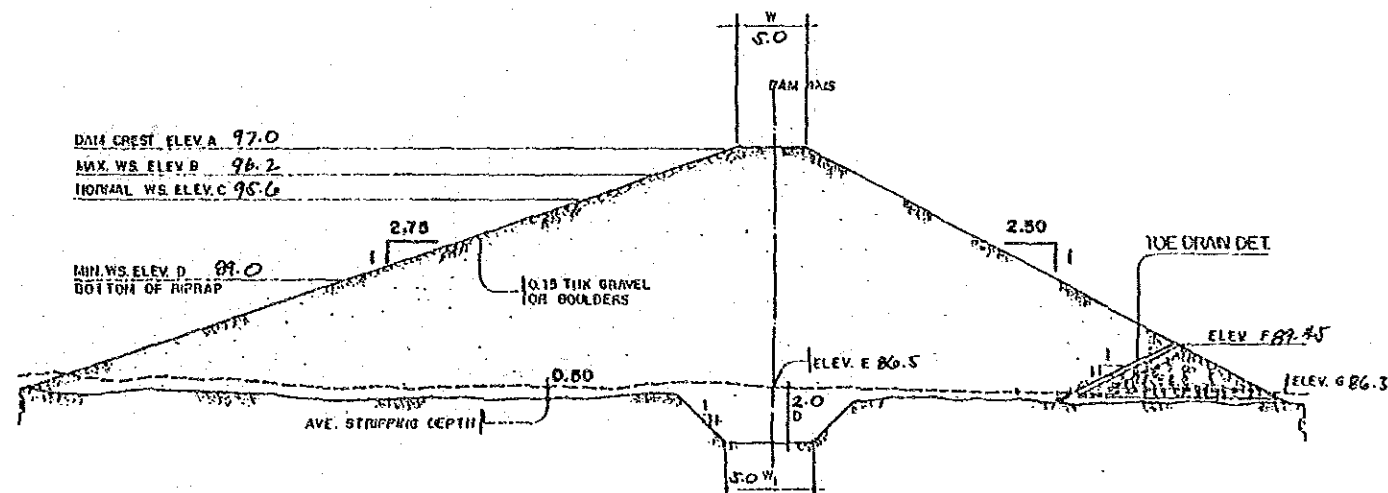
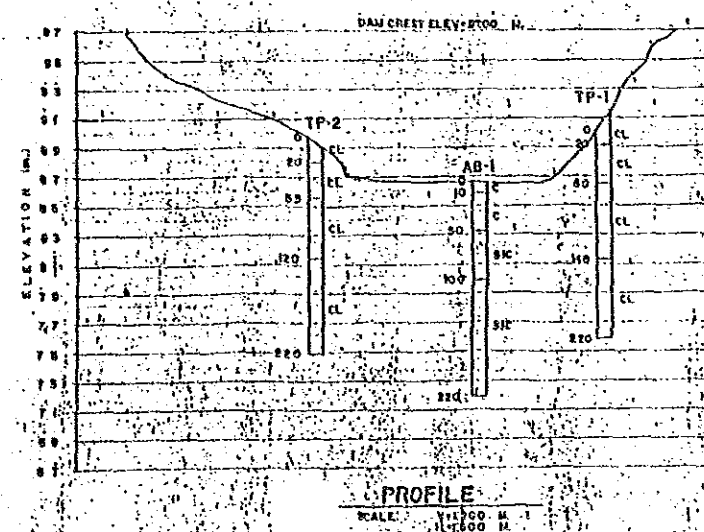
2. Planning Environmental conservation plan is not formulated.		
3. Design Depth of core trench shall be modified during construction. Stability of upstream slope of the dam shall be checked. Center line of the spillway shall be shifted to left side. Weir shall be provided in the spillway. Center line of conduit is recommended to be straight.

Note:

silty clay with 2.0 m depth is piled up on the mud, sand and silty stone and shale.
