## 7.5 Mechanical/Electrical Facilities and Instrumentation

### 7.5.1 Mechanical Facilities

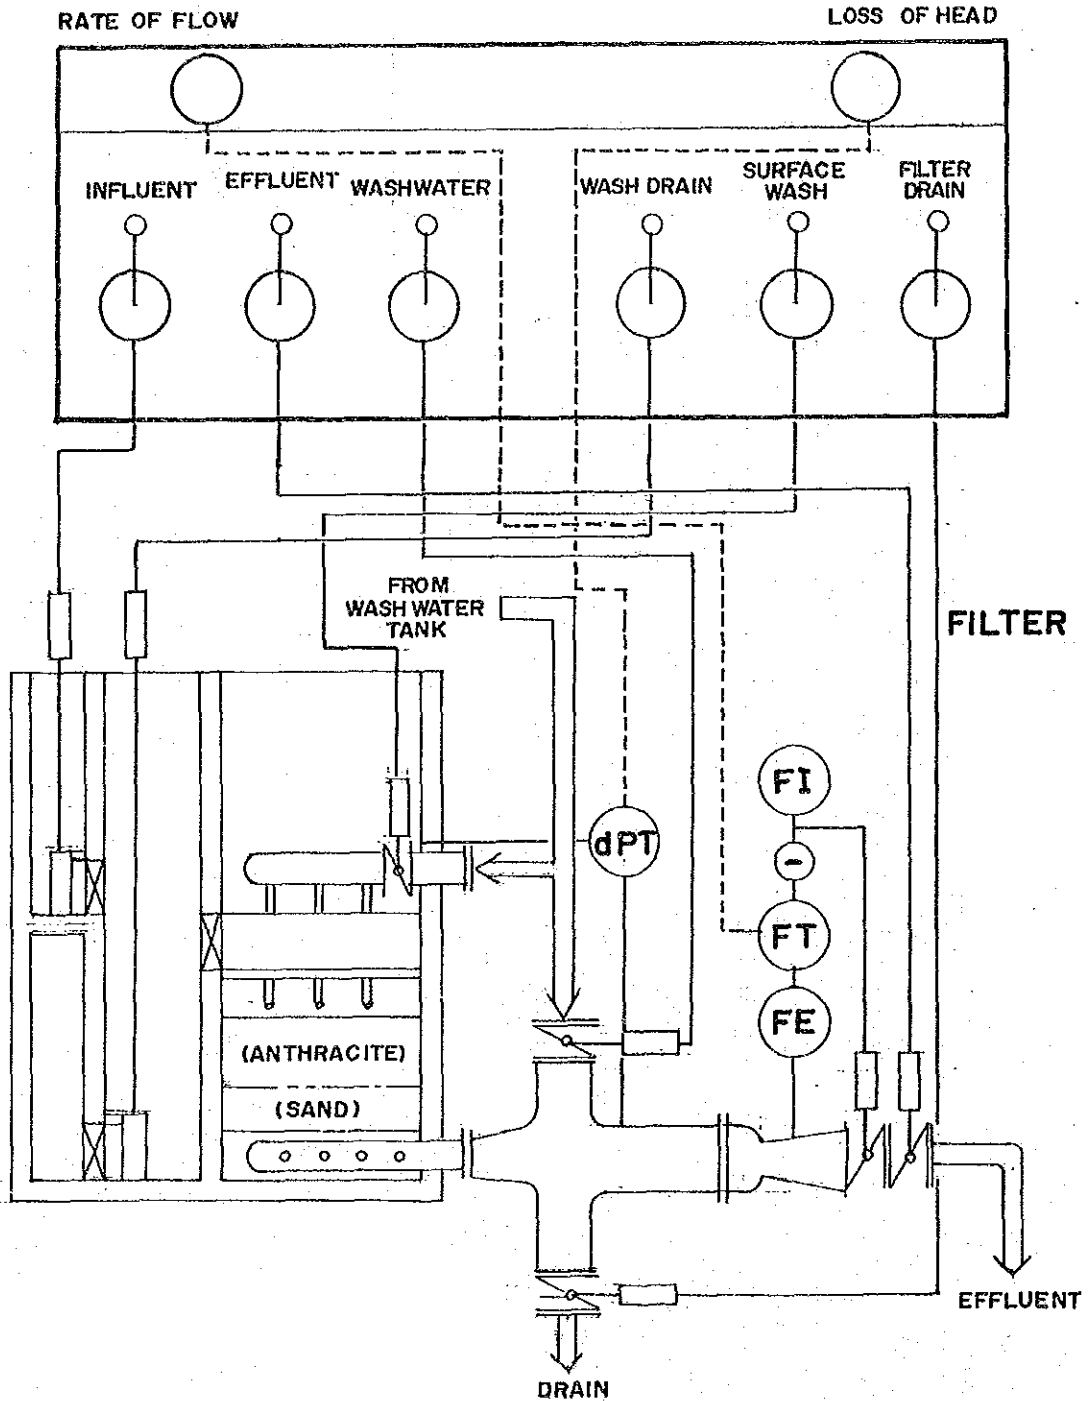
Fig. 7.5.4  
 FILTER CONTROL SYSTEM  
 IN PLANT NO.2

Filtration facilities, as shown in Fig. 7.5.4, have the same condi-

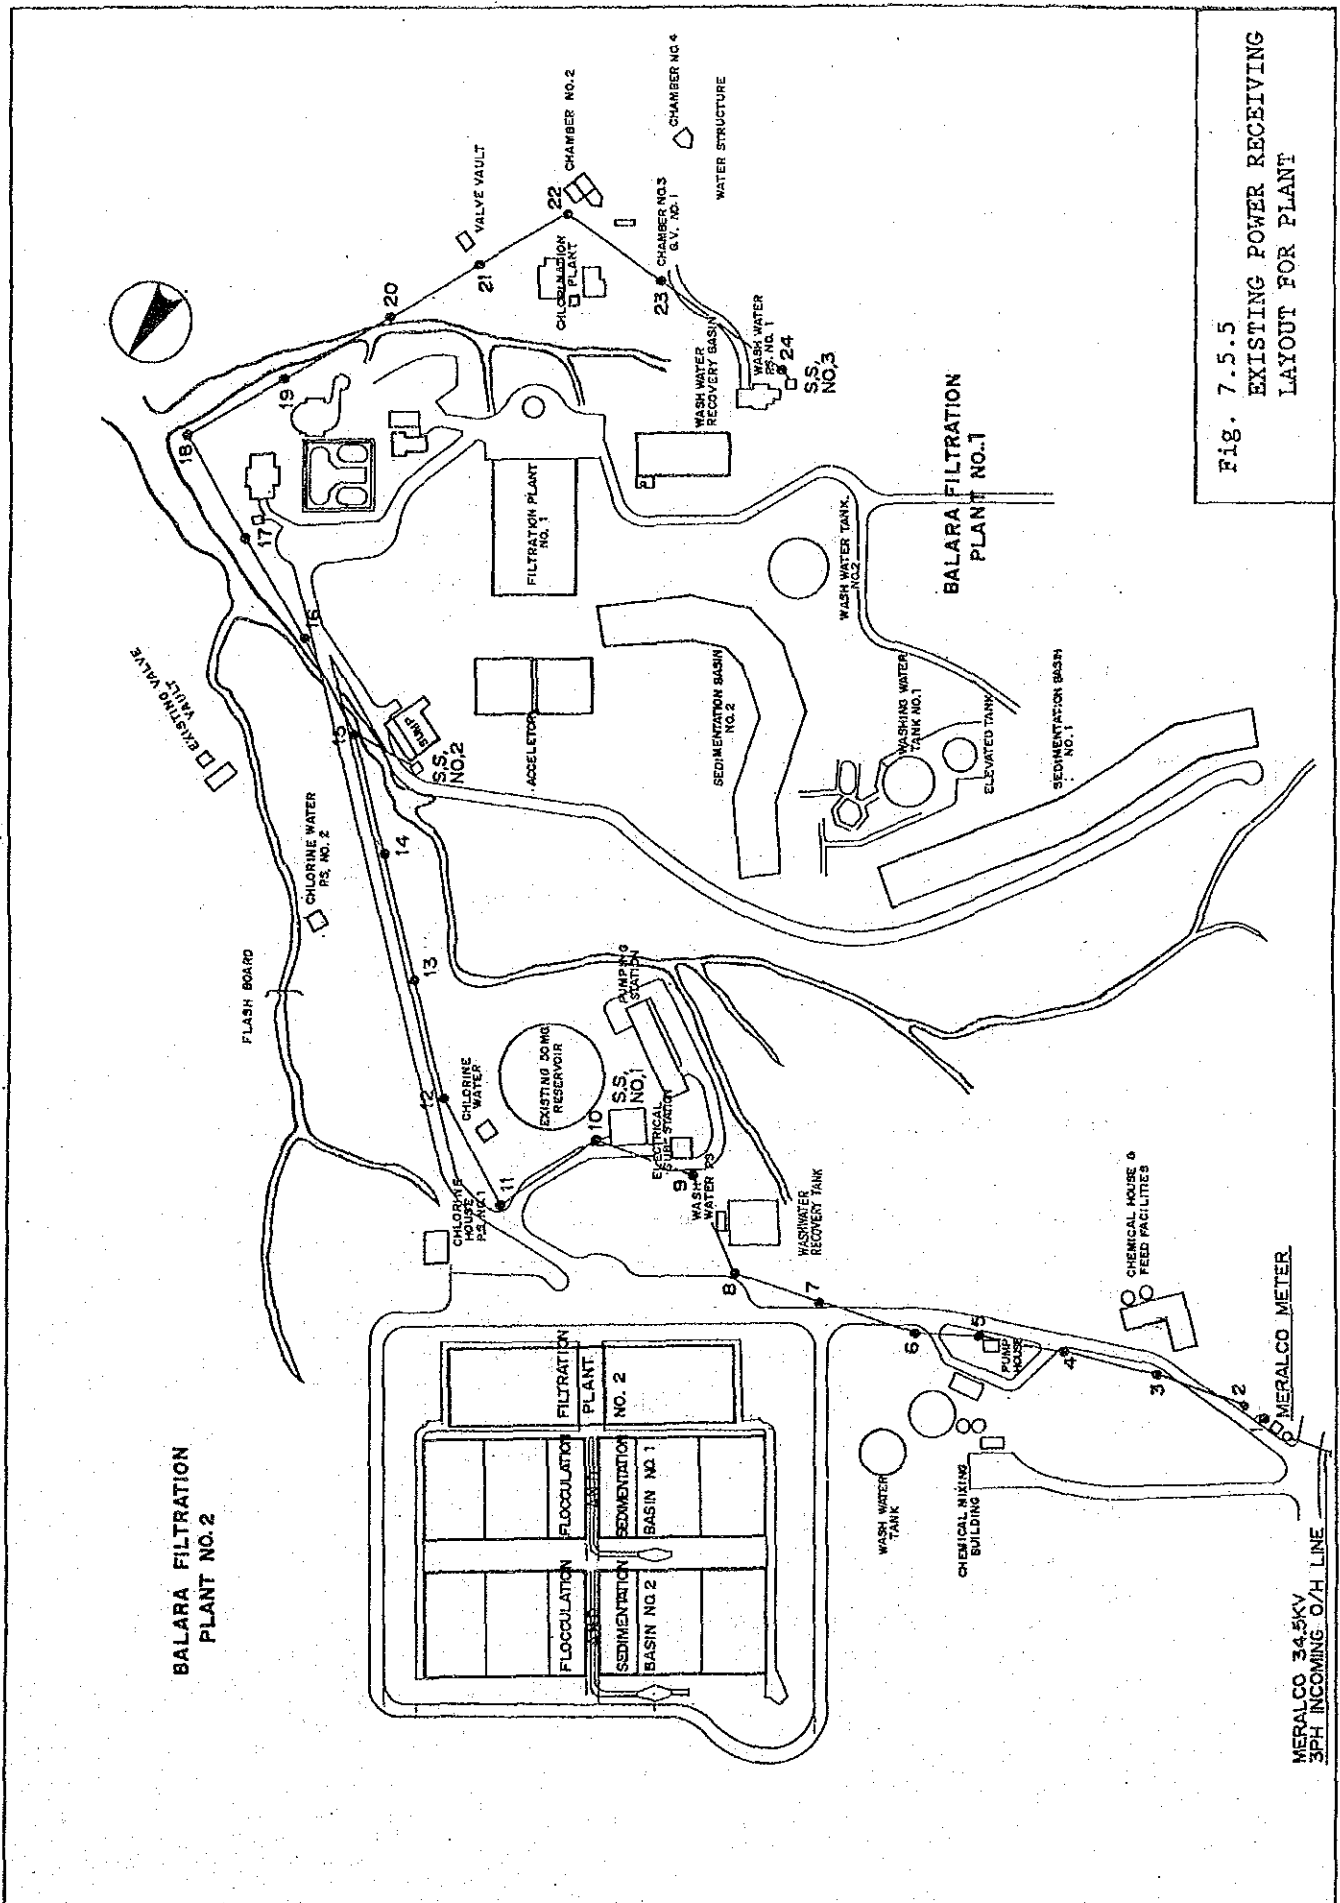
Fig. 7.5.5  
 EXISTING POWER RECEIVING  
 LAYOUT FOR PLANT

The Balara Treatment Plant receives its electrical supply from the 34.5 kV distribution line of the Manila Electric Company (Meralco) through a metering device installed by Meralco in the Plant. Overhead distribution lines (approx. 1,200 m) are laid to supply electricity to three substations in the Plant. (Refer to Fig. 7.5.5)

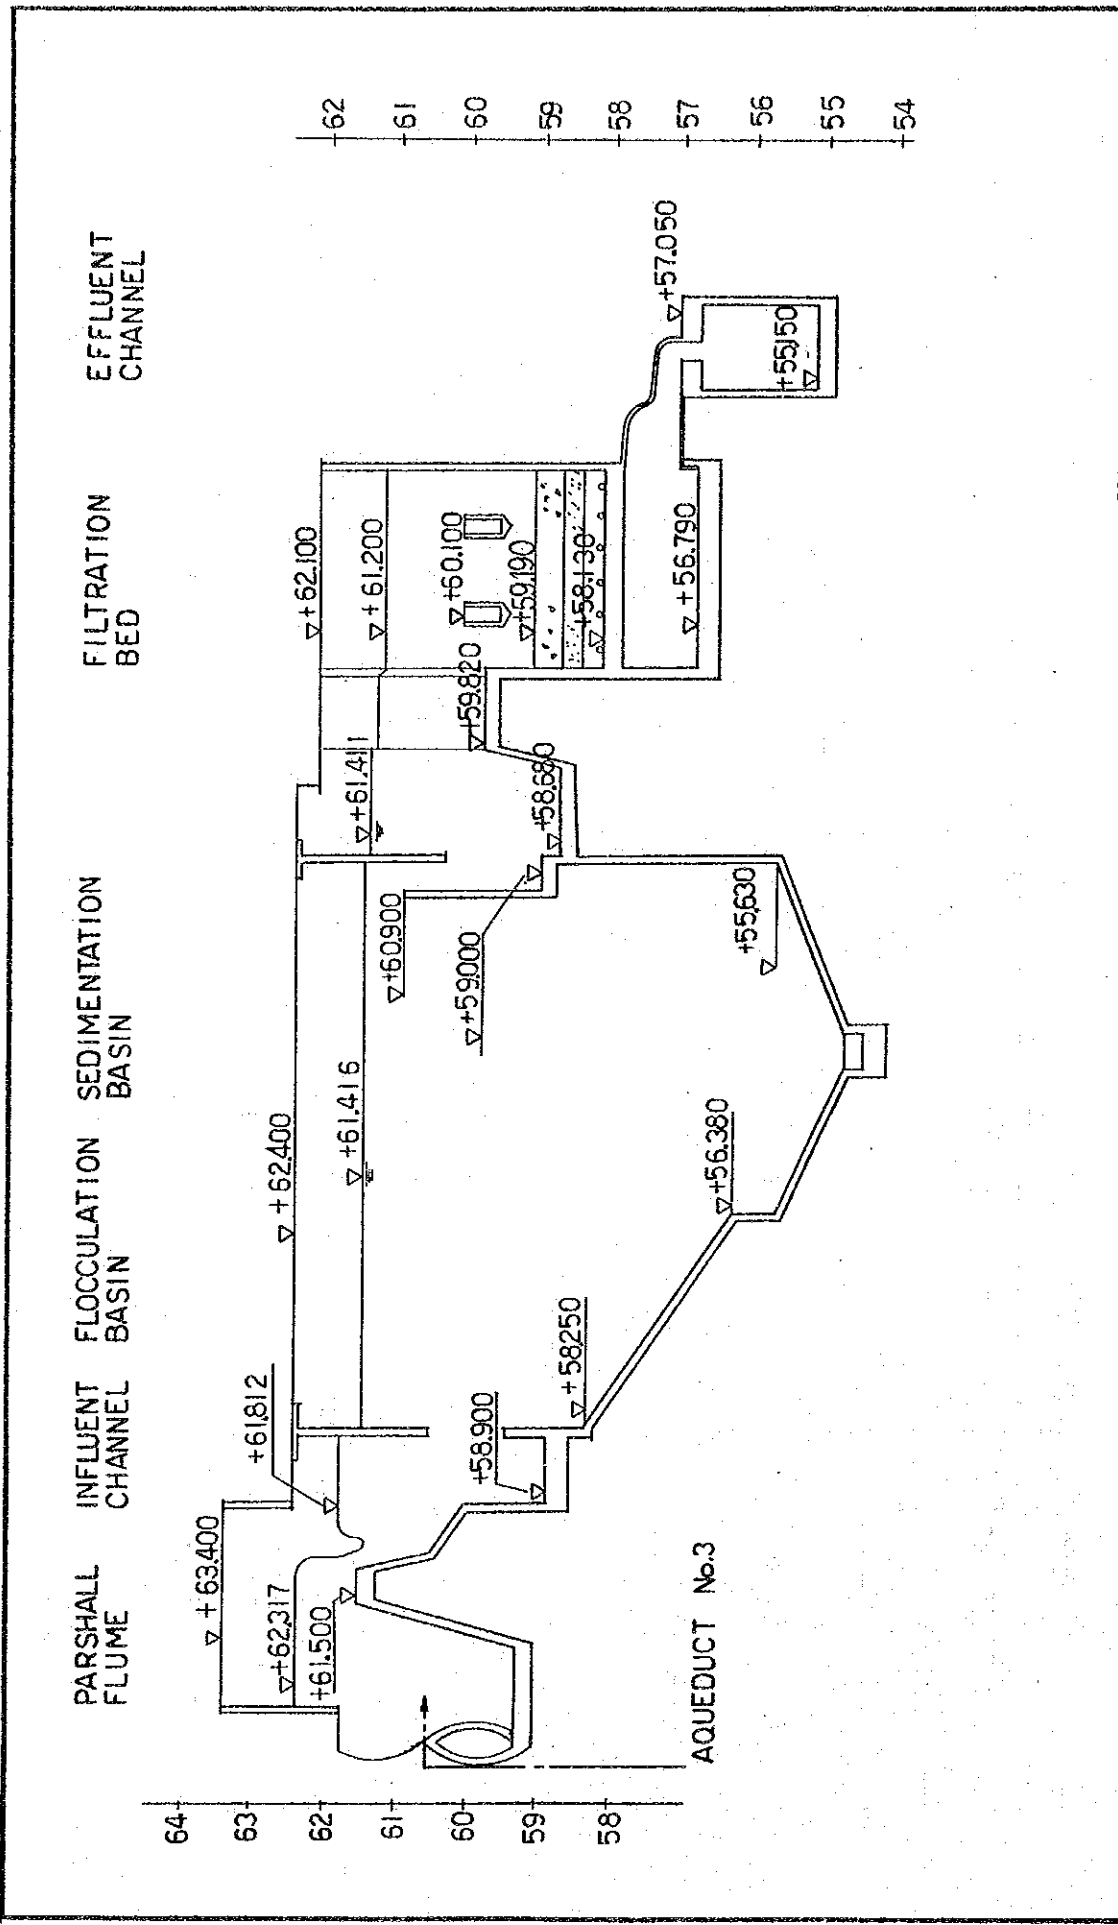
Fig. 7.7.2. ACTUAL HYDRAULIC PROFILE OF PLANT NO.2

The raw water taken by the Balara Plant is treated as it undergoes several processes as hydraulically shown in Figs. 7.7.1 and 7.7.2 which include coagulation, flocculation, sedimentation, and filtration.

The designed filtration process is a system of constant-rate filtration using a rate-controller installed at the effluent line. At present, due to superannuation of rate controllers, filter beds are operated as declining-rate filtration system. Washwater drains through washwater trough, washwater gullet, washwater drain sluice gate, and washwater drainage channel. Hydraulic capacity of a series of washwater drain system of Plant No. 2 is observed to be insufficient so that washwater troughs are submerged and not functional during backwash.

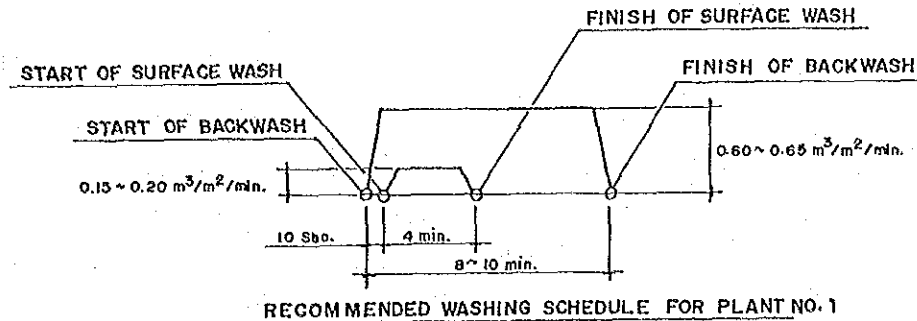
For Plant No. 1, washwater tank capacity is 1,026 m<sup>3</sup> and its minimum recovery time is calculated to be 44 min according to the pump discharge capacity. To maximize the performance of the filter facilities, figure below shows a typical washing operation schedule.

Combination of surface wash and backwash provides a violent scrubbing of the area between the anthracite and sand layers where most of the filtered materials are removed. Washing rate should be adjusted by the valves, after confirming of the rising ratio of water level. Backwash is then stopped when the wash water become clean.

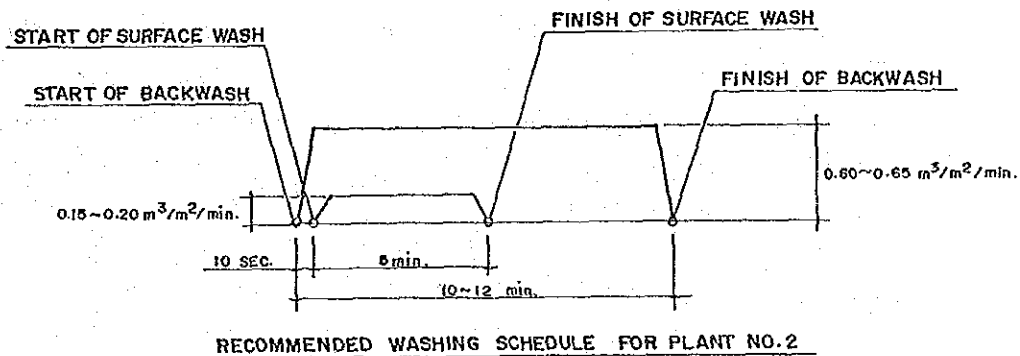
For Plant No. 2, washwater tank capacity is 1,308 m<sup>3</sup> (X 2 tanks) and its recovery time is less than 1 hour.

Recommended washing schedule is described as shown below; Plant operation procedure should be the same as mentioned in Plant No. 1.
