4.1.2 Geotechnical Investigation

4.1.4 Study on the Present Condition of Tunnel Deterioration

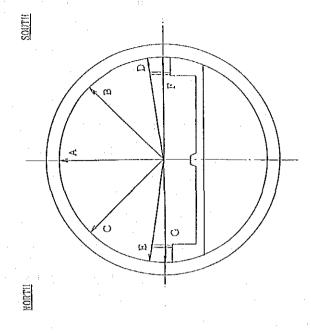
MEASUREMENT IN M. M.	U 1-	- 32 - 15	- 50 + 33	0 + 2	+ 5 - 47	- 20 10	- 65 + 25	0 - 50	+ + 01 -	- 51 + 25	- 75 + 35	11 + 9 +	- 34 - 4	+ 35 - 38	€ + 01 -	+ 11 - 20	+ 5	- 33 + 65	- 16 -10	+ 2 + 9	+ 80 - 55	-50 ++	+ 20 + 4	+2 -8
NEA.	E	1	+ 35	+ 24	- 29	0)+	+ 13	- 24	+ 54	11+ .	8 +	+ 33	- 31	58	 	- 53	- 26	ł	1	1 +	- 70	52 + .	+ 2	1
	D.	I	- 25	+ 29	+ 42	- 21	. — 63	- 92	- 11	- 56	- 37	+3	+ 16	+ 53	+13	+ 51	+ 32	- 8	+ 11	+ 15	174	ت	+31	I
	с U	I.	+ 27	°; + +	+36	+ 108	+ 27	ĩ	+ 140	+ 84	+ 61	+63	+ 31	+ 59	+ 12	- 23	+ 51	- 40	1	5	- 23	+ 92	+34	1
	æ	1	. – 21		18+	+ 38	- 36	+ 78	- 19	- 42	- 23	=	+ 21	+ 69	- 12	+ 34	+ 93	+ 28	+ 32	+ 54	+ 102	16+	+ { {	
	<		- 20	- 45	- 33	- 33	+ 5	+ 13	- 11	==+	=	- 30	+	- 36	<u>-</u> 1	<u>1</u> +	- 1 3	ۍ ا	- 37	- 15	- 11	- 25	- 40	1
	Point	۲ ،	J'4n	J _	- <u>-</u>	h h		ر ۲	J ,	J 451	J #) °	J 1.1	J 67 n	ر ، ،	J 13		J 14 -		J 16	J 17.	J 1A	۲ اه	J 20

- MARK MEANS NO MEASUREMENT DUE TO OBSTACLE
