DESCRIPTION AND DESIGN OF RESTORATION MEASURES
FOR EACH DISASTER SPOT (BENGUET)

PROVINCE: **BENQUET**
SPOT No. : **Bt-1(1/3)**

NAME OF ROAD : **ITOGON-BALATOK ROAD**
ROAD CLASSIFICATION : **NATIONAL SECONDARY ROAD**

TYPE OF DISASTER : **CUT SLOPE FAILURE**

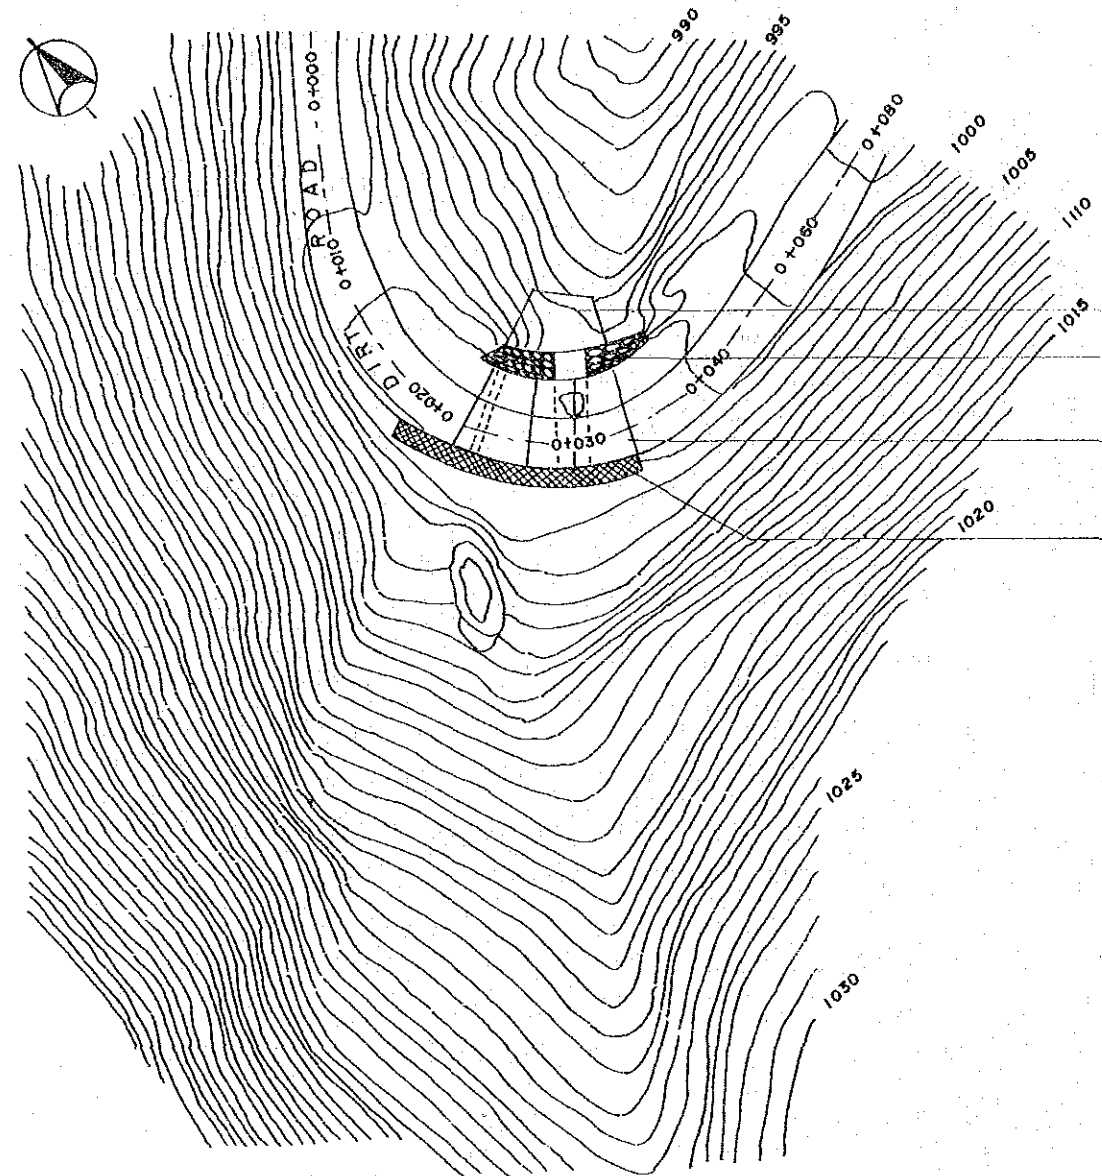
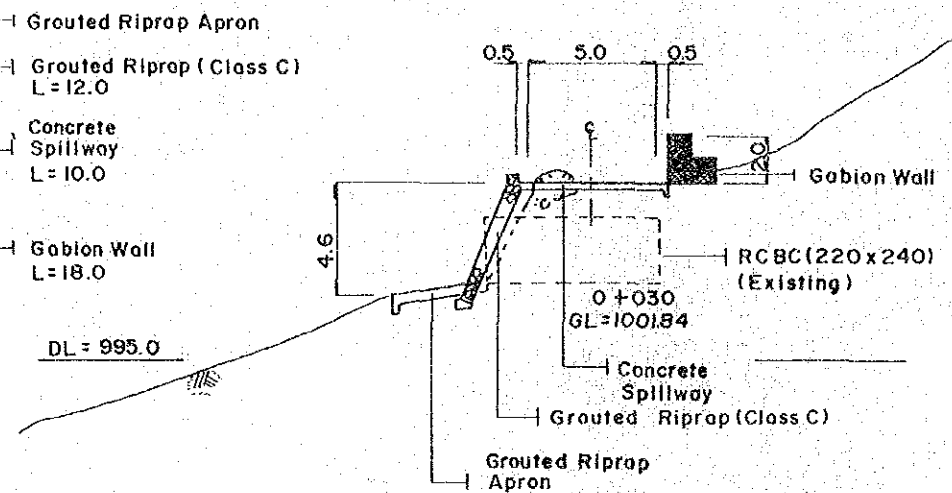
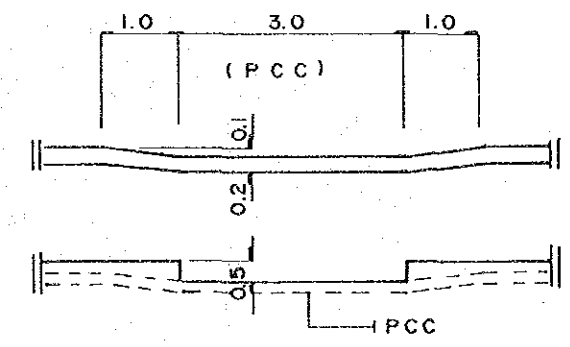
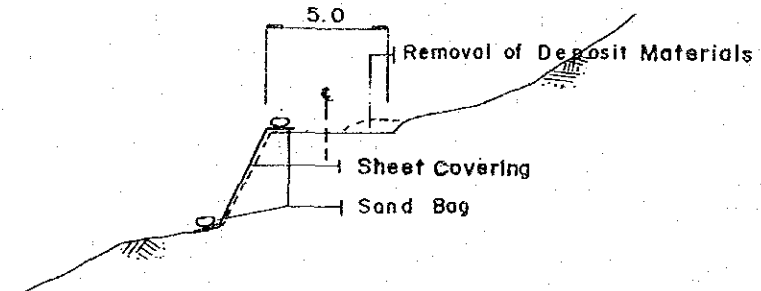
DRAWING NO.
30

- Type of Disaster : Culvert and Its related Damages
- Magnitude of Damage : RCPC - 2 x 0.60 meter diameter
RCBC - 2.4 meter x 1.6 meter
Embankment Slope - 18 meter wide x
5 meter high

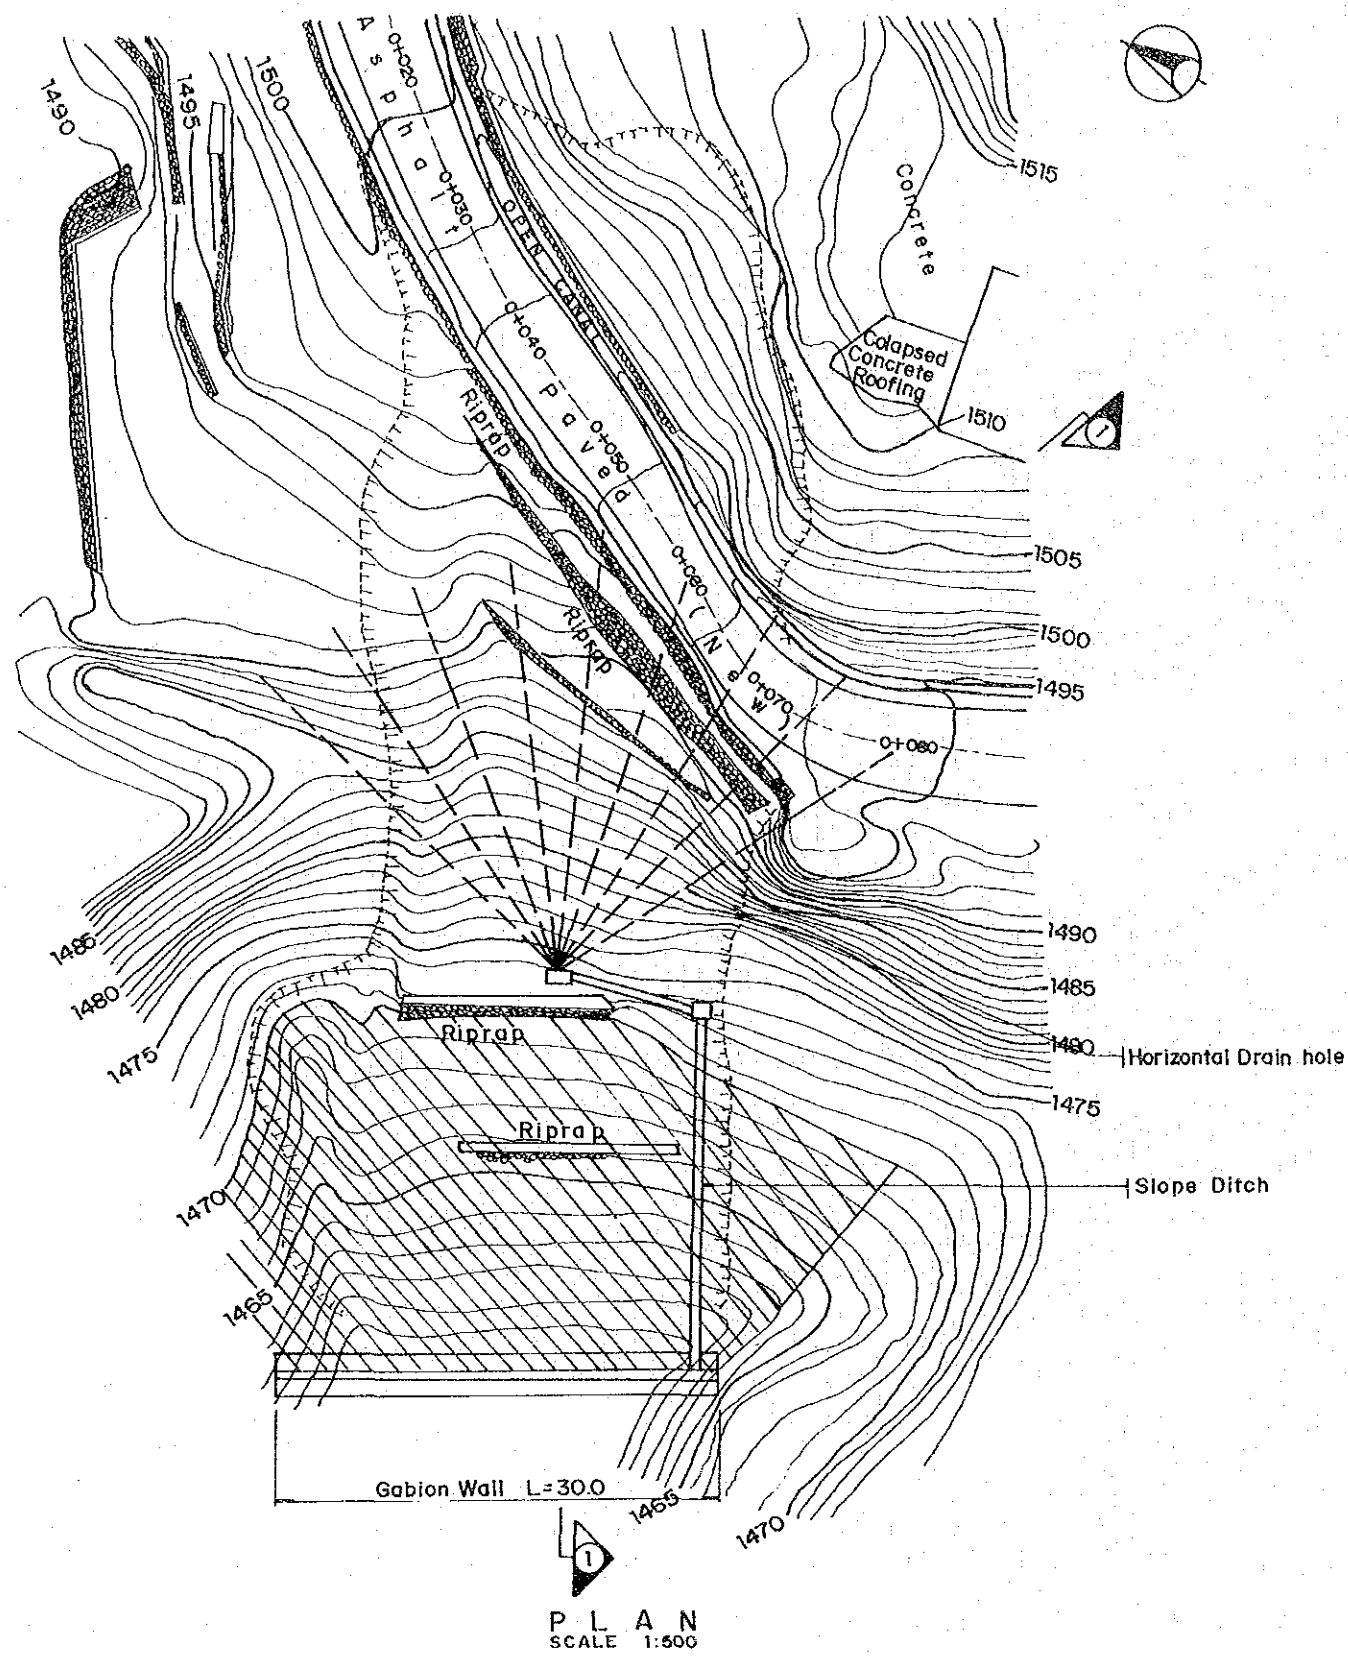
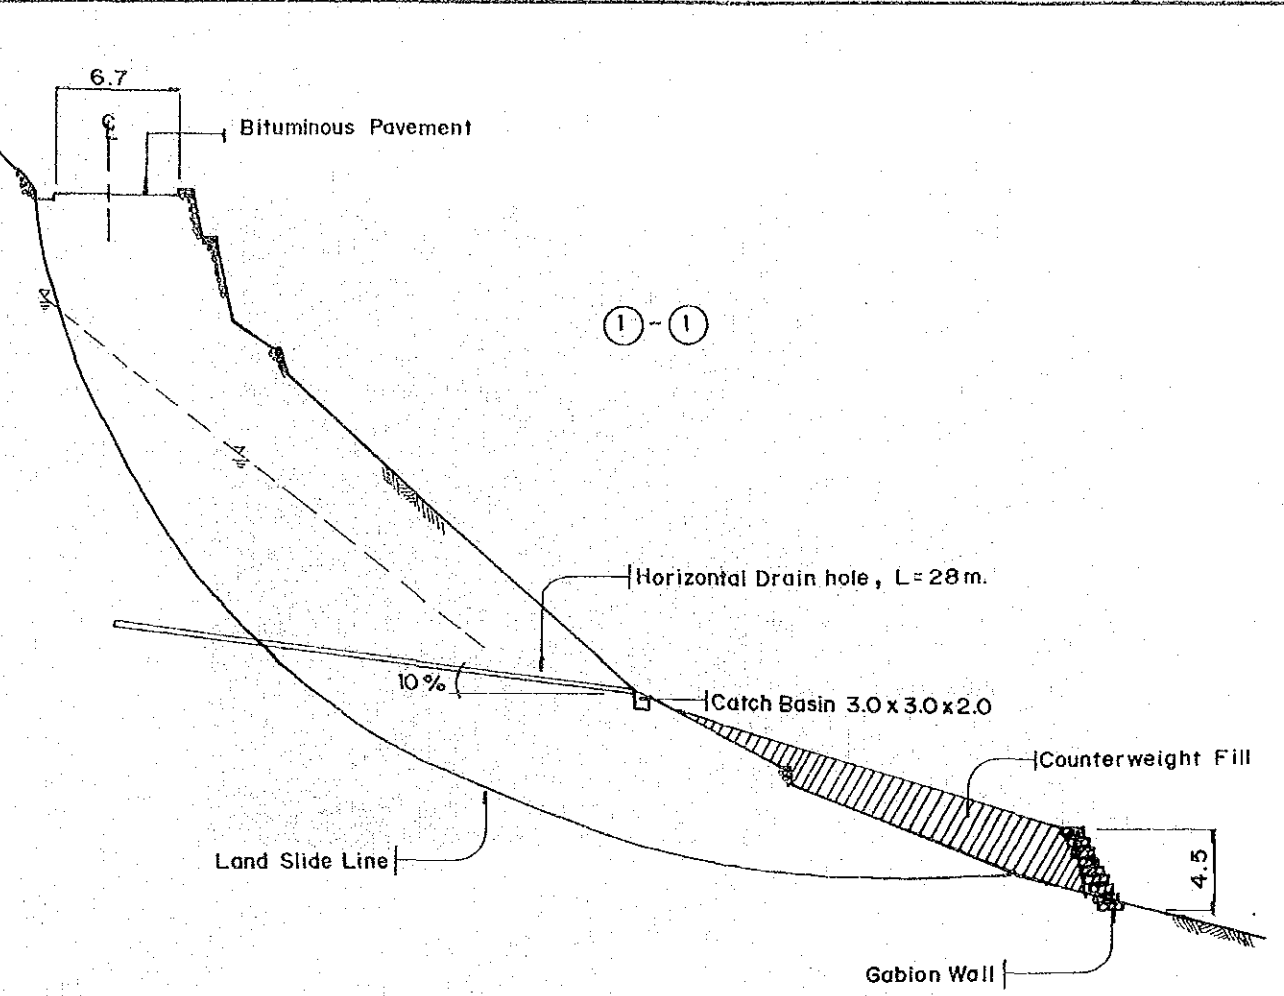
DRAWING NO.
32

The road is paved with asphalt in fair condition having a gradient slope that varies from 8-10 percent. This particular section was extensively damaged by earthquake causing a massive landslide eroding the slope surface and partly damaging the residence situated on top of the mountain. The embankment side of this spot was immediately restored by the City Engineers Office to protect the roadway from scouring and it was considered as sinking area.

The soil slide along the slope of the mountain when saturated water caused loss of shear resistance between soils. It is also considered this portion as sinking area on the locality.

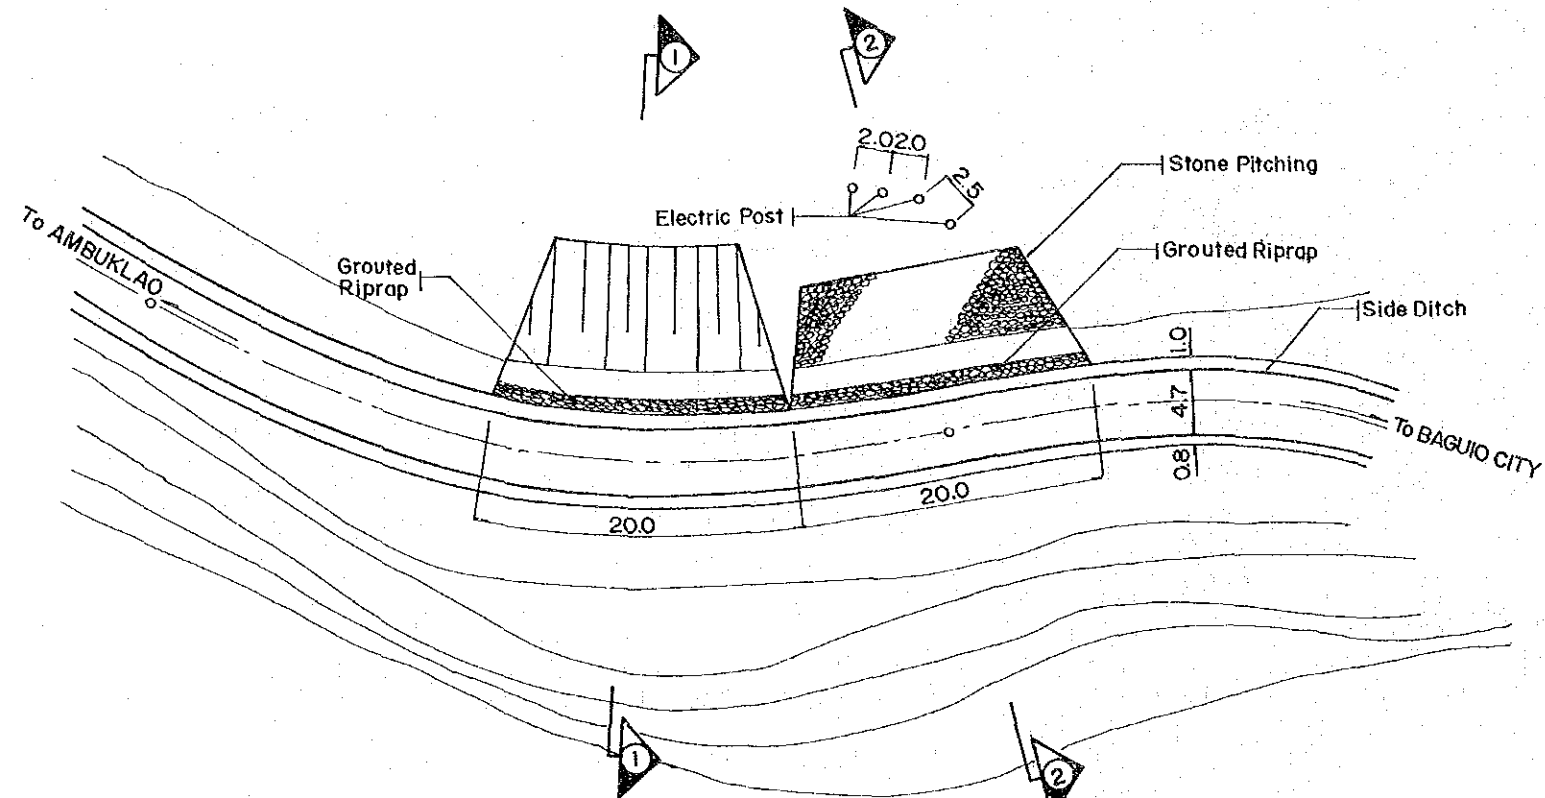
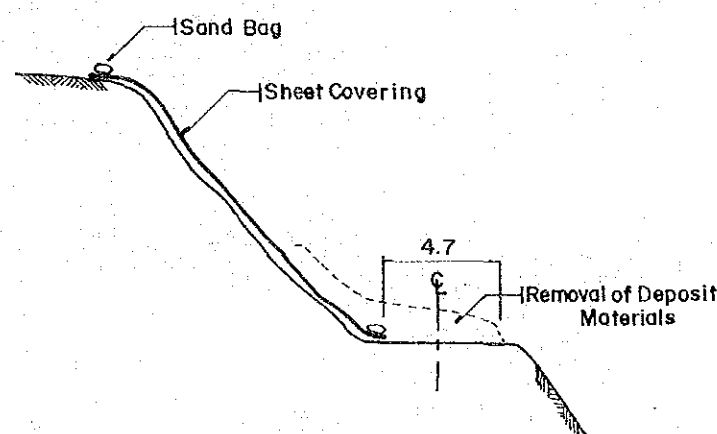
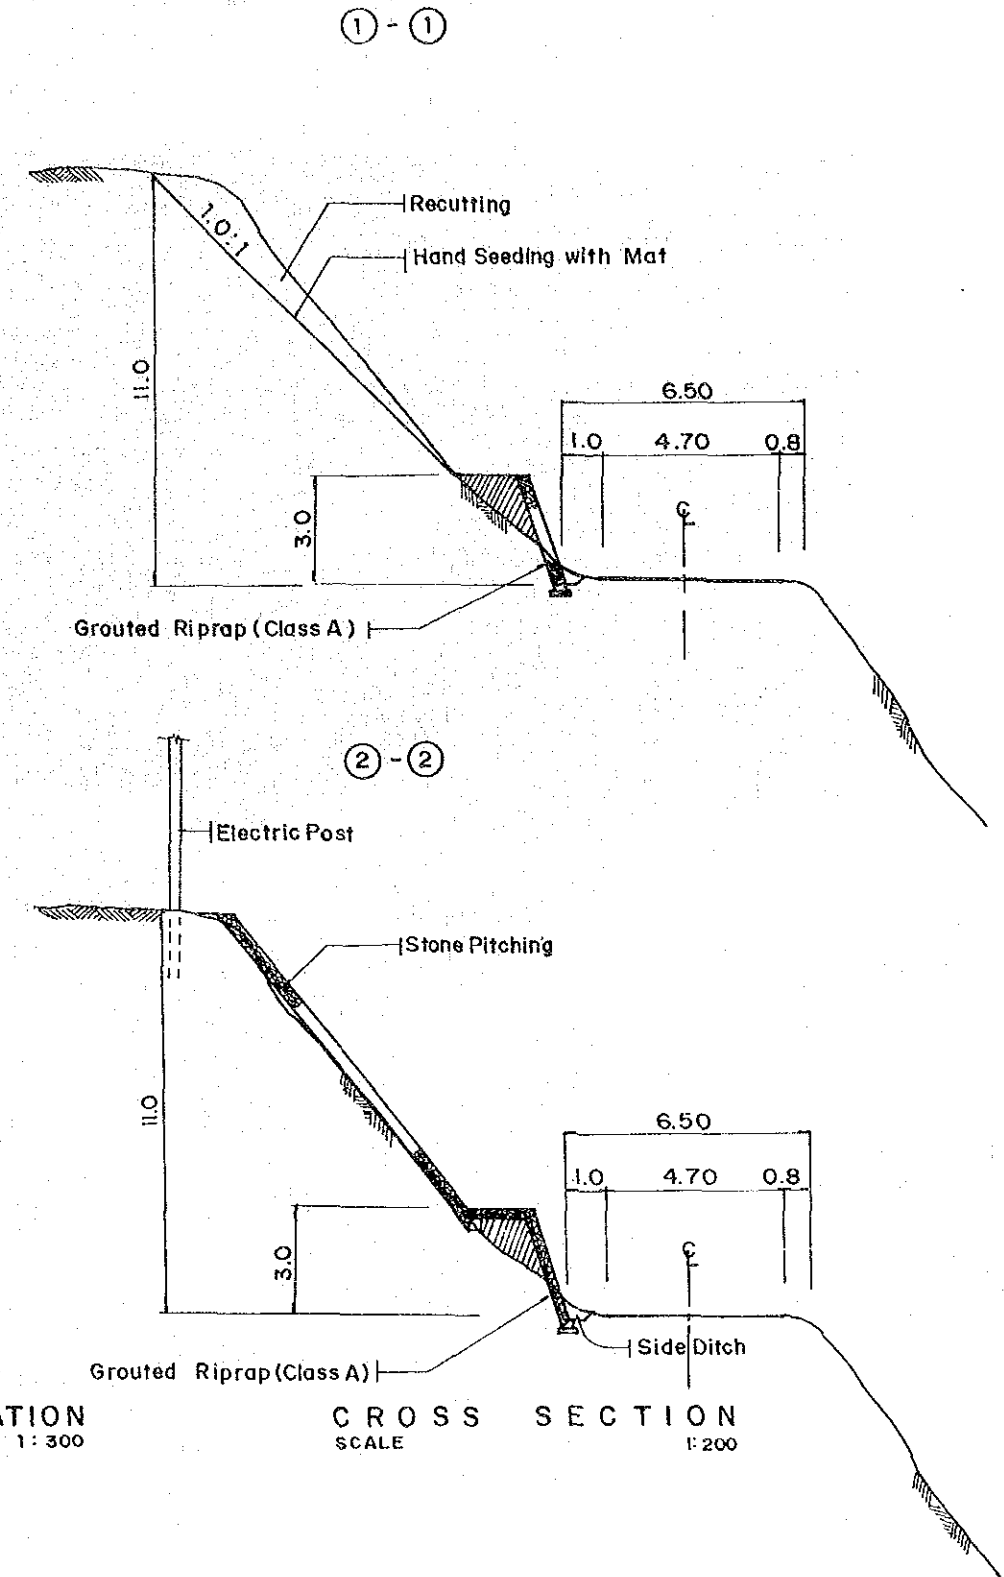
DRAWING NO.
 34

- Type of Disaster : Cut Slope Failure
- Magnitude of Damage : 40.0 meter in wide x 10.72 meter in
height
- Date Noticed :
- Degree/Period of Traffic Interruption : Low with one lane
passable

This failure is directly caused by earthquake that hits the Benguet Province last July 16, 1990 and heavy rains poured down in this locality after the earthquake. Slope surface water runs with high velocity along the steep gradient slope of 50 degrees to roadway causing erosion. Existence of gullies were also observed on the slope surface.

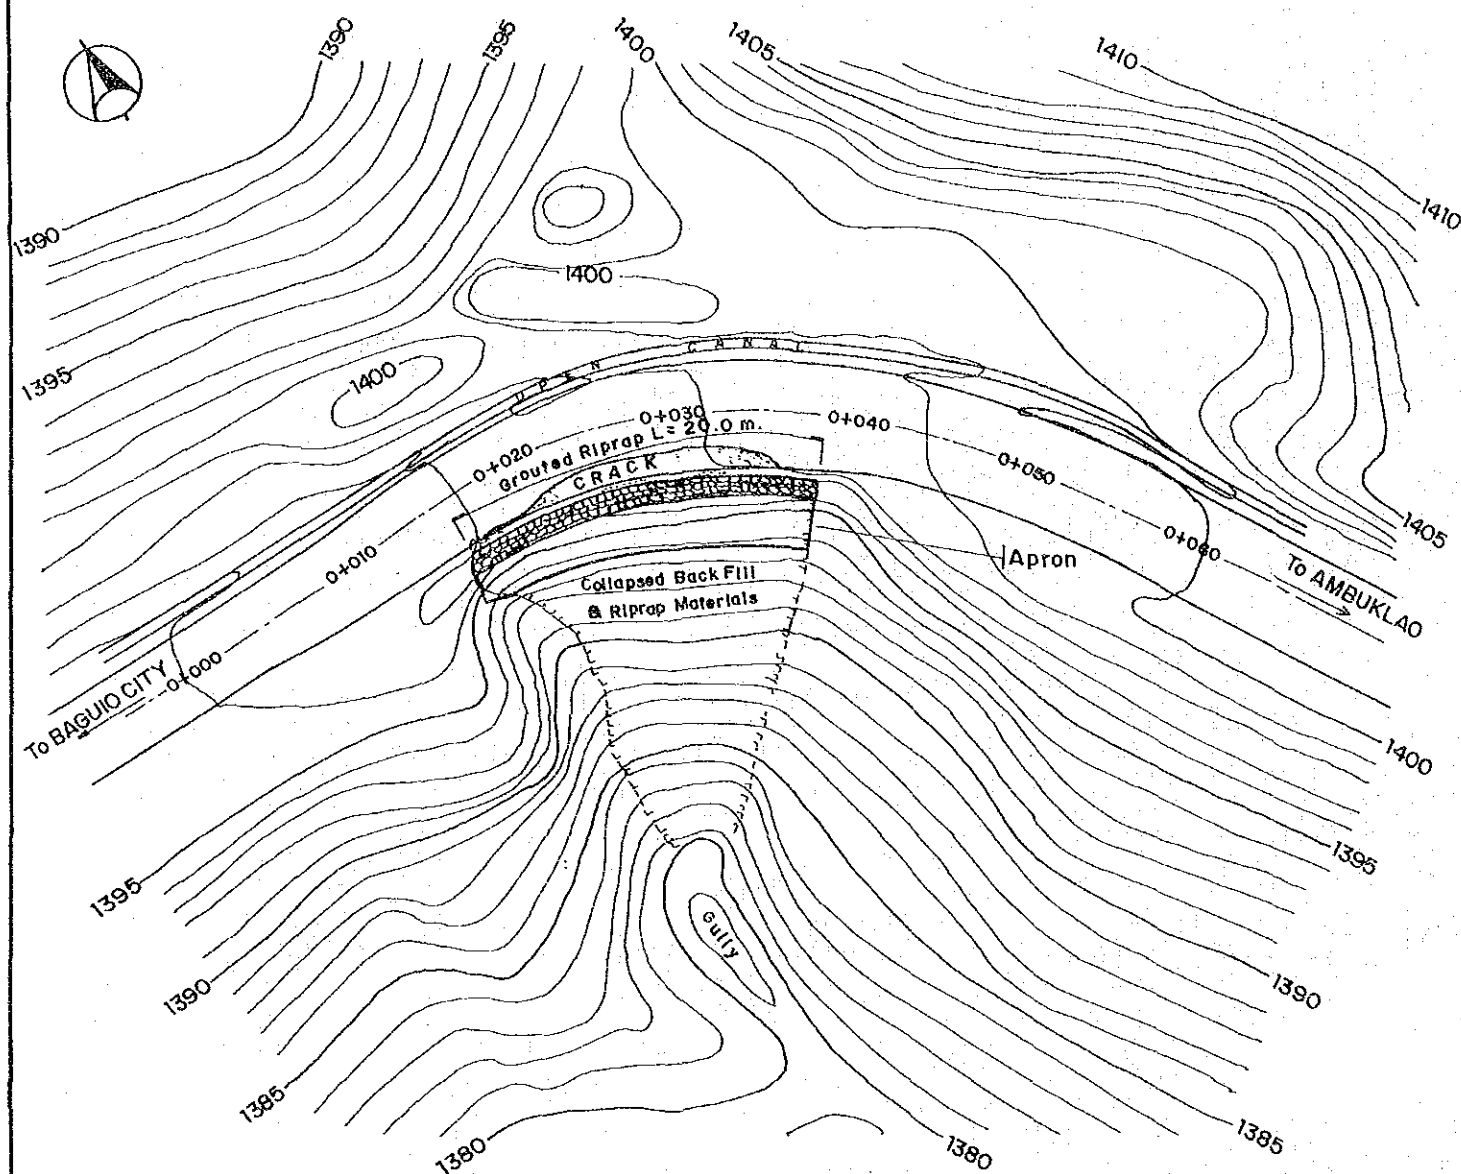
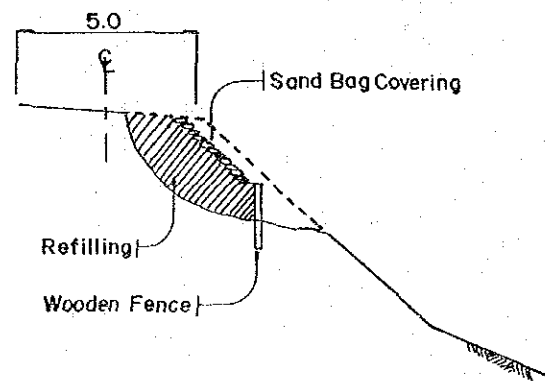
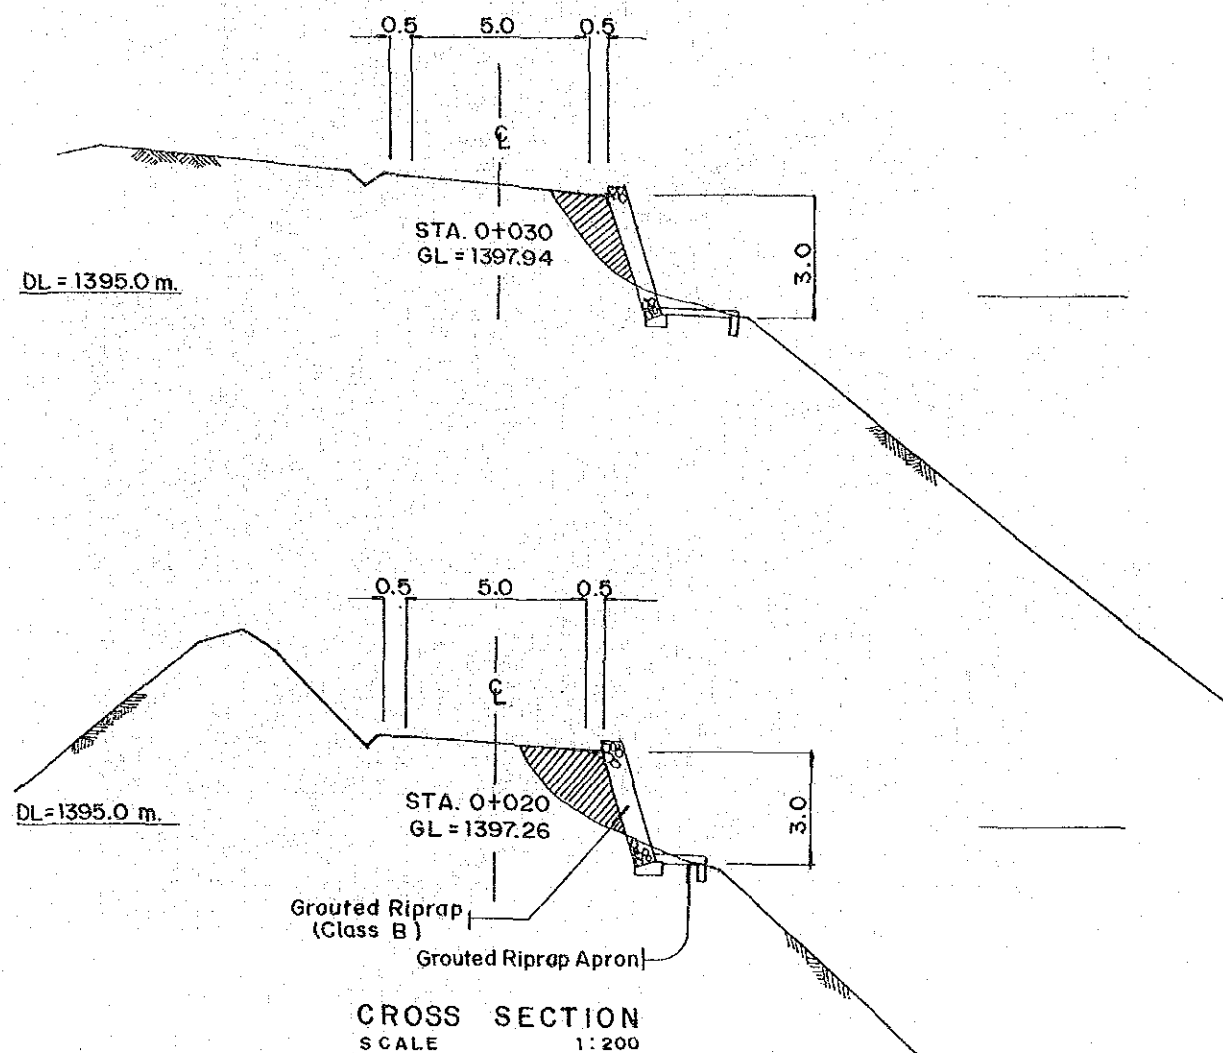
DRAWING NO.
 36

- Type of Disaster : Embankment Failure
- Magnitude of Damage : 20 meters wide x 19.0 meters high
- Date Noticed : Sept. 1990
- Degree/Period of Traffic Interruption : Medium / one lane Passable

This embankment failure is 20.0 meters wide and 19.0 meters high on slope. Previously, the slope was protected by riprap, however, it collapsed. Boulders on the present slope surface were those used for riprap. A triangular side ditch having a depth of 0.20 meter x 0.50 meter wide exists on the mountain side portion of the road. The asphalt pavement has a cut of 14.50 meters in length and 1.50 meter wide near the shoulder of the road where the eroded embankment had occurred.
