DESCRIPTION AND DESIGN OF RESTORATION MEASURES
FOR EACH DISASTER SPOT (BATANGAS)

PROVINCE: **BATANGAS**
SPOT No. : **Bs-3(1/2)**

NAME OF ROAD : **MAHAYAHAY JCT. - PAYAPA ROAD**
ROAD CLASSIFICATION: **NATIONAL SECONDARY ROAD**

TYPE OF DISASTER : **EMBANKMENT SLOPE FAILURE**

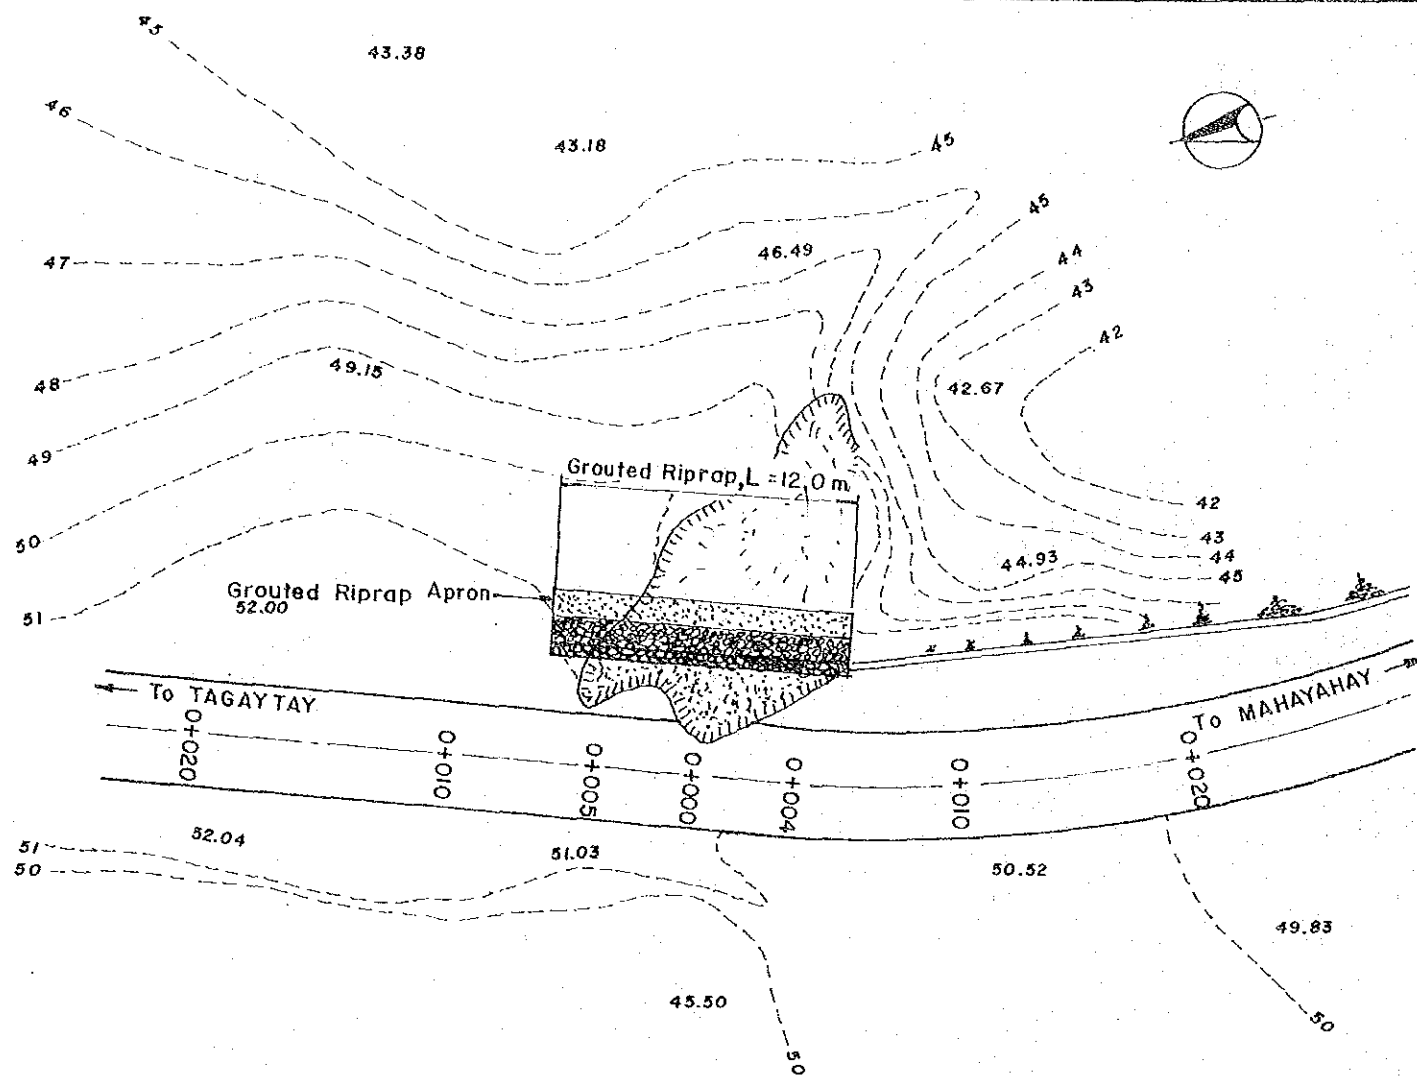
PLAN
 SCALE: 1:300

- Type of Disaster: Collapsed Grouted Riprap and Shoulder Erosion
- Magnitude of Damage: 12.0m W. x 2.5m H
- Date Noticed:
- Degree/Period of Traffic Interruption: Medium and One lane still passable
- Description of Disaster:

For this particular spot, the retaining wall was constructed without any foundation to hold the structure firmly. It is laid on a relatively erodable material of unconsolidated volcanic ashes and sands. The top and the toe of the retaining wall have been constantly disturbed by movement of water along the side drain from higher vertical alignment of the road. Direct erosion at the shoulder of the road and at the toe of the retaining wall is then occurring when soil particles are loosened and transported by water. The said phenomena led to the caving-in of the natural slope materials and eventual collapse of the retaining wall. To date continuous scouring has further damaged the road embankment which has already encroached half of the road section making it highly dangerous to traffic.

- Poor drainage system (silted and vegetated).
- The natural slope (valley side) consist of volcanic ashes and sand which is highly erodable materials.
- The caving-in of natural slope materials created a hallow portion behind the structure protecting it.
- The erosion of soil behind the retaining wall had progressed deeper to the toe of the structure thus created a cantilevered condition which eventually collapsed due to its own weight.
- No weep holes and foundation were provided.

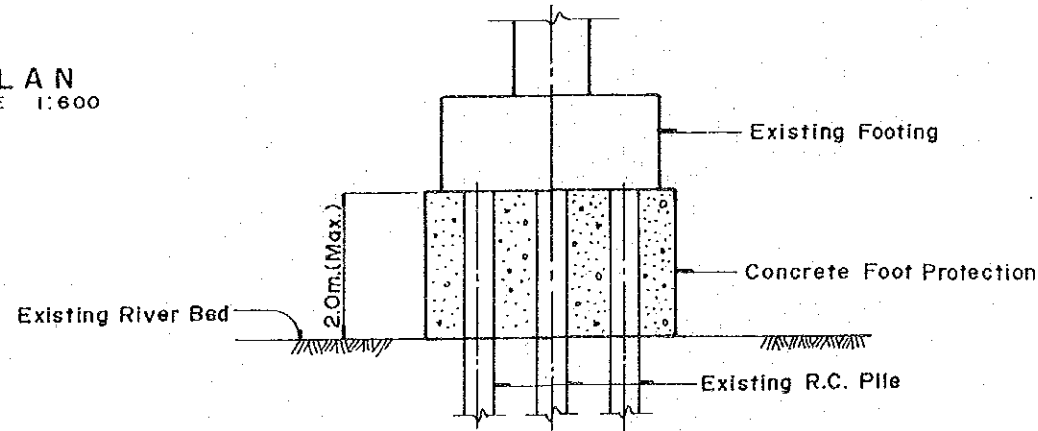
CROSS SECTION OF EXISTING PIER
SCALE 1:100

- Type of Disaster: Permanent Bridge Damage (Expose of Pile)
- Magnitude of Damage: Two pier foundations are exposed, scouring depth is 2.0 meters at pier 1 and 1.5 meters at pier 2.
- Date Noticed: 1985
- Degree/Period of Traffic Interruption: Low
- Description of Disaster:

The existing Sirisian Bridge is 3 spans at 12.0m, 2-lane RCDS structure. Scouring of the river bed materials at the footing of the bridge was noticed in 1985. During its construction in 1983, pier footings were placed below the river bed, however, the river bed is presently lowered by 2.0 meters below the bottom of footing at pier 1 and 1.5m at pier 2 which has severely exposed the foundation footings. Gabion mat at the lower portion of the abutment protection was partly sagging due to the lowering of original river bed. Retaining wall was constructed in 1989, adjacent to the structure at the downstream portion, to protect the river bank from scouring and the feeder road and neighboring houses from overflowing.

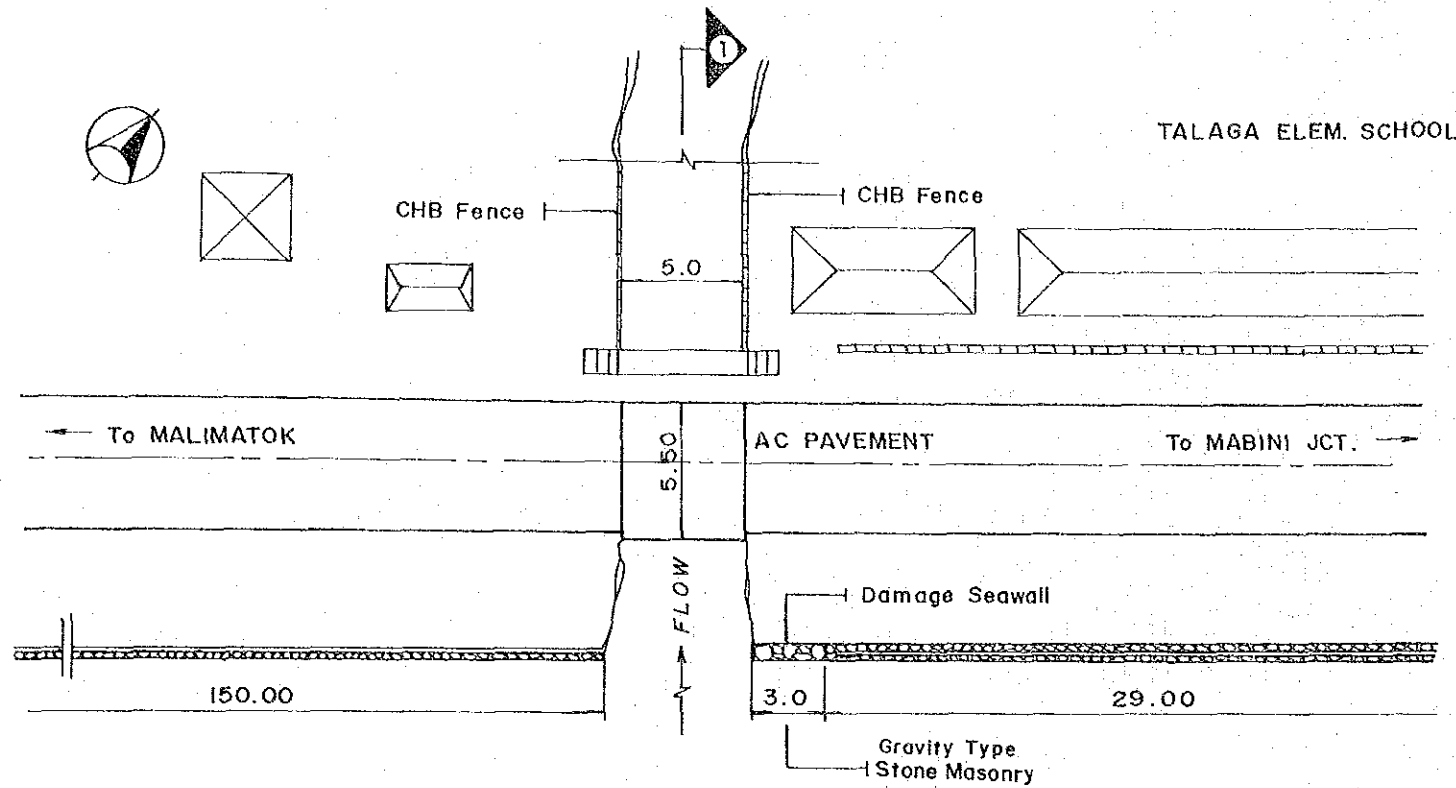
- Type of Disaster: Seawall Damage
- Magnitude of Damage: At one end 3.0m, and other end 1.5m long
- Date Noticed: Occured 1990
- Degree/Period of Traffic Interruption: Low/None
- Description of Disaster:

The original 52.0m length of the seawall was just cut short to the existing length of about 32.0m due to fund constraints. The seawall was constructed with the dimension of 0.8m top width, base width of 1.8m and 1.3m in height. The primary purpose of constructing this seawall was to protect the opposite school building from seawaves. However, damage with an extent of 3.0 meters long at one end adjacent to the spillway and 1.5m long at the other end in front the gate of the school building occurred during the 1990 typhoon.

The damage was caused by the backwash wave action at both ends of the seawall during the typhoon. This could also be attributed to the poor construction method and workmanship wherein insufficient amount and poor quality of mortar was applied only along the side of the structure, and no grout was used inside the structure as shown in the picture above.

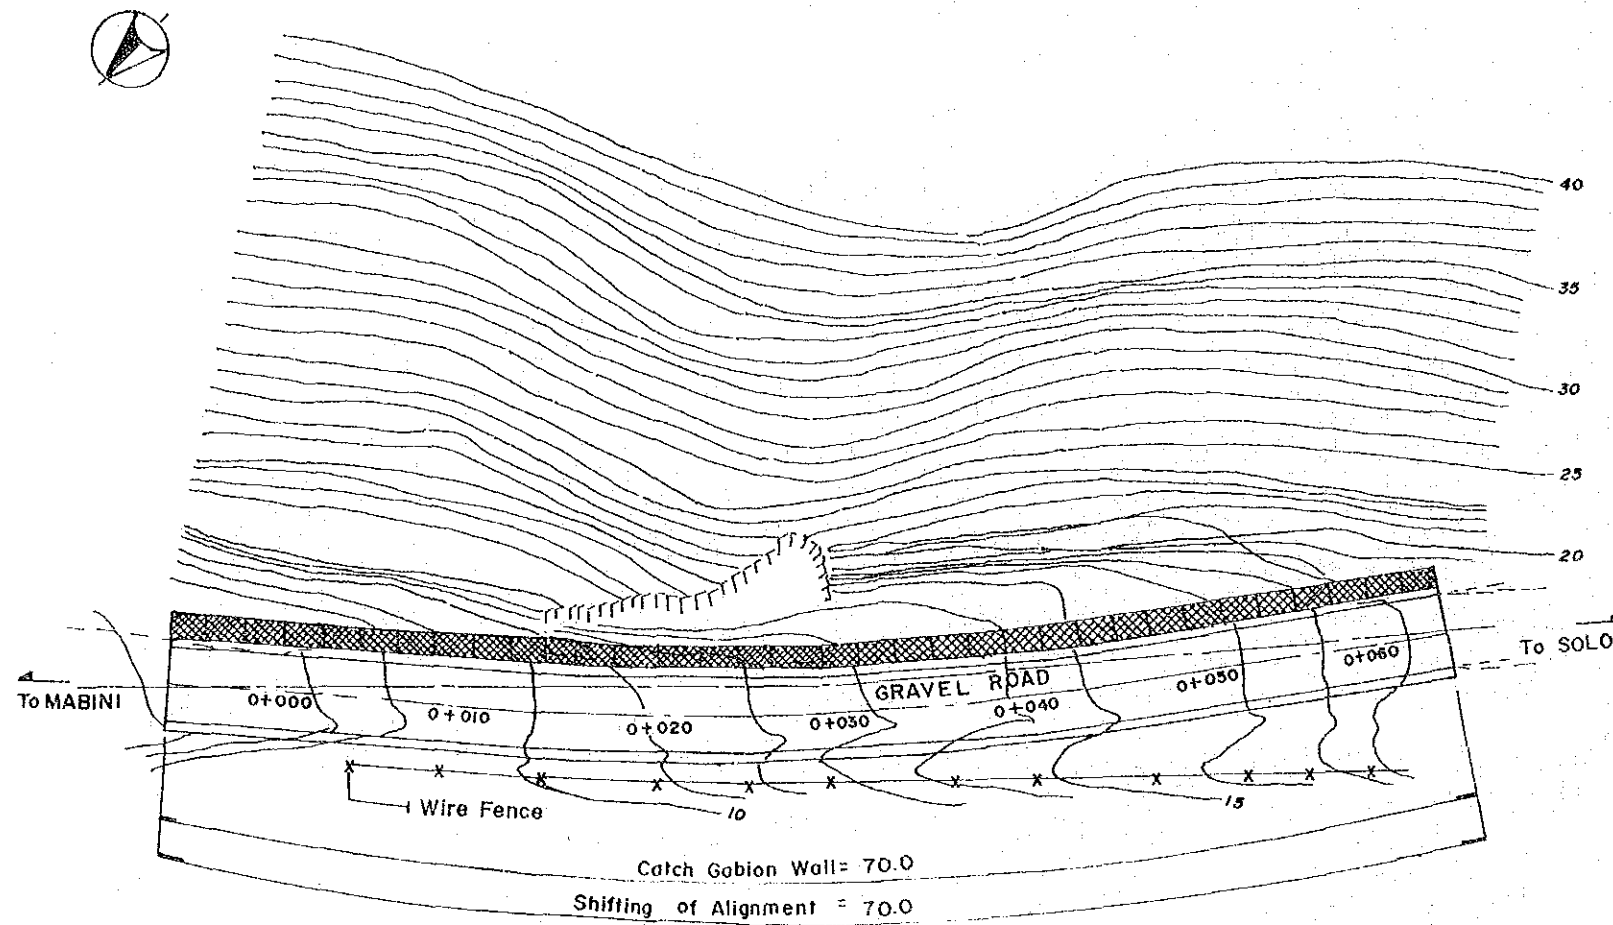
PLAN
 SCALE 1:400

- Type of Disaster: Rockfall
- Magnitude of Damage: 7.0m in height x 70m in length
- Date Noticed: Once a year
- Degree/Period of Traffic Interruption: High/5 days/year
- Description of Disaster:

This failure occurs at least once a year. The height of disaster dimension varies from 3.5 - 7.0m in height and 150m long, but due to continuous rockfall and sliding of top soils damaged area is increasing year by years. The falling rocks and debris block the whole width of the road, resulting in a total closure of traffic for about 5 days, thus impact to the road is very high.

- Major failure occurs along the developed joints.
- Due to orientation of joints which incline towards the road, rockfalls are most likely to occur along these joints during heavy rains.

- * Removal of deposit materials
- * Removal of unstable Materials

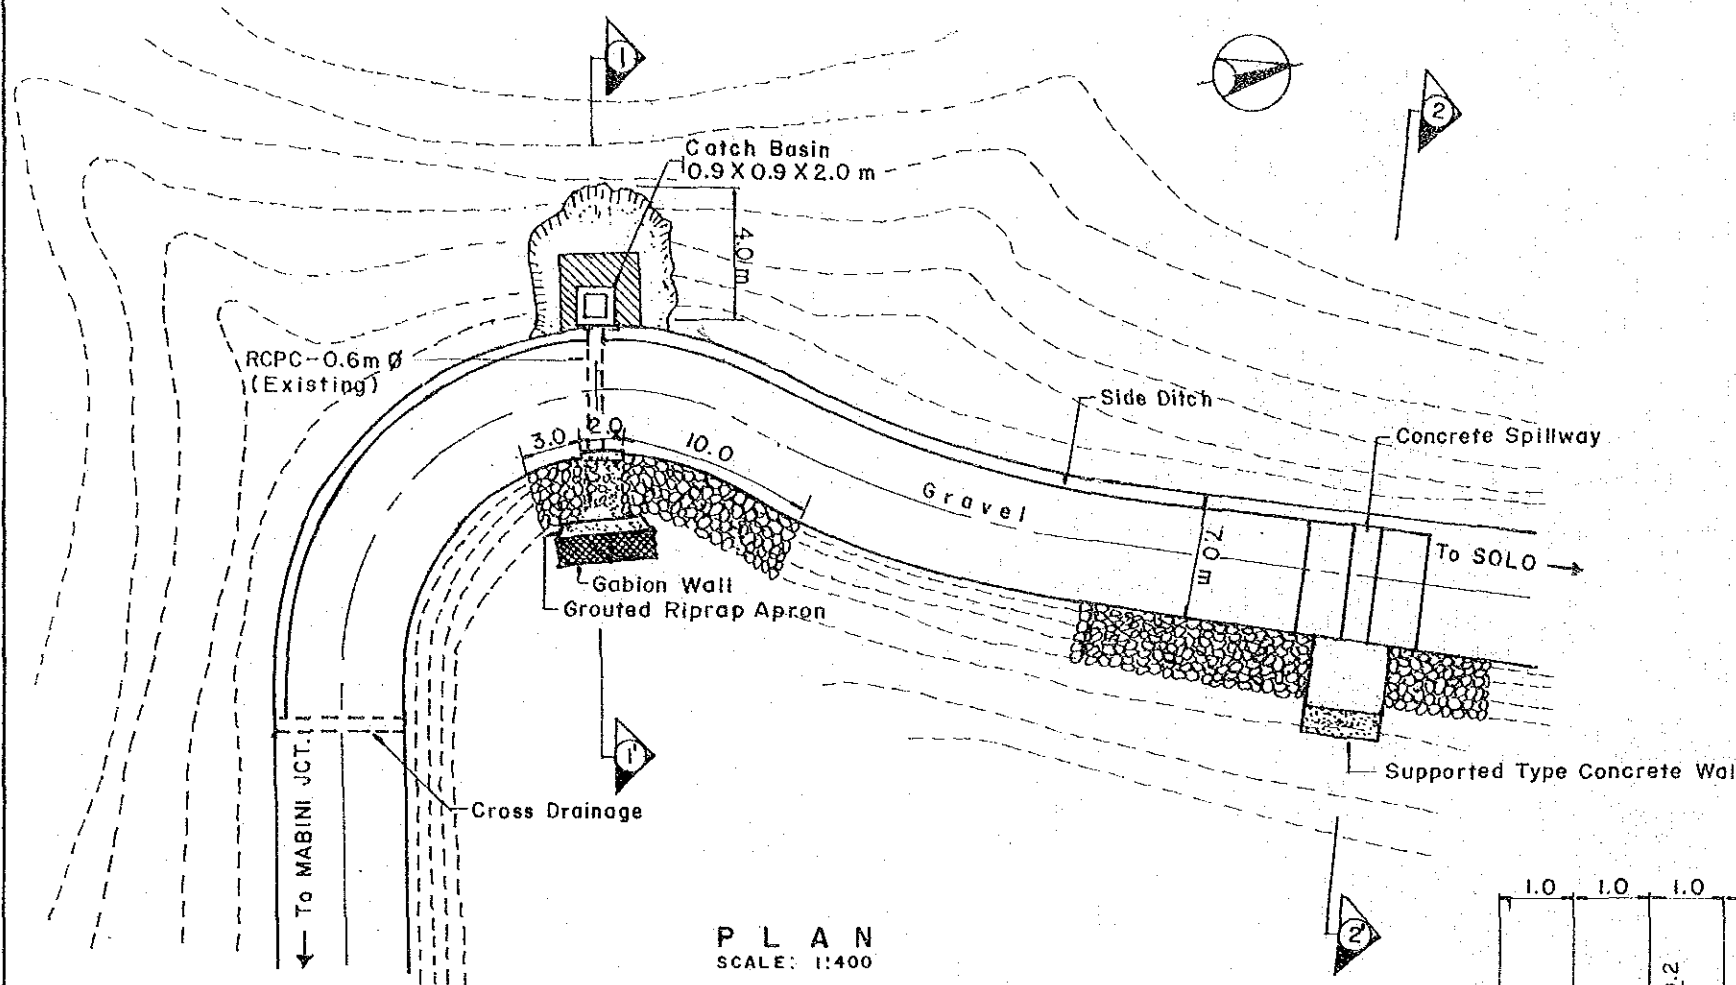
- Type of Disaster: Floody/Muddy Road
- Magnitude of Damage: 42m long along the roadway
- Date Noticed: During rainy season
- Degree/Period of Traffic Interruption: Low
- Description of Disaster:

The existing pipe culvert 0.60m ϕ was laid 42.0m away from the lowest portion of the roadway. It is observed that the pipe culvert entrance is partly clogged with rocks and other debris and has insufficient capacity to discharge the rain water. No side ditches were provided/constructed, so at every heavy rain the water coming from the gullies and spring is rather confined in the roadway therefore road surface resulted to a floody/muddy road.

- Improper location of pipe culvert.
- Culvert pipe diameter incorrect.
- Partial obstruction of culverts by rocks and natural debris and other materials.
- No side drain.

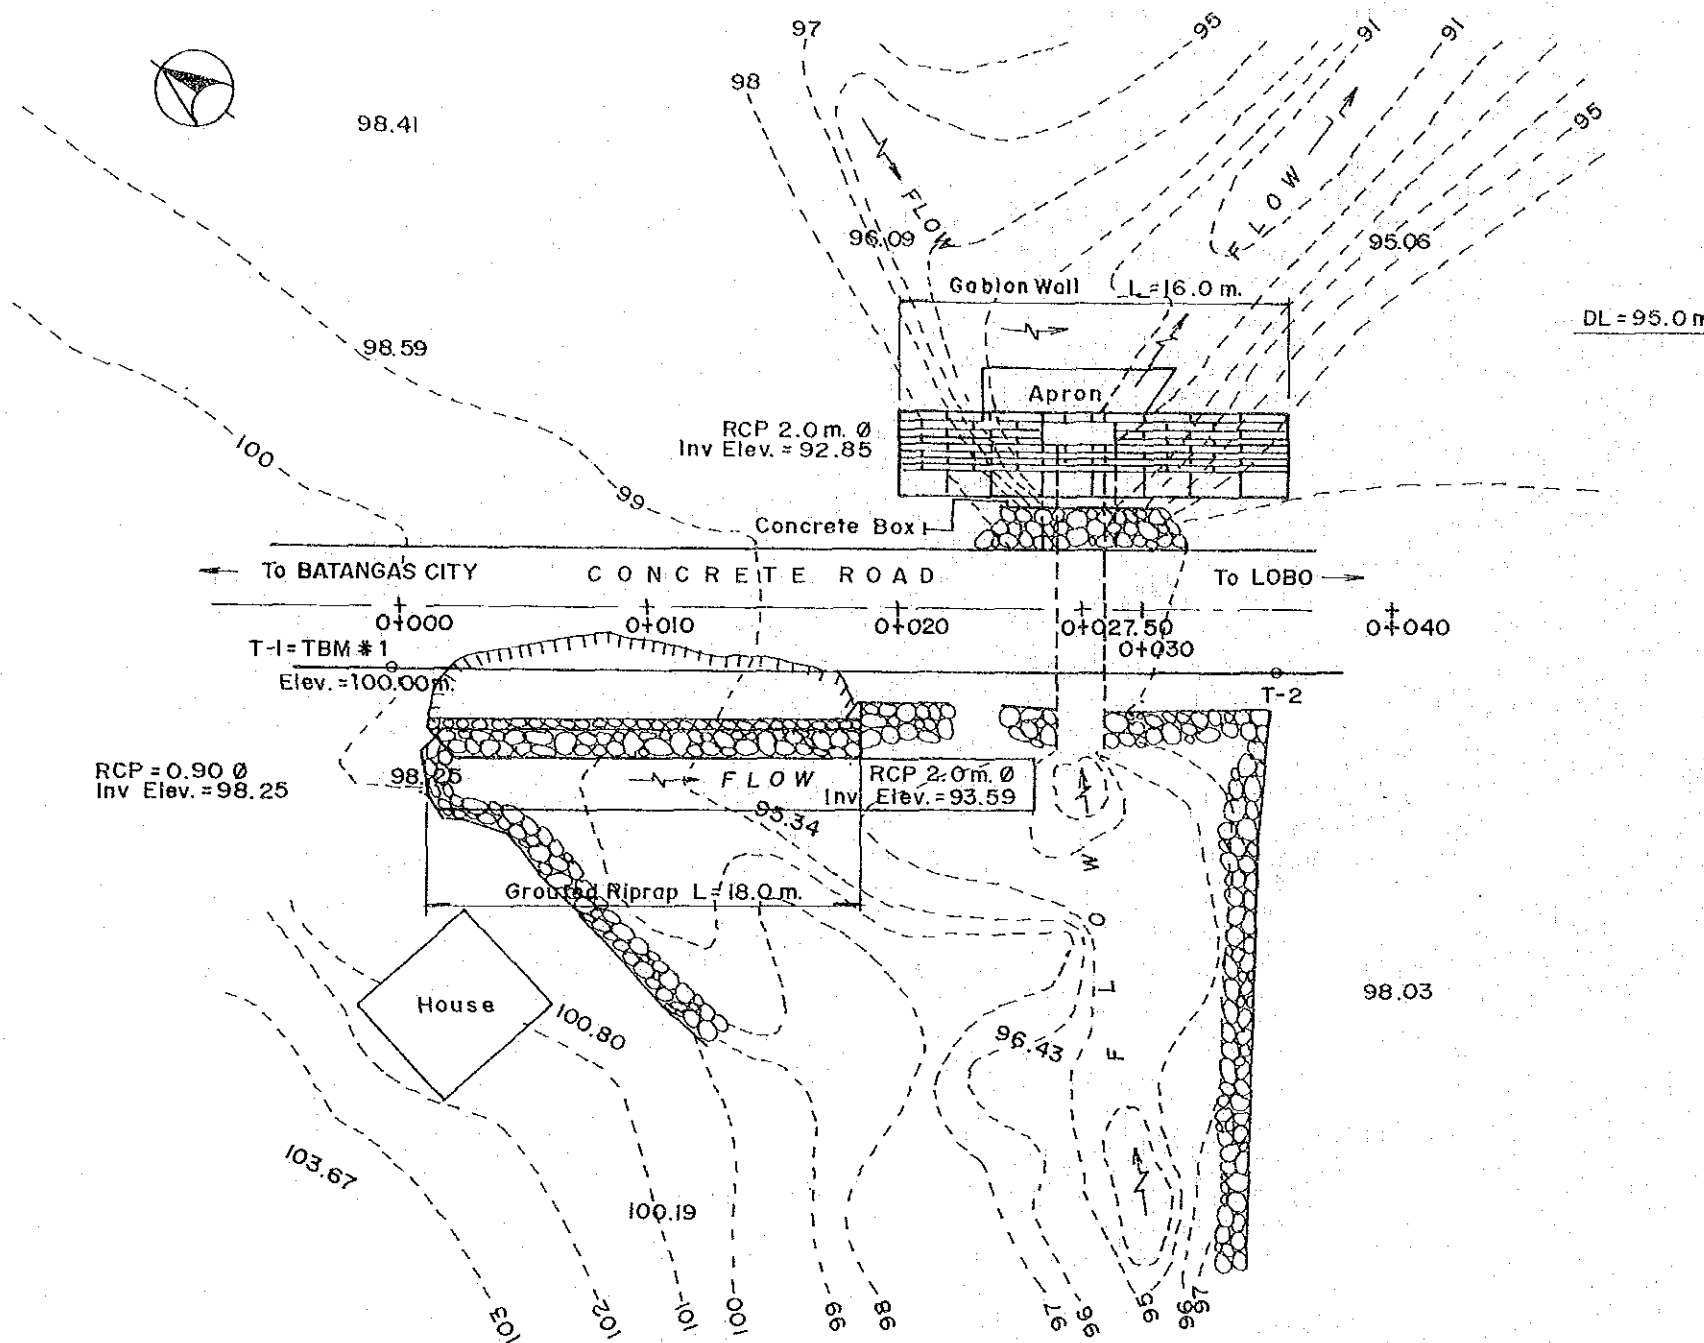
PLAN
 SCALE 1:300

- Type of Disaster: Erosion of embankment protection and almost half of the roadway.
- Magnitude of Damage: 16m. long and 3.0m. in height
- Date Noticed:
- Degree/Period of Traffic Interruption: Medium
- Description of Disaster:

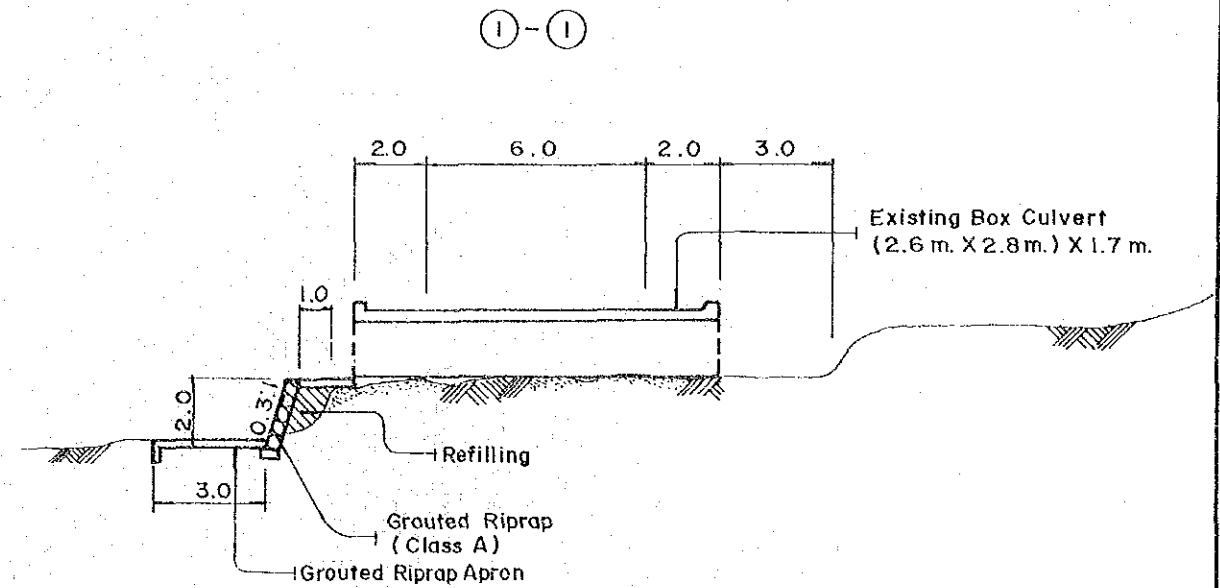
CROSS SECTION OF URGENT RESTORATION
 SCALE 1:200

- Type of Disaster: Scoured riverbed at the downstream portion
- Magnitude of Damage: 1.5m height, 8.4m long, 1.0m wide
- Date Noticed:
- Degree/Period of Traffic Interruption: Low/None
- Description of Disaster:

Similarly, it was observed that the creek channel and banks were heavily eroded/scoured due to the cascading action of floodwaters hitting the wingwall before it enters the inlet.

The material for this particular spot is characterized as volcanic sand with gravel easily to accelerate and erode. Due to strong flow of water during heavy rains, the riverbed from the foot of the apron started to scour carrying the deposited sediments and causing the apron to be in its hanging condition which is expected to damage further the main structure if no countermeasure will be taken into consideration immediately.

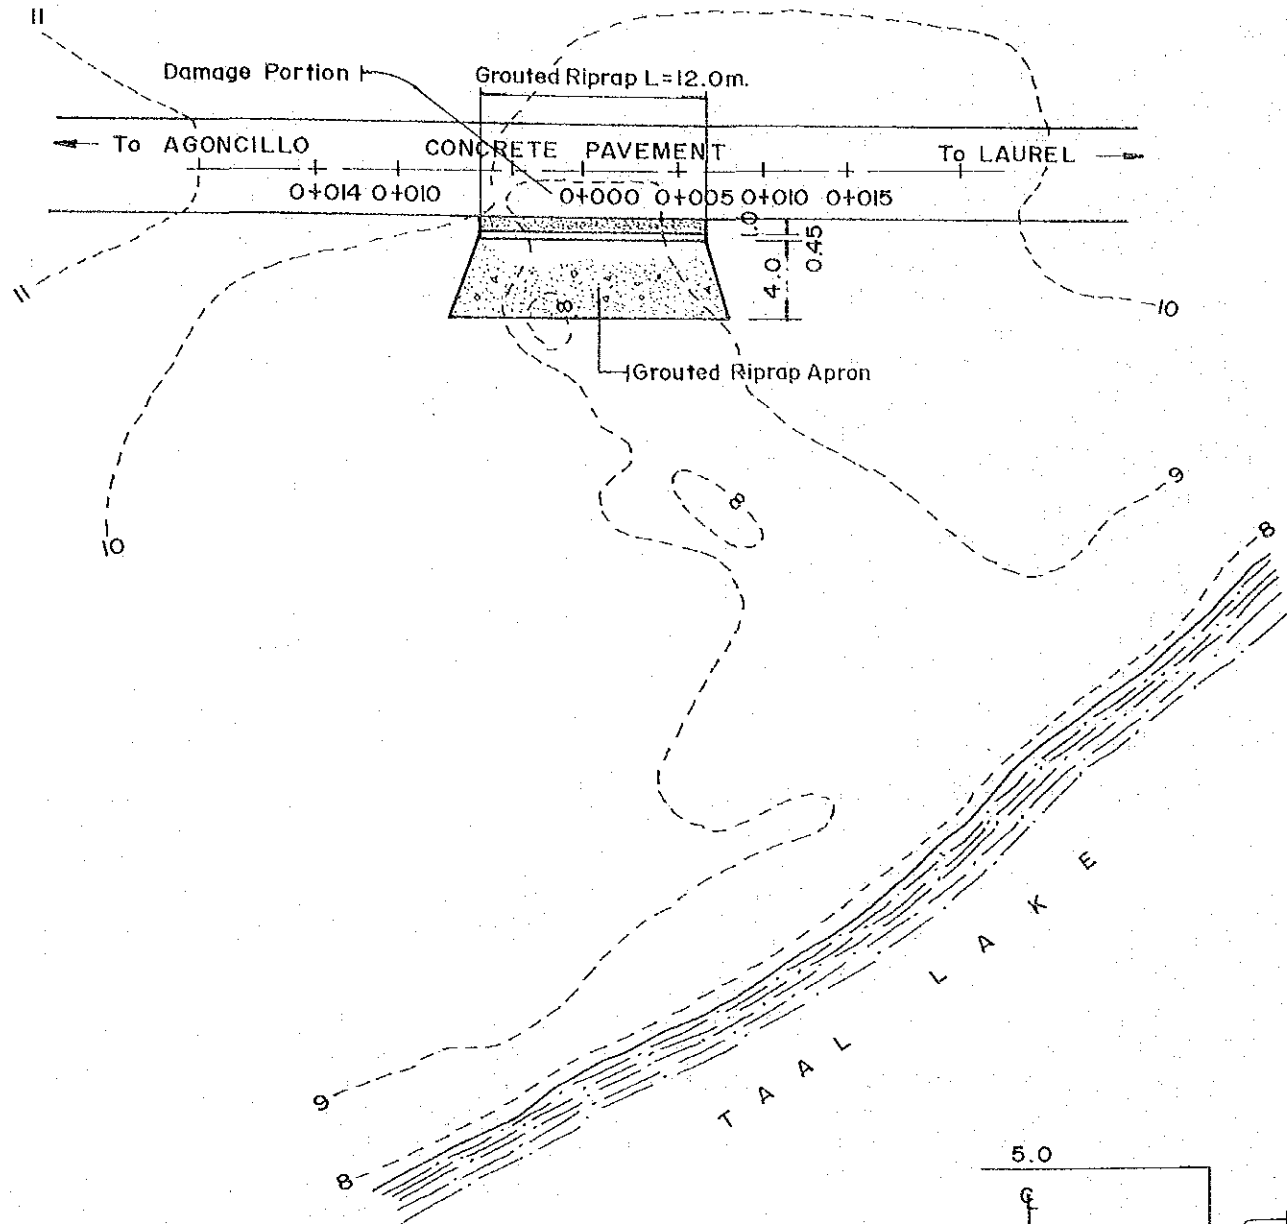
PLAN
 SCALE 1:400

- Type of Disaster: Scouring of Natural Roadbed and shoulder erosion.
- Magnitude of Damage: 12.0m long, 1.5m wide, 1.4m height
- Date Noticed:
- Degree/Period of Traffic Interruption: High/Closed to traffic
- Description of Disaster:

At this particular spot, the road shoulder as well as the natural roadbed materials were totally scoured and has a magnitude of damage of about 12.0m long, 1.5m wide and 1.4m in height, causing the PCC pavement to hang. The scoured portion had already reached a width of 1.5m and a slight sagging on PCC pavement was observed. The hanging pavement is considered dangerous when subjected to heavy load. Immediately beside this failure is a lagoon which is enclosed by deposit of sand dunes which presently acts as a barrier from further scouring of the affected area.

As the embankment protection was not constructed in this particular spot and the road was just about 45m away from the shore line of Taal Lake, this damage was triggered mainly by wave action during high tides that directly hits the embankment/natural road slope. Failure was also aggravated by the flow of big volume of running water coming from the mountain slope which directly drains into this section during heavy rains.
