DRAWING NO.
102

Batangas Spot No. 48 (BS-48)

5. RESTORATION MEASURES FOR SELECTED SPOTS IN LEYTE

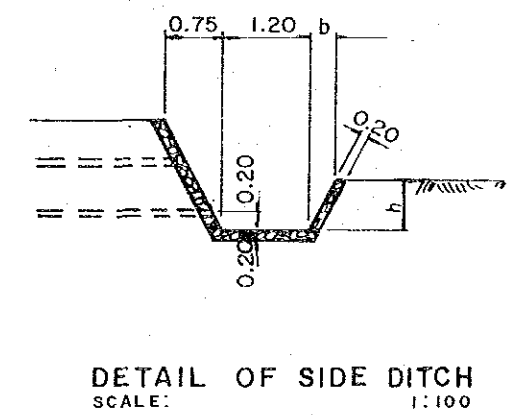
- Type of Disaster: Floody/Muddy Road
- Magnitude of Damage: 2.0 kms
- Date Noticed: Every rainy seasons
- Degree/Period of Traffic Interruptions: Low/None
- Description of Disaster:

This damage was caused by higher elevation of abutting lands on both sides compared to that of the road surface and insufficient drainage facilities.

TYPE OF WORK	UNIT	TOTAL
PERMANENT RESTORATION			
P2-2	SIDE DITCH	L.M	140
P2-4	R.C.P.C. 0.61m ϕ	L.M	48
P19-1	GRAVEL SURFACING	SQ.M	525
PI-3	REFILLING / EMBANKMENT	CU.M.	446
