DESCRIPTION AND DESIGN OF RESTORATION MEASURES
FOR EACH DISASTER SPOT (LEYTE)

PROVINCE: LEYTE
SPOT No. : L-4(1/2)

NAME OF ROAD : BARUGO - BABATNGON ROAD
ROAD CLASSIFICATION: NATIONAL SECONDARY ROAD

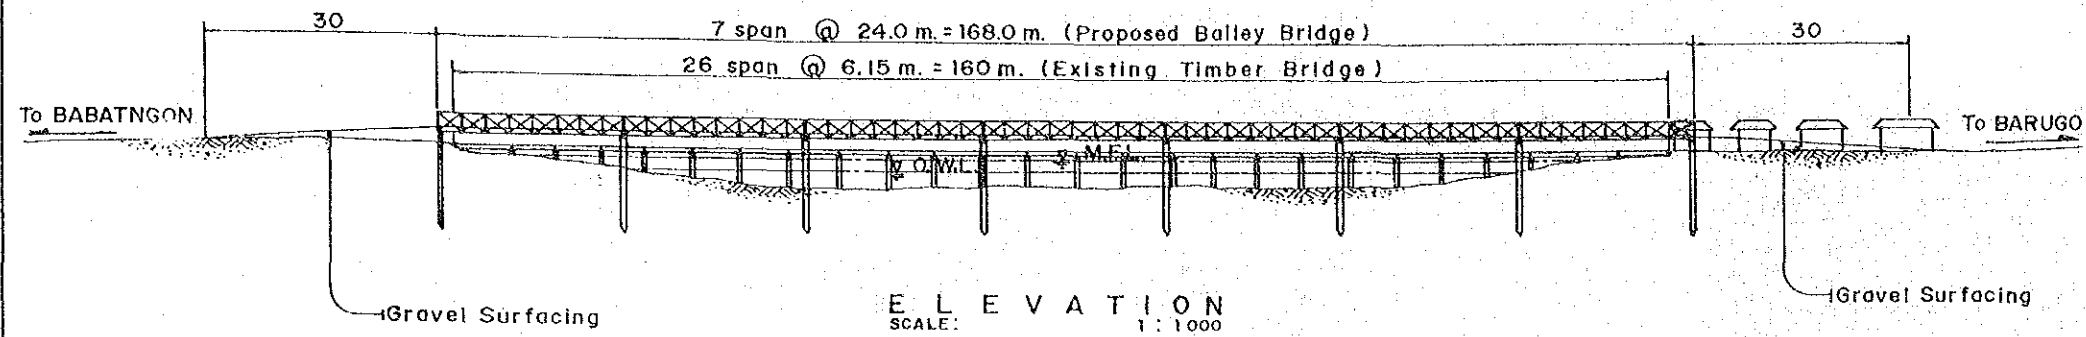
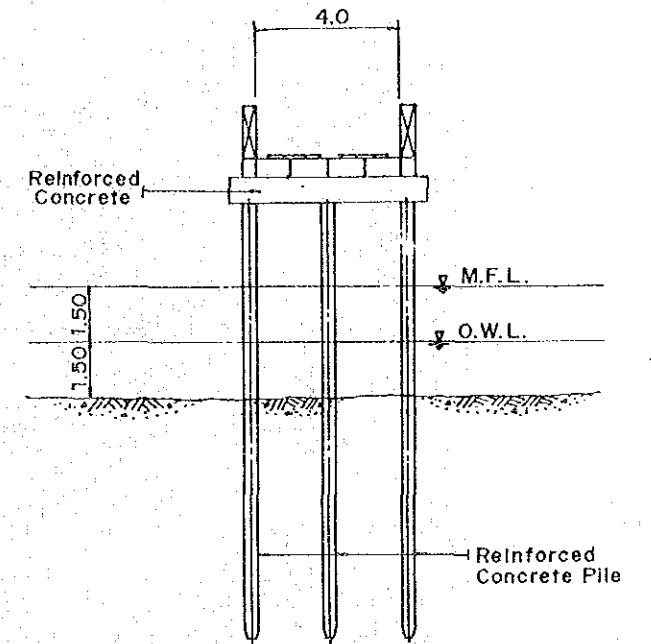
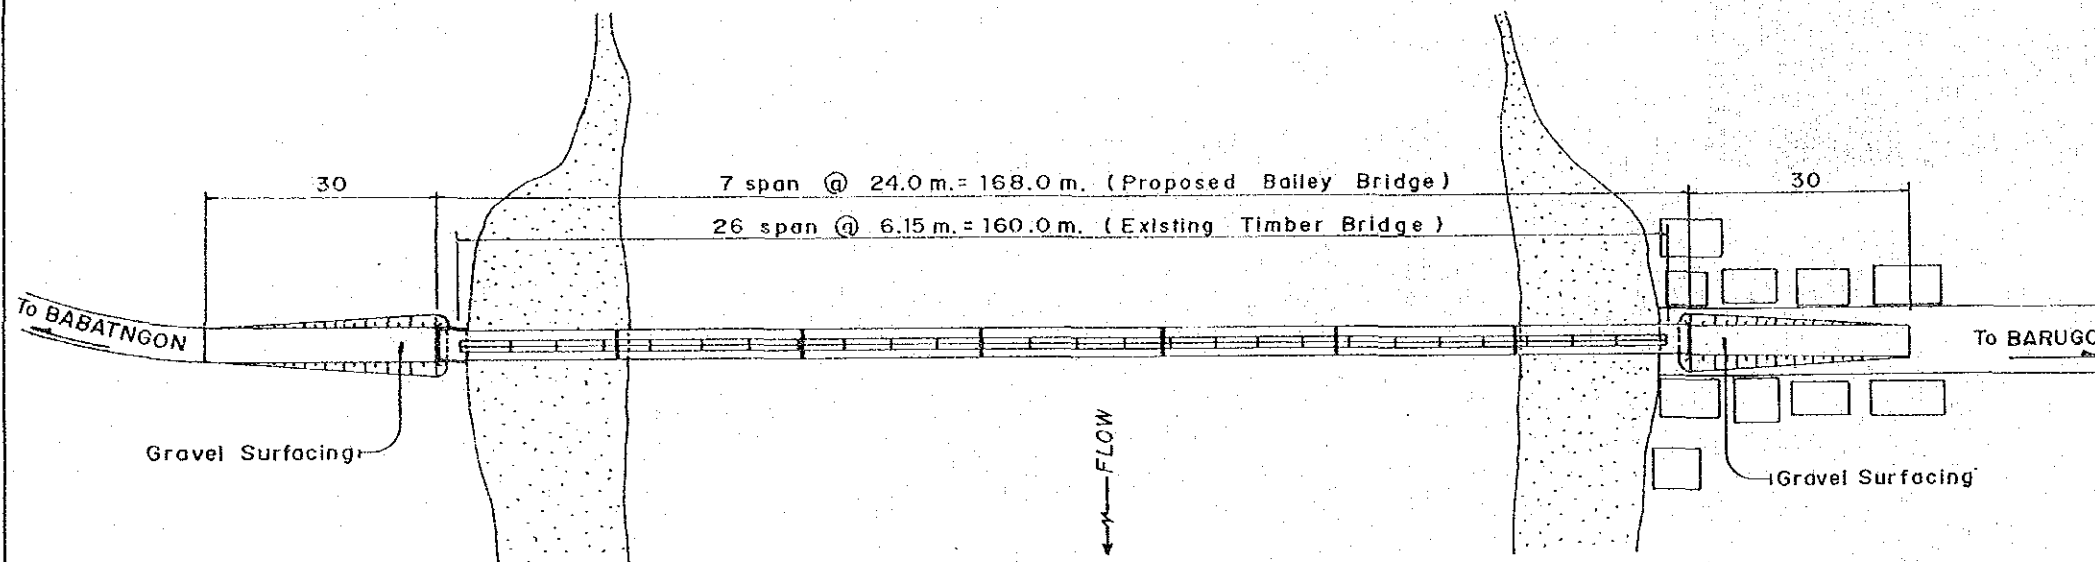
DRAWING NO.
 126

- Type of Disaster: Washed out of superstructure/scouring on abutments
- Magnitude of Damage: 160.0 meters
- Date Noticed: 1988
- Degree/Period of Traffic Interruption: High
- Description of Disaster:

The Cabarasan timber bridge has a total length of 160.0m, composing of 26 spans and a 1-lane bridge with 4.0m width.

The timber bridge was washed out last 1988 during typhoon "Undang". Since that time the bridge was not passable to traffic and temporary foot bridge was made available to crossing pedestrians.

- Tidal waves that hit the bridge last 1988 by typhoon "Undang" caused the superstructure to be washed out.

TYPE OF WORK	UNIT	TOTAL
URGENT RESTORATION		
U1-4	REFILLING / EMBANKMENT	CU. M. 360
U6-2	H-PILE BENT	L. M. 288
U6-3	BAILEY BRIDGE	L. M. 168
U7-1	GRAVEL SURFACING	SQ. M. 240

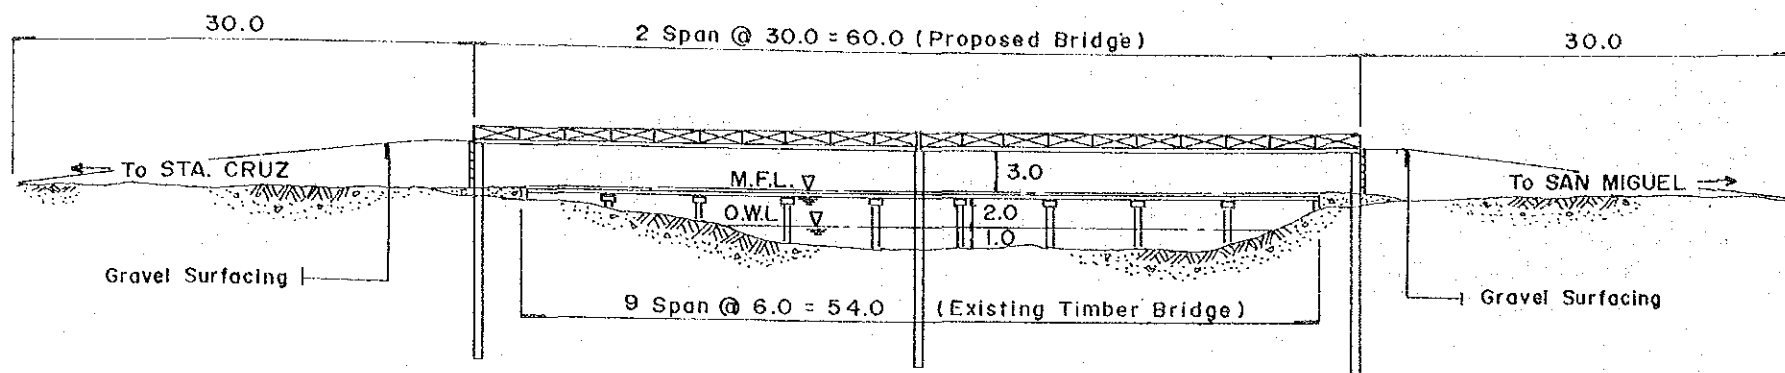
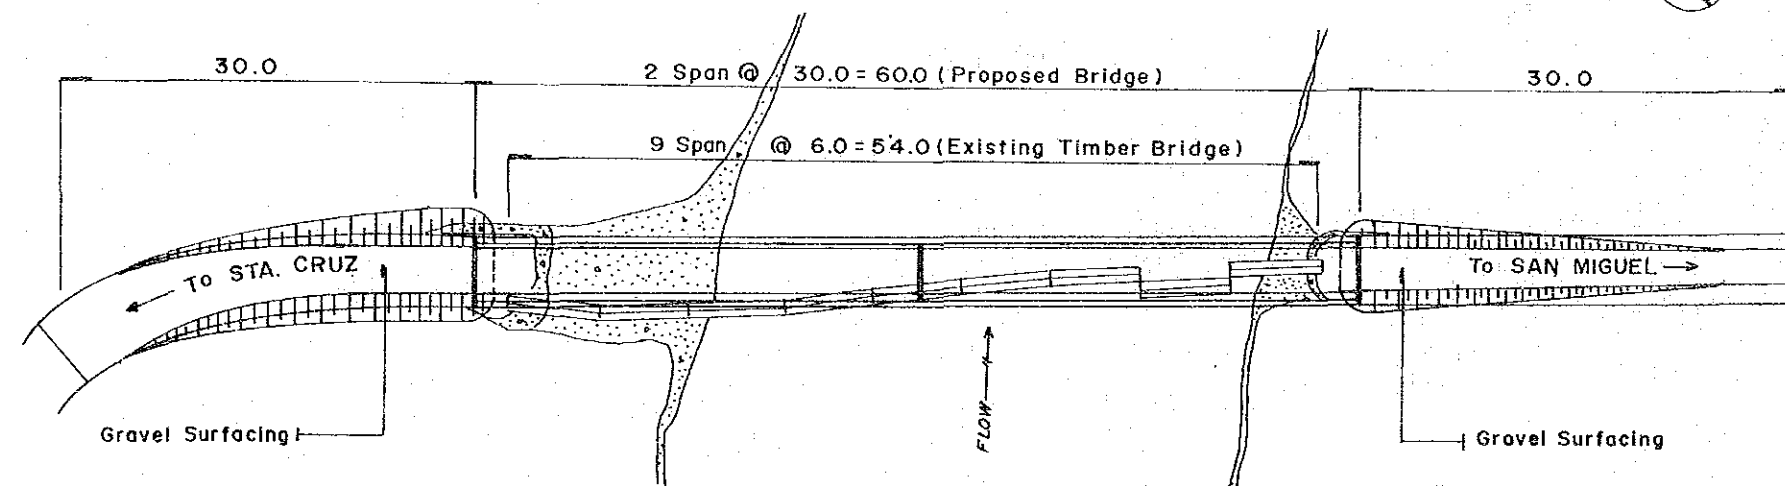
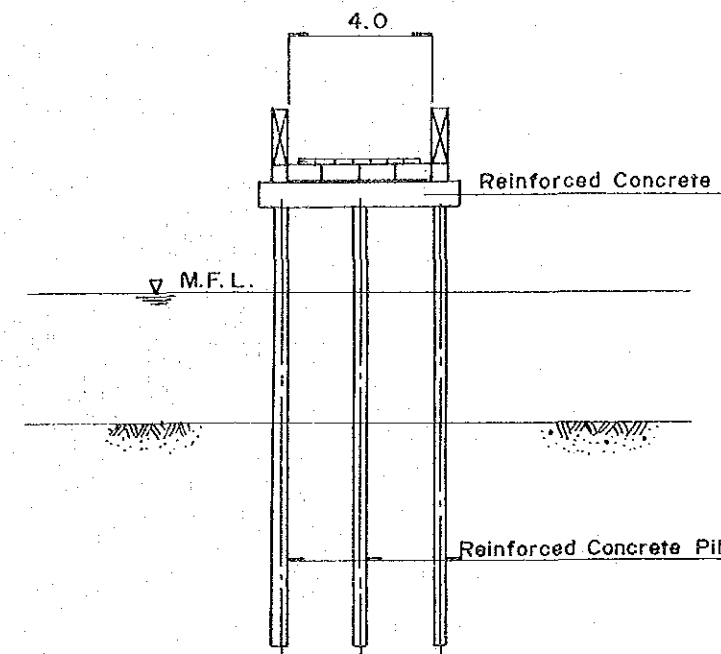
DRAWING NO.
 128

- Type of Disaster: Timber bridge washout
- Magnitude of Damage: 54.0 total length of bridge washout
- Date Noticed: 1986
- Degree/Period of Traffic Interruption: High
- Description of Disaster:

Insufficient free board and too short span length between piers caused accumulation of logs and debris flowed from upstream.

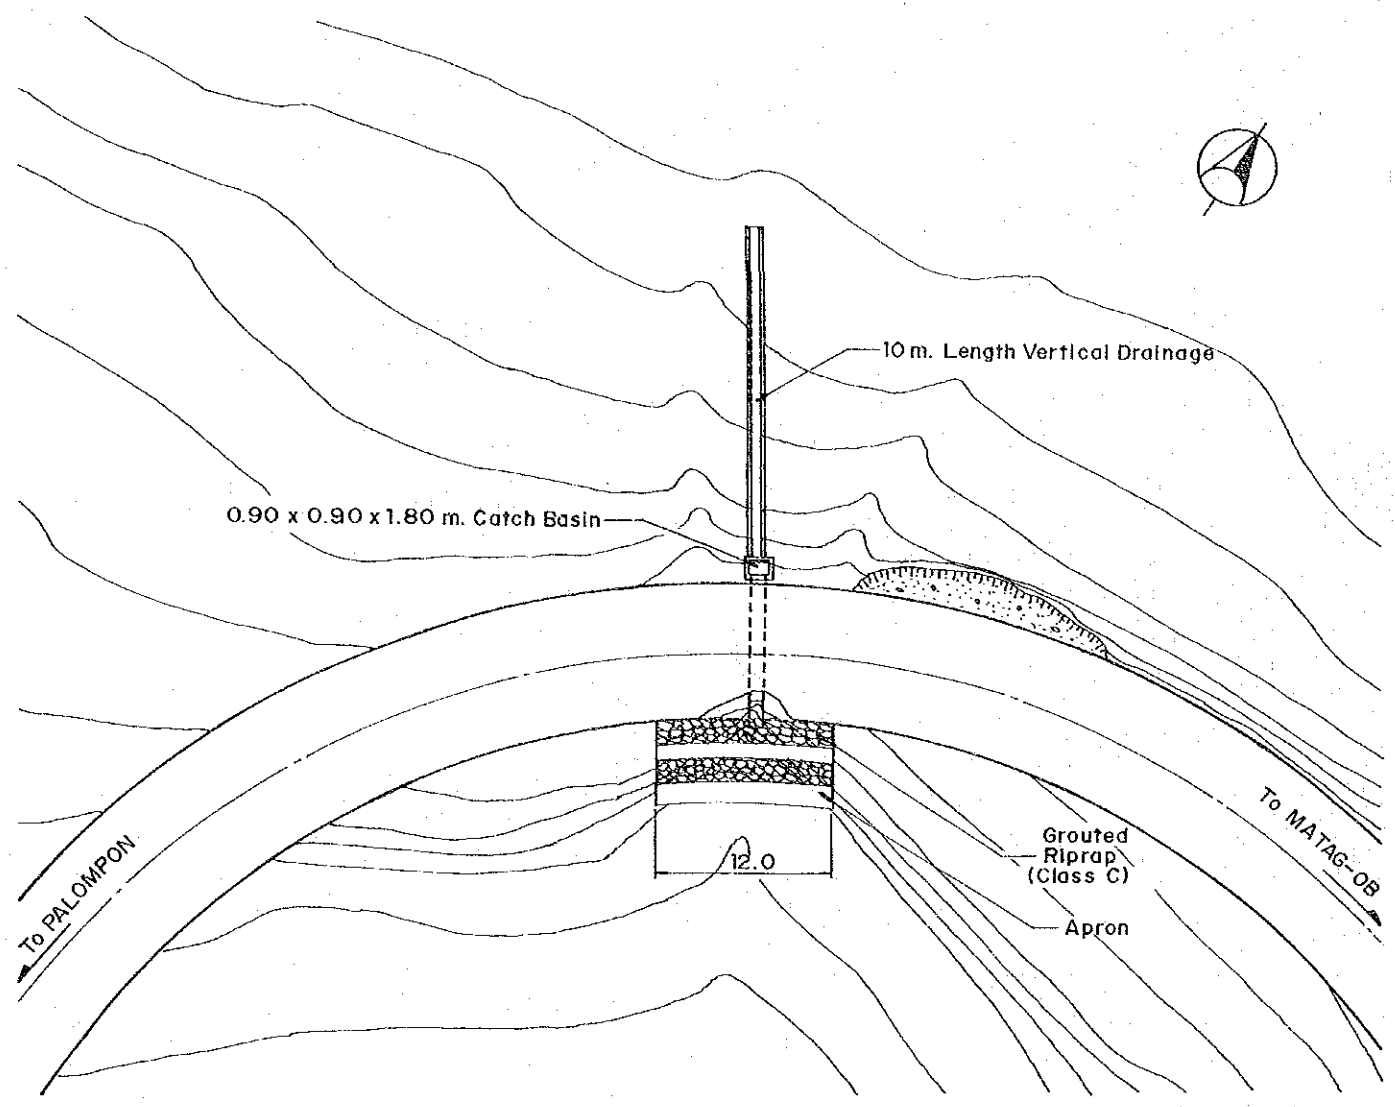
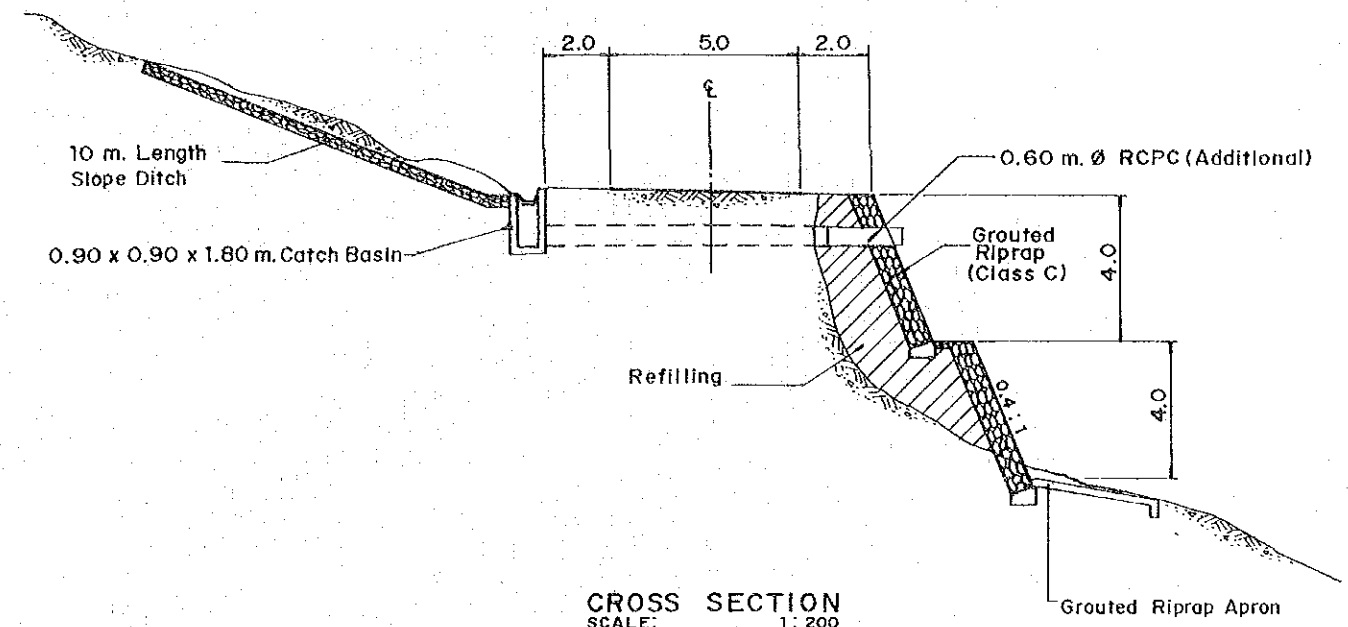
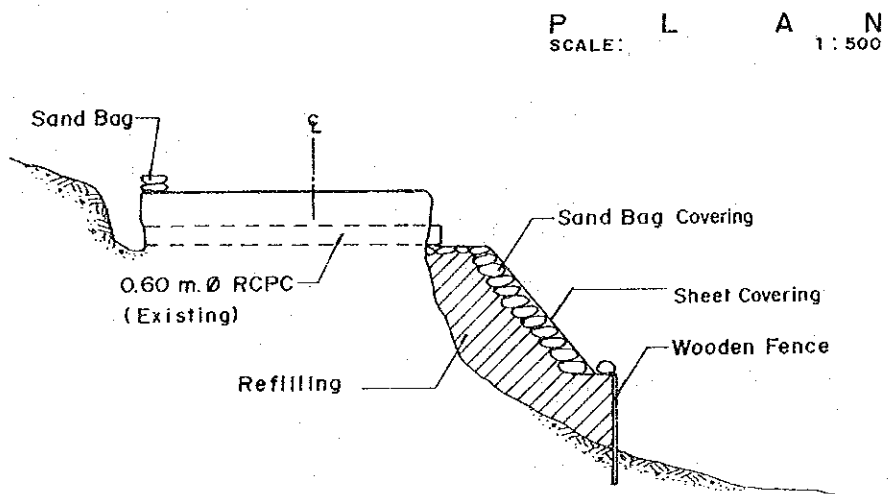
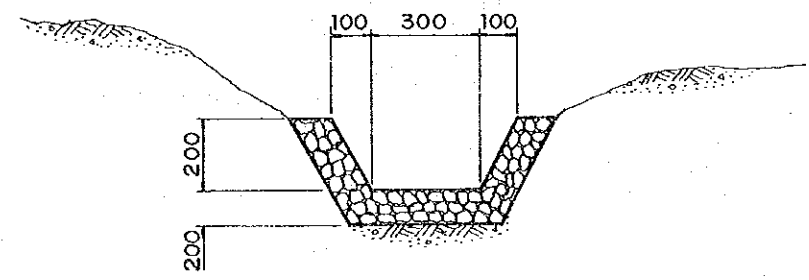
DRAWING NO.
 130

- Type of Disaster: Culvert damaged
- Magnitude of Damage: Inlet and outlet facilities of 0.610m RCP
- Date Noticed: 1988
- Degree/Period of Traffic Interruption: Low
- Description of Disaster:

This culvert damaged is located on a sharp curve at a radius of about 57.0m. Inlet portion was partially clogged.

During heavy rain, water that comes from high elevation cannot be accommodated to the existing drainage pipe of 0.610m ϕ . Also, absence of side ditches and damaged inlet facilities caused water to flow on the roadway and runs directly on embankment slope that causes heavy scouring. No outlet facility is provided.

TYPE OF WORK		UNIT	TOTAL
PERMANENT RESTORATION			
P2-1	SLOPE DITCH	L.M	10
P2-4	R.C.P.C 0.6 m. Ø	L.M	1.2
P2-5	CATCH BASIN	E.A.	1
P6-2	GROUTED RIPRAP	CU.M	63
P16-3	GROUTED RIPRAP APRON	CU.M	5
URGENT RESTORATION			
U1-4	REFILLING / EMBANKMENT	CU.M	120
U3-1	SHEET COVERING	SQ.M	72
U3-2	SAND BAG COVERING	SQ.M	72
U4-3	WOODEN FENCE	L.M	12

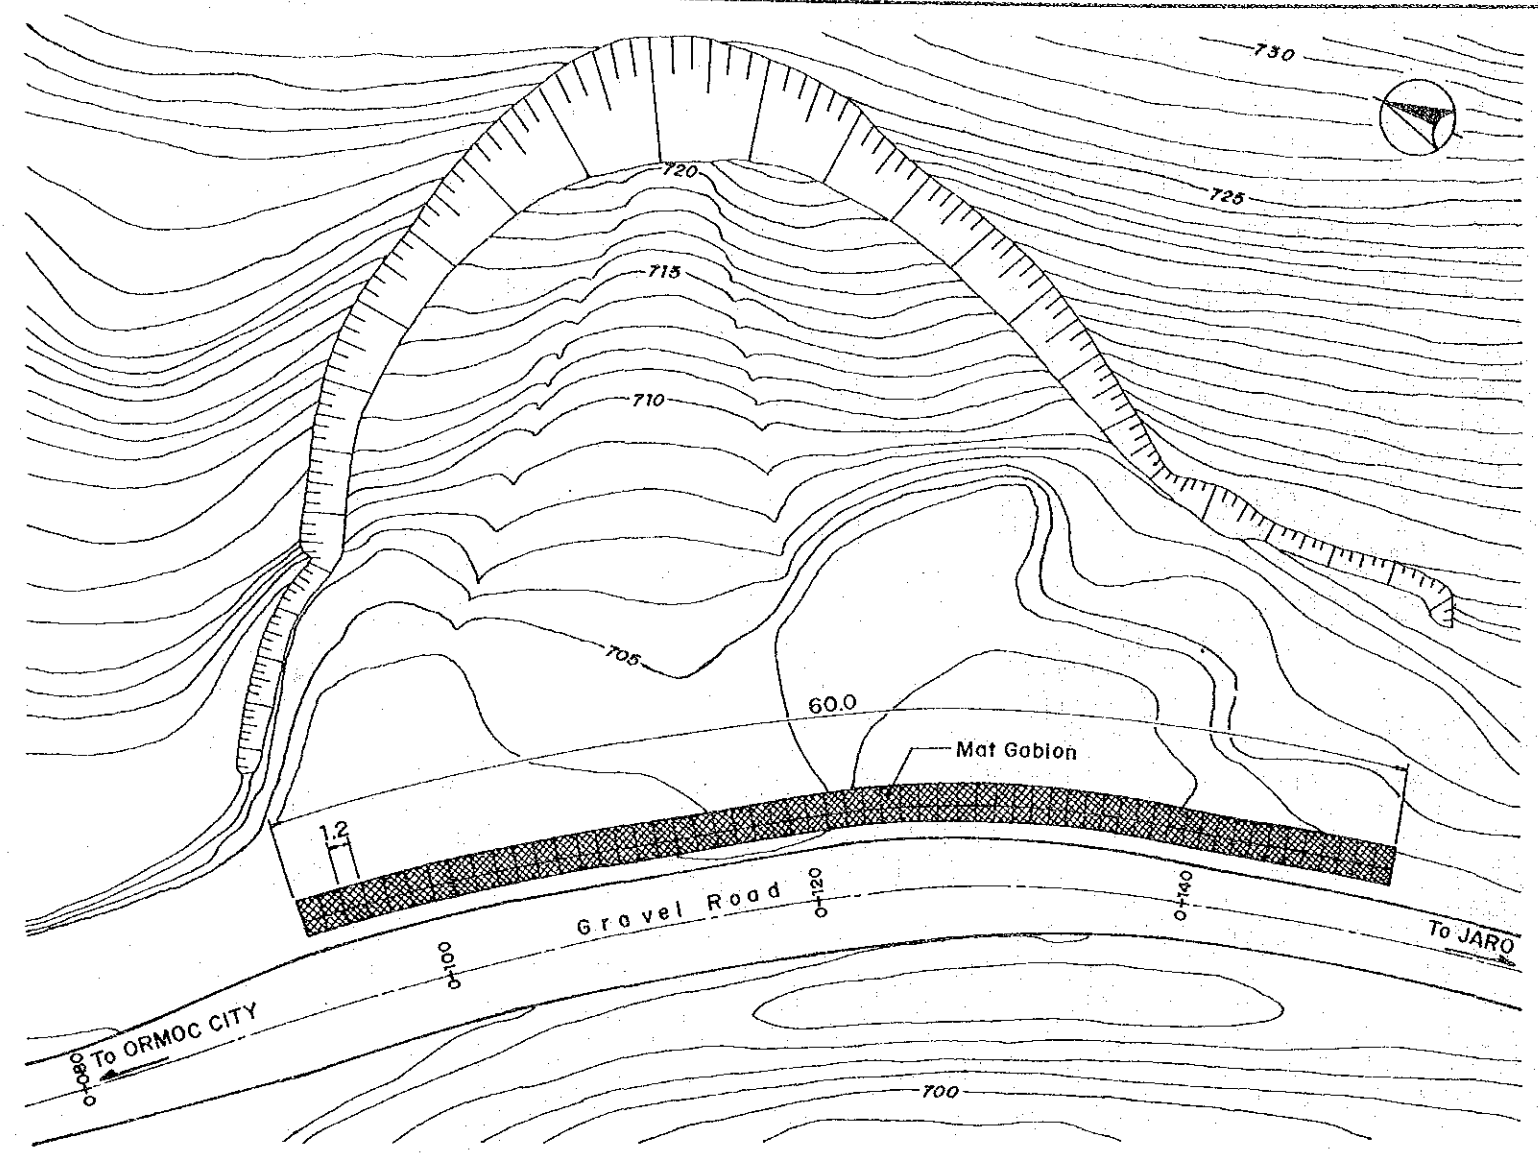
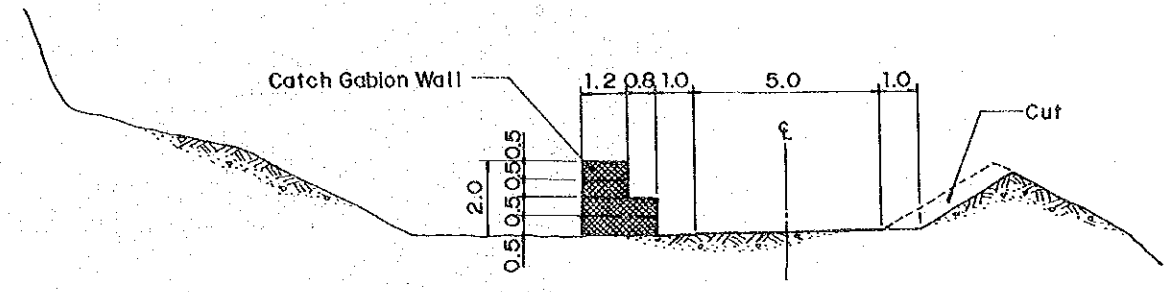
DRAWING NO.
 132

- Type of Disaster: Cut slope failure
- Magnitude of Damage: 60 meters in length; 24.0m in height
- Date Noticed: Nov. 12, 1990 (typhoon "Ruping")
- Degree/Period of Traffic Interruption: Low
- Description of Disaster:

Damaged section is about 60.0m in length and 24.0m in height. Mountain slope is about 34° angle from the roadway.

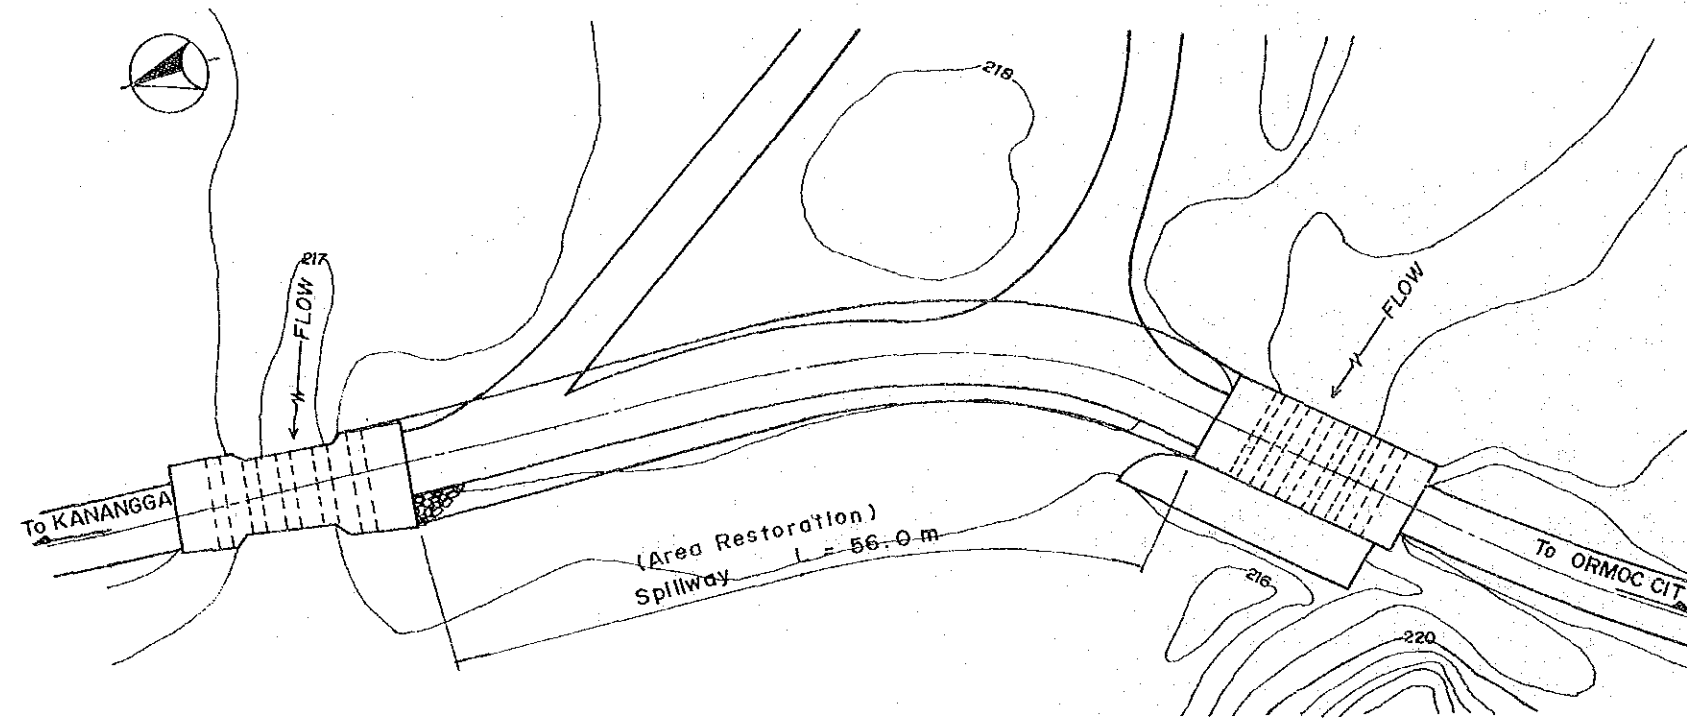
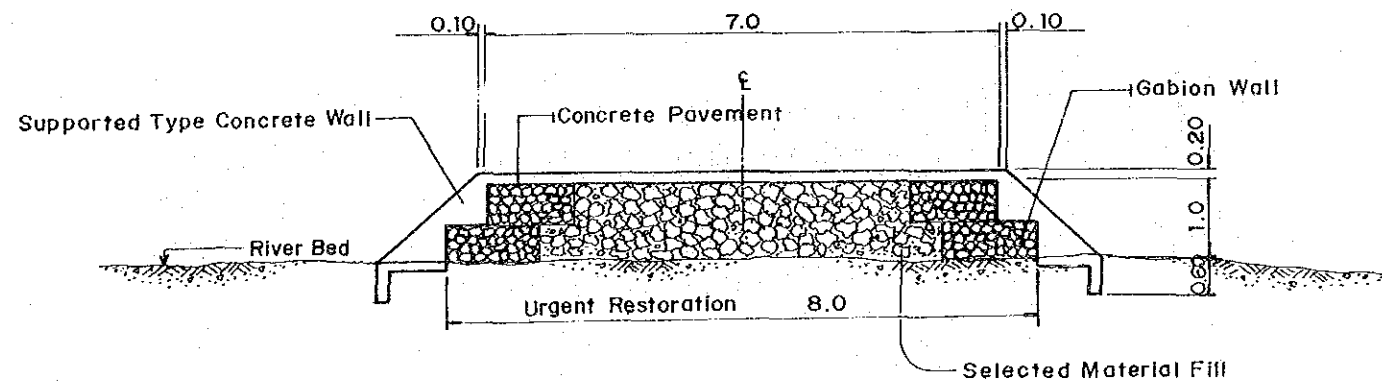
DRAWING NO.
 134

- Type of Disaster: Spillway Damaged
- Magnitude of Damage: 56.0m in length
- Date Noticed: 1988
- Degree/Period of Traffic Interruption: High
- Description of Disaster:

The spillway 56.0m in length and 6.5m width was damaged last 1988. Approach of the spillway is about 12.0m in length was washed out.

- Debris and logs flowed from upstream by flood water usually damaged the structure.
