PROVINCE : **LEYTE**
SPOT No. : **L-23 (1/2)**

NAME OF ROAD : **TABANGO - SAN ISIDRO ROAD**
ROAD CLASSIFICATION : **NATIONAL SECONDARY ROAD**

TYPE OF DISASTER : **FLOODED/MUDDY ROAD SURFACE**

Leyte Spot No. 23 (L-23)

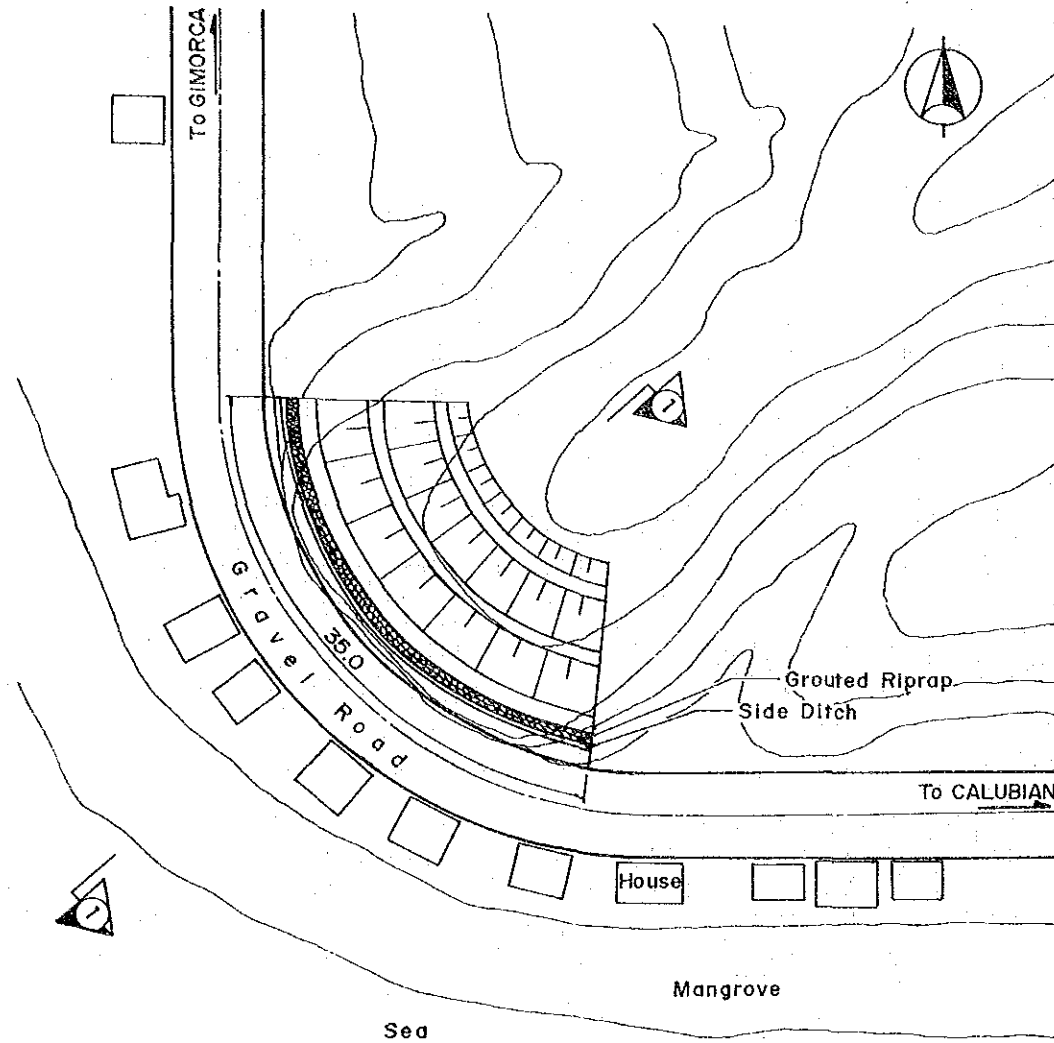
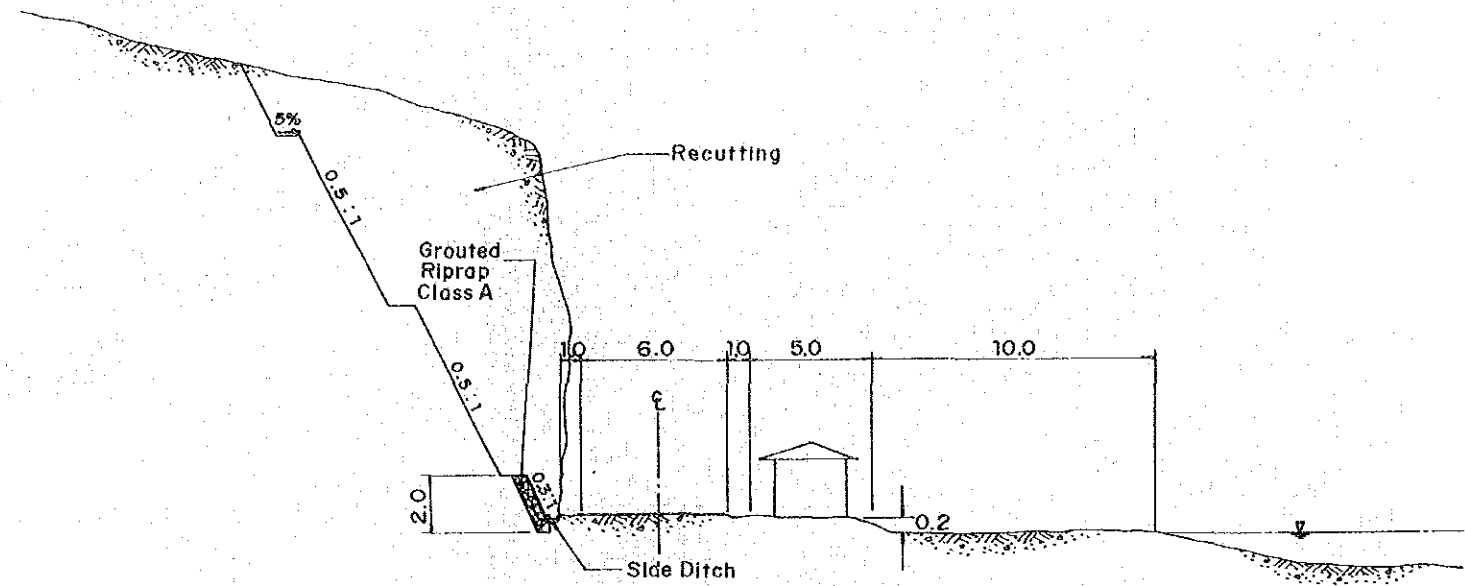
DRAWING NO.
 136

TYPE OF DISASTER : ROCK FALL / DEBRIS FALL

URGENT RESTORATION:

- Removal of deposit materials
- Removal of unstable materials

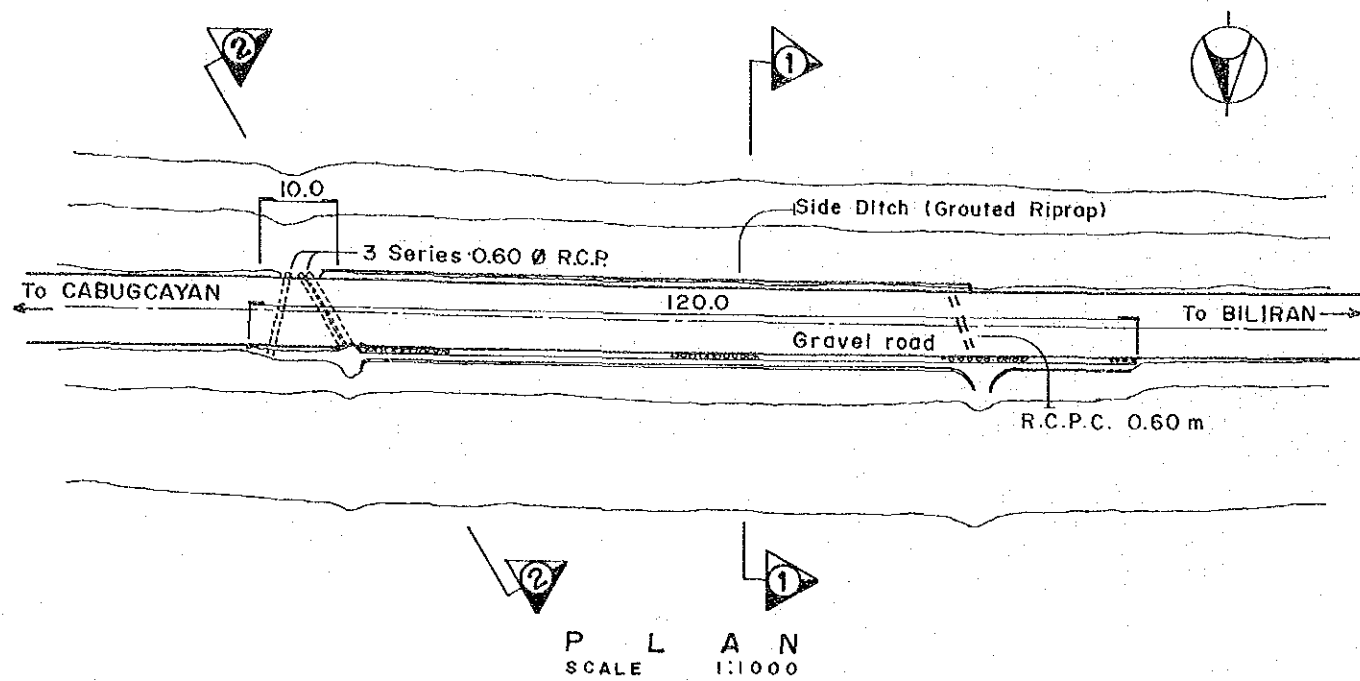
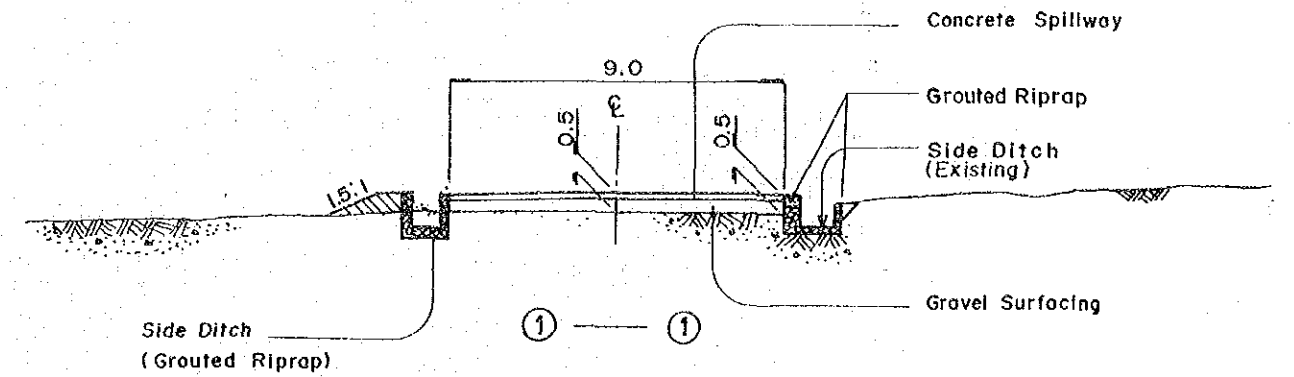
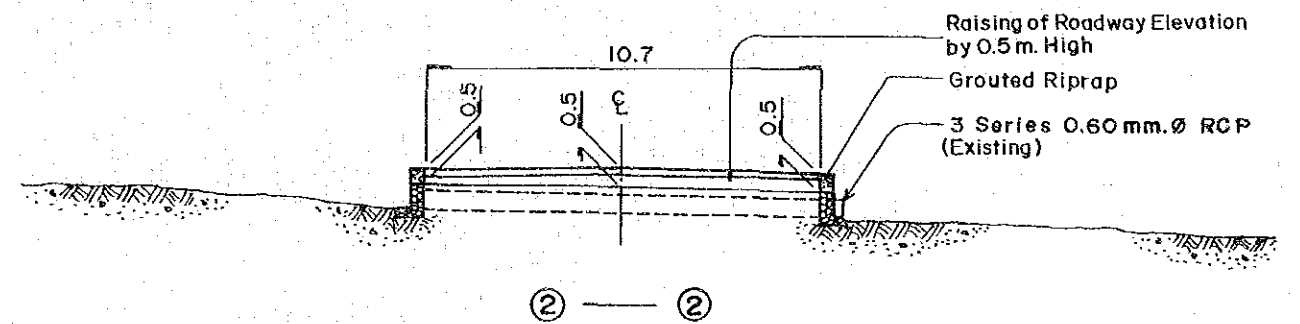
DRAWING NO.
 140

- Type of Disaster: Flooding and Muddy Road
- Magnitude of Damage: 120.0m length of flooded section
- Date Noticed: Every heavy rain
- Degree/Period of Traffic Interruption: Low
- Description of Disaster:

- Lower elevation of the road than abutting land and insufficient drainage facilities that causes the road to be flooded and muddy during heavy rain.

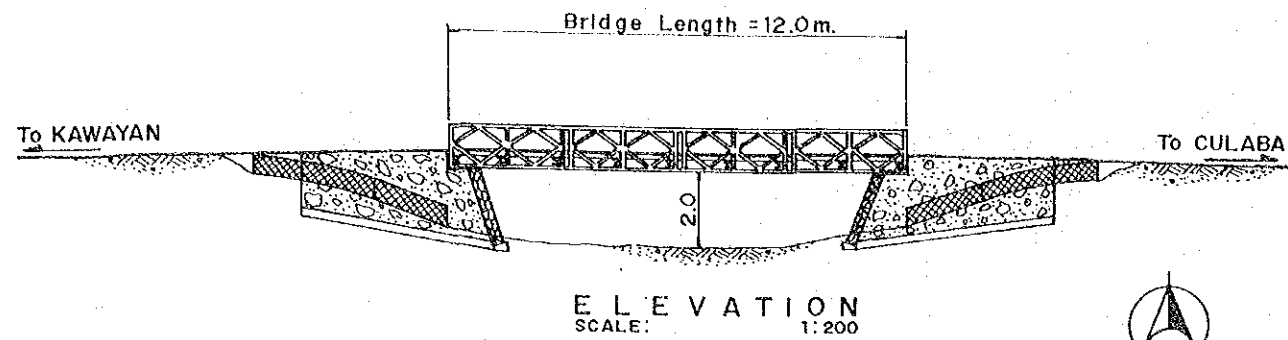
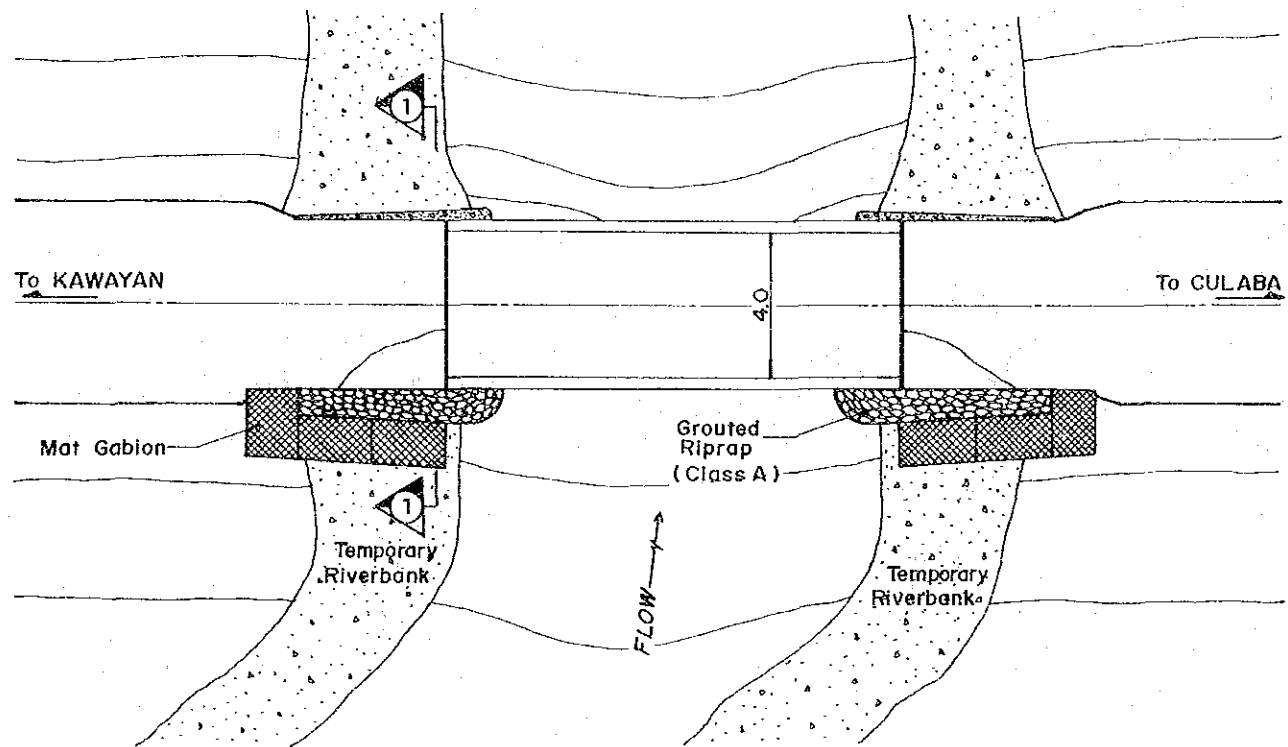
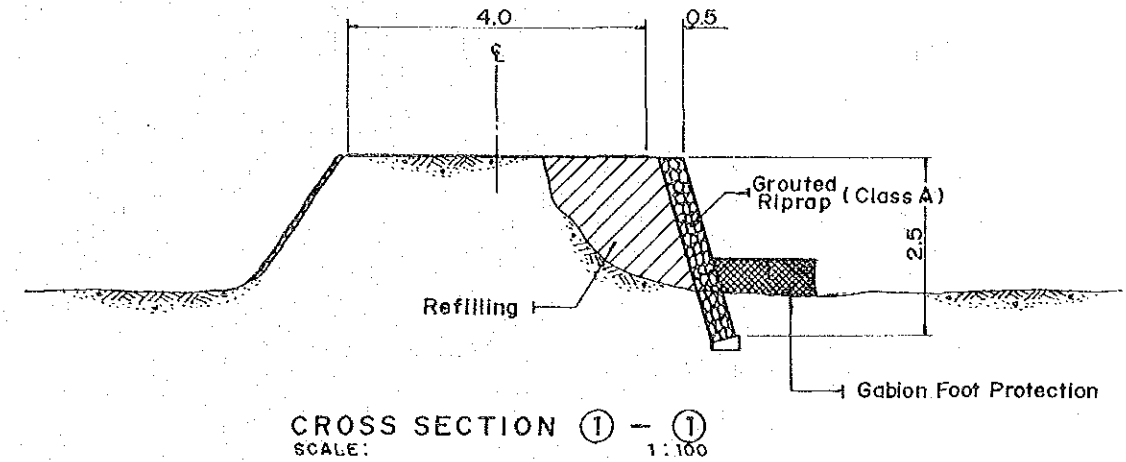
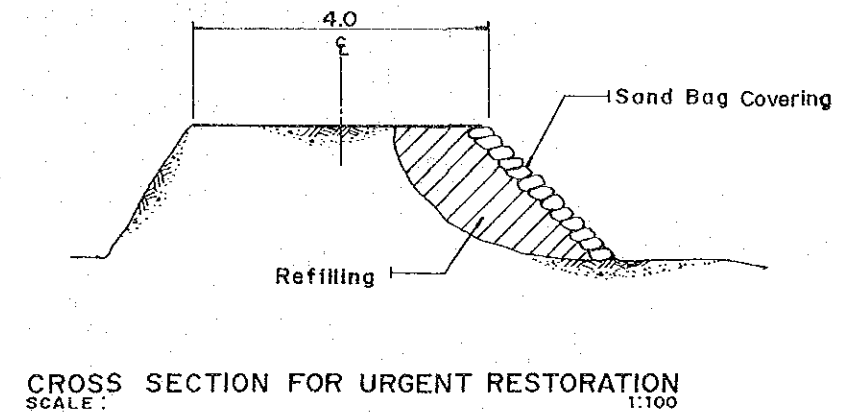
DRAWING NO.
 142

- Type of Disaster: Deep scouring of approach (restored)
- Magnitude of Damage: 2.0 meters length and 1.5 meters depth
- Date Noticed: December 1988
- Degree/Period of Traffic Interruption: Low
- Description of Disaster:

- Two direction of flow caused by debris from upstream, resulting in deep local scouring of the approach.

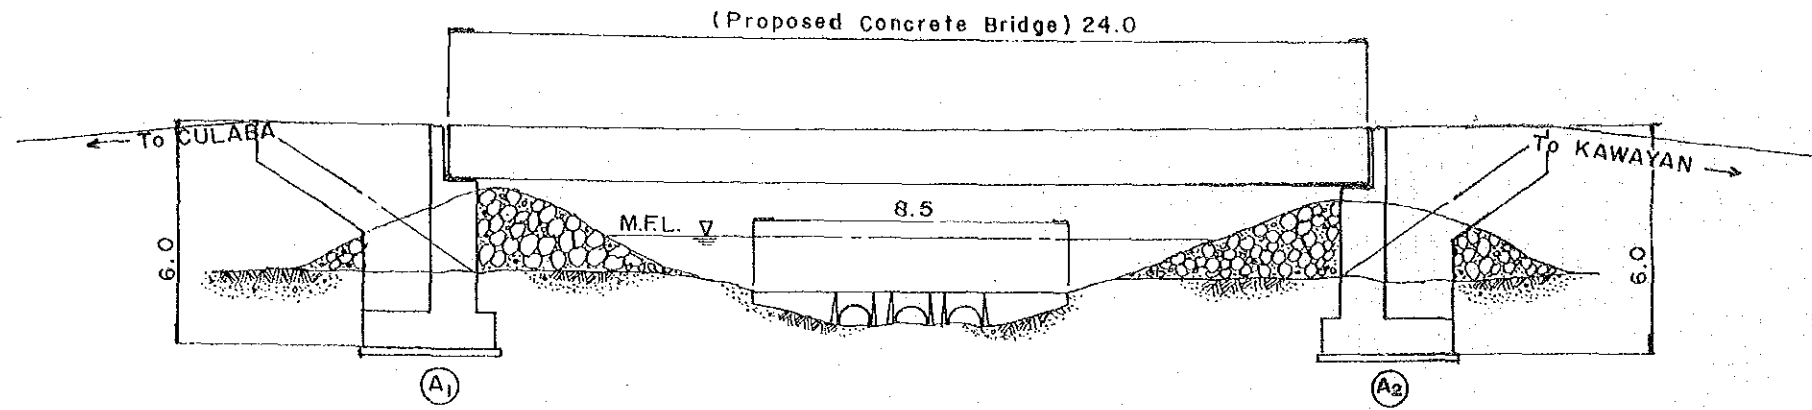
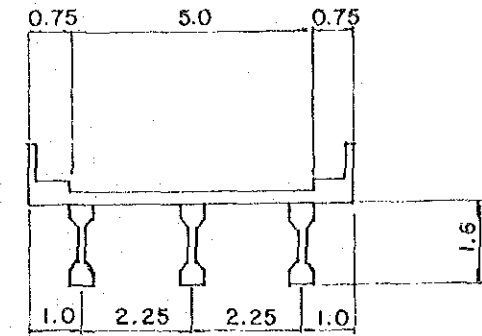
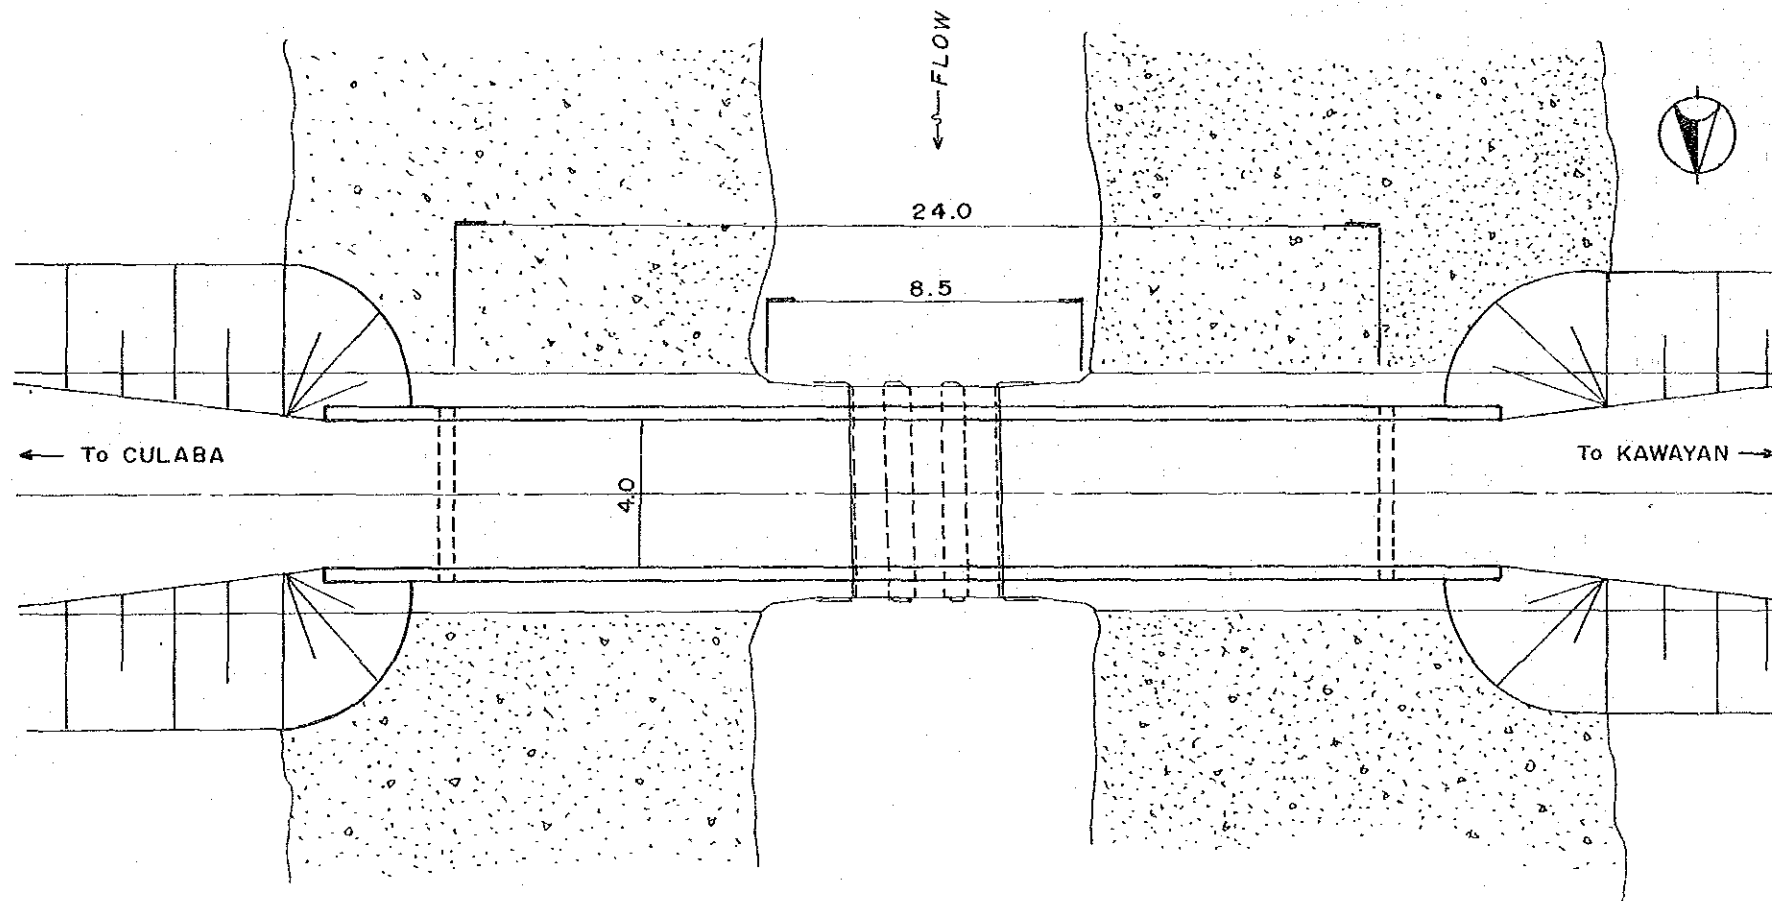
DRAWING NO.
 144

- Type of Disaster: Spillway damaged
- Magnitued of Damage: Both approaches about 8.0m each damaged
- Date Noticed: 1988
- Degree/Period of Traffic Interruption: High
- Description of Disaster:

The Tuccdao spillway is 8.5m. in length and 6.0m in width. Both approaches at about 8.0m. each were damaged last 1988. Too short spillway, thus damaged of approach usually occurred everytime there is flood. Shallow river bed caused debris to overflow along the river bank.

URGENT RESTORATION
 ● Removal of deposit materials

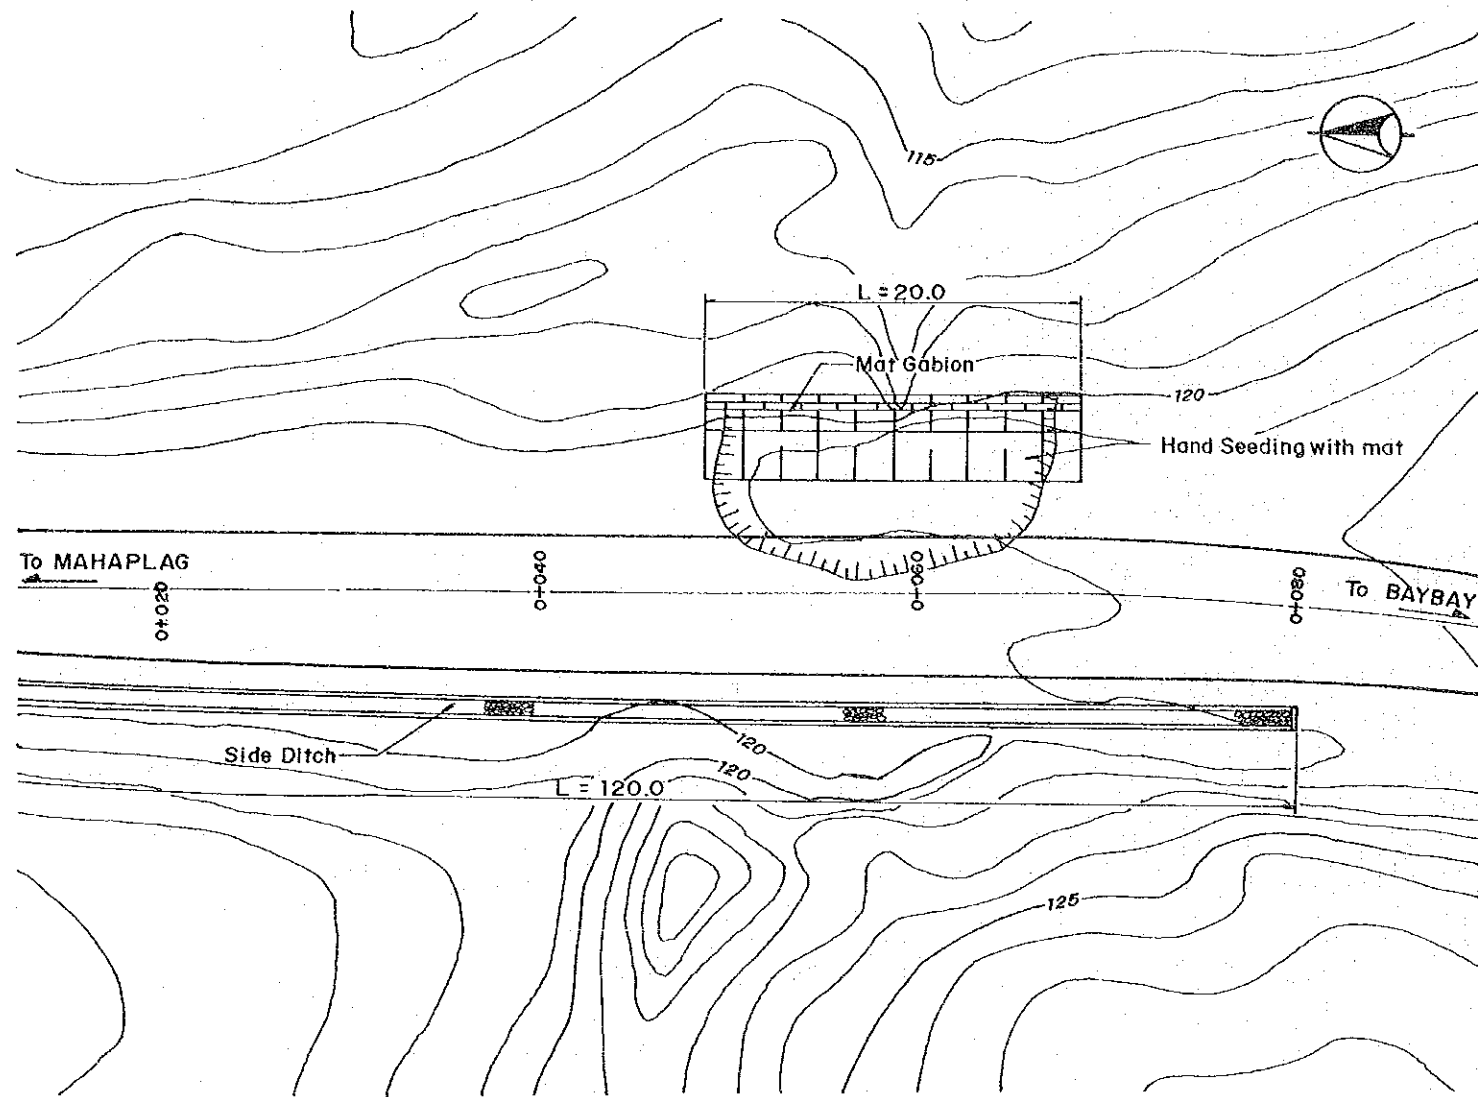
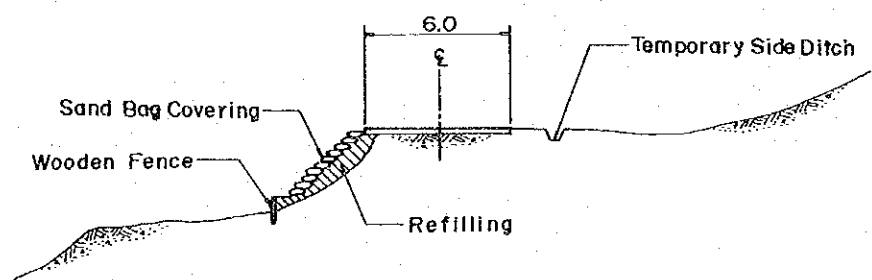
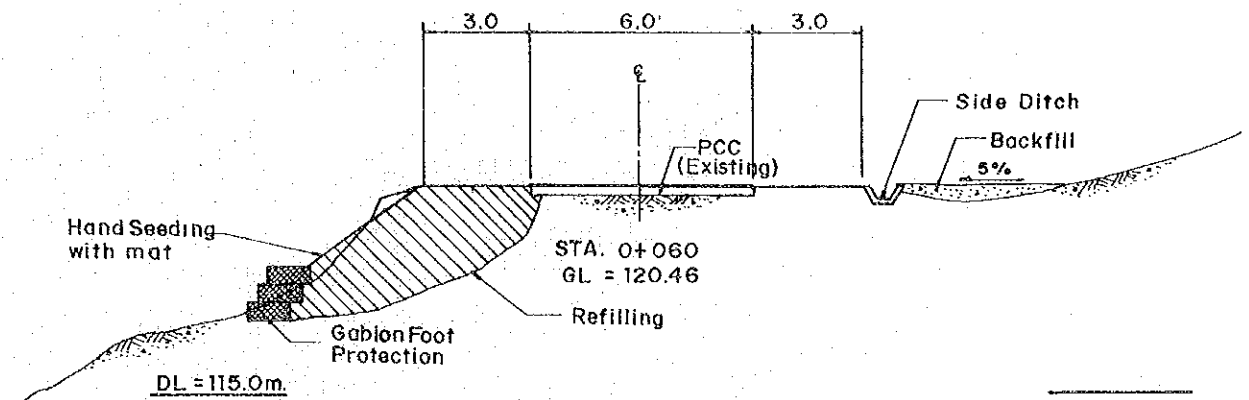
DRAWING NO.
 146

- Type of Disaster: Embankment Failure
- Magnitude of Damage: 45m. length
- Date Noticed: Dec. 1988
- Degree/Period of Traffic Interruption: High
- Description of Disaster:

Cracks on concrete pavement occurred last 1988. It was about 45.0m in length.

Saved water on mountain side was permeated to embankment side and embankment soil was loosened.

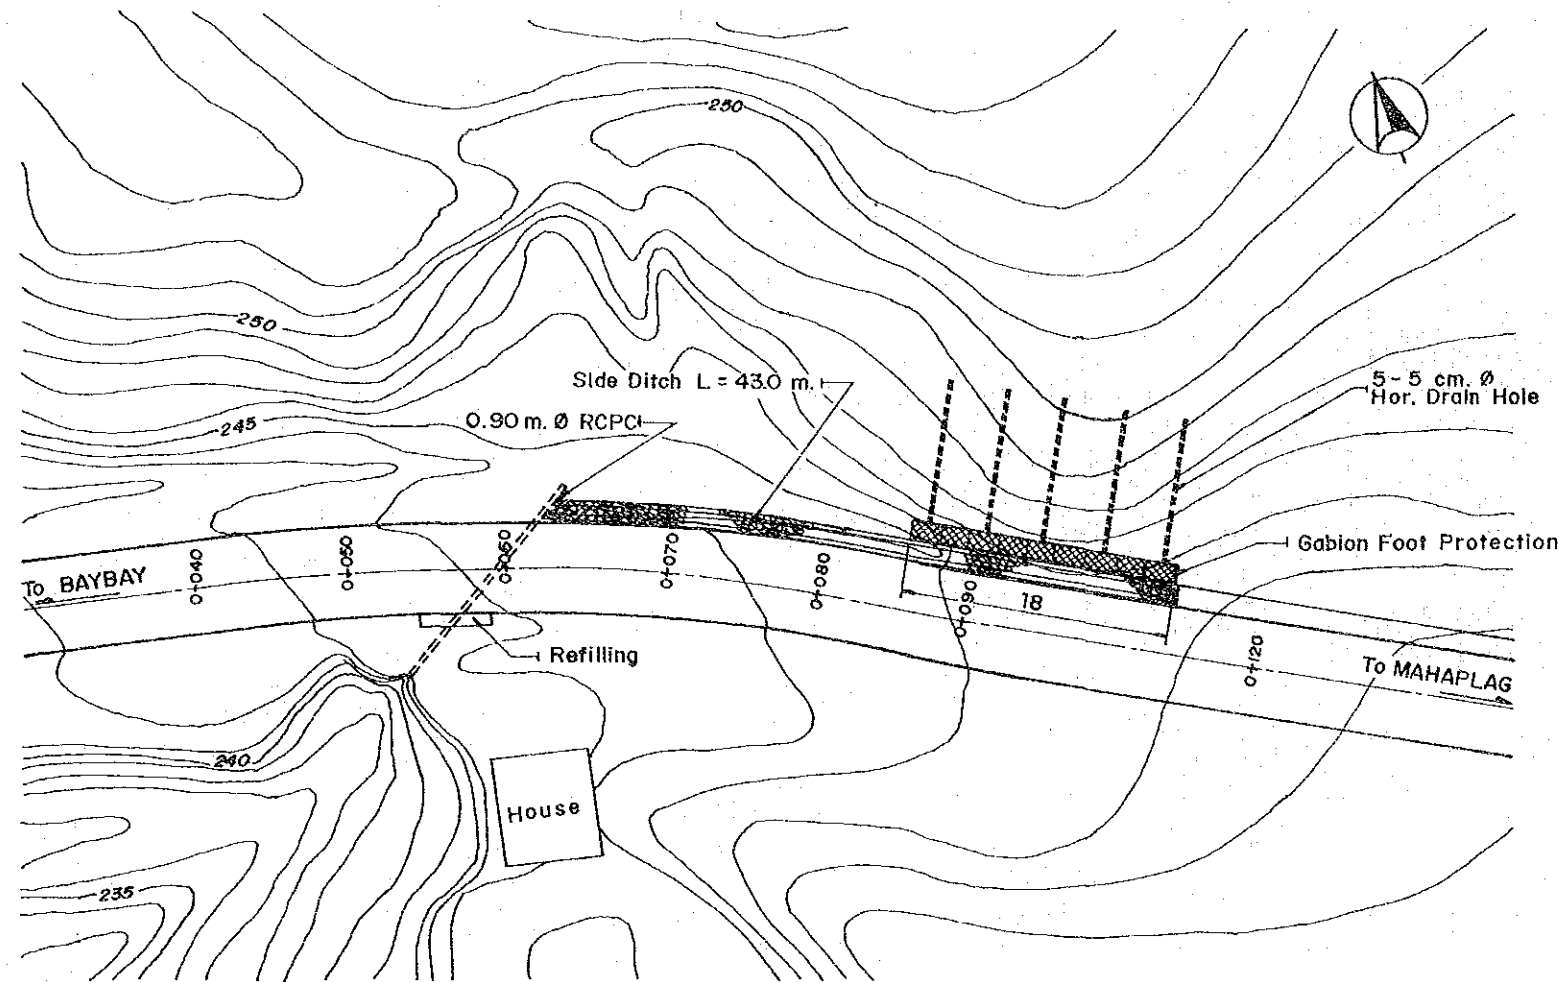
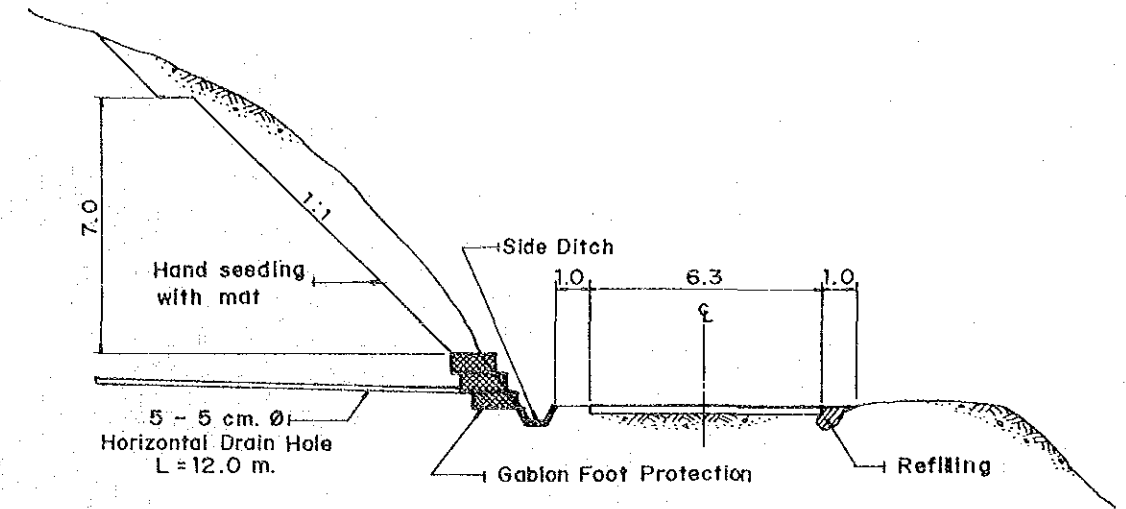
DRAWING NO.
 148

- Type of Disaster: Scouring around the inlet, side ditch and embankment failure at outlet.
- Magnitude of Damage: (Inlet) 6.0m in length; 1.50m in width; 2.0m depth (Outlet) 5.0m in length; 5.0m in width; 15.0m depth
- Date Noticed: 1988
- Degree/Period of Traffic Interruption: Low
- Description of Disaster:

The culvert damaged is located on a curved at a radius of about 132.0m. Vertical alignment is around 6%.

Embankment failure at outlet is about 5.0m length; 5.0m width; 15.0m depth.

Inlet & outlet facilities of the culvert as well as side ditches were damaged.

Landslide cause damage to the drainage and insufficient drainage facilities caused water to overflow on the surface of the concrete pavement thus causing water to run directly on the embankment slope that caused scouring.

URGENT RESTORATION:

- Provide temporary side ditch .
- Removal of deposit materials .

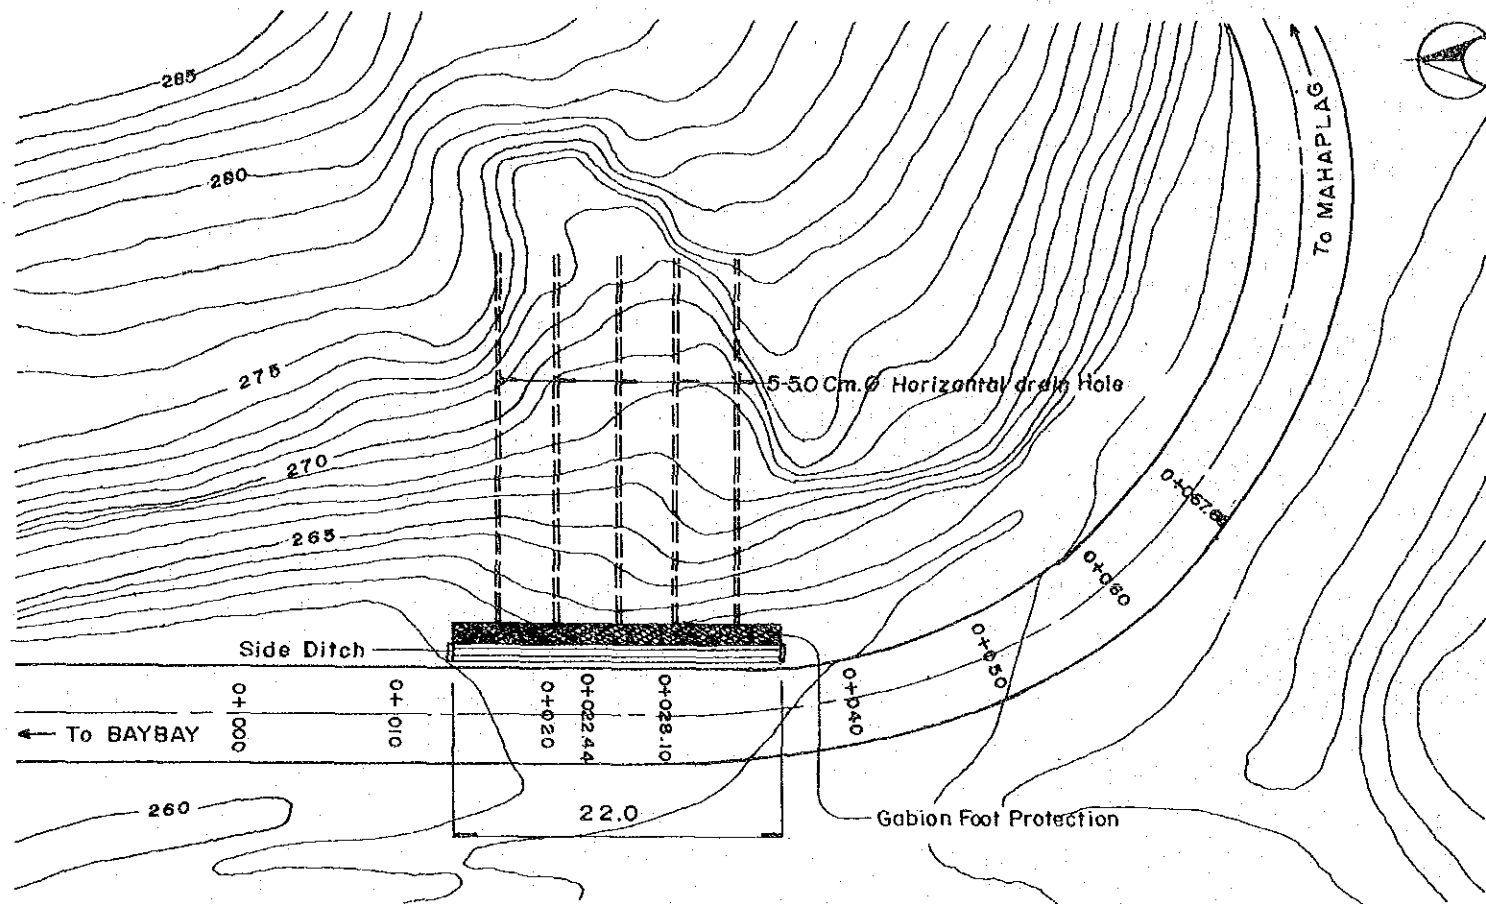
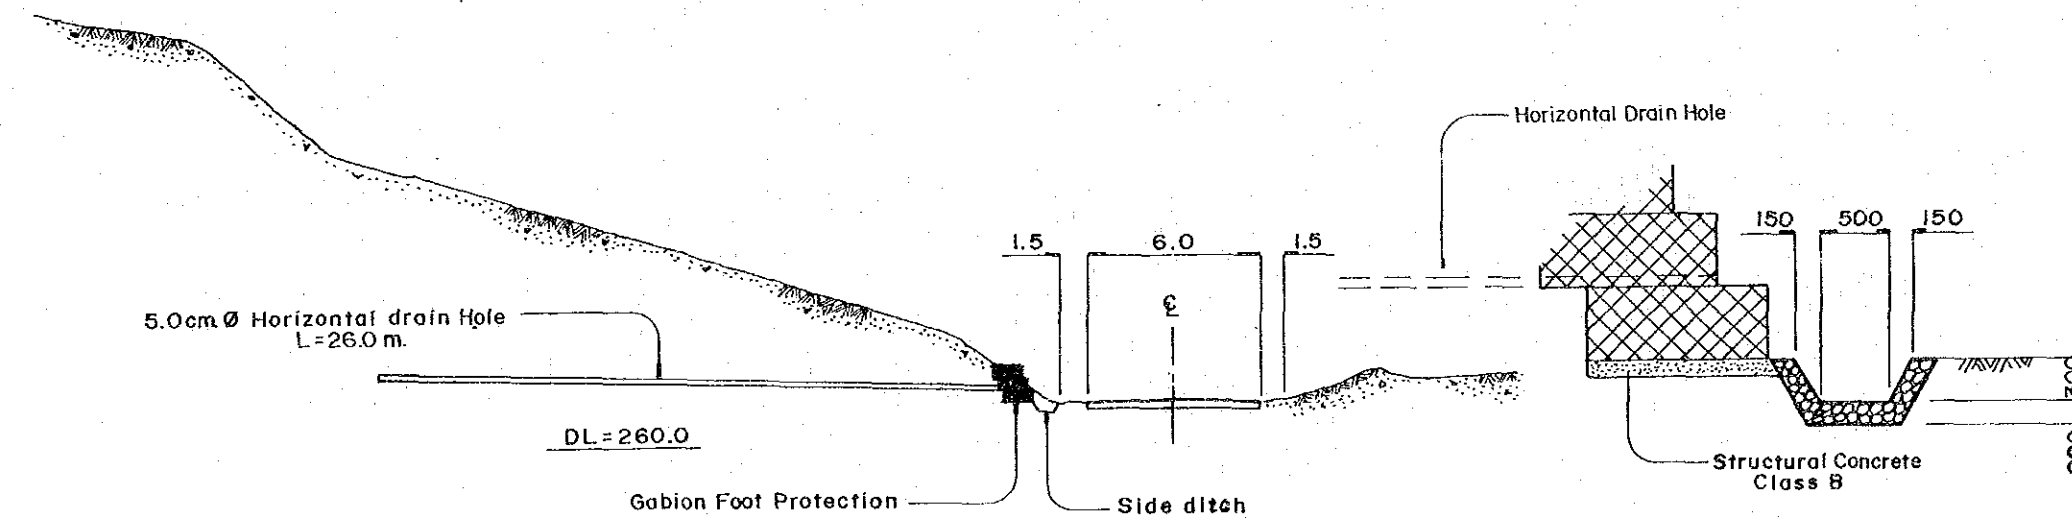
DRAWING NO.
 150

- Type of Disaster: Landslide
- Magnitude of Damage: L=50.0m; H=15.0m
- Date Noticed: 1988
- Degree/Period of Traffic Interruption: Low
- Description of Disaster:

Mass of soils slid along the slide plain when saturated water caused loss of shear resistance between soils. At present, the slope seems to be stable.

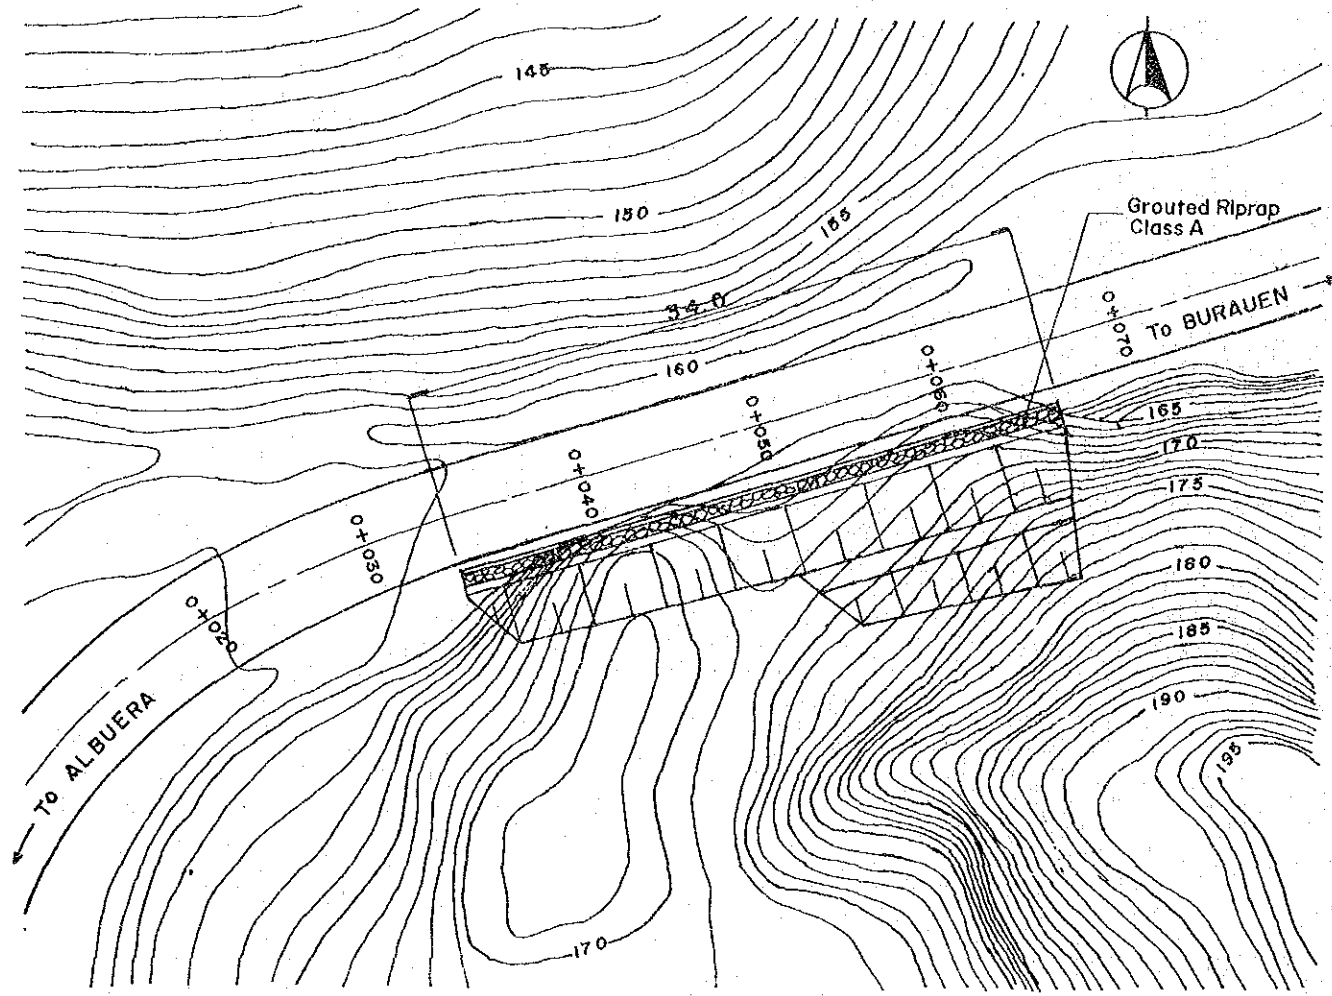
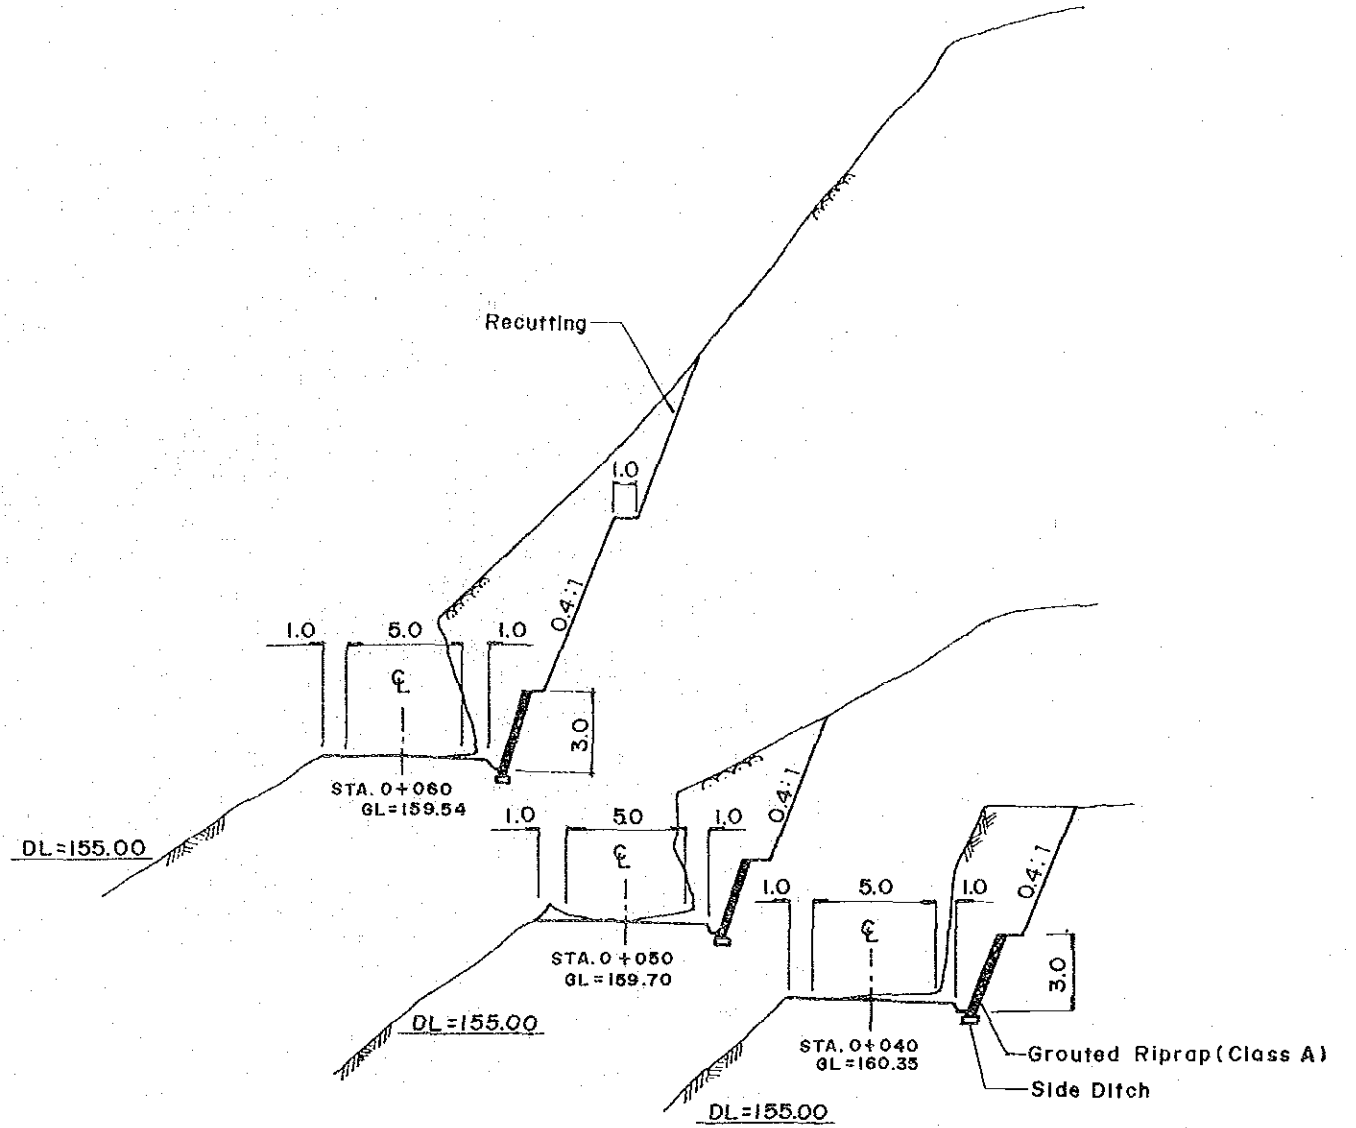
DRAWING NO.
 152

Rock fall is expected due to it's overhang situation and highly weathered condition.
