3. Survey on Aids to Navigation

Survey on Aids to Navigation had been conducted at 20 stations from May 2 to May 23. Table 3.2 and Figure show the areas covered.

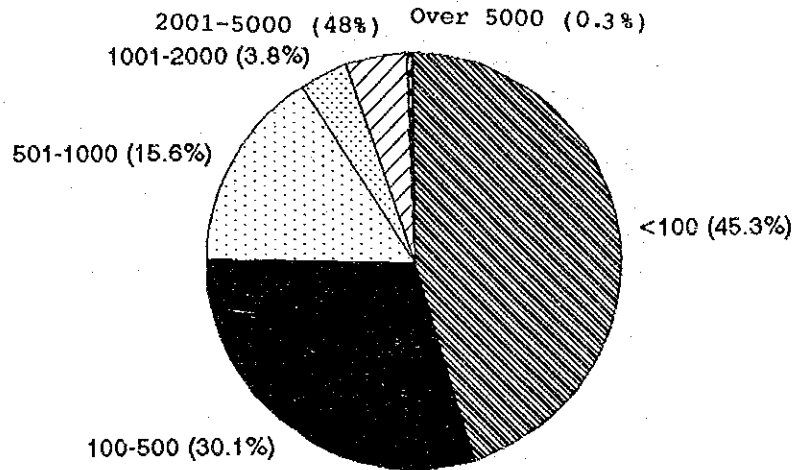
Figure 2.10
Vessel Characteristics by Size (Tons)
Cebu City Port

Vessels with Gross Tonnage (GRT) of less than 100 tons dominate the Cebu City Port with a percentage of 45.3, followed closely by 100-500 GRT at 30.1% and 15.6% for 501-1000 GRT.

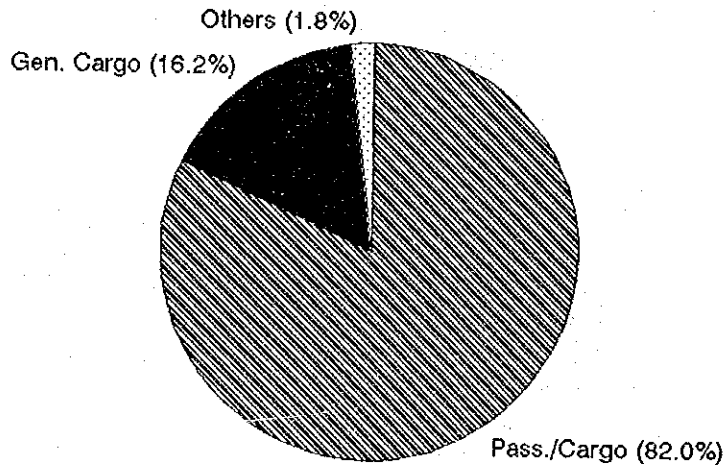
Figure 2.11
Vessel Characteristics by Type
Cebu City Port

Passenger/Cargo type ships comprise 82.0% at the total sea vessels docking/anchoring within the Cebu City Port, as can be seen in Figure 2.11. The General Cargo type registered 16.2% while the other types (i.e, motor tanker, motor launch, motor boat and barge) amounted to 1.8% .

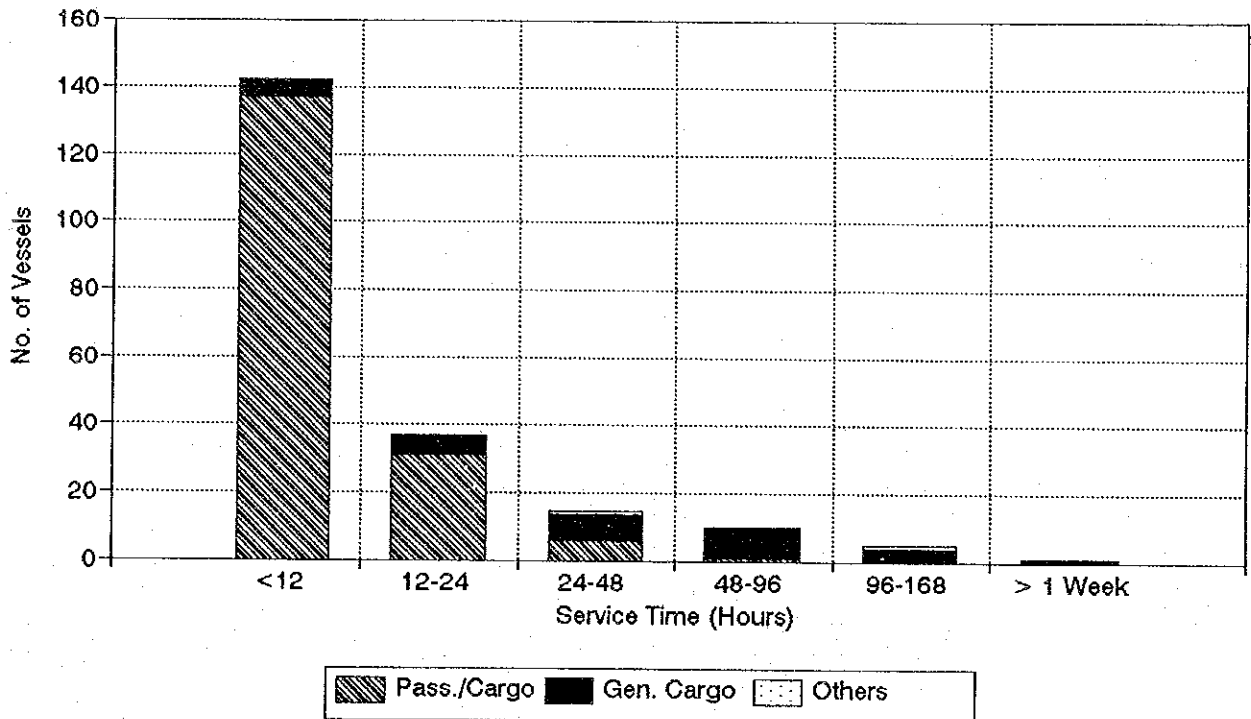
Figure 2.12
Service Time by Vessel Type
Cebu City Port

Unlike the Manila North Harbor, service time in Cebu City Port is generally shorter with large volume of vessels docking for less than 12 hours. Average service time of Passenger/Cargo and General Cargo are 10 hours and 56 hours. Around 80% of Passenger Cargo vessels are small, below 100 tonnages, than their service time is quite short.

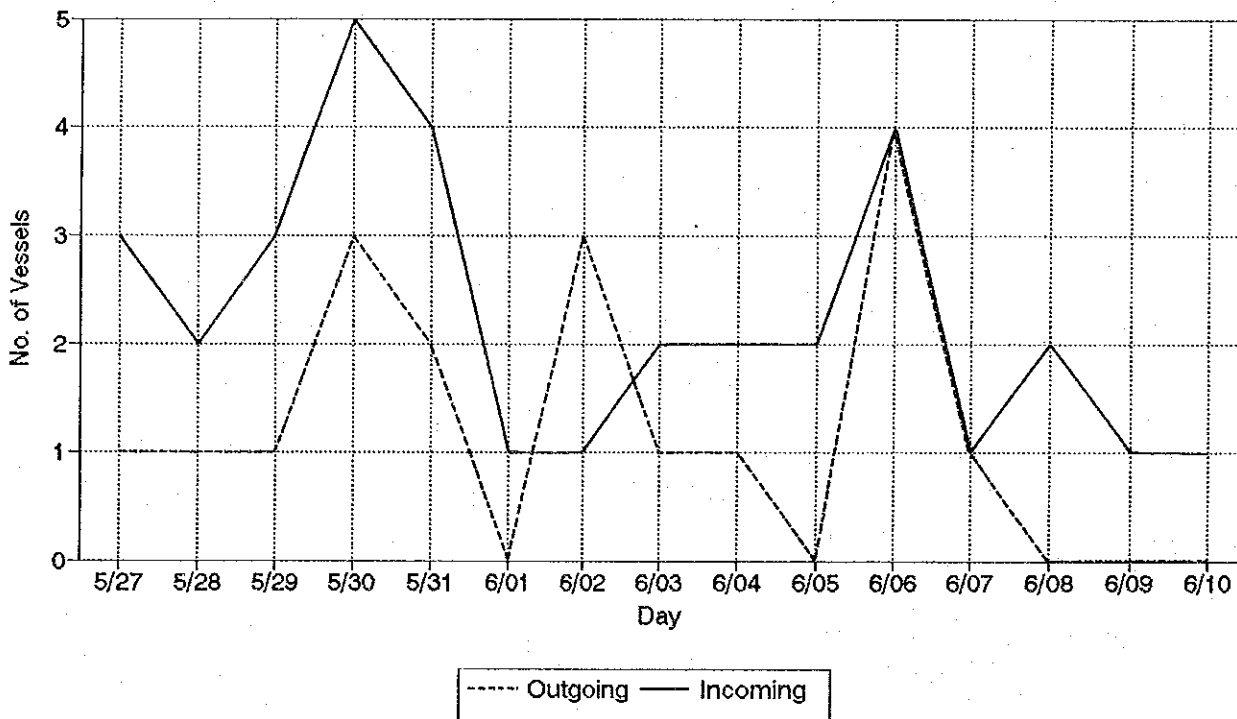
Figure 2.15
Daily Traffic Volume
Cagayan de Oro Port

The presence of neighboring private ports along the seashore of Cagayan may be the reason for the scarcity of traffic volume in the Base Port. Maximum and minimum incoming daily volume are recorded at 5 and 1 while the maximum outgoing is 3 and not-at all as a minimum.

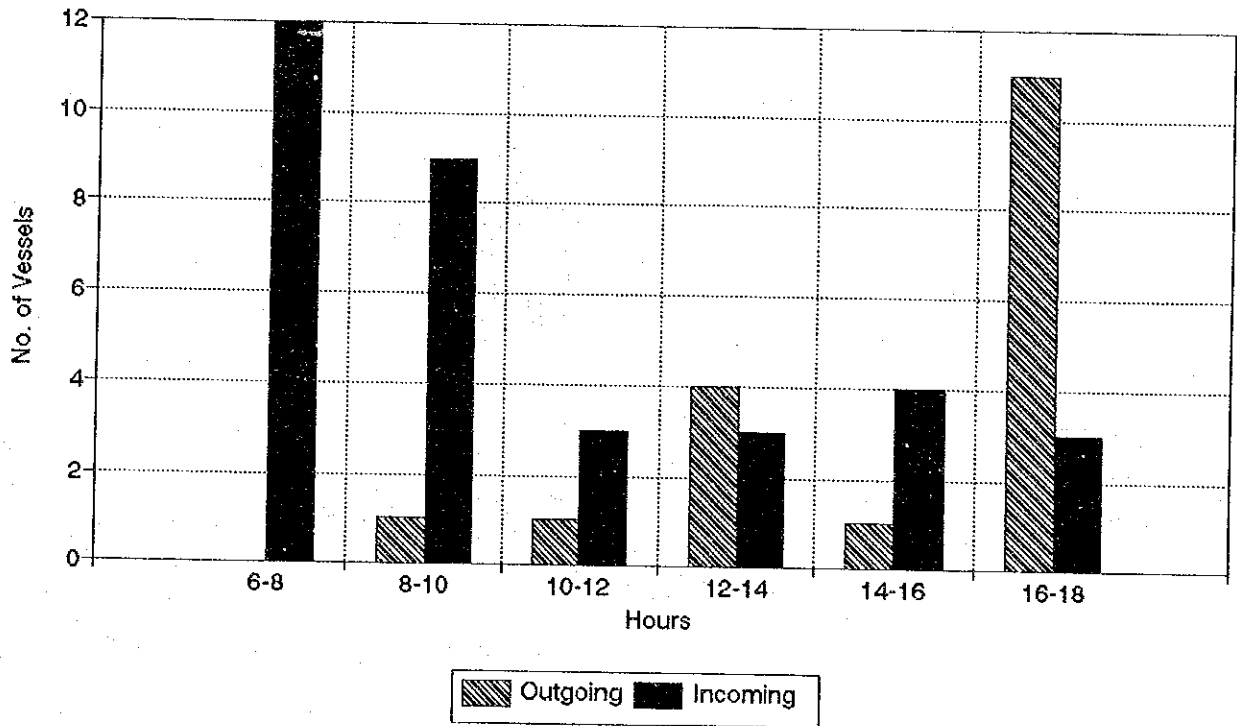
Figure 2.16
Traffic Volume Every Two Hours
Cagayan de Oro Port

Peak hour incoming traffic volume is recorded at 6.00 - 8.00 a.m. while outgoing volume reach its peak at 4:00 - 6:00 p.m.

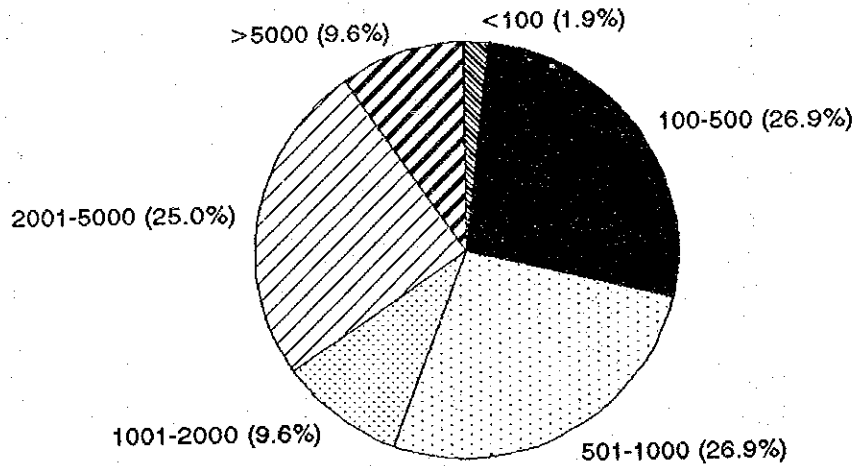
Figure 2.17
Vessel Characteristics by Size (Tons)
Cagayan de Oro Port

Small vessels with a gross tonnage ranging from 100-500 tons has the highest share among the vessels in Cagayan de Oro Port. However, large and middle vessels have considerable shares respectively.

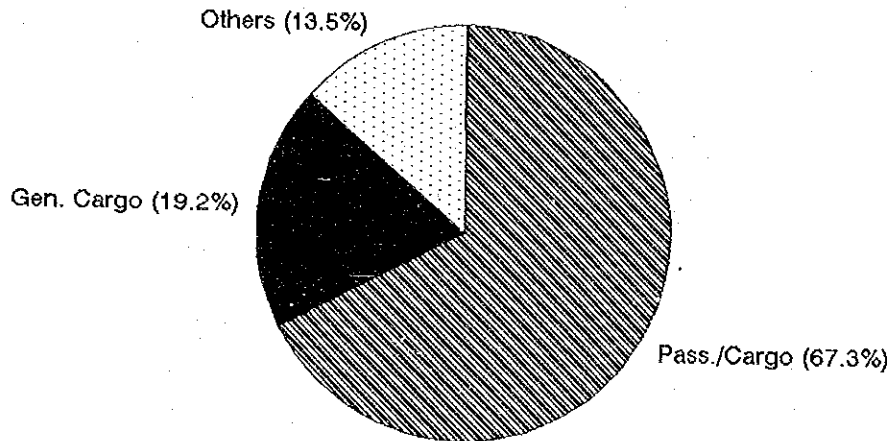
Figure 2.18
Vessel Characteristics by Type
Cagayan de Oro Port

Passenger/Cargo vessels has the highest share of 67.3% followed by General Cargo vessels at 19.2% and the rest at 13.5%.

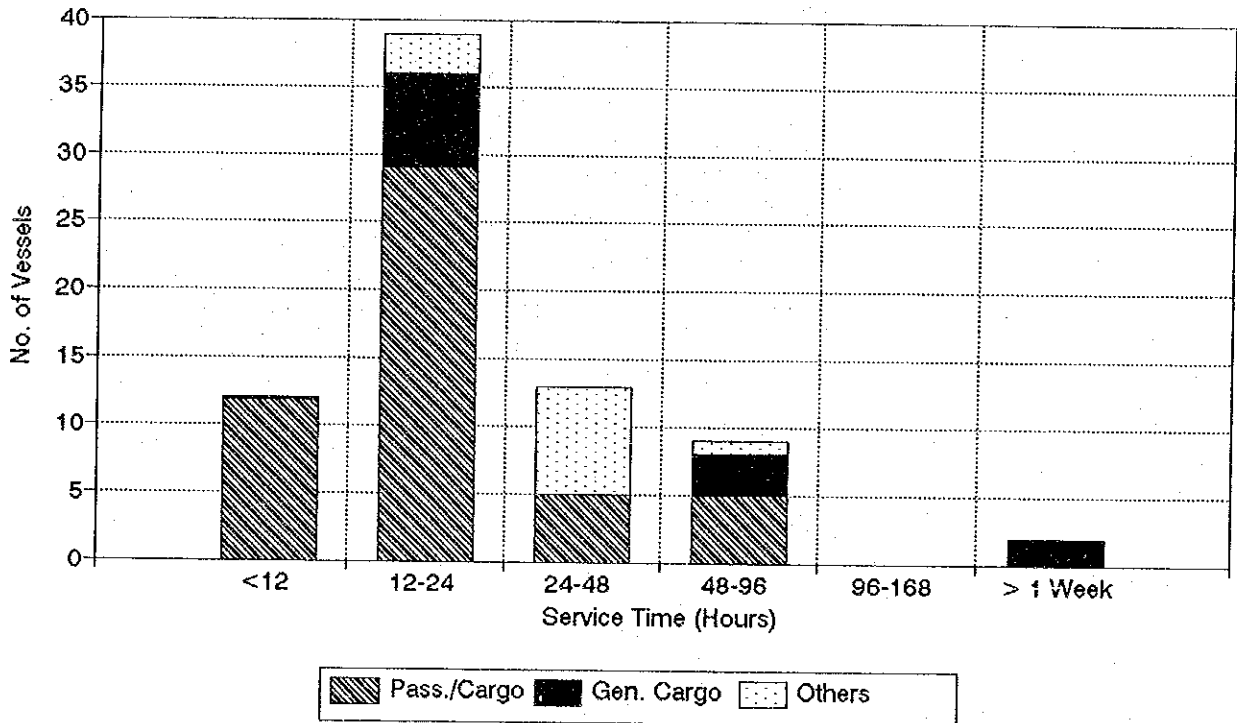
Figure 2.19
Service Time by Vessel Type
Cagayan de Oro Port

Average service time of Passenger/Cargo and General Cargo is 22 hours and 62 hours respectively. Due to introduction of modernized stevedoring service, service time is considerably short.

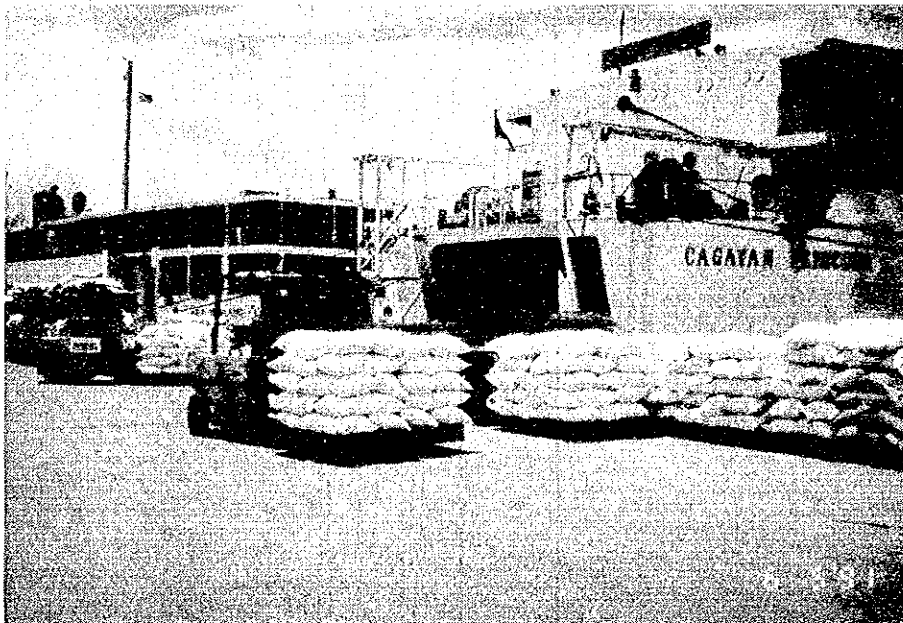
Picture CDO - 2

Modernized Stevedoring System
