3. Present Status of Power Plant Facilities

6.2.3 Formulation of Rehabilitation Plan

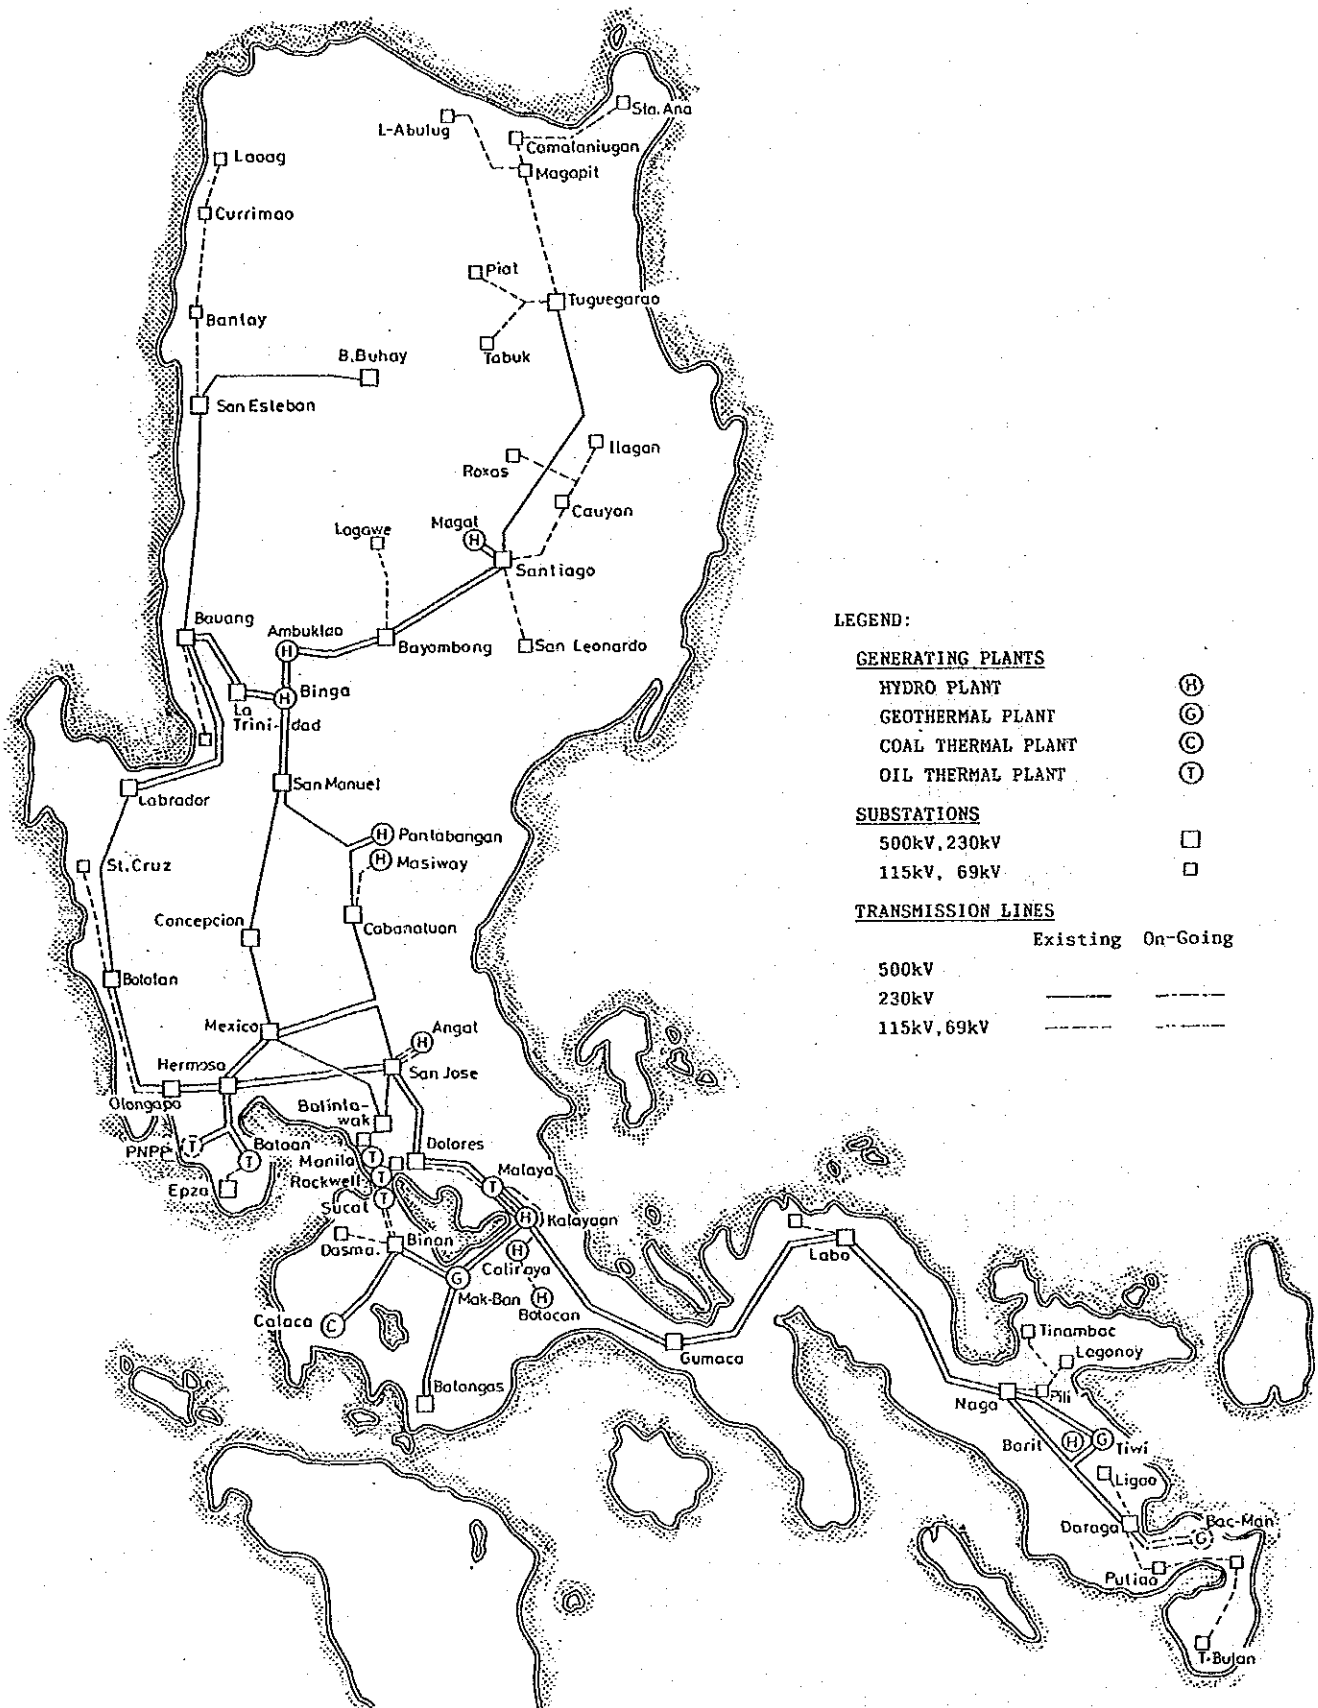
Fig. 6-4-1 LUZON GRID POWER SYSTEM DIAGRAM

As shown in Fig. 6-4-1, the Luzon Grid consists mainly of 230 kV system which runs through the island from north to south, with 115 kV system used in some parts of the island. The secondary transmission voltage is 69 kV. Data on the 230 kV transmission lines are shown in Table 6-4-1, and the length of transmission lines and the substation capacity for each area office are shown in Table 6-4-2.
