付属資料 VI 農村建築の震害とその原因

RURAL BUILDINGS IN TURKEY THAT HAVE SUFFERED DAMAGES
IN RECENT EARTHQUAKES AND THEIR MAIN CAUSES

M.HASAN BODUROGLU

Structural Damage due to the 1976 Çaldıran Earthquake

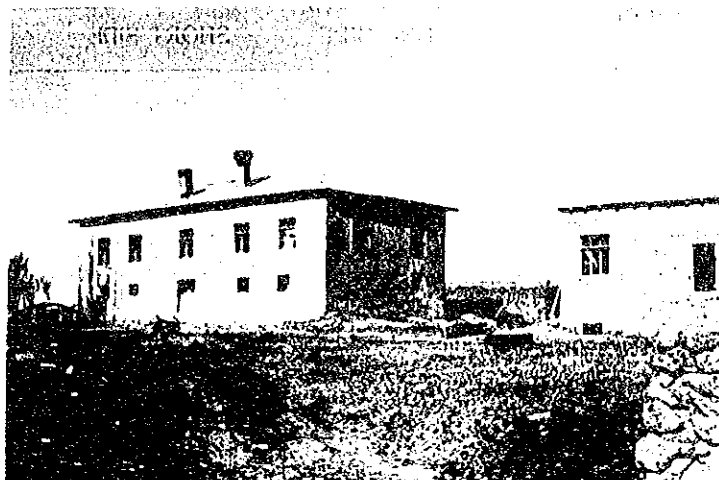
Fig. 3 Adobe House from Muradiye.

There is not adequate quantitative data on the dynamic characteristics of rubble stone and adobe masonry buildings in Turkey. The period of vibration measurements made in two buildings in Muradiye Town, one in adobe building (dimensions $7.5\text{ m} \times 4.5\text{ m}$ height 3.0 m) and one in rubble stone masonry (dimensions $5\text{ m} \times 12\text{ m}$, height 3.0 m) are shown in Figs. 3 and 4. It appears that these buildings had relatively long periods and damping values for one-story high buildings (Figs. 5 and 6).

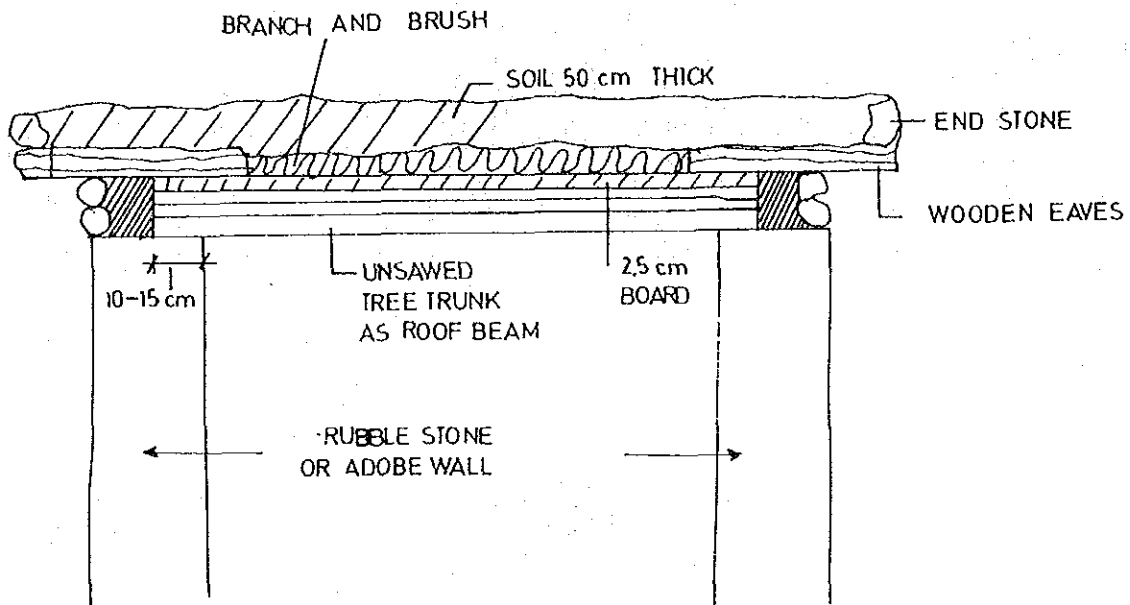
Fig. 7 Typical Flat Earth Roof Cross Section.

The typical flat earth roof is as shown in Fig. 7. This is a very widely used roofing detail where this type of roofing is adopted. The roof is supported by round tree trunks which were not sawed and which act as roof beams. Their span is usually determined by the size of trees available in the region, but they are rarely more than 4.0 meters. The roof beams are spaced at intervals varying from 25 cm to 50 cm. The beam ends rest on top of the walls only for a depth of 10–15 cm. On top of these beams boards of 2–2.5 cm thickness are placed and are sometimes nailed to the logs acting as beams. On top of these boards tree branches, bushes etc. are placed. The final insulation layer is composed of soil with a thickness sometimes exceeding 50 cm. Such a roofing system usually has a weight of 0.75–1.0 tons/ square meters. Where as an ordinary reinforced concrete slab of 12 cm thickness has a weight of 0.3 tons per square meters.

In order to prevent the rain and snow melt seepage through the earth roof, after every rain, and usually at the start of the rainy season, new finer material is added to the roof and compacted by stone cylinders called 'log'. Every earth roof generally has a stone 'log' used for compaction of roof soil. Thus over the years the soil layer on top of the roof gets thicker, denser and heavier. With time the roof beams are also affected by moisture, attack of fungi, and creep of timber and start developing large deflections, thus roof beams get weaker. To prevent water accumulation in places where there is large deflections, the roof should be as flat as possible. This is achieved by placing a thicker layer of soil onto the deflected portions of the roof. Thus through these processes with the passage of time the roof gets heavier and the beams weaker.

Another very important weakness of this type of roofing is the connection between the walls and the roof beams. As mentioned before the beam ends rest on the wall for a depth of only 10–15 cm. The only way of transfer of force between the roof and the wall is through friction. If the wall or the roof makes large displacements the roof is highly liable to fall down in the case of an earthquake.

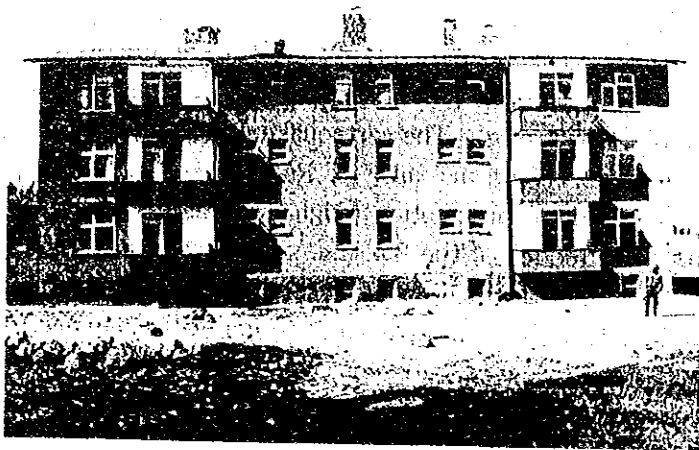
Fig. 18 Çaldıran Staff Housing.

This three story brick masonry building had a plan and orientation with respect to the fault as shown in Fig. 19. It is located approximately 300 meters away from the fault.

During the earthquake it was slightly damaged. The dynamical and structural characteristics of this building were as follows :

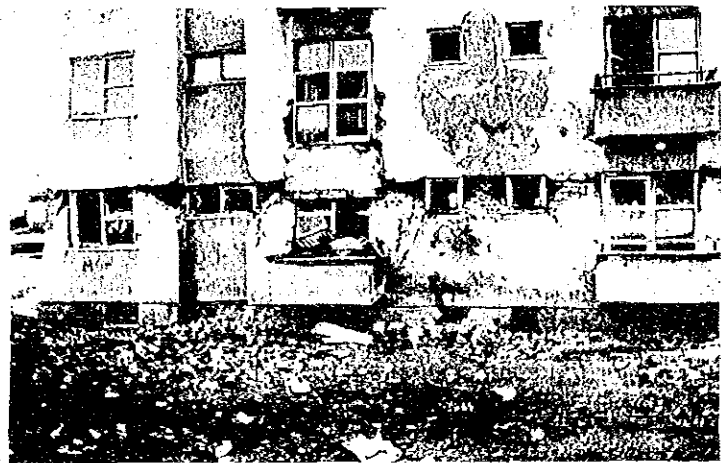
Fig. 20 Muradiye Staff Housing.

This was a designated 'type' building constructed all over Turkey. The three story brick masonry building had a different plan and orientation with respect to the Çaldıran fault (Fig. 21). Although it is located in Muradiye town which is approximately 25 km away from Çaldıran town where the intensity was highest (IX MSK). The assigned intensity in Muradiye was only VII MSK (Ref. 1). However this building was more severely damaged than the staff housing in Çaldıran. The structurally 'weak' axis of the building coincided with the direction of the fault in Çaldıran which is taken as the direction of the dominant component of the ground motion. The damage inside the building in the long direction were as severe as the outside (Fig. 22). The dynamical and structural characteristics of this building were as follows :

Of the two opening ratios given in the long direction, the larger one is for the ground floor and the smaller one is for upper story. The period for undamaged building was measured in an identically the same type building located in Ankara. In the damaged direction

of the building (long direction) the vibration period of the building were increased by 3 times due to the degree of damage caused by earthquake.

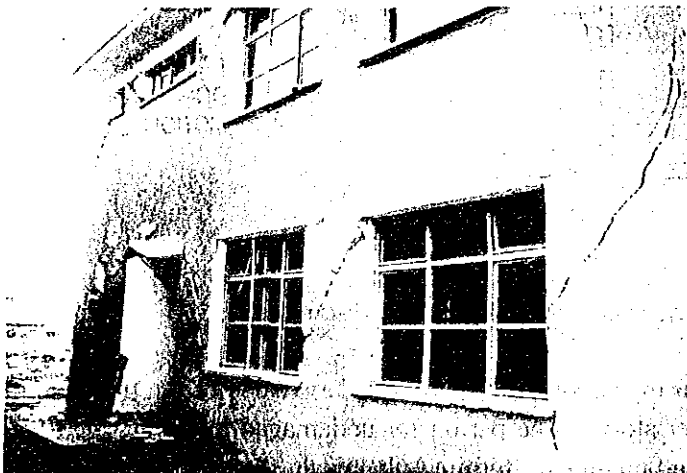
Fig. 23 Muradiye Junior Highschool Annexe.

This was another designated 'type' building constructed throughout Turkey (Fig. 23). Its plan and orientation with respect to the fault formed by the November 24, 1976 earthquake is as shown in Fig. 24. This building also sustained considerable damage. The dynamical and structural characteristics of this building is as follows :

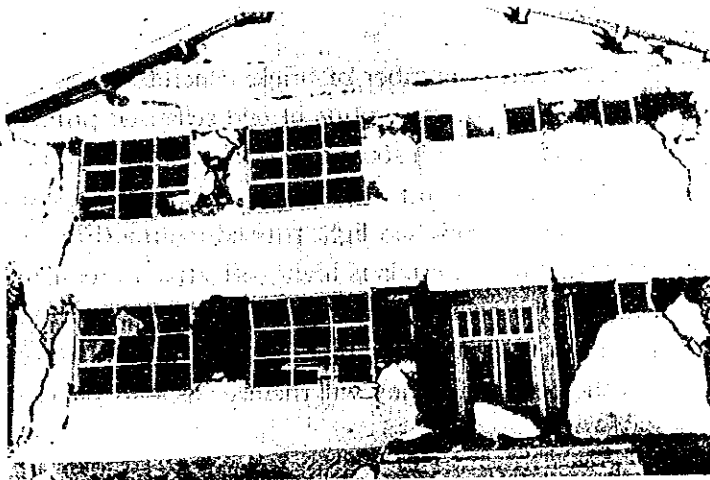
Fig. 25 Lice Junior Highschool Annexe.

It happened that the same type of building had been in the town of Lice and damaged by September 6, 1975 earthquake, magnitude of which was 6.9 (Reference-3). The intensity assigned to town of Lice was VIII MSK. The building in Lice had been more severely damaged than the one in Muradiye. The damaged building in Lice is given in Fig. 25.

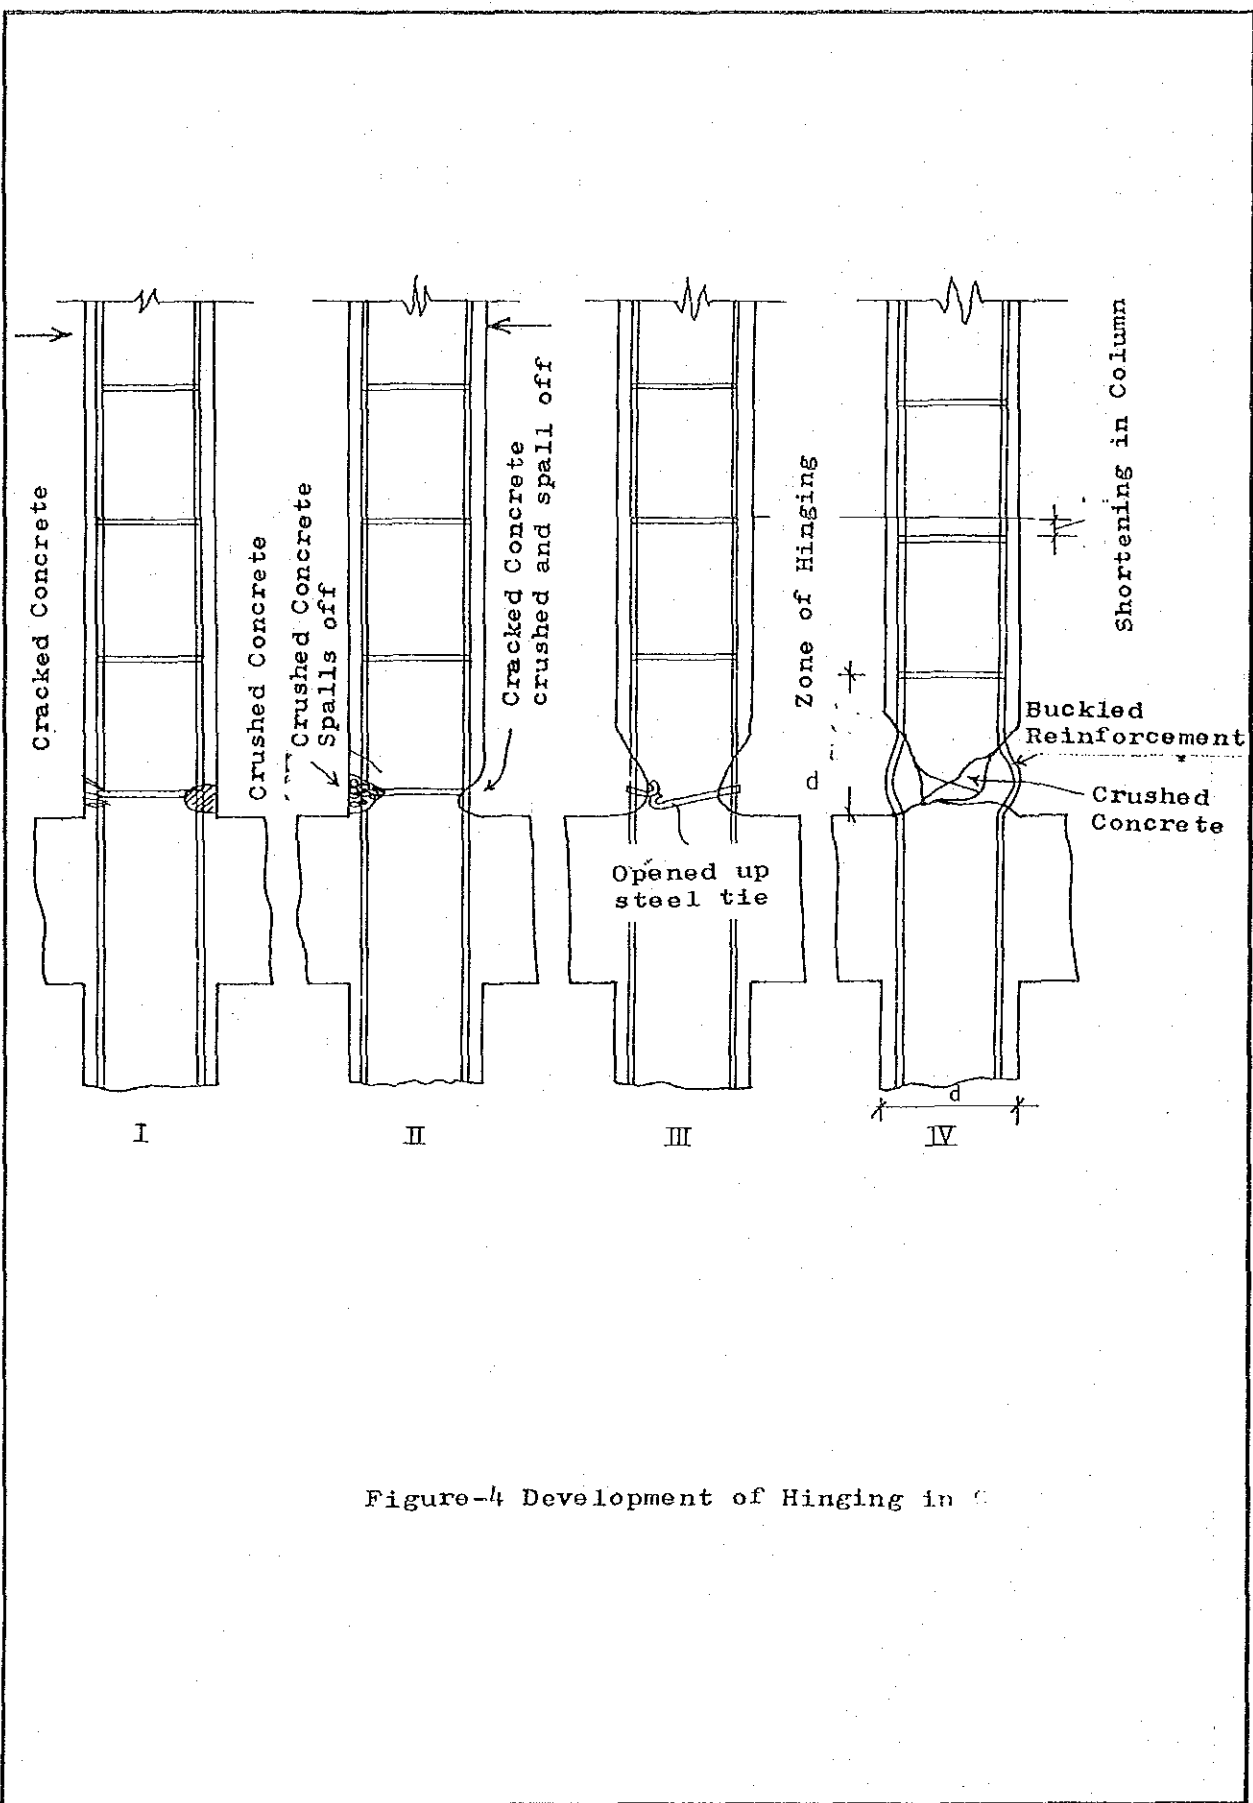
Figure-4 Development of Hinging in C

The most commonly observed damage in reinforced concrete buildings are the column damage by hinging as shown on Figure-4. This is a ductile failure with a lot of energy dissipation. As long as more columns with fixed ends than the earthquake energy turn into hinges, eventhough there may be severe hinging in the columns the building will resist the earthquake. Since the columns have low percentage of longitudinal steel this type of tension or moment failure is frequently encountered.

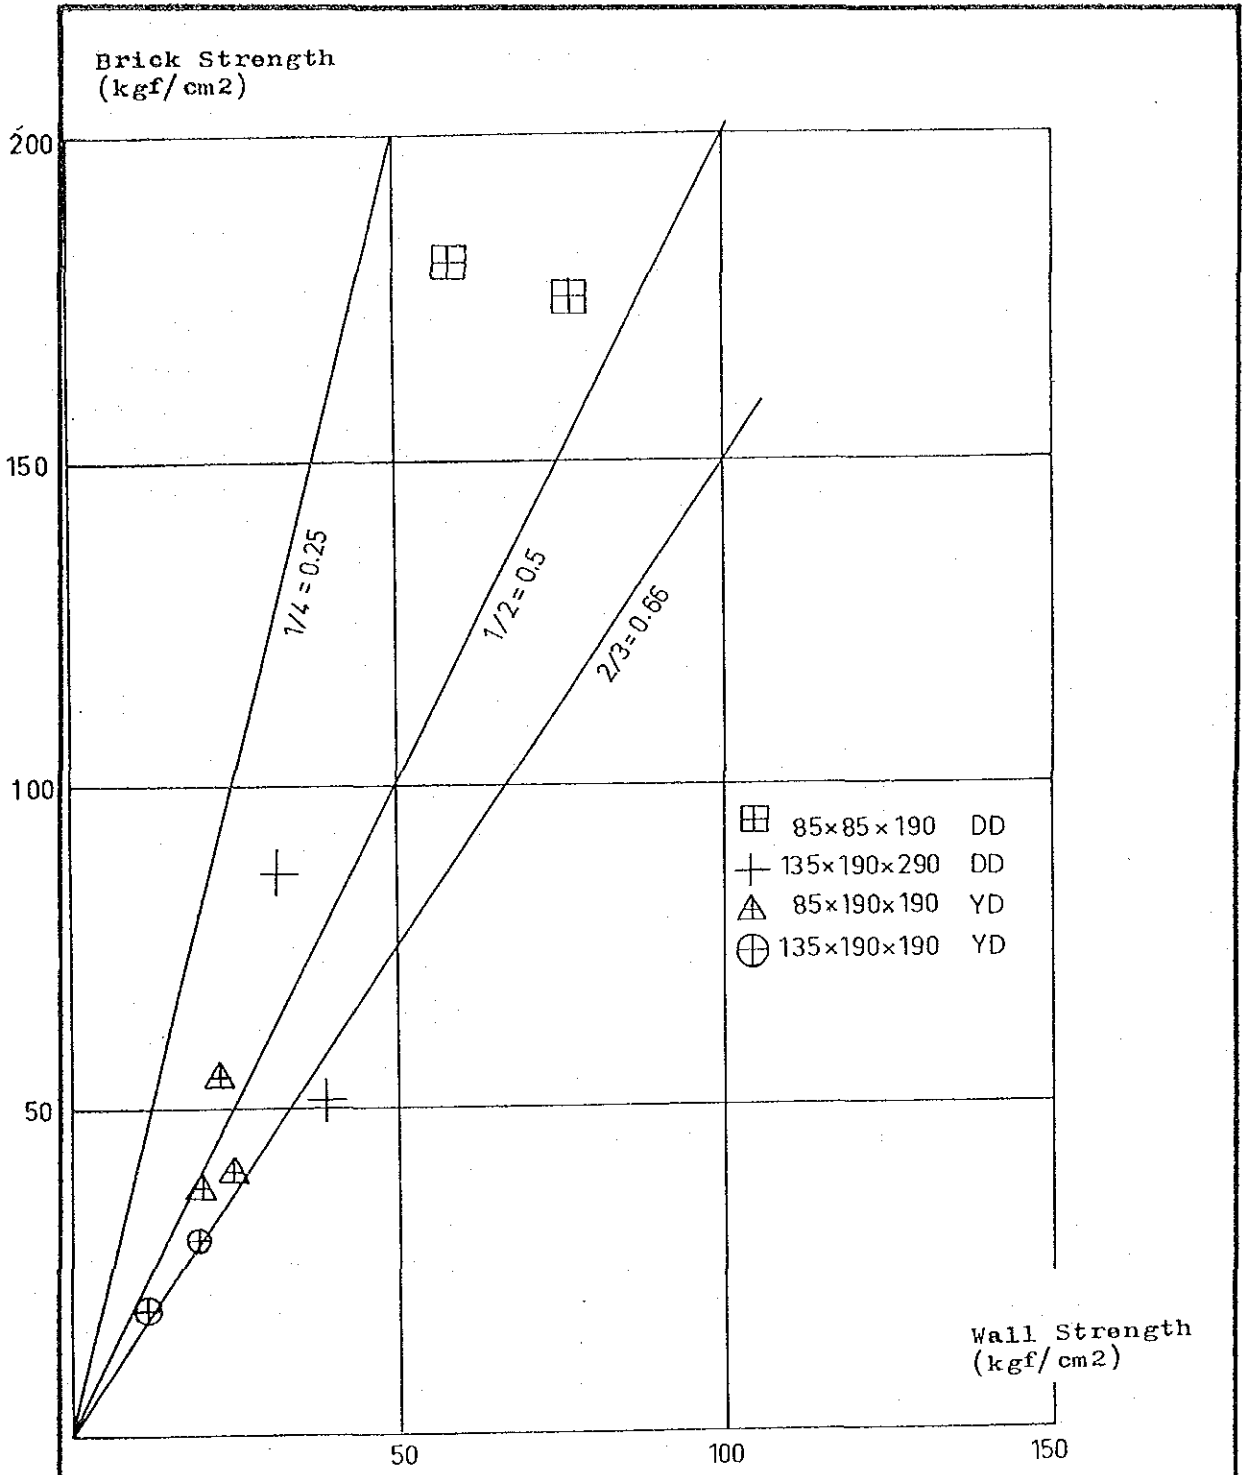
Figure-16 Relation Between Wall Strength and Brick Strength

In Turkey there are now four kinds of clay bricks used in masonry houses; 1-Hand made bricks: They are fired at low temperatures and they have low strengths. Their compressive strengths are 20-30 kgf/cm². Their dimensions are 190x90x55 and 220x105x55 mm. With the construction of brick factories all over Turkey their production is on decline. 2-Factory Made Load Carrying Solid Bricks: These bricks can have vertical perforations of 15 % of their cross section area. Compressive strengths are about 200 kgf/cm². They are 190x95x50 mm size. Even the lowest quality ones have a compressive strength of 100 kgf/cm². 3-Factory made Load Carrying Block Bricks: These have vertical perforations. They have two types 190x90x85 and 190x290x135 mm. The area of perforations are 30-35 % in the first and 50-55 % in the second type. The first type has compressive strengths of 100-150 kgf/cm² while the other type has 60-70 kgf/cm². The second type is widely used although it has more perforations than which is allowed by standards to be used in load carrying walls. 4-Hollow Block Filler Bricks: Although they are produced for filler walls of reinforced concrete buildings they are being used as load carrying walls in masonry buildings. They have 45-50 % perforations and 190x190x85 and 190x190x135 mm dimensions. Their compressive strength about 20 to 30 kgf/cm².

The kind of mortar used in masonry is of low strength. The cement, lime and sand ratio of 1:4:8 by volume is the most commonly used mortar mix ratio. This mortar has a 28th day compressive strength of approximately 10 kg/cm². Using this type of mortar with the above type of bricks results in wall compressive strengths of 0.3-0.75 times the compressive strength of brick. A test carried out by the author shows the relation between brick strength and wall strength in Figure-16. There is not much information about the shear and tensile strengths of walls made from these materials. Strengths in the order of 1-2 kgf/cm² seem to be probable values for this kind of masonry construction in Turkey.

The earthquake code requires that the strength of the brick to be used should not be less than 50 kgf/cm².

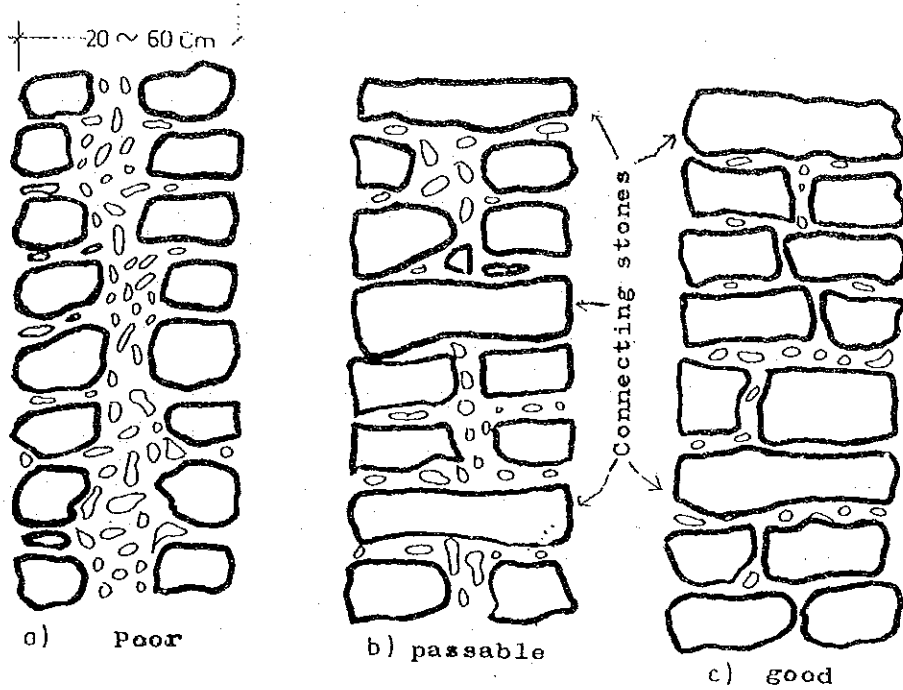
Figure-20 Typical Wall Cross Sections

In figure-20 rubble stone masonry wall types are given. If there are horizontally bedded and cracked rock formations relatively good stone work is done. However most of the time the walls are like as given in Figure-20a. The stone is collected from river beds or fields. These are usually round, well polished and sometimes moss covered stones. The wall is usually made from stones of all sizes. In such cases even if cement reinforced lime sand mortar is used as mortar it is quite difficult to achieve connection between the stones. Use of large sized stones also prevents bonding between stones. This is evidenced from the damage of state built school, medical center etc buildings built by using the same stone but cement, lime and sand mortar. Although such built public buildings do not collapse, they are severely damaged and demolished.

Use of mud as mortar does not provide any connection or bond between stones after the mud has dried out and crumbled. Dried mud usually falls out on the wall. The only connection between stones are achieved by friction. During an earthquake such walls have almost no shear strength.

Lack of bond stones extending through the width of the walls results in the wall cross section as given in Figure-20a. Thus the walls look like sandwich walls with no connection between the inner and outer faces. In many small earthquakes the outer face of the wall separates from the wall and fall down.

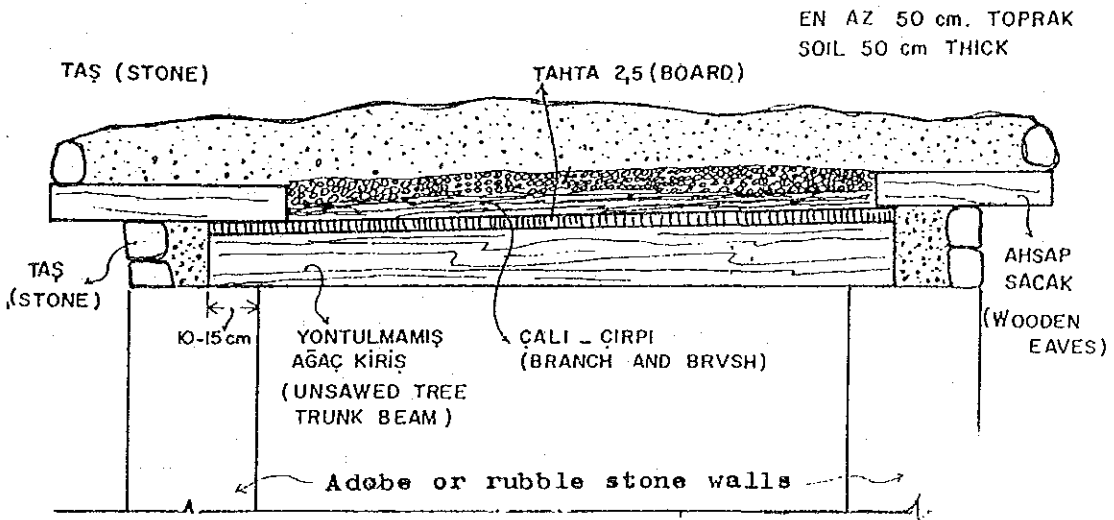
Figure-21 Flat Earth Roof Detail)

In Figure-21 the typical flat earth roof and its connection to the walls are given. Roof beams are made of unsawn tree trunks. The span depends on the type of trees available in the region. It is usually below 4.0 meters. The roof beams are placed at 25 to 50 cm intervals. The ends of the beams resting on the walls are usually 15 centimeters. On top of the beams planks of 2-2.5 cm thickness are placed. In some regions instead of planks canes are placed. On top of the planks tree branches and bushes are placed. The final insulation layer is the soil layer whose thickness sometimes reaches 50 cm. The weight of such a roof system can be as high as 0.75 to 1.0 ton/m². On the other the weight of a reinforced concrete slab of 0.12 m thickness has a unit weight of only 0.3 tons/m². Thus the roofing system is even heavier than reinforced concrete slab.

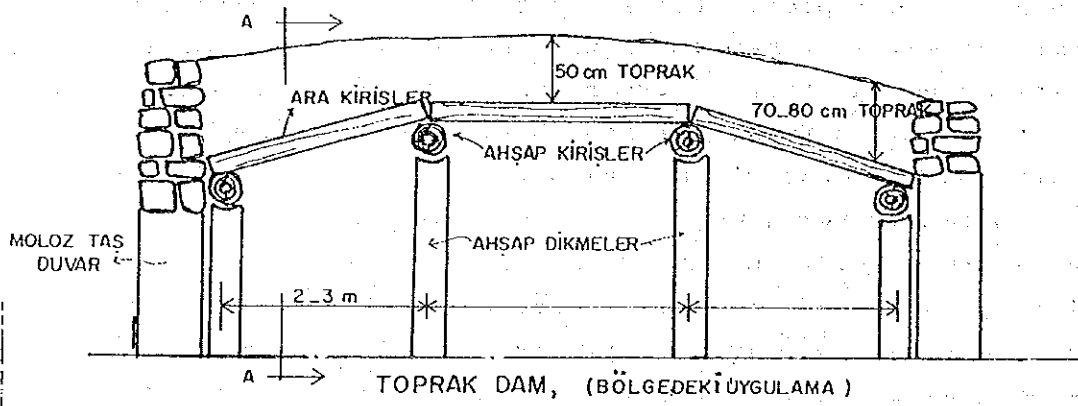
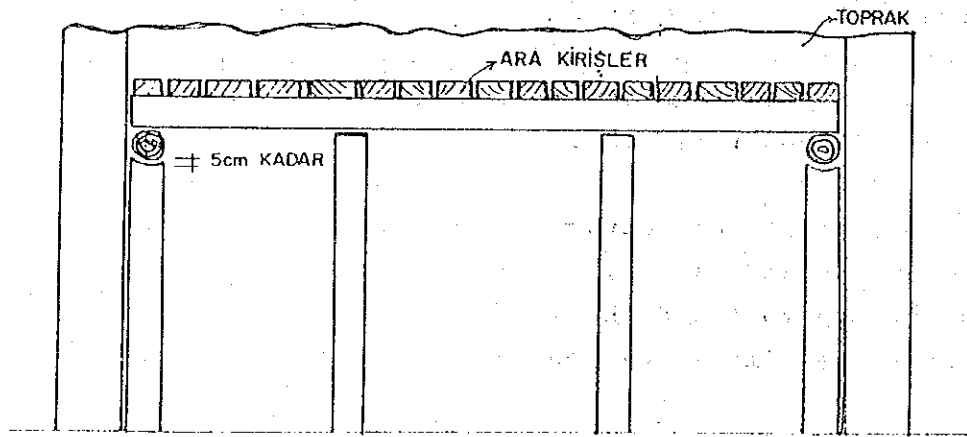
Figure-22 Flat Earth Roof Application in Eastern Anatolia

In order to carry this roof load and the heavy snow fall, in the eastern Anatolia the roof beams are supported by timber posts at intervals and the roof is made dome like by putting higher posts in the middle and shorter posts near the walls. Figure-22. This in a way prevents the collection of water in the middle of the roof.

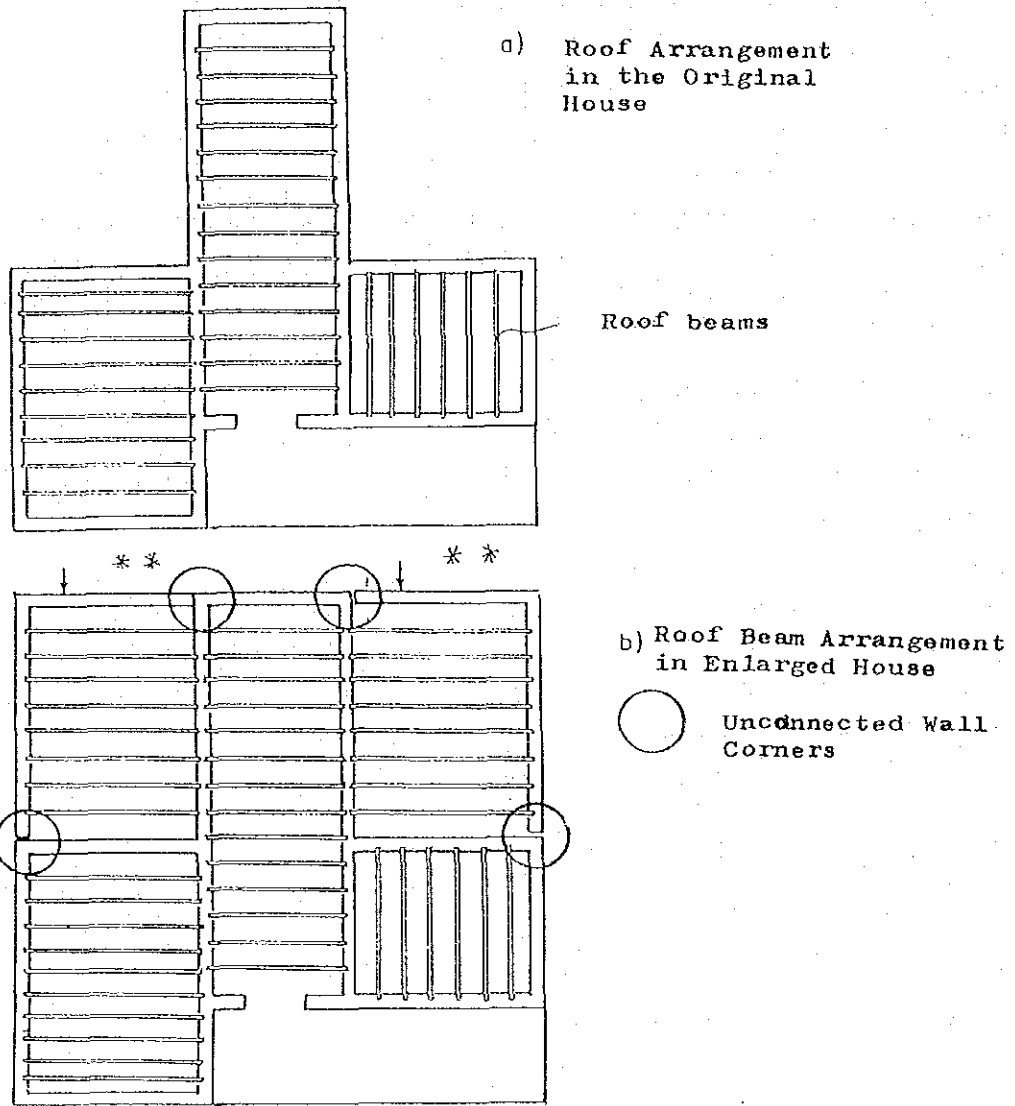
Figure-23 Roof Beam Arrangement of Rural Houses

The addition of new rooms to the already existing houses also creates walls unconnected to each other. In Figure-23 the walls carrying the roof with roof beams and the walls which are not carrying the roof and which are not connected to other walls as well are indicated. Such walls neither carrying the roof beams nor connected to other walls at the corners are the most critical walls of the houses. The damage starts with the seperation of these walls from other.
