**BASIC DESIGN STUDY REPORT**  
**ON**  
**THE PROJECT FOR PROTECTING REVETMENT**  
**ON THE BANK OF MEGHNA RIVER**  
**IN**  
**THE PEOPLE'S REPUBLIC OF BANGLADESH**

NOVEMBER 1992

PACIFIC CONSULTANTS INTERNATIONAL  
NIPPON KOEI CO. LTD.

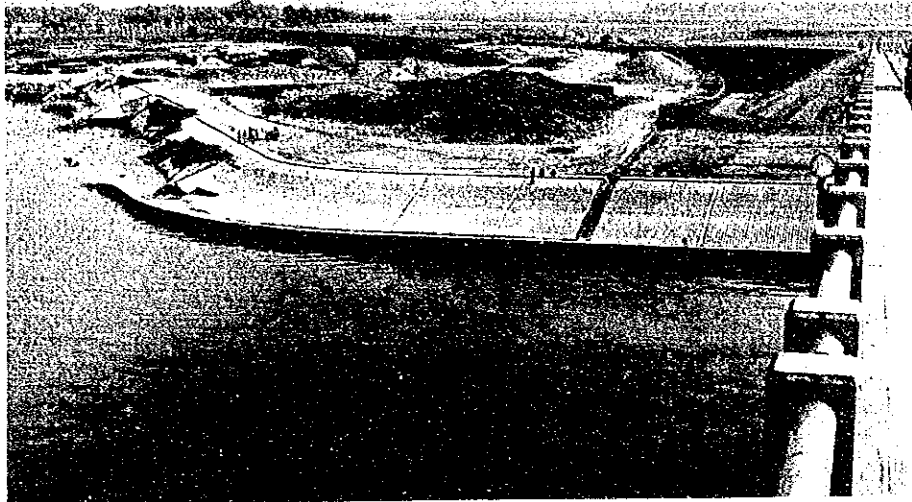
Photograph (1)

UP STREAM SIDE

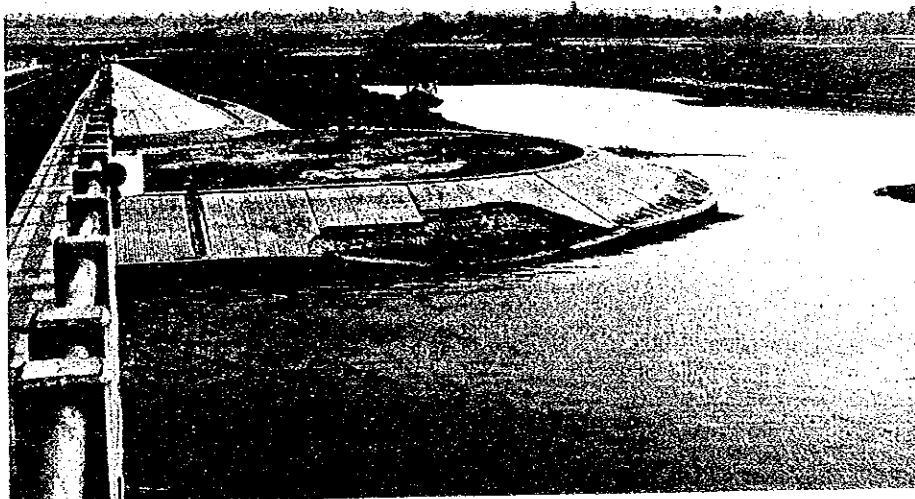
Photograph (2)

DOWN STREAM SIDE

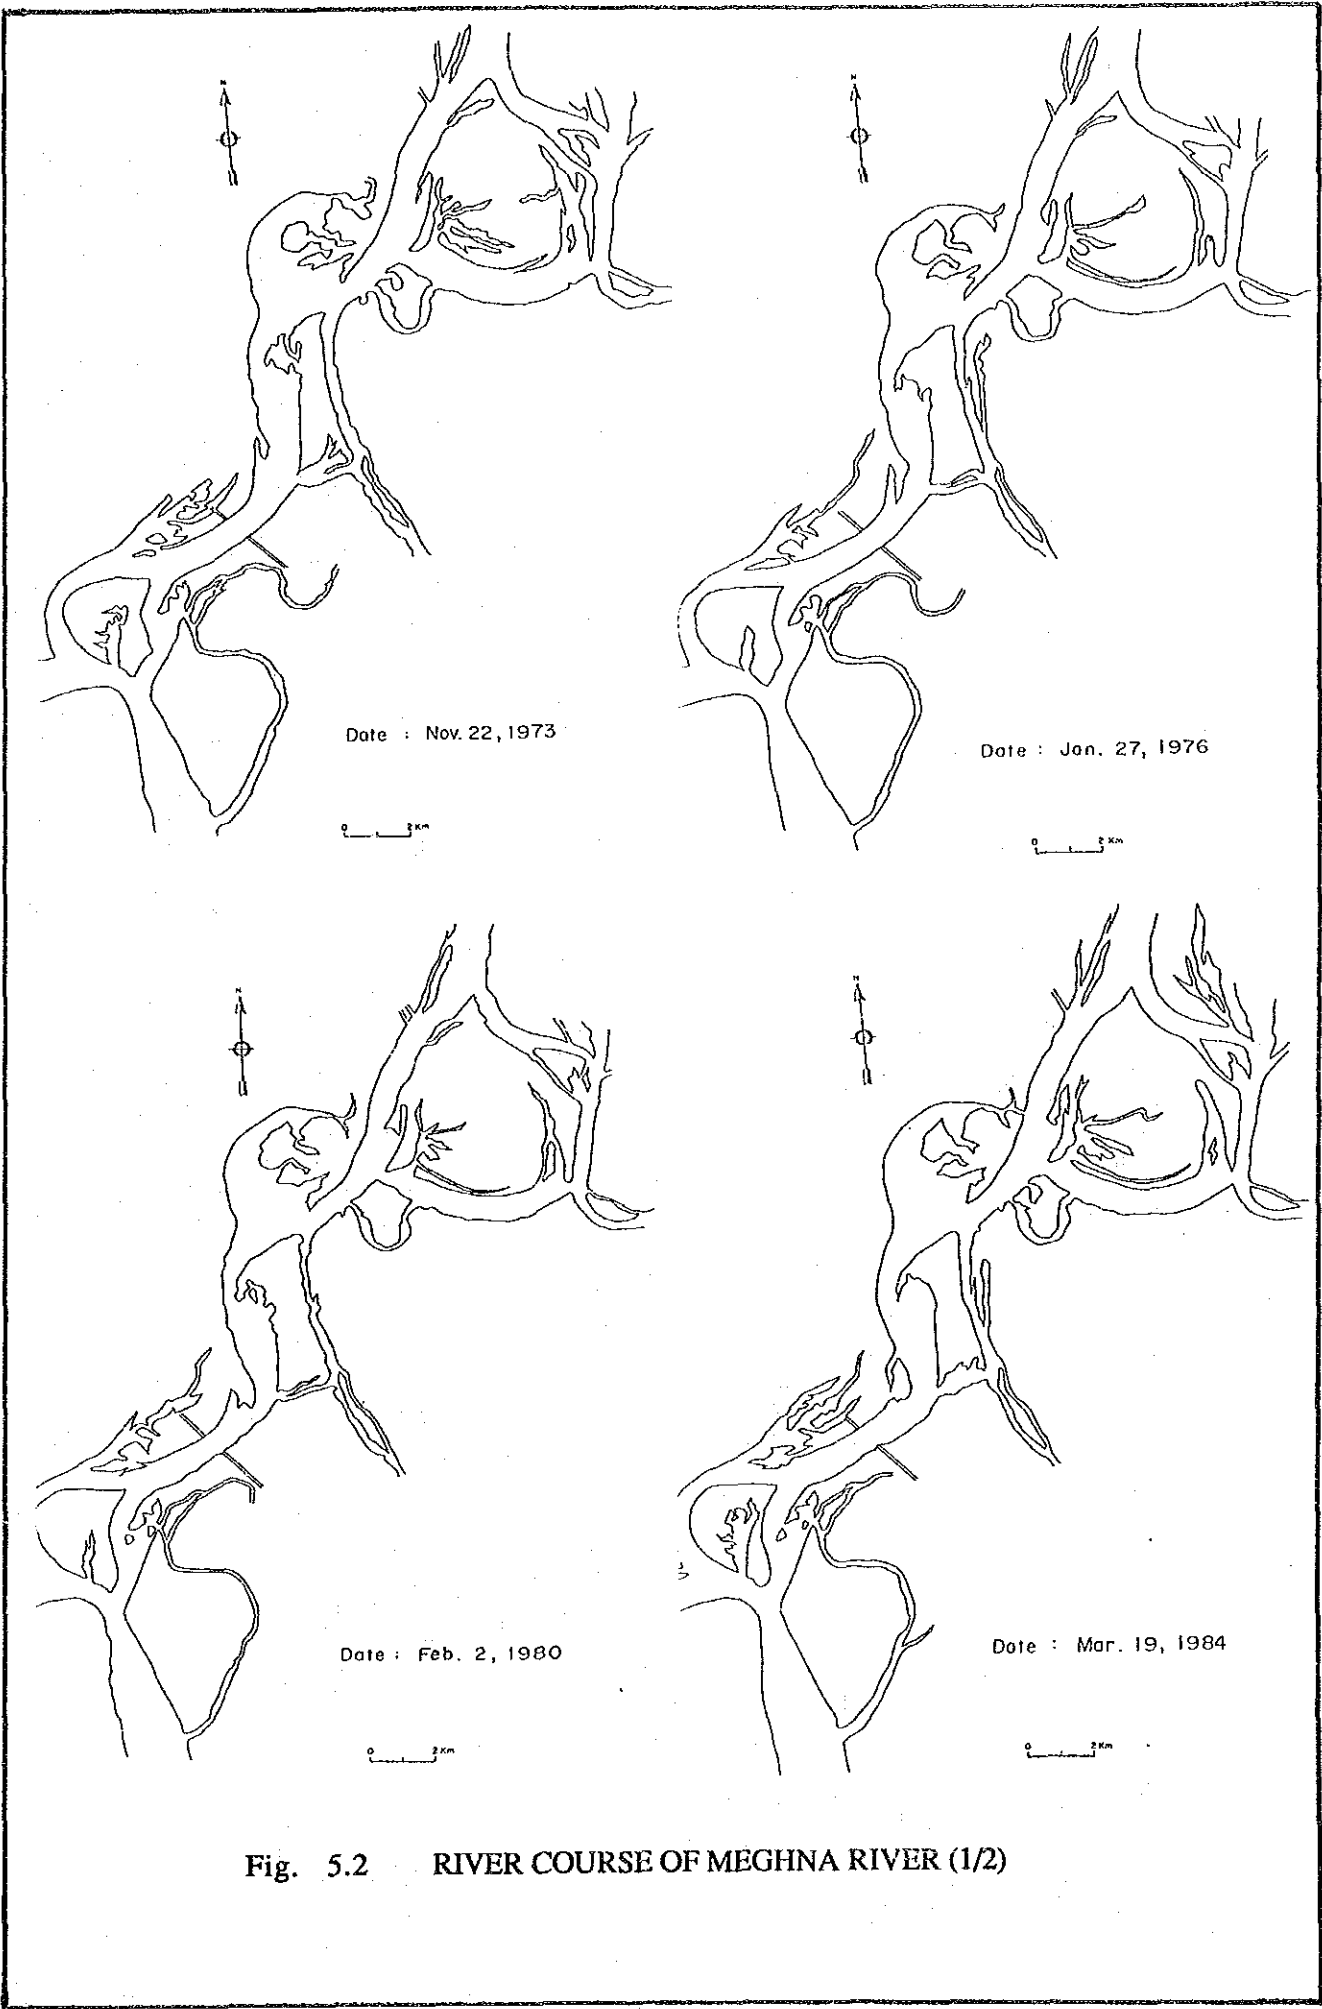
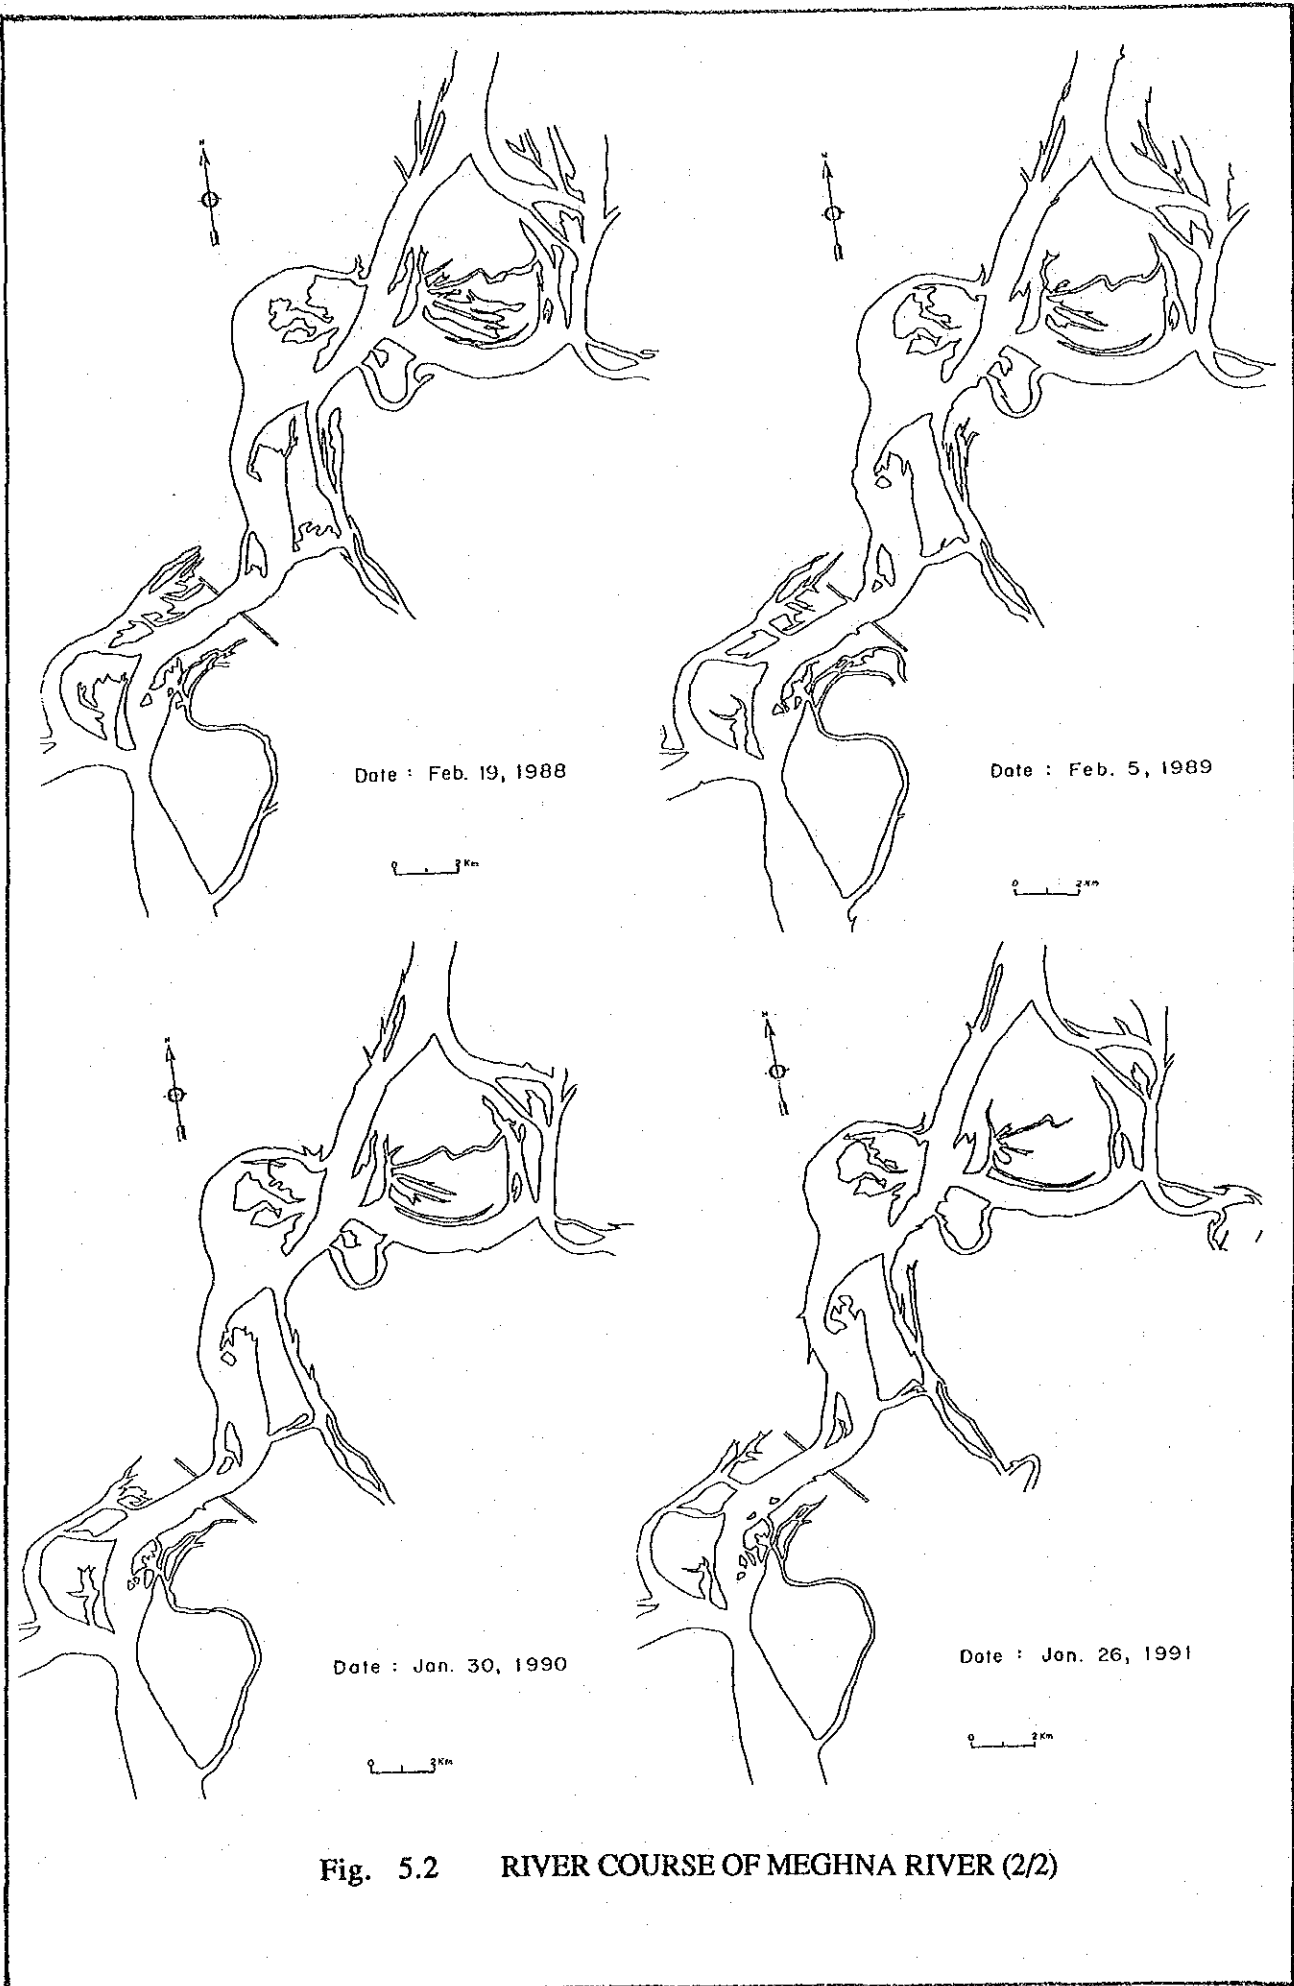
Fig. 5.2 RIVER COURSE OF MEGHNA RIVER (1/2)

Based on the Landsat images, the shoreline from about 15 km upstream to 8 km downstream of the Meghna Bridge was delineated as shown in Fig. 5.2 to check the change of the river course. As the result of the comparison of the two images, the area of erosion and siltation were clarified as illustrated in Fig. 5.3. The last figure in Fig. 5.3 (2/2) shows the shorelines in 1973 and 1991. The characteristic feature of bank erosion can be described chronologically as follows:

- The sand bar just upstream of the Bridge on the right bank was extended downstream between 1973 and 1976.
- The right bank from No. U10 to No. U6 and the left bank from No. U4 to No. U1 were eroded extensively between 1976 and 1984.
