**BASIC DESIGN STUDY REPORT**  
**ON**  
**THE PROJECT FOR PROTECTING REVETMENT**  
**ON THE BANK OF MEGHNA RIVER**  
**IN**  
**THE PEOPLE'S REPUBLIC OF BANGLADESH**

NOVEMBER 1992

PACIFIC CONSULTANTS INTERNATIONAL  
NIPPON KOEI CO. LTD.

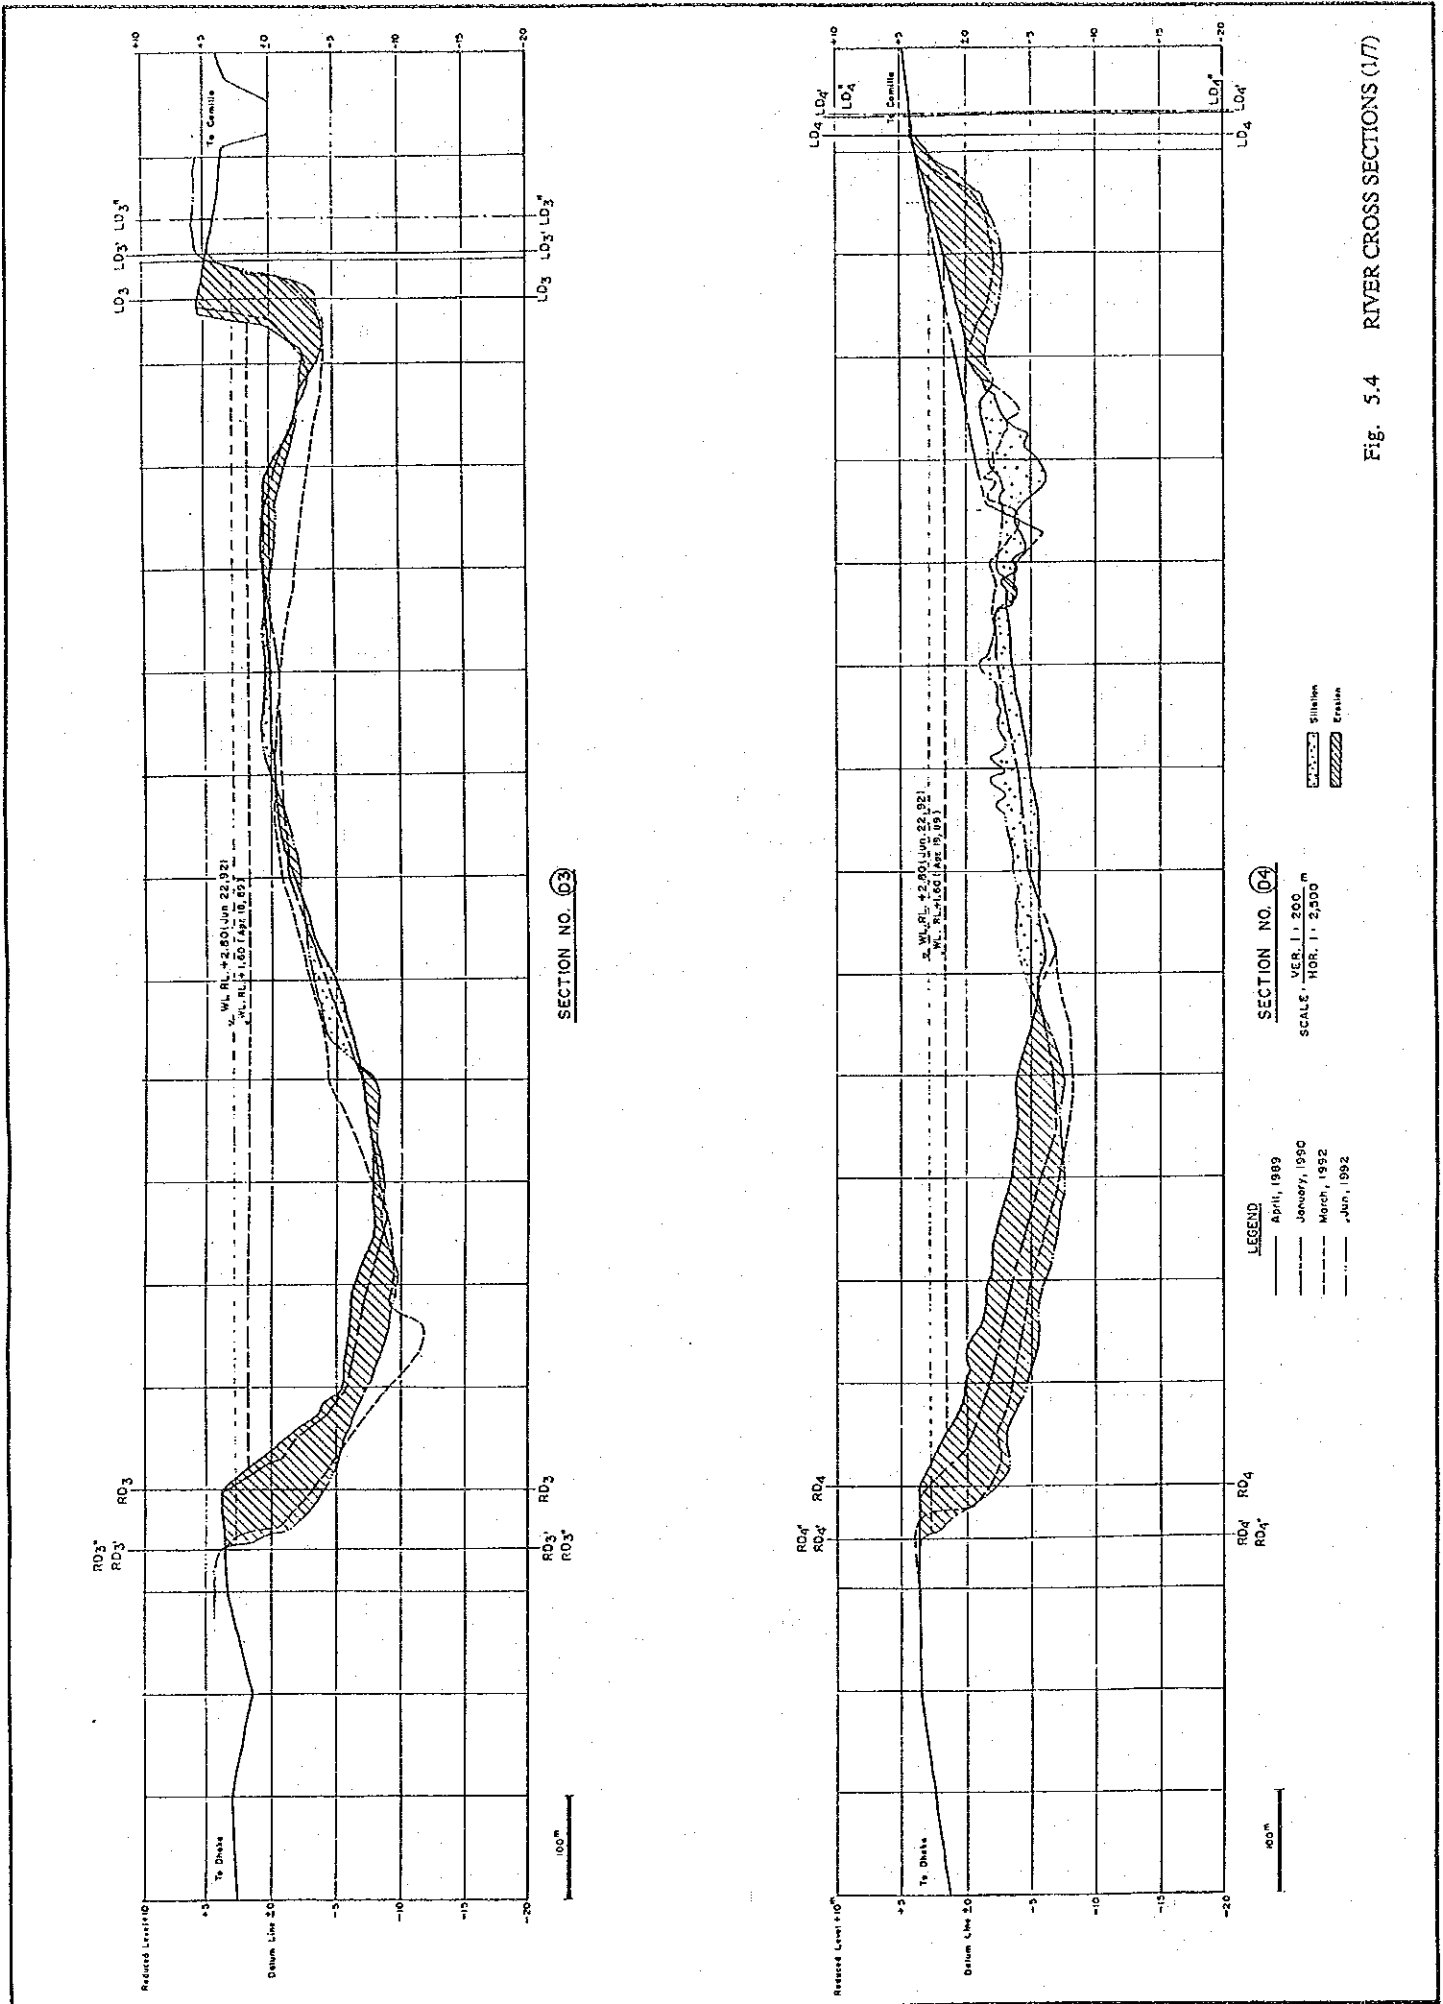
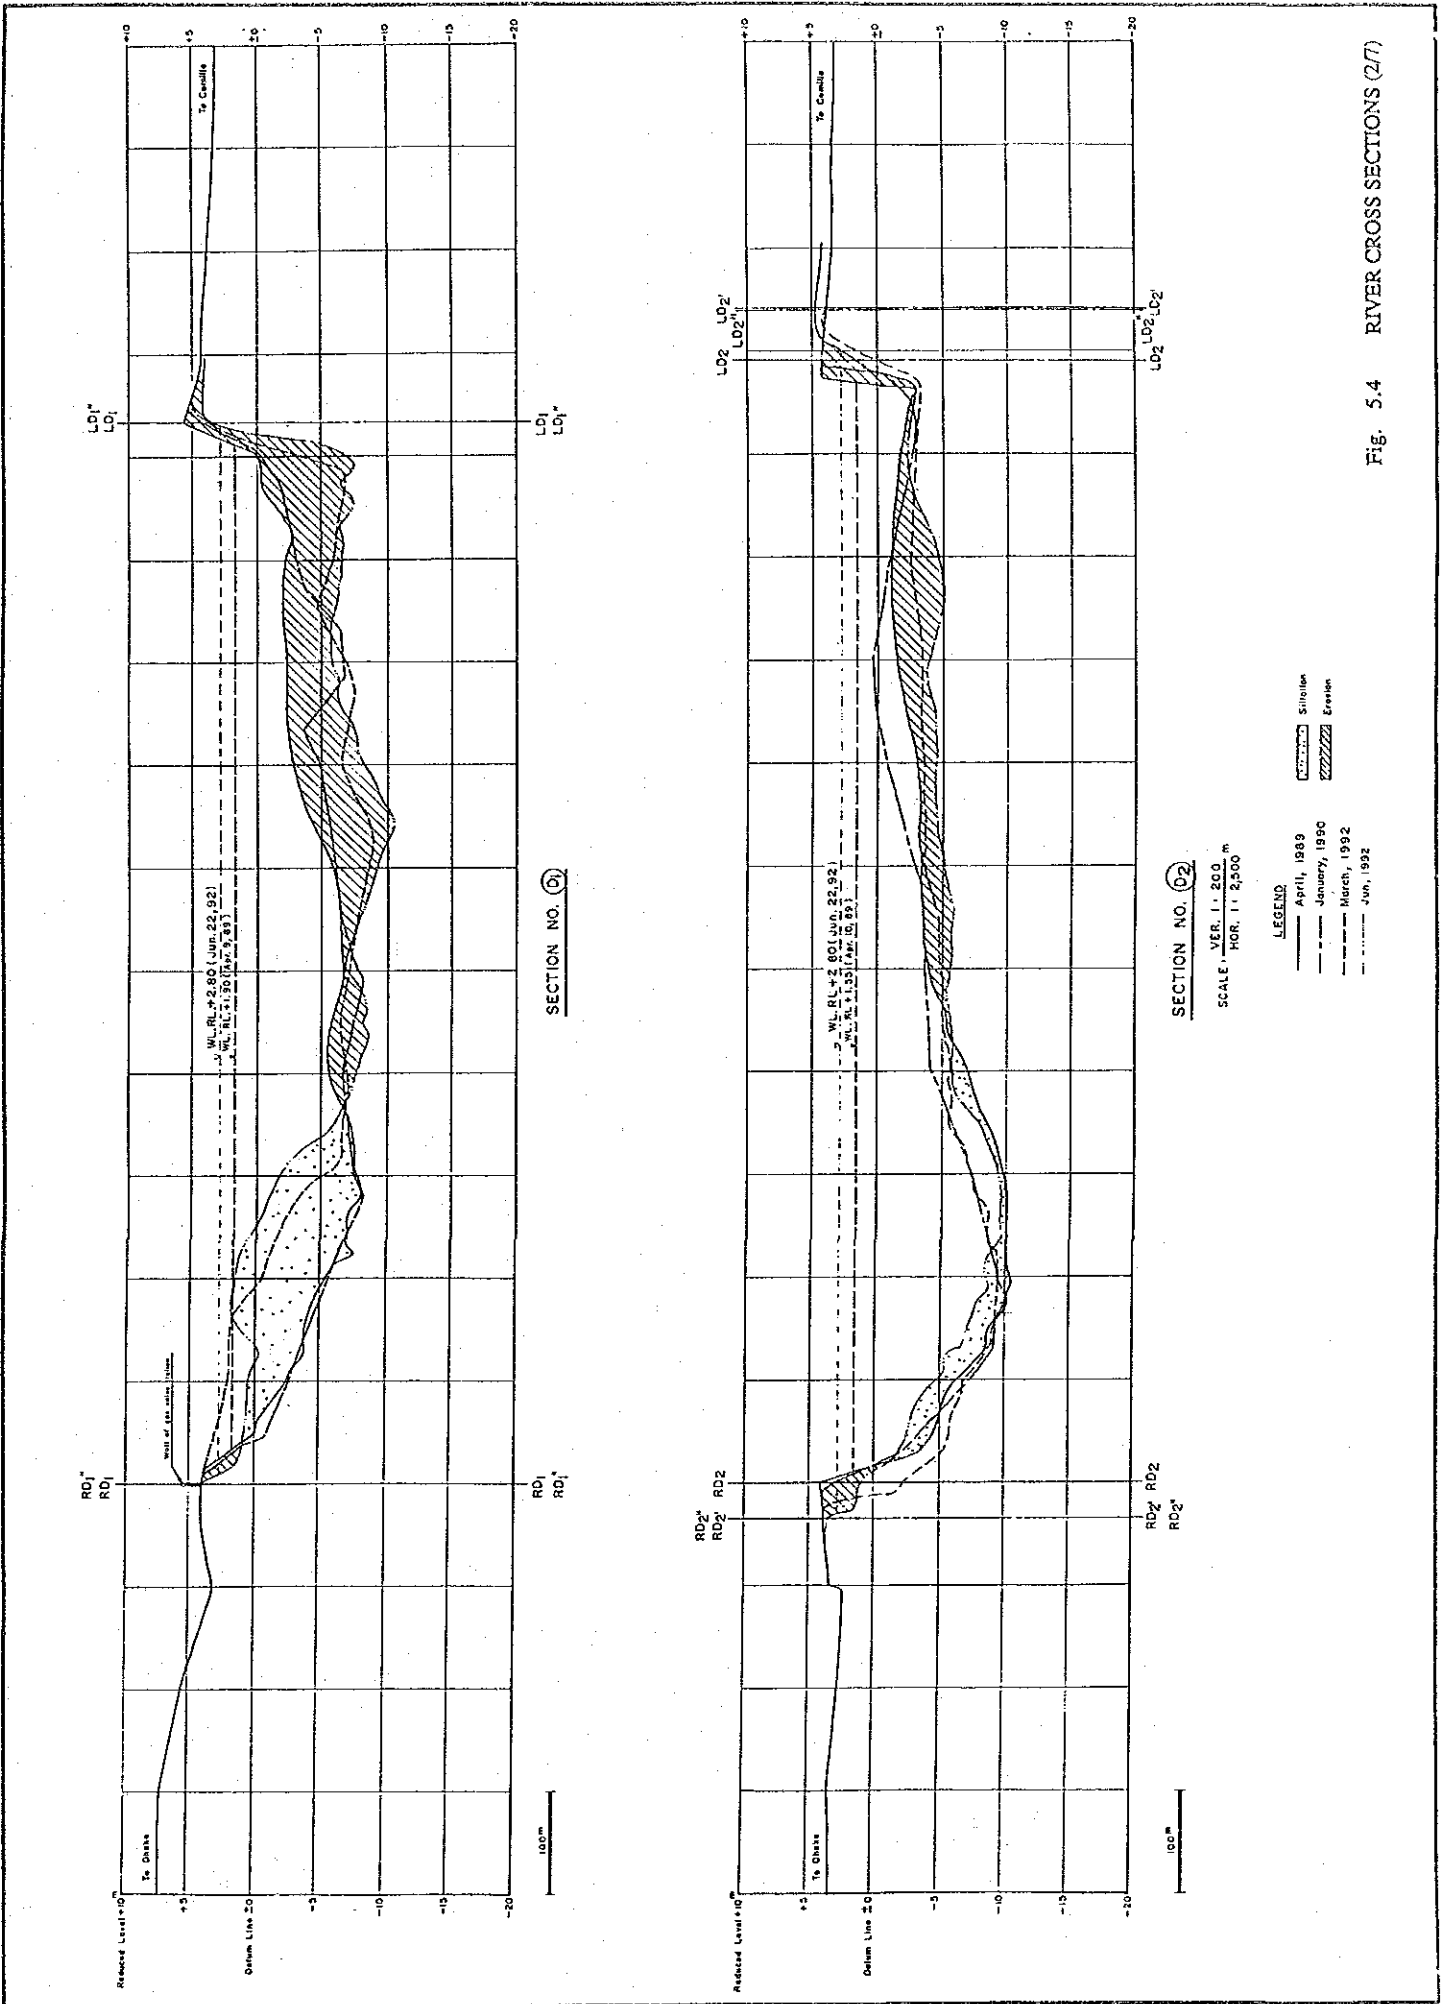
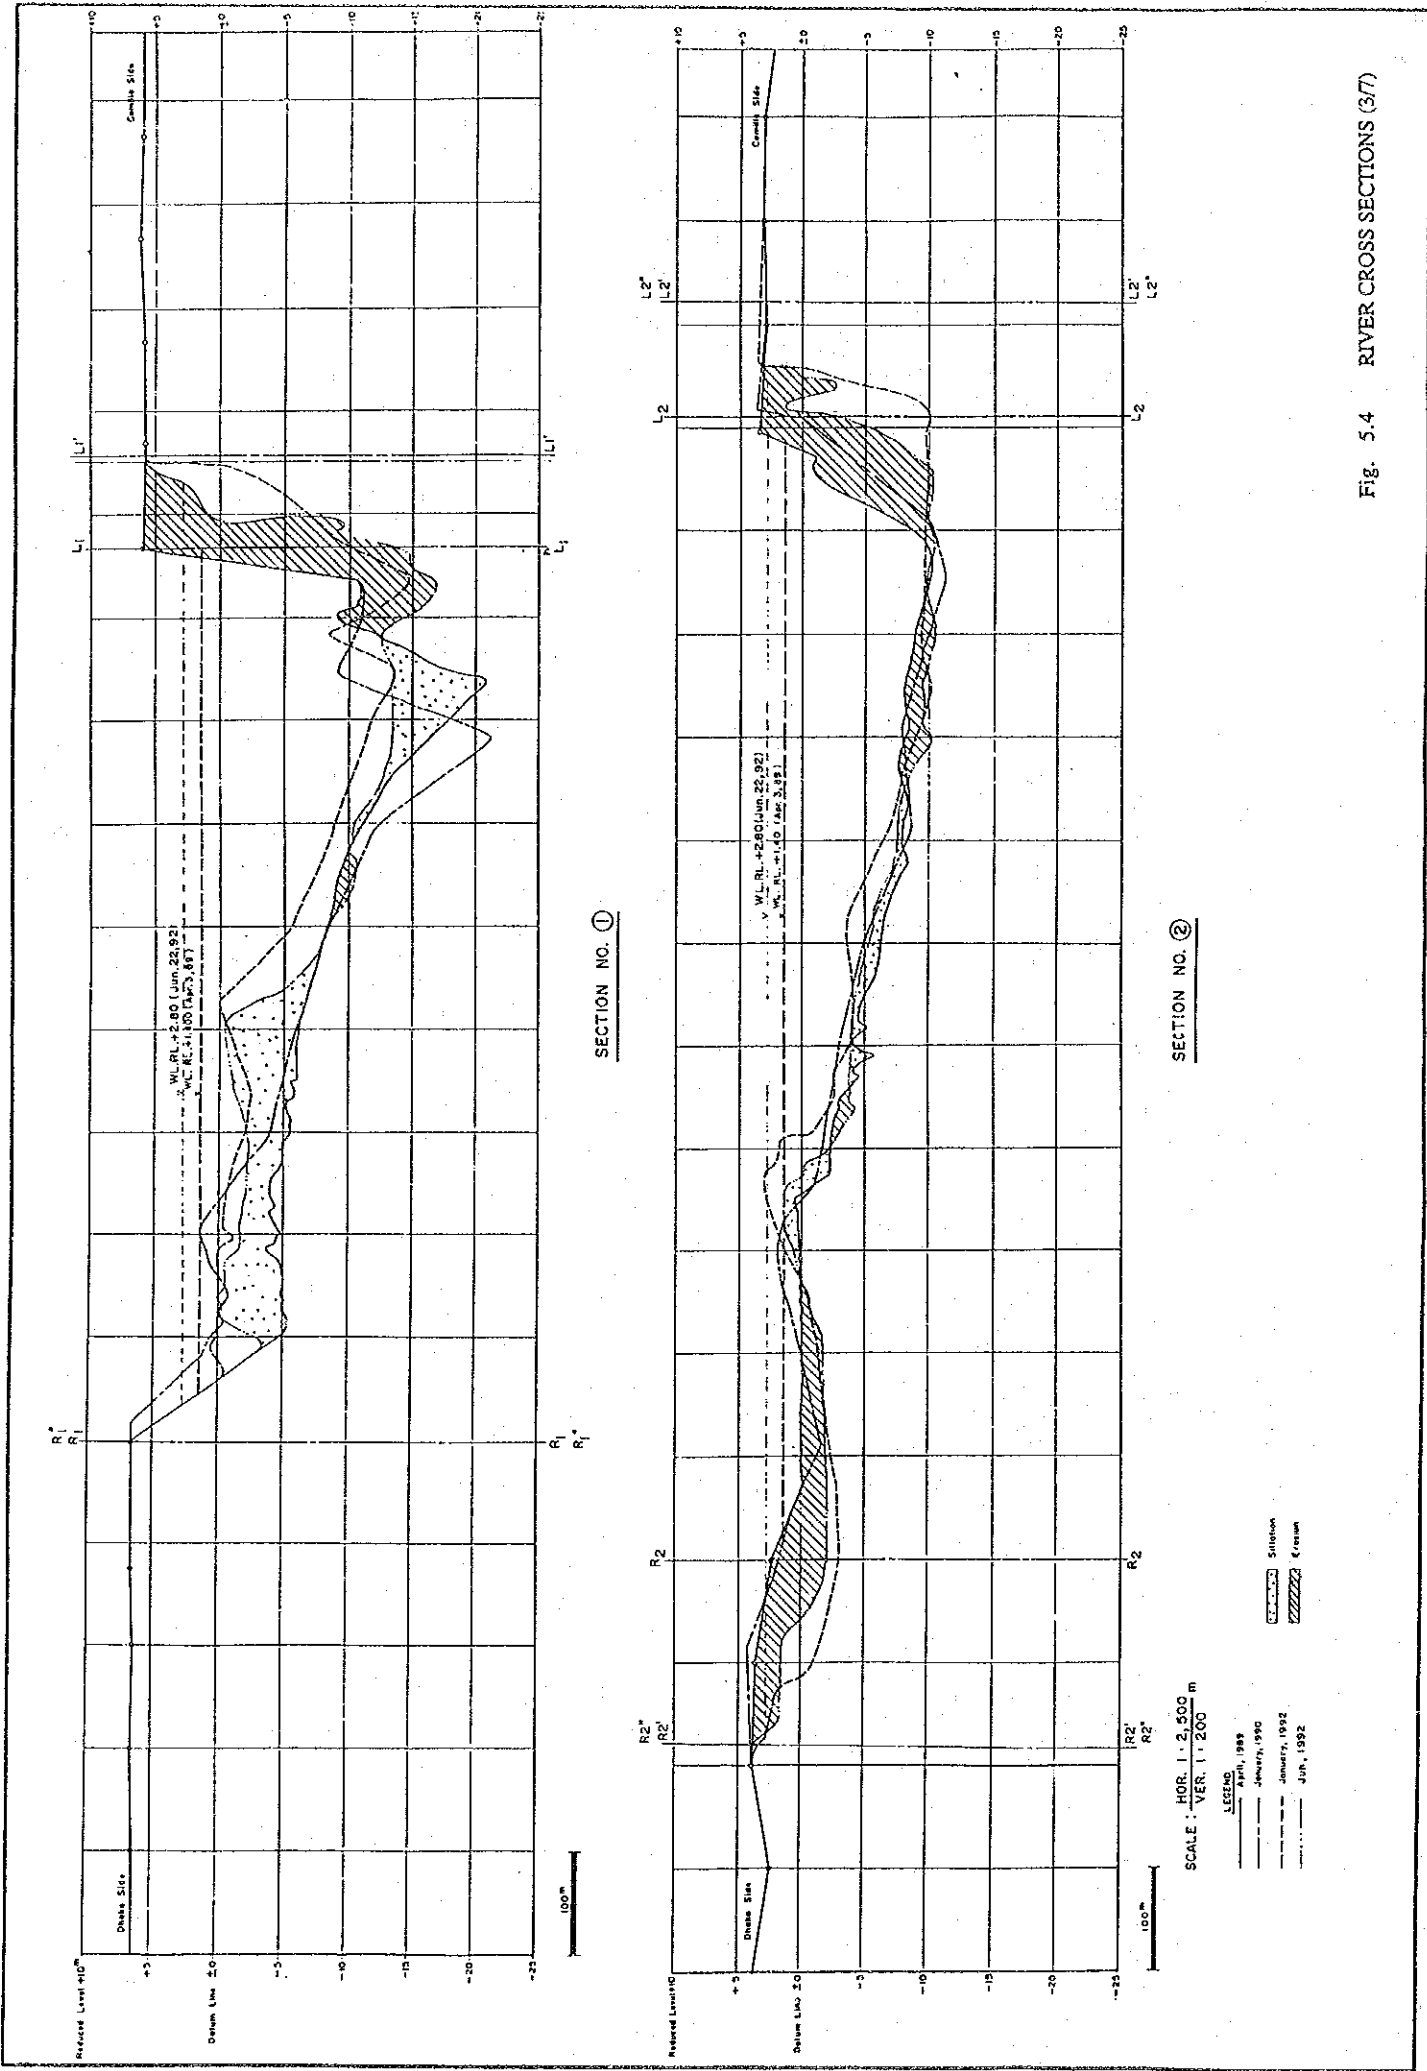
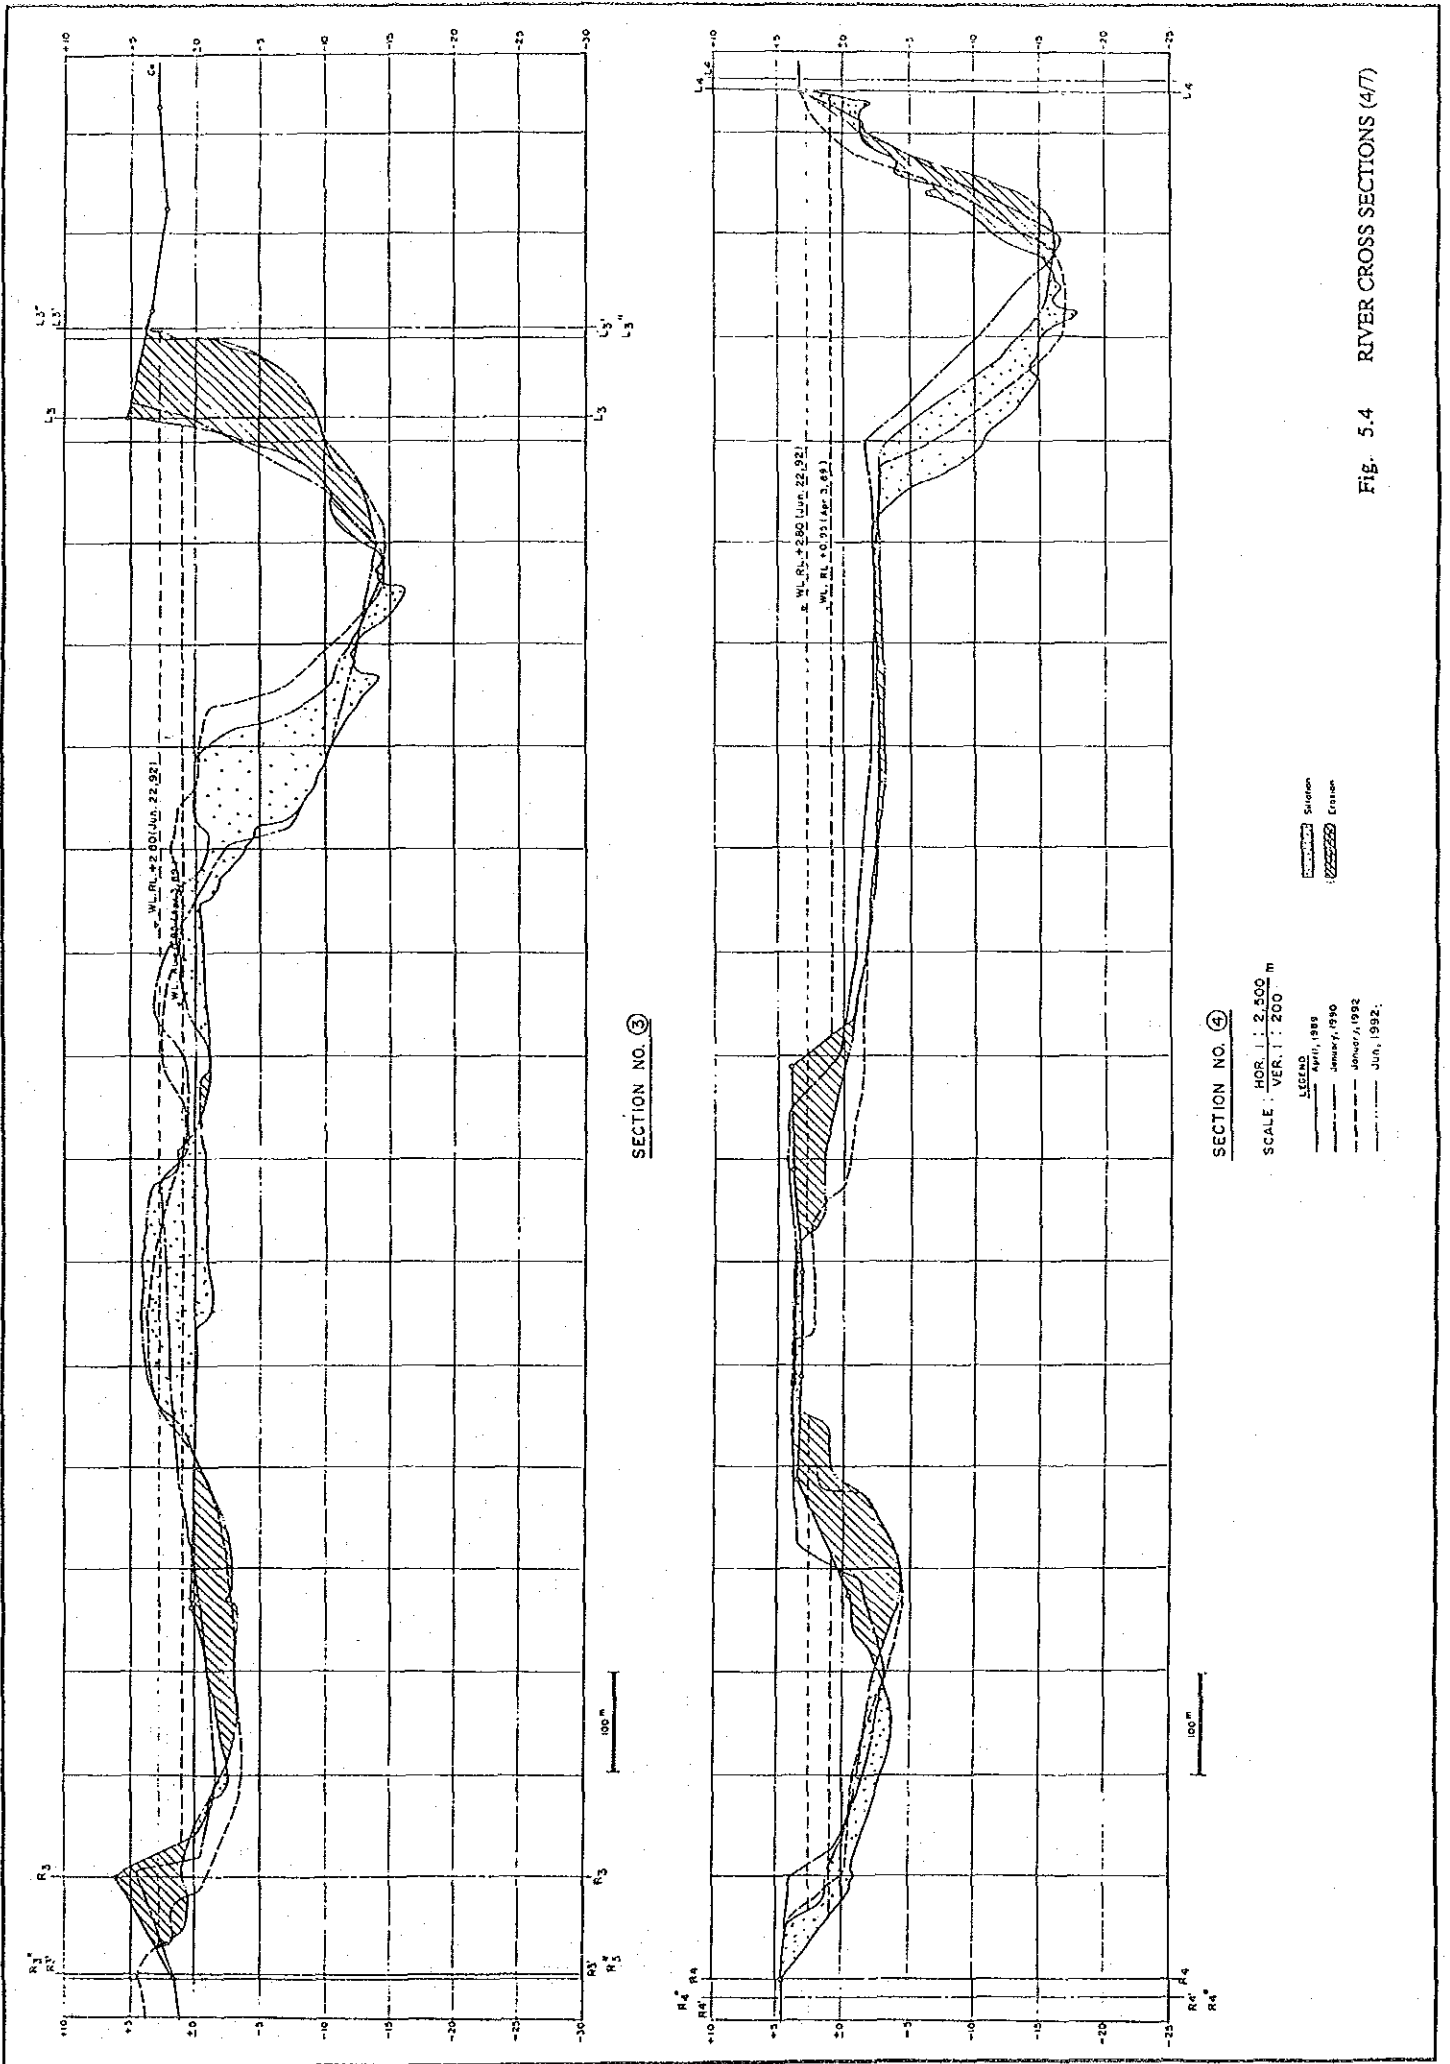
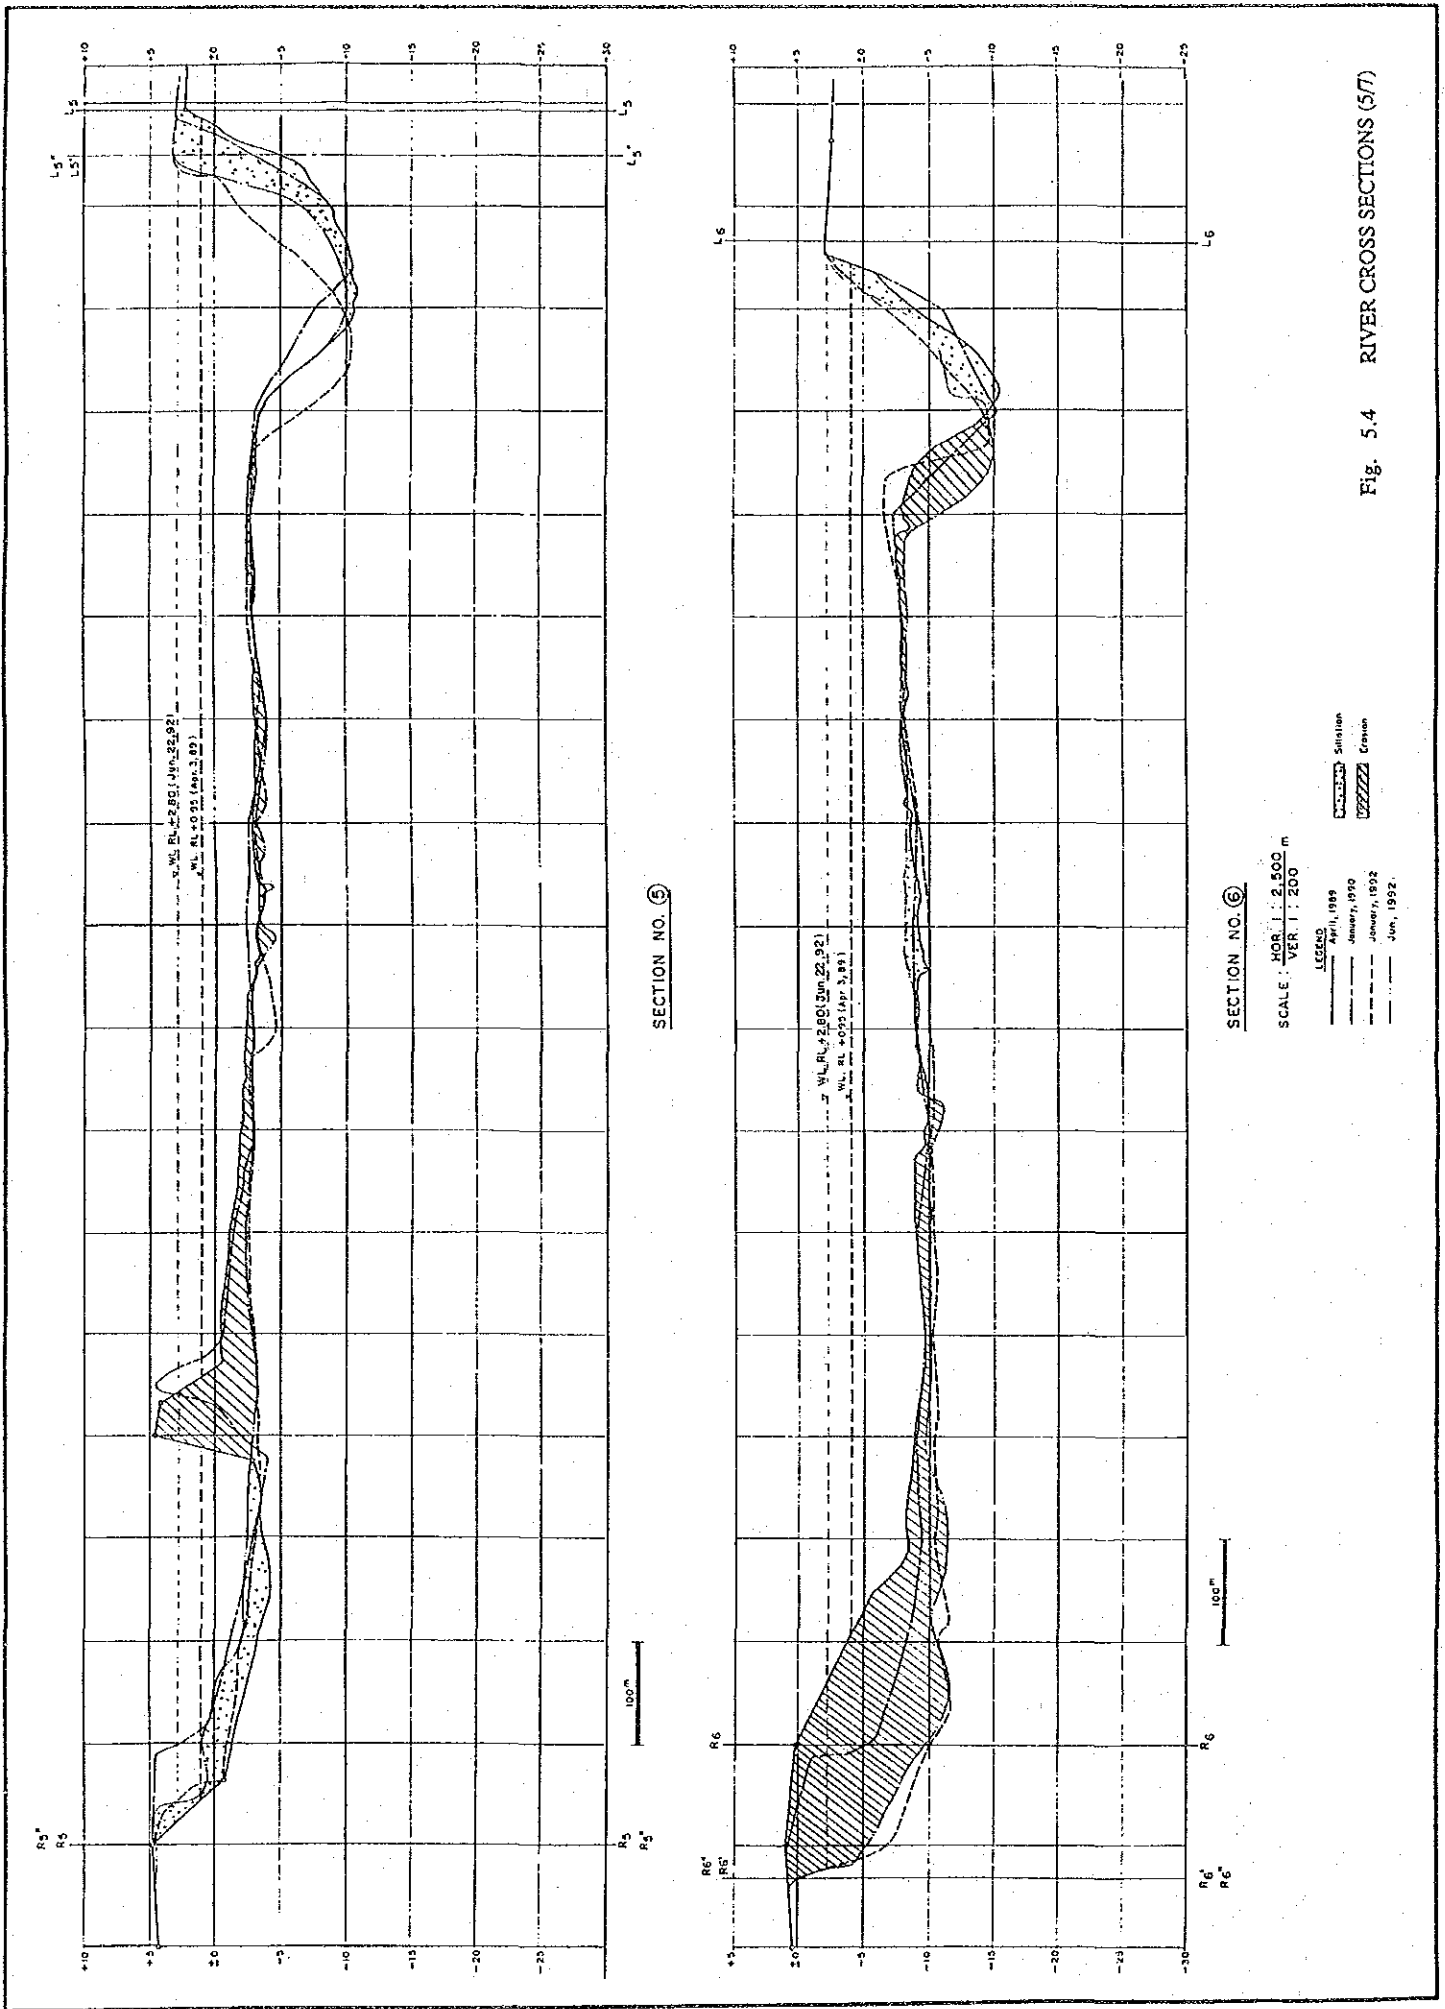
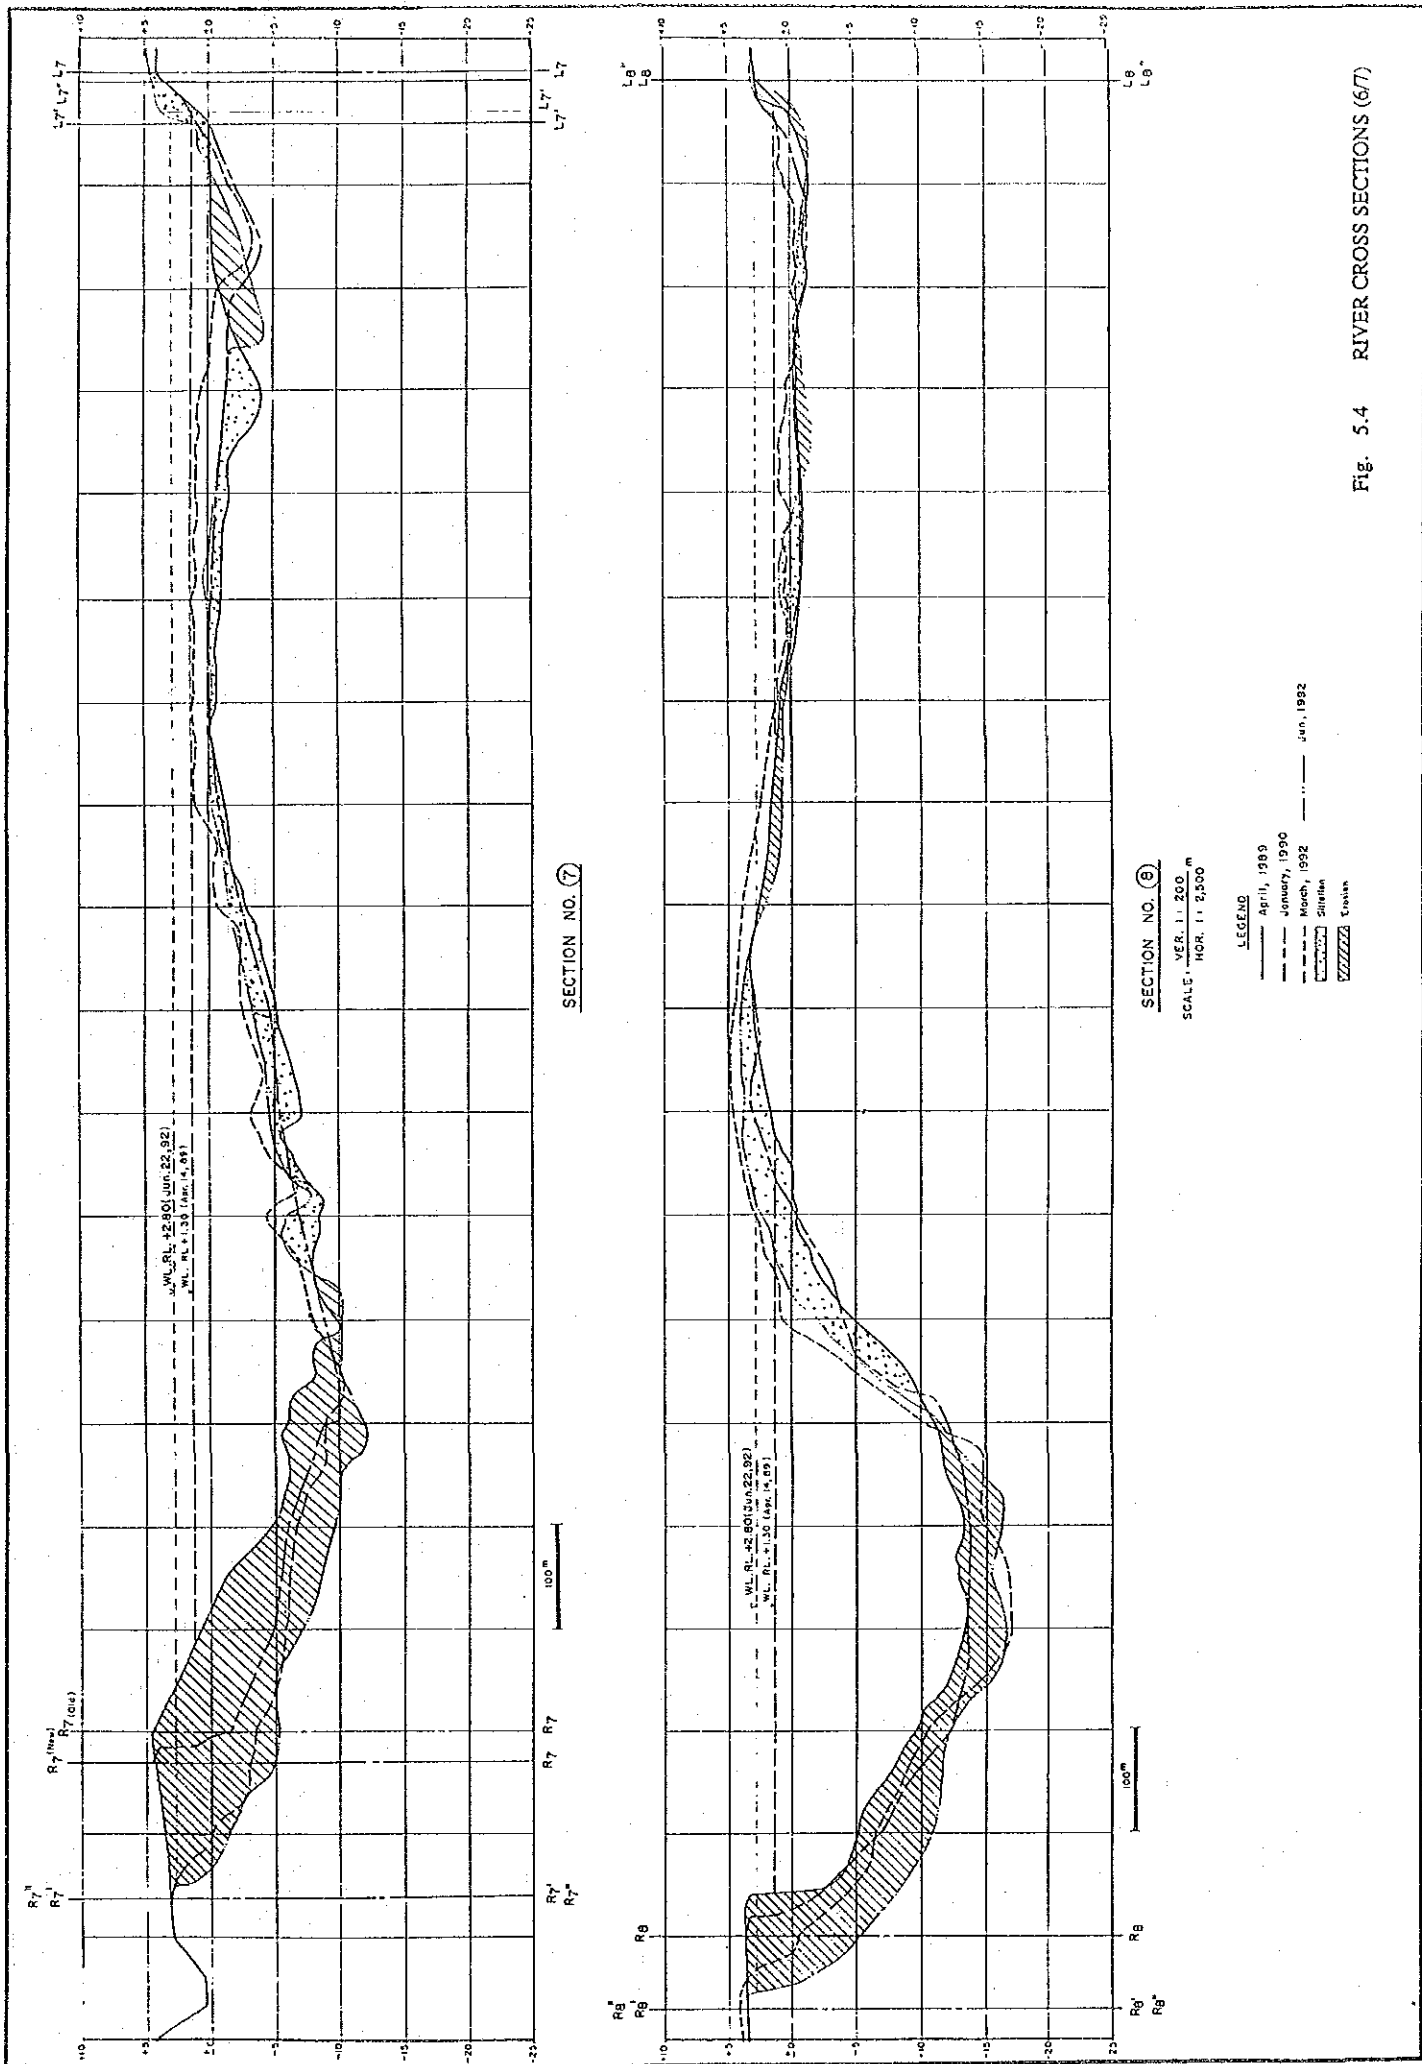
Fig. 5.4 RIVER CROSS SECTIONS (1/7)

In addition to interpretation of the Landsat images, the extent of bank erosion and siltation was reviewed based on the river cross sections obtained through past surveys. Fig. 5.4 presents the sectional area of scouring and siltation for the two survey results in April 1989 and June 1992 for comparison. Referring to the series of cross sections, a river course of deepest portion (thalweg) was drawn with contour lines shown in Fig. 5.5. The shift of thalweg is closely related to the water colliding front at river banks and the development of sand bar. Its characteristic features between No. U10 and No. D4 are as follows:

- From No. U6 to No. U5  
Within this stretch, the direction of main current moves toward the right bank. The sand bar, 60 m wide (above R.L. 2.0 m) at No. U5 as surveyed in April 1989 has, disappeared.

- From No. U5 to No. U4  
The upstream apex of the triangular-shaped sand bar has been scoured and has moved about 400 to 500 m downstream in this stretch. Just upstream of No. U4, the Branch Meghna joins the main river on the left bank.
