The Study on the Rehabilitation and Conservation Program of Bridges in The Republic of Chile

Final Report

March 1993

Japan International Cooperation Agency

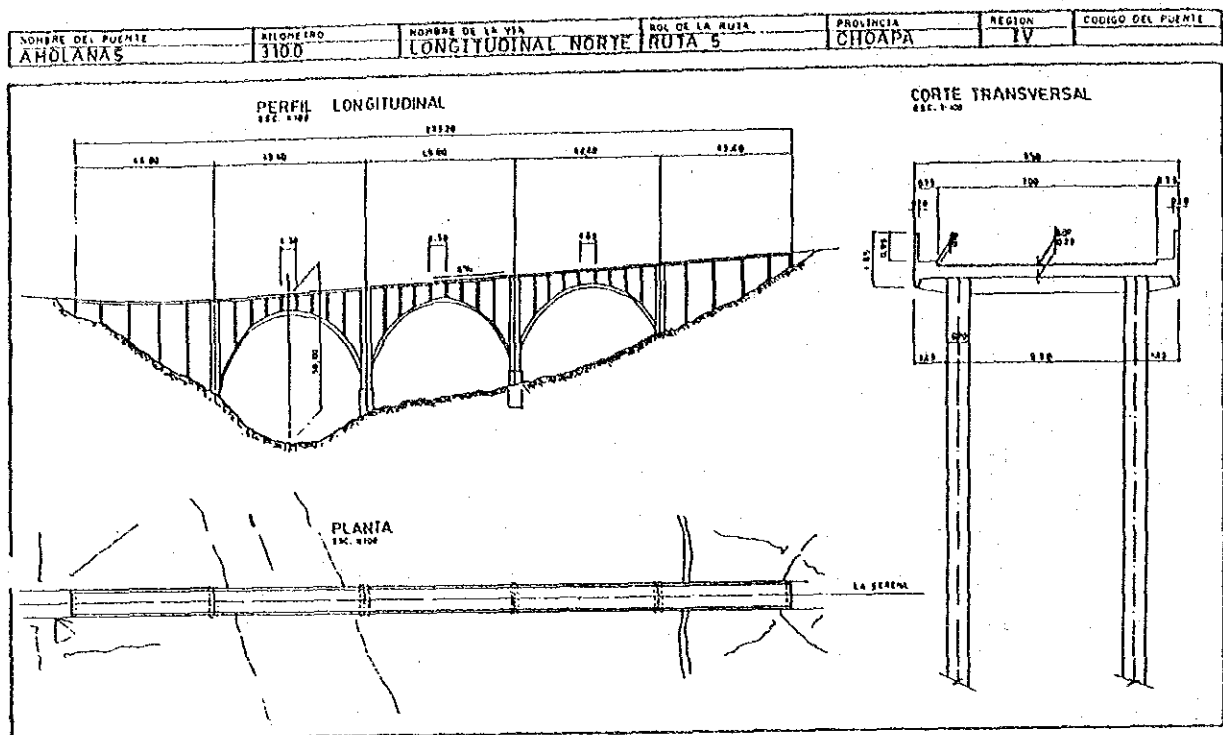
Figure 3-2 AMOLANAS Bridge

No	Bridge Name	Situation
1	Amolanas	Damage to the pavement and slab on the side span of the Santiago side was significant as a result of the impact of live loads.
2	Pullally	Deformation of the three continuous spans on the La Serena side was large. The ratio of beam depth to span was small (1/26), and vibration was heavy during vehicle crossing. According to MOP the bridge had a history of collapsing.
3	Maipo	There were no middle crossbeams. There were no lateral pre-stress at the end horizontal beams. The bridge piers were two individual pillars and their resistance to earthquakes was questionable. Part of the foundation was exposed by scouring.
4	Peuco	Two main steel girder bridge. No solid floor beam and damage at the welded parts
5	Claro	Being a monumental structure in Chile, a request was made to restore it. Scouring on the foundation was pronounced.
6	Loncomilla	The depth of the footings for the abutment and bridge pier was insufficient. Therefore, H-shaped steel was exposed to scouring and the bridge pillars were tilting.

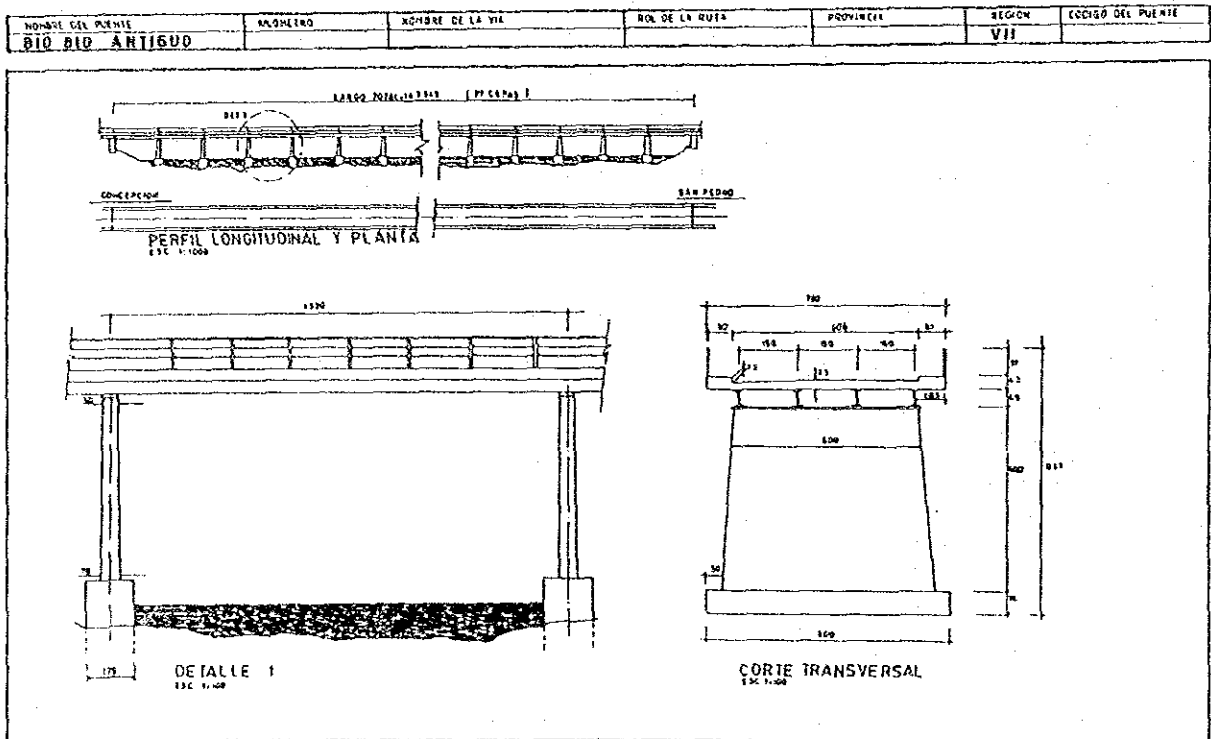
Figure 3-7 BIO BIO ANTIGUO Bridge

7	Bio Bio Antiguo	The bridge collapsed during an earthquake in 1960. Vehicles over eight tons were prohibited from using the bridge. Traffic capacity was insufficient.
8	Ramadillas	The frequency of use by heavy trucks carrying timber was high. Serious cracks have appeared in the abutment concrete.
9	Malleco	The structure was constructed in 1973, but the grid buckled before the opening ceremony. Stiffening material was later added. Although this was a 3 main girder structure, there were no crossbeams to enhance load distribution and deflection was large.
10	Pichoy	The abutment shifted during an earthquake. The abutment width is very narrow and vulnerable to earthquakes. The Gerver hinge was also damaged.
11	Cayumapu	The abutment and bridge pier were significantly tilting as a result of earthquakes.
