3-1-4 Survey Results and Examination

3-2 Load Test

Chapter 4 Bridge Repair Design and Cost Estimation

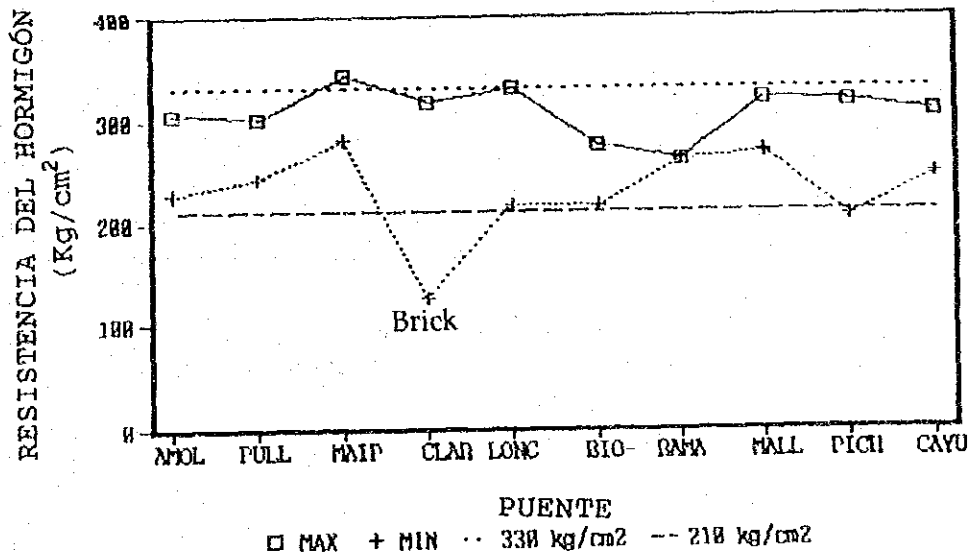
Figure 3-22 Maximum and Minimum Figures for Schmidt Concrete Hammer Measurement Results

The concrete strength of ten bridges, as measured by the Schmidt Hammer Test, has a maximum average of 330 kg/cm² and a minimum average of 210 kg/cm². Maipo and Loncomilla bridges, whose upper structures consist of pressed concrete girders, are beyond the maximum of 300 kg and their concrete strength was found to be higher compared with other bridges. The concrete strength at some locations was measured as low for the Bio-Bio, Lamadillas, Pichoy, and Cayumapu bridges; however, these strengths do not present an immediate problem in terms of structure failure. Table 3-9 shows the measurement results of the Schmidt Hammer Test. These plotted results are represented by Figure 3-22 and Figure 3-23.

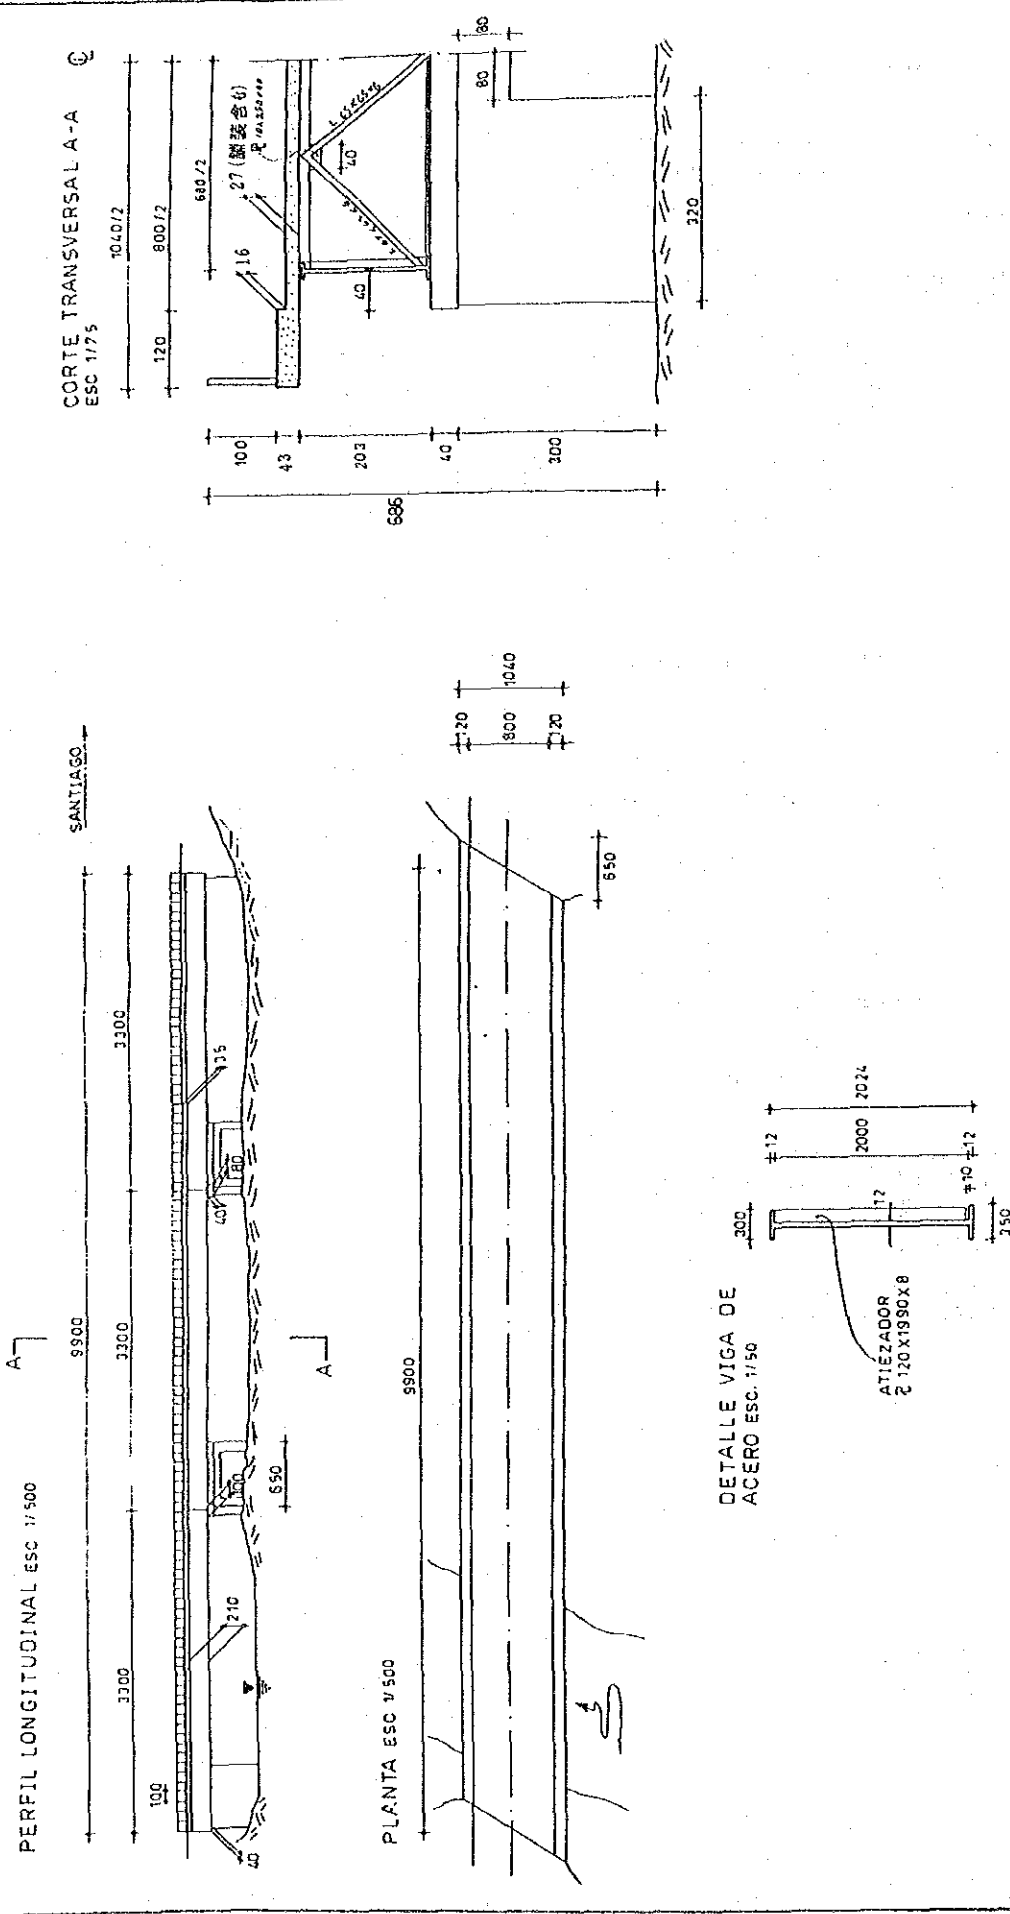
Figure 3- 34 Peuco Bridge General Drawings

Cracks generated from the lower flange reached the web near the center of the span on the Santiago side and large-scale repair had been performed. Traces of breaks were also seen on the upper member of the floor beam and the diagonal members. These had been repaired by simple welding. There was evidence that the floor beam had been moved, and it was not clear whether the breaks were a result of load stress or artificial cuts in order to move the floor beams.

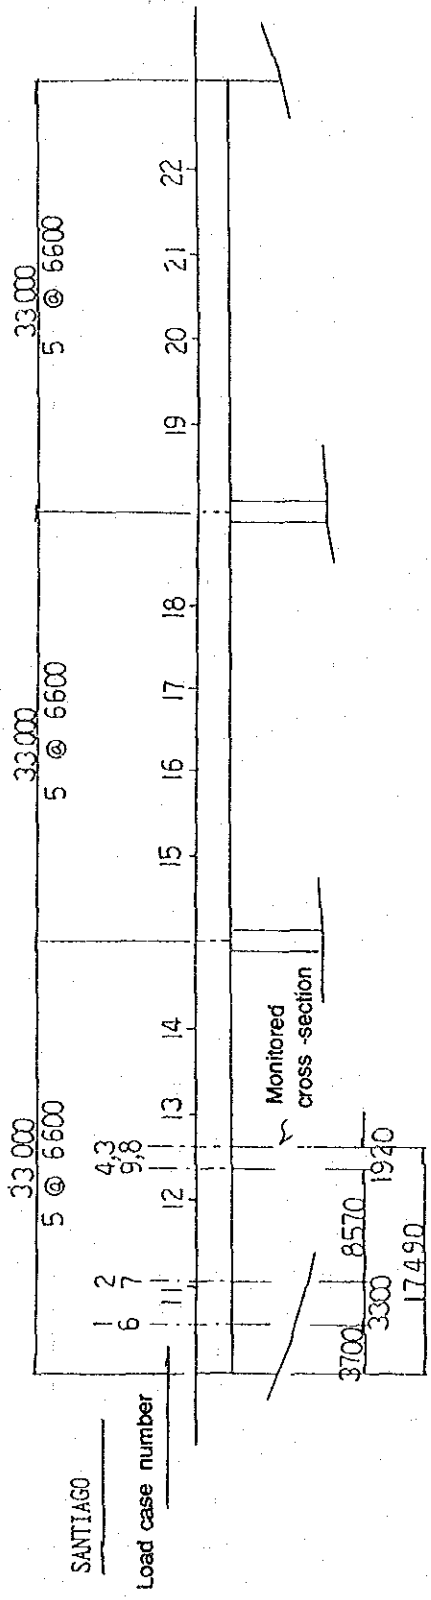
Figure 3-43 Main Girder Stress Distribution Near the Span Center

- 6) As Figure 3-43 shows, stress distribution on the main girder cross-section was not in a smooth triangular distribution; the neutral axis was near the upper flange and behaved as a composite girder. Comparing gauges No. 12 and No. 13 (web back surface), both showed different results based on the location of the load. It was understood that web transverse bending had occurred.

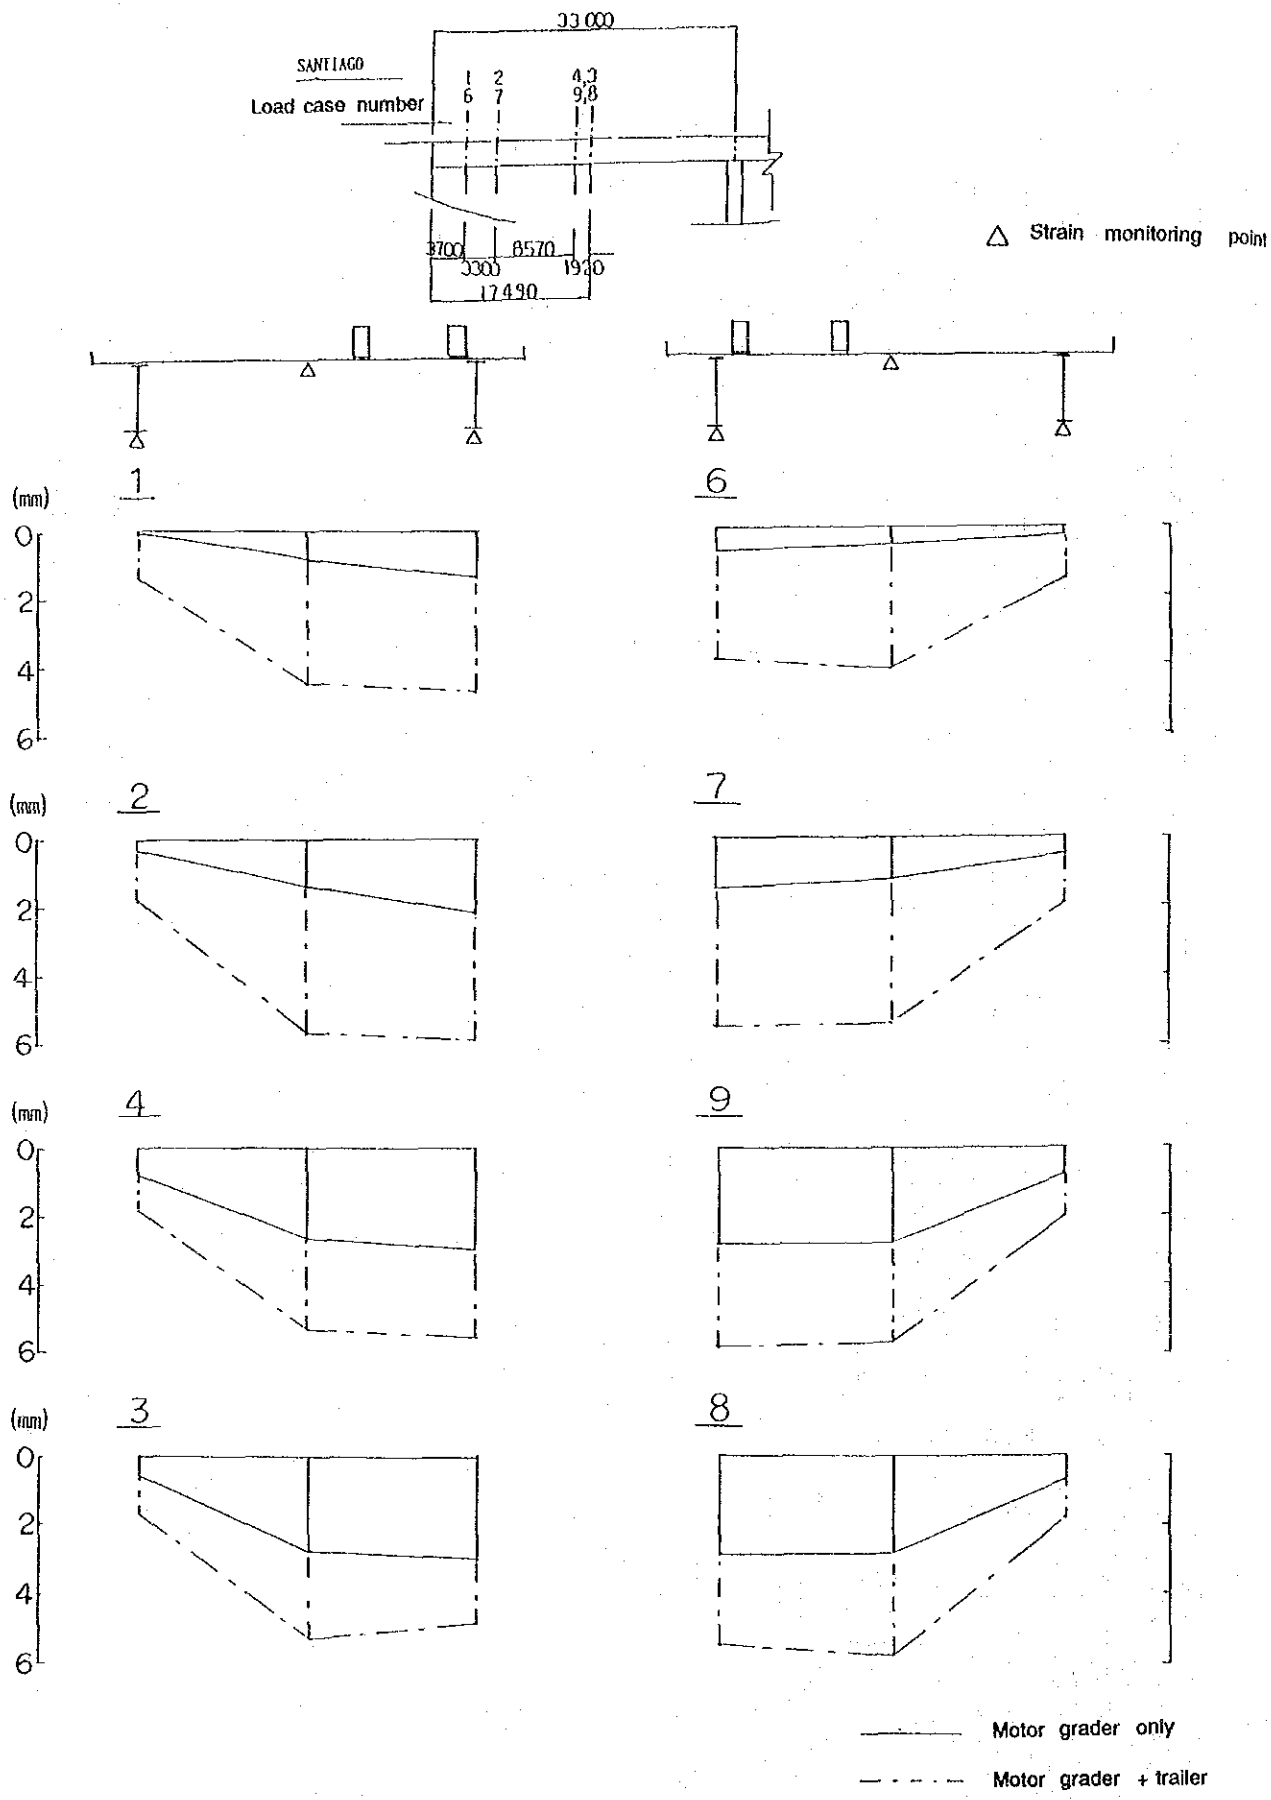
Figure 3-44 Displacement of the Main Girder and Slab

Figure 3-44 and Table 3-19 show the results of the strain measurements. The maximum value of strain was 3.0 mm for the main girder and 2.9 mm for the slab when the vehicle weight was 14.68 tons; and 5.9 mm for the main girder and 5.8 mm for the slab when the vehicle weight was 36.52 tons. The strain on the slab was relatively large.

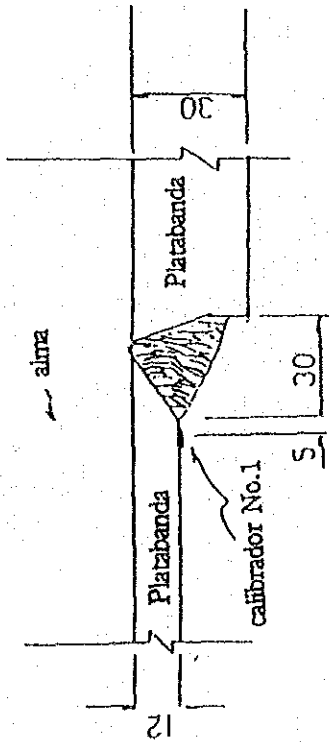
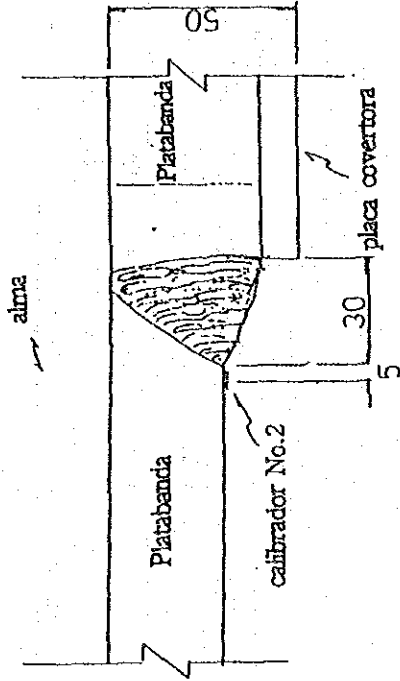
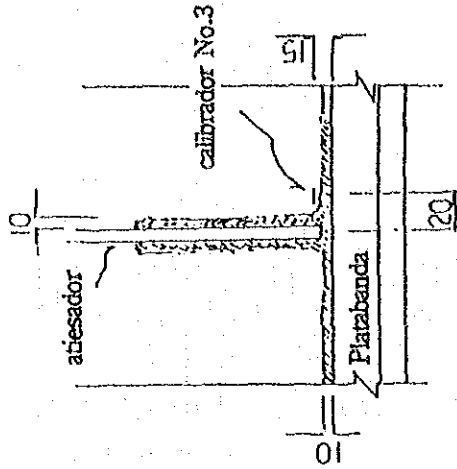
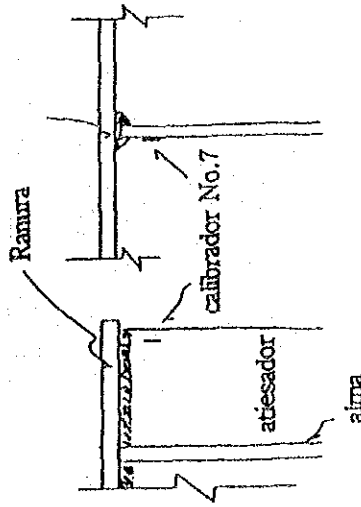
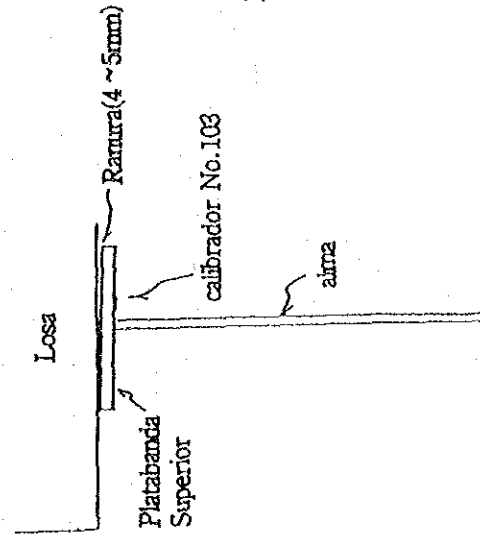
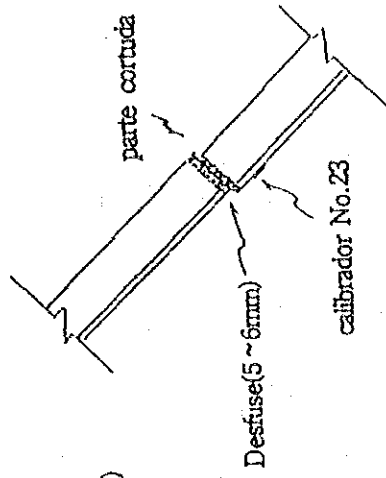
Figure 3-49 Monitoring Point Sketch

Figure 3-49 shows a sketch of the monitored parts. The following points were confirmed through observation of the monitored parts.

Numbers 1 to 4 were factors in influencing the level of stress and No. 3 and No. 6 provide explanations as to why significant stress was not found at No. 7, No. 100, and No. 103.

- 1) Fatigue life is less than two years at the cross-section change point of lower flange as shown in Table 3-22.
- 2) Welding at the floor beam is cut several times.
- 3) The main girder is broken and repaired by weldment at the side.
- 4) There are some problems for the design concept of two main girder bridge under construction

Replace of the PUECO bridge is recommendable by the following reason;

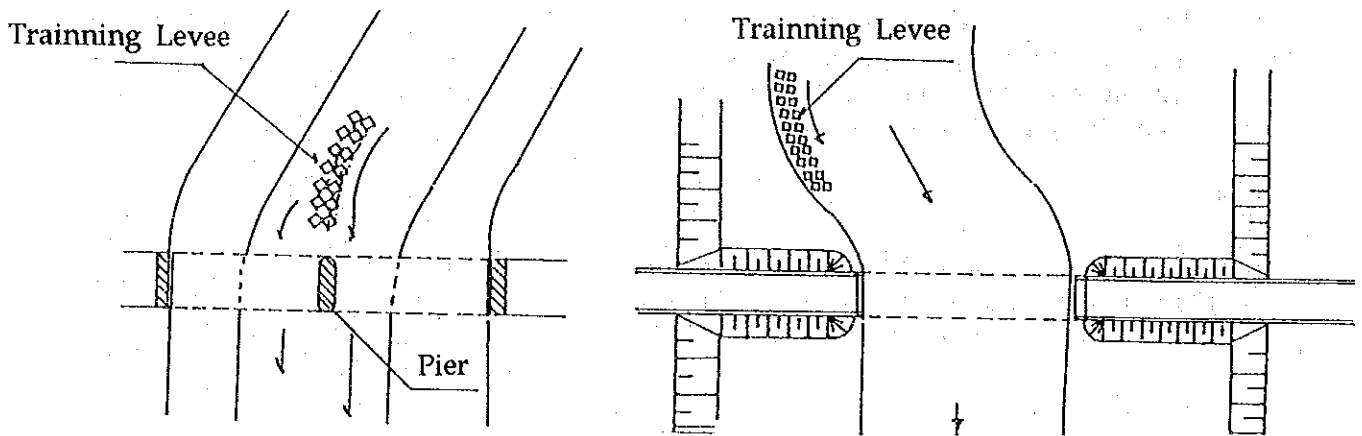
Figure 4-1 Training Levee

- (i) It changes the stream direction and reduces the scours of the abutments and piers.
- (ii) It protects the access road embankments by deflecting the stream parallel to them.

1) Construction of the training levee around the bridge.(Refer to Figure 4-1)

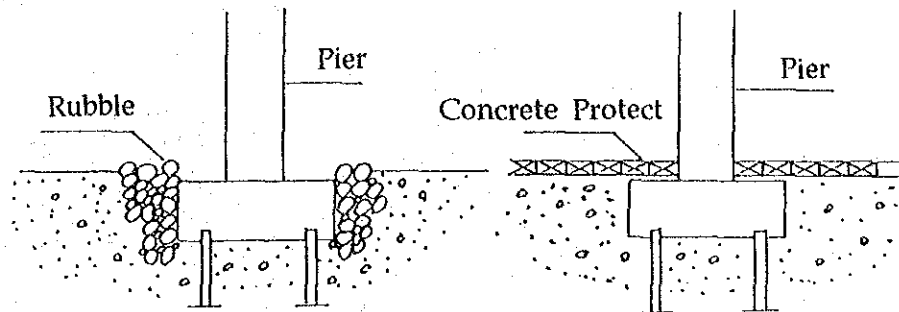
Figure 4-2 Protecting Works for the Scour

- (i) Large stones or artificial blocks are buried from the level deeper than the scour depth to the level of the present riverbed.
- (ii) It is protected by covering concrete. (Either tetrapod or cross-shaped concrete blocks will do)

2) Embedding the existing protecting works deeper than the scour depth (refer to Figure 4-2).

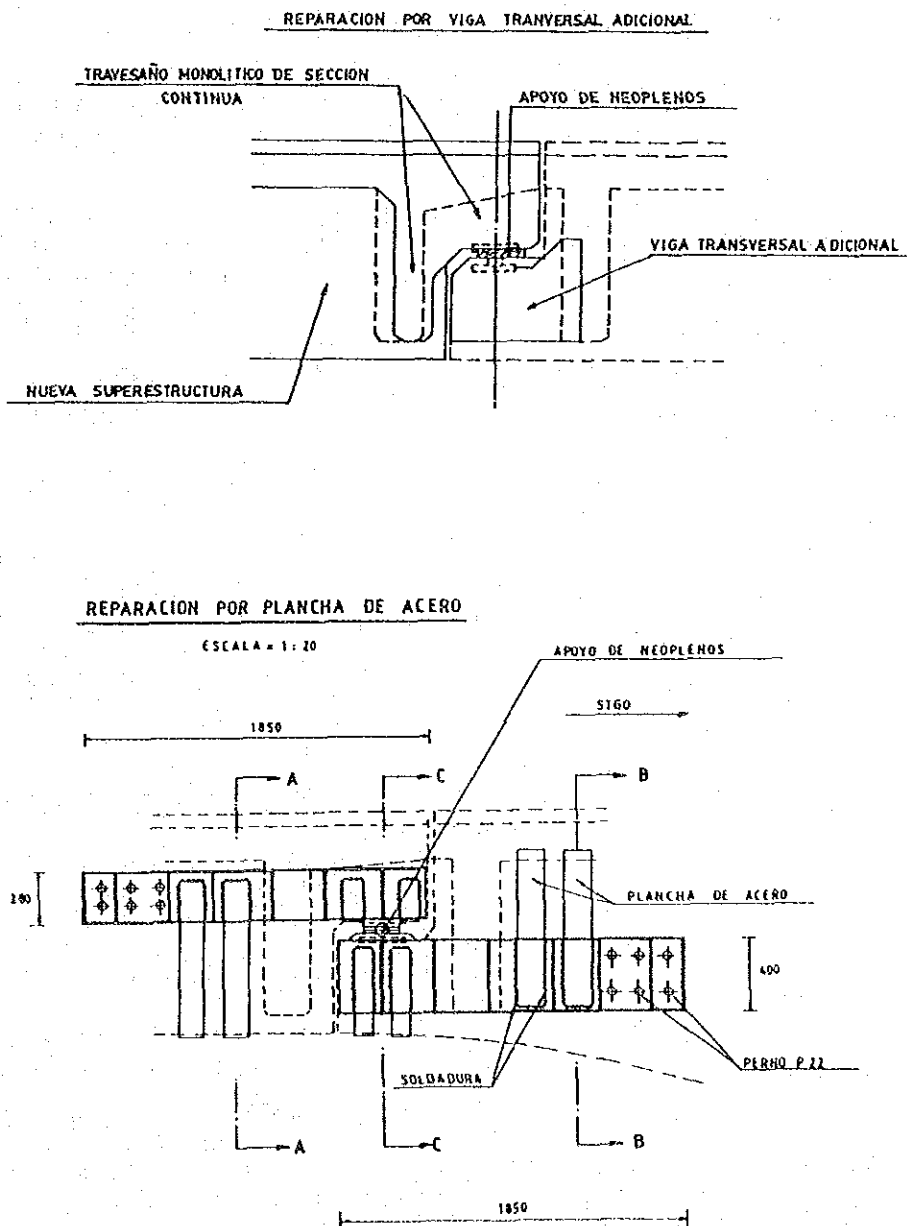
Figure 4-17 Standard Repair Method for Gerber Hinge

This is an irregular T-shaped reinforced concrete girder bridge with Gerber hinges in the middle. Leakage through the hinges have resulted in rusting of the shoes and the Gerber girders do not have adequate cross-sections against shear forces. Reinforcement work will be carried out either by insertion of additional cross beams or steel plates as shown below. (Refer to Figure 4-17)
