THE STUDY  
ON  
THE MAINTENANCE AND REHABILITATION  
OF  
BRIDGES  
IN  
MALAYSIA

FINAL REPORT

VOLUME IV  
DRAWINGS

DECEMBER 1992

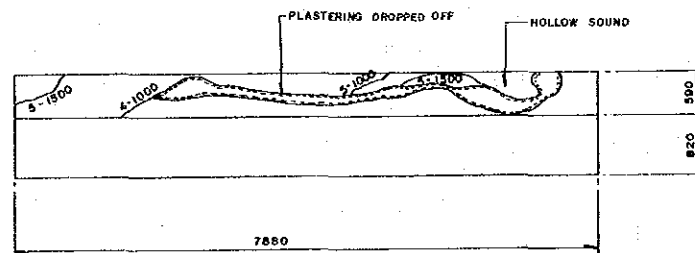
**SECTION B-B  
(ABUTMENT 1)**  
1:50

**NOTES:-**  
1) BOTH ABUTMENTS ARE MASONRY WITH CEMENT MORTAR PLASTERING.  
2) CRACK AND FLACKING ARE ON THE PLASTERING SURFACE ONLY.
