**REPORT OF JAPAN DISASTER RELIEF TEAM**  
**(EXPERT TEAM)**  
**ON THE EARTHQUAKE**  
**IN**  
**REPUBLIC OF INDONESIA**  
**OF**  
**DECEMBER 12, 1992**

**MARCH, 1993**

**JAPAN INTERNATIONAL COOPERATION AGENCY**  
**(JICA)**

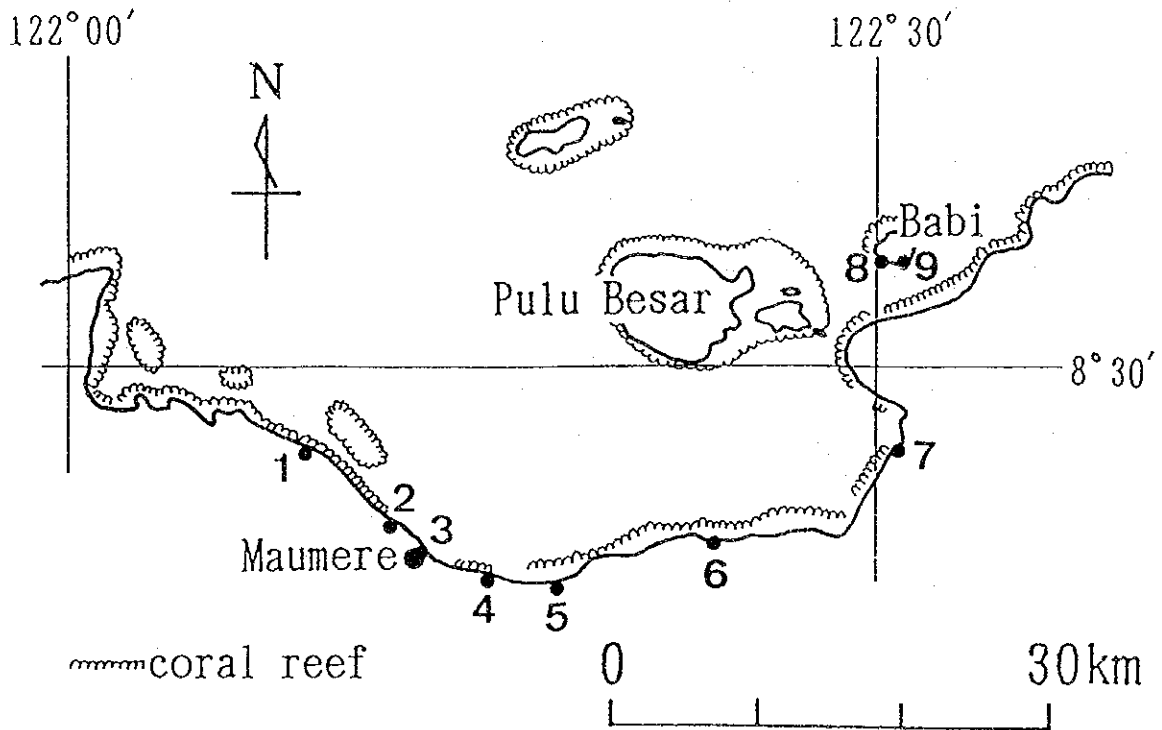
Fig. 3.1 Location Map and Tsunami Inundation Height

Figure 3.1 shows the location map of the observation sites and the measured inundation height in meter. Maximum inundation height of 2.45 m was measured at Wuring area in Flores island. Tsunami height decreases from this area to east because of the sheltering effect of Besar island, and to west due to the existence of the offshore coral reef as shown in Fig. 3.2. In Babi island maximum inundation height was about 3.7m, and it is about 1.2 m larger than that at Wuring area.

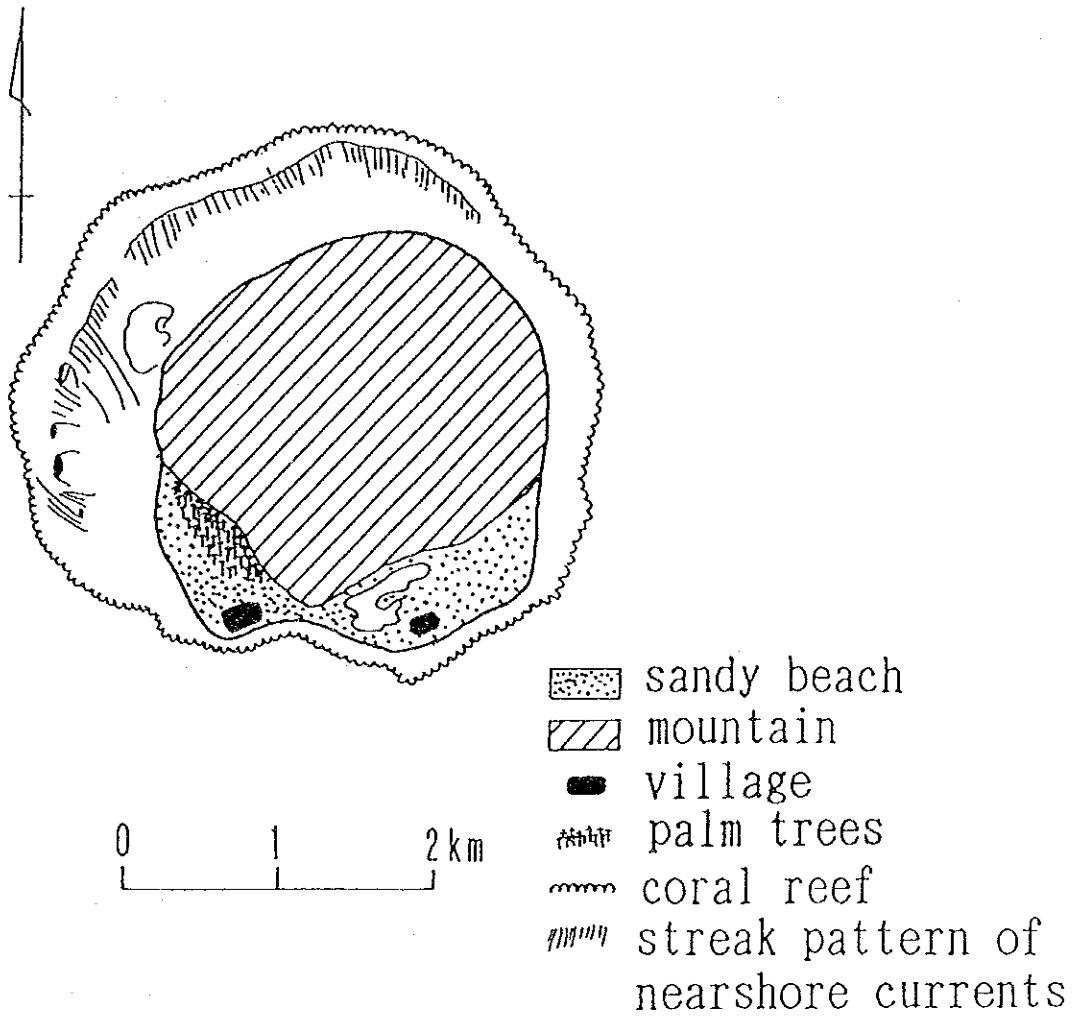
Fig. 3.3 Topographic Map of Bai Island Read from Aerial Photograph

Babi island is located about 38 km northeast of Maumere Port. This island is of circular shape and its diameter is about 2.5 km. Coral reef well develops around this small island as shown in Fig. 3.3. Off the north shore of this island wide reef develops due to the incidence of wind waves, whereas it is narrow off the south shore. In addition, two large cusped forelands develop on the south side of the island. These geomorphological features imply that the location receiving the most severe action by wind waves are north and northwest shores, and two cusped forelands were formed by the depositional effect of the coral debris produced near the reef edge by the action of breaking wave and carried by the longshore currents around the island.

Tsunami front invaded these sandy beaches from south, where water depth is very deep since the coral reef does not exist. The direction of the tsunami movement can be confirmed to be from south to north by the following observations:

- 1) Debris of the houses were scattered in the palm trees north of the original positions as shown in Fig. 3.3.
- 2) Palm trees were fallen down by tsunami with their roots heading south.
- 3) An eyewitness from this disaster pointed out that the tsunami came from south.

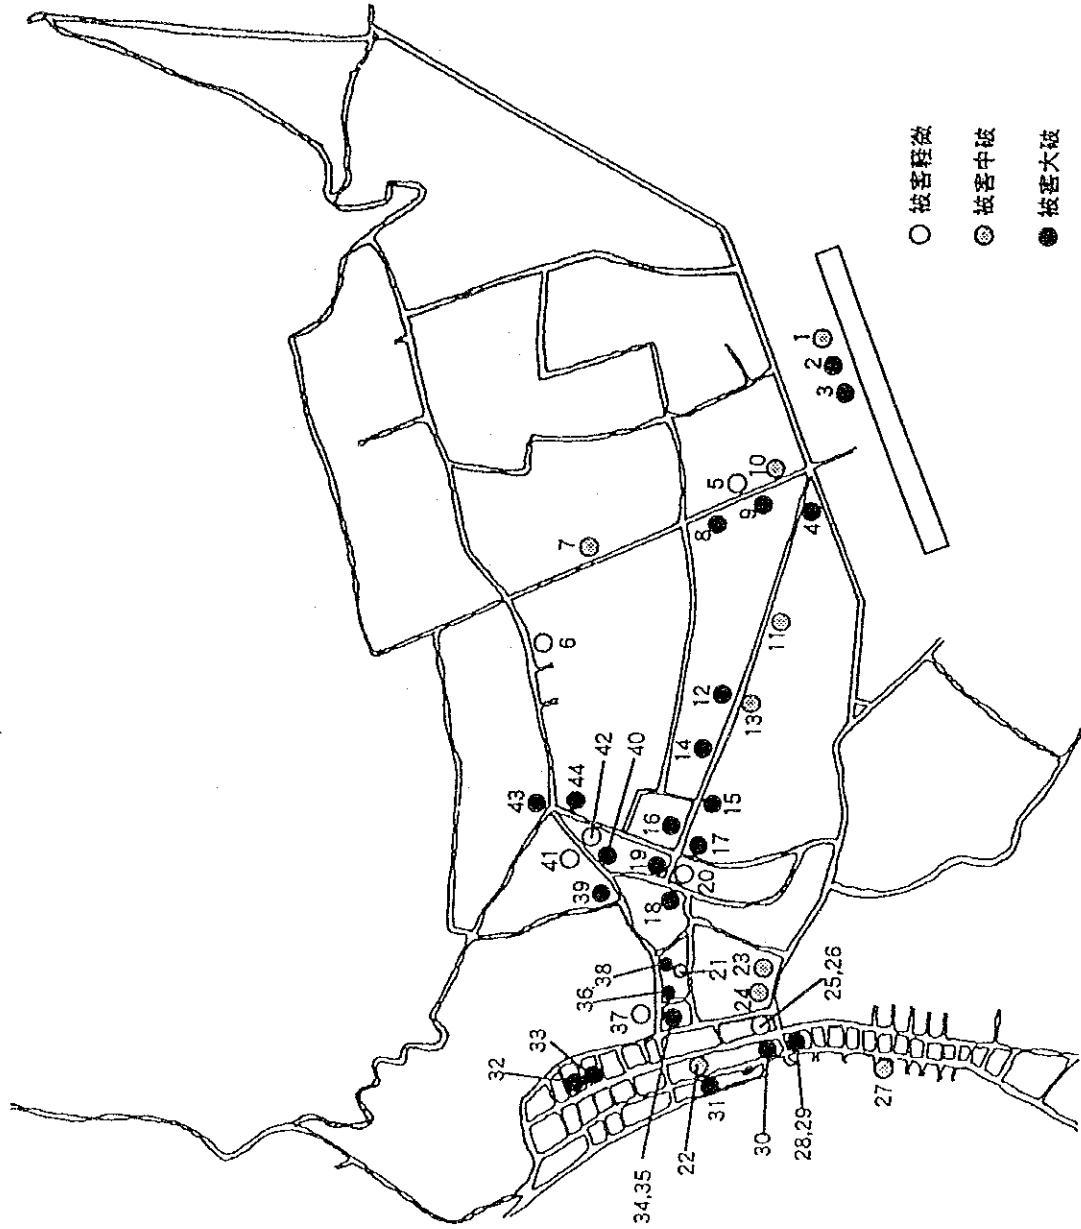
Fig. 4.1 Ende City Map

Ende city locates in the central area of Flores Island and face to Savu Sea. Its population is about seventy thousand. Building team surveyed forty-four buildings in this city area for two hours guided by the staff of Ende prefecture office. Fig. 4.1 shows the outline of Ende city map. The numerals in this figure are the buildings which we reconnoissanced. Later part of this section, photographs of such buildings are shown.

Among thirty two brick masonry buildings (M), fifteen buildings were collapsed (47%). Two reinforced concrete framed masonry wall buildings (RC + M) were collapsed among twenty-two same types buildings (9%). Sixteen (RC + M) buildings were severely damaged (73%). Twenty-seven M structures were also severely damaged (84%).

Many of photographs as shown in later part, showed such traces of "out-of-plane" collapse of masonry buildings.

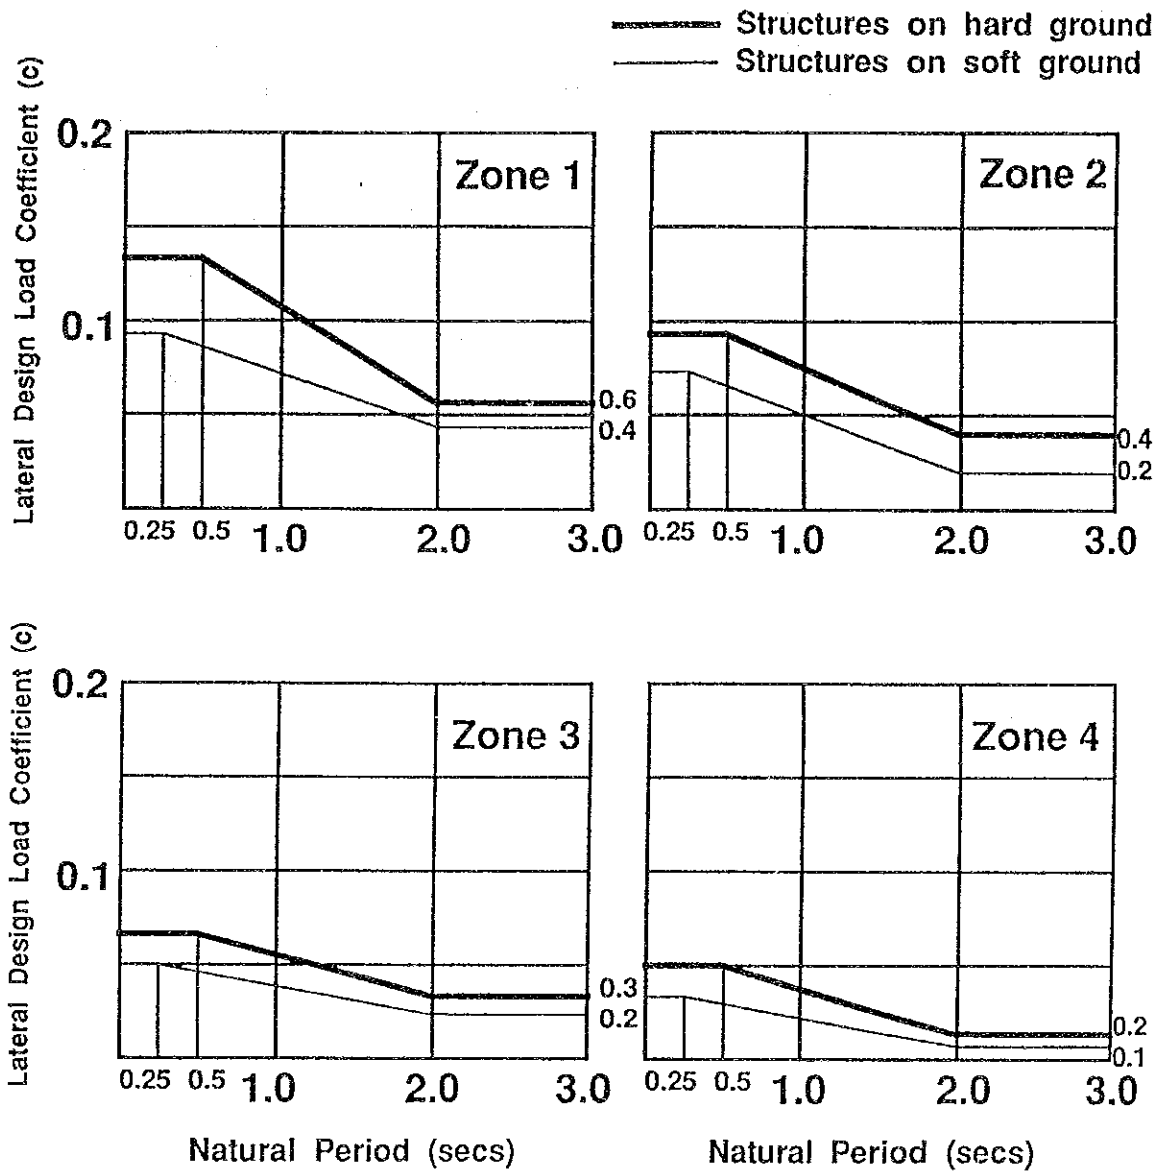
Fig. 4.4 Unmodified C Values

where  $C$ ; base design shear coefficient, six categories are defined in all of Indonesia Republics. In each zone, two values are defined by the soil condition Flores Island is classified in Zone 2, as shown in Fig. 4.4.

According to this code, Fig. 4.4 becomes design base shear coefficient assuming  $I=1.0$  and  $K=1.0$ .  $C_d$ 's values are 0.09 in hard soil and 0.07 in soft soil in zone 2 for the short natural period of structures.

Calculated ultimate shear capacity coefficient of in-plane masonry wall system is larger than this design coefficient. However its out-of-plane capacity was evaluated as about 0.1 g. It is easily realized that the responded earthquake force to the structure exceeds 0.1 g, then many masonry structure collapsed in out-of-plane. Considering these earthquake damage, design base shear coefficient  $C_d$  should be discussed again.
