## 4.5 Recommendations

## 5. Damage of Lifeline Facilities

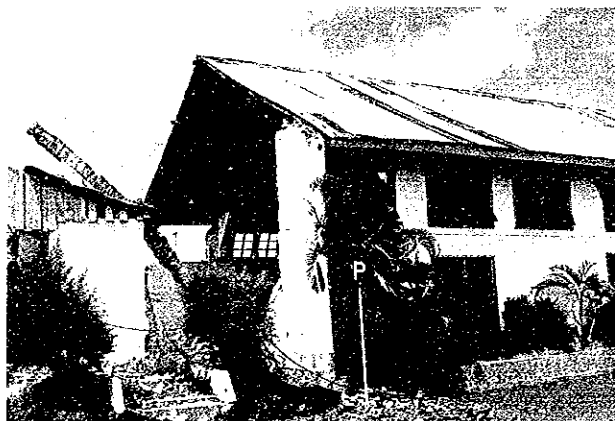
Photo 4.17 Ende Assembly Hall; Collapse of Side Wall

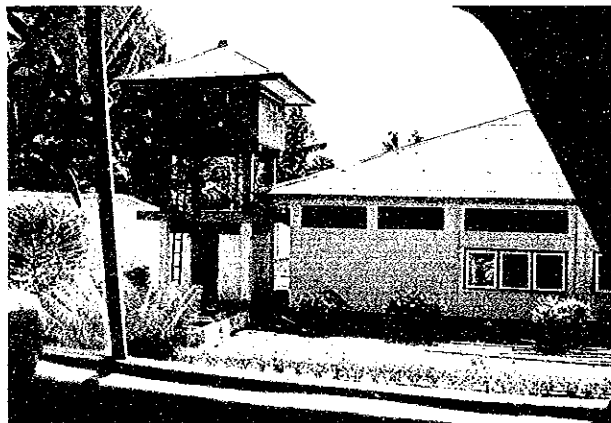
Photo 4.22 Same Type Reinforced Concrete Tower

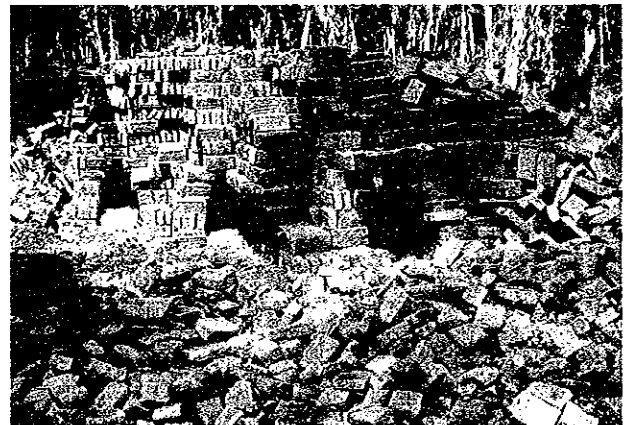
Photo 4.58-3 Then This Raw Bricks are Burned for Twenty Four Hours; Combustion Material: Banana Trees
