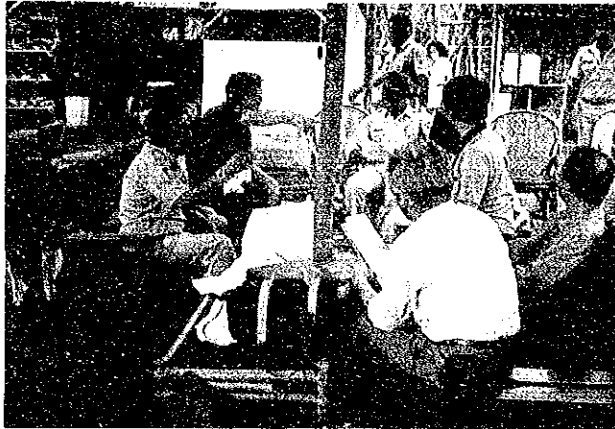
Photo 7.1 Headquarters of Ende Regency

- 2) Because of the serious damage of the regency office, the chief of regency is taking command of the Headquarters for Disaster Countermeasures in the Governor's official residence. (Photo 7.1)
- 3) Brigadier General Sulatin in the Udayana District (Head Office: Denpasar) was dispatched to Maumere and is taking command of his own headquarters in Waioti Airport.

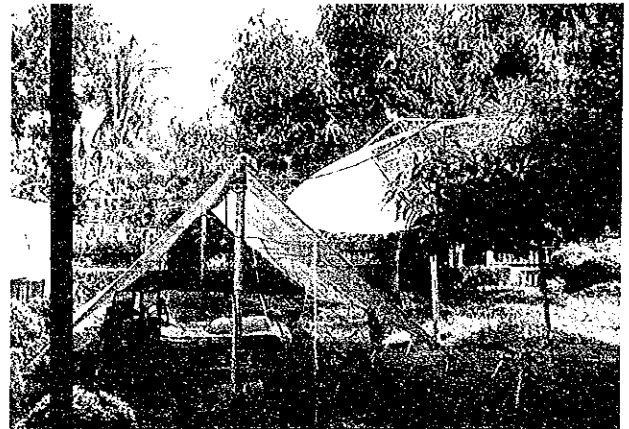
Photo 7.2 Parabola Antenna in the Headquarters of Ende Regency

The ways to communication at emergency is shown in Fig. 7.2 (Photo 7.2)

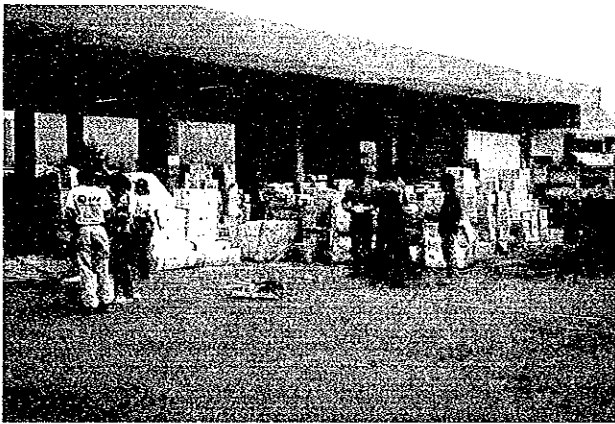
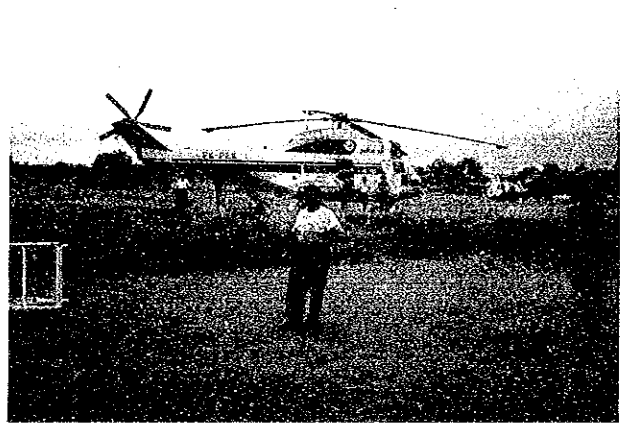
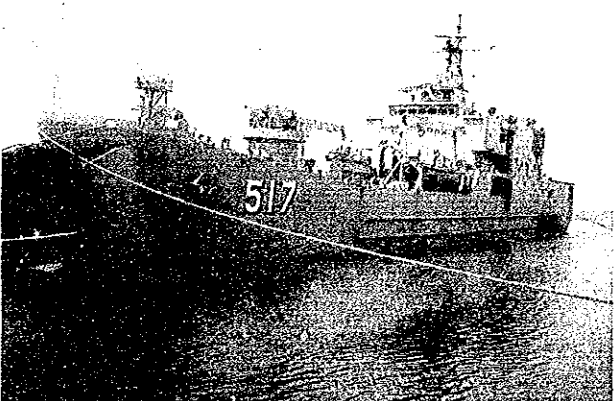
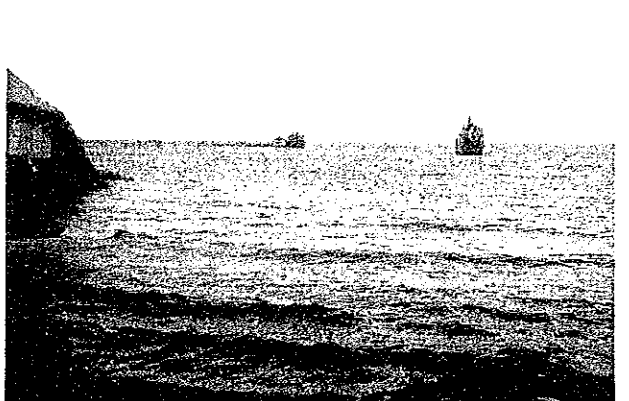
- a. There has been no trouble in daily life since business services resumed and the relief supplies were arrived. (Photo 7.3 to 7.6)

Photo 7.3 Relief Supplies at Maumere Airport

Photo 7.4 Helicopters to Distribute the Supplies

Photo 7.5 Transport of the Relief Supplies or Heavy Construction Machines by ABRI

Photo 7.6 Transport of the Relief Supplies or Heavy Construction Machines by ABRI

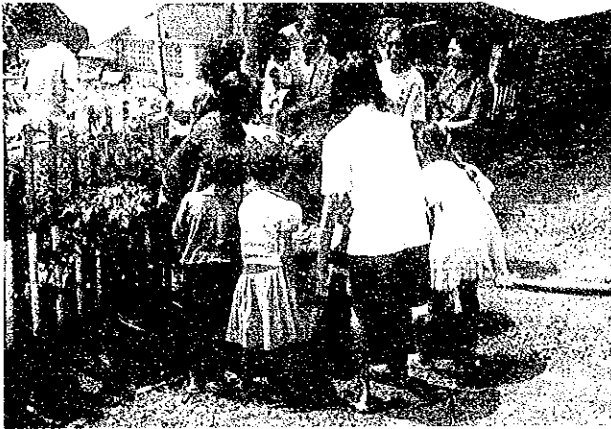
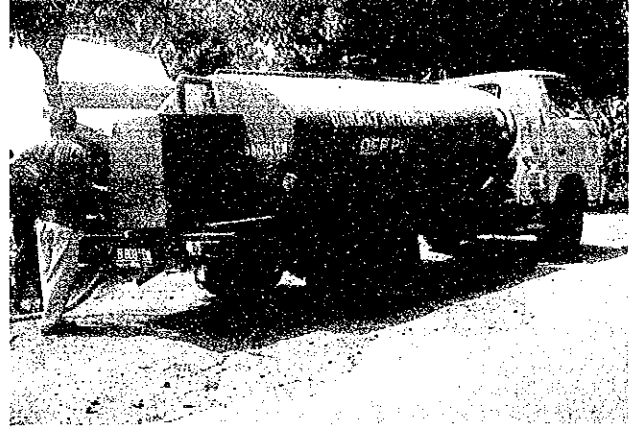
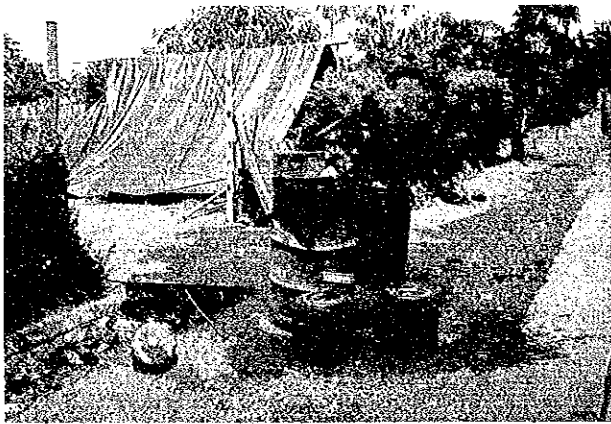
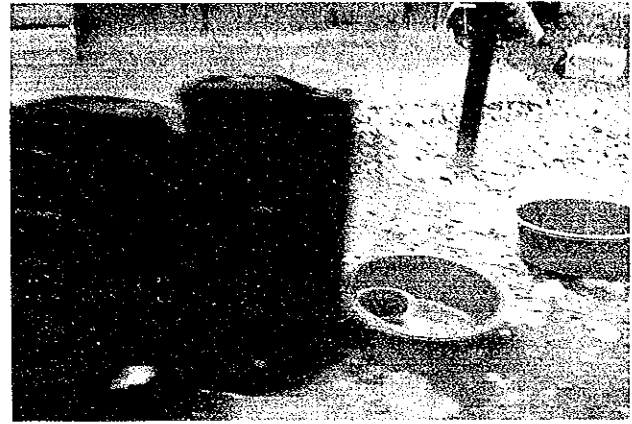
- b. The waterworks were stopped for three days. Afterward, some main wells were broken and the capability of water supply was less than half compared with before. Now water supply is implemented with tank trucks. (Photo 7.7 to 7.10)

Photo 7.7 Water Supply with Tank Trucks

Photo 7.8 Water Supply with Tank Trucks

Photo 7.9 Water Supply with Tank Trucks

Photo 7.10 Water Supply with Tank Trucks

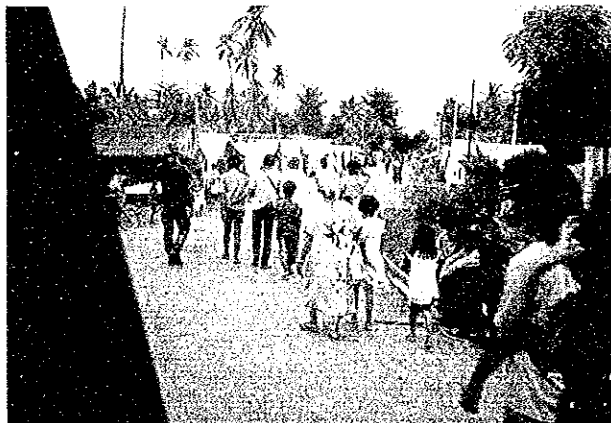
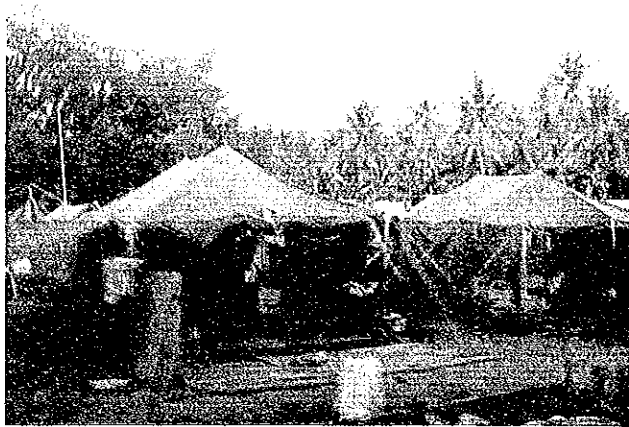
- 1) Most of the people, who lost their houses, are living in tents as tentative residence. (Photo 7.11 to 7.13)
 - 2) The lack of tents makes some people accommodated in open space like the style of camp. Approximately 100 tents are pitched in the field in front of official residence. Big tents of them are accommodated as many as 10 families (each family consists of 3 to 4 persons). (Photo 7.14)

Photo 7.11 Tentative Residence with Tents

Photo 7.12 Tentative Residence with Tents

Photo 7.13 Tentative Residence with Tents

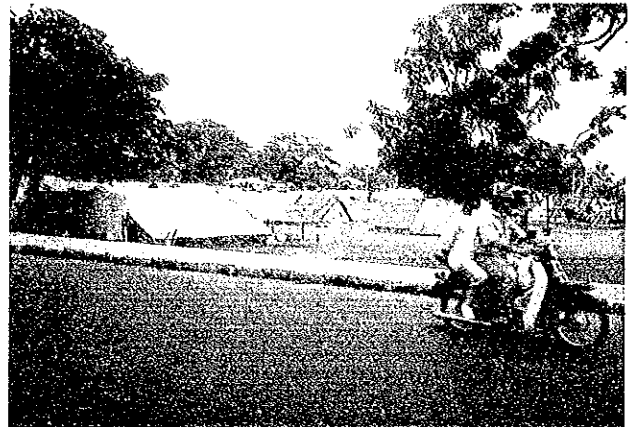
Photo 7.14 Tentative Residence with Tents

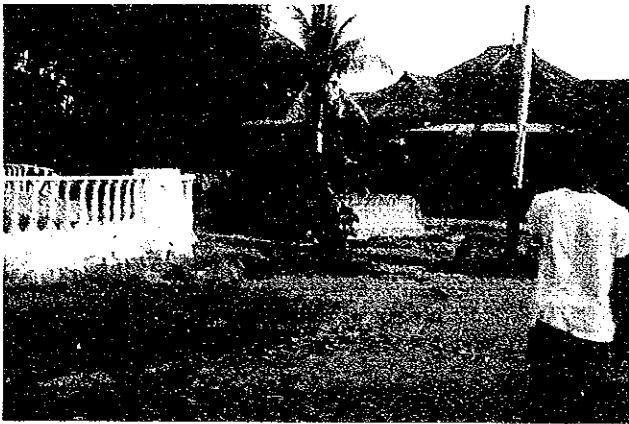
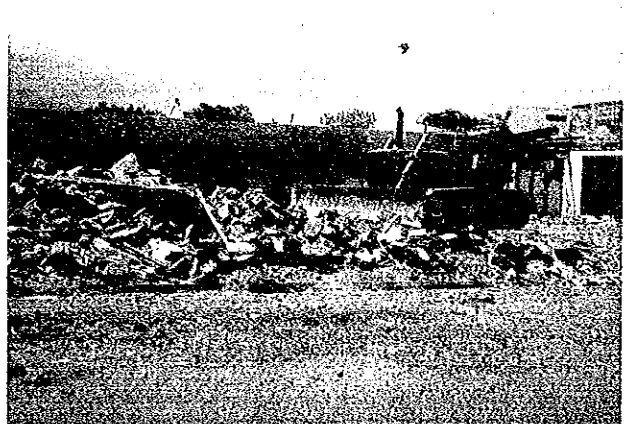
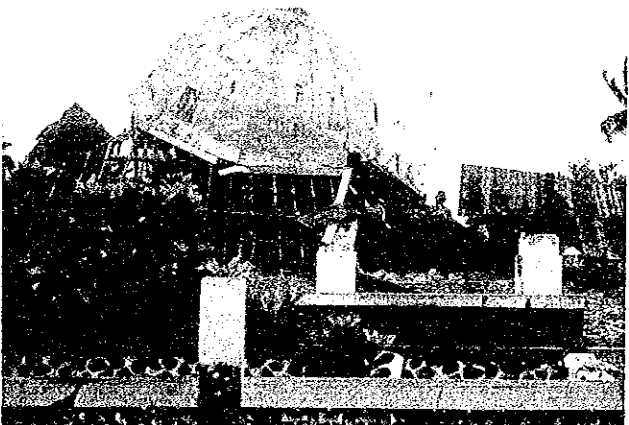
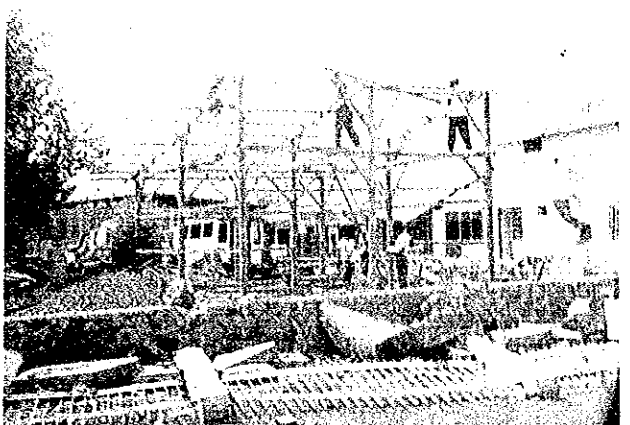
- (2) Some heavy construction machines such as bulldozer were offered by ABRI and rehabilitation works is about to be carried out practically. (Photo 7.15 to 7.18)

Photo 7.15 Bulldozer Offered by ABRI

Photo 7.16 Bulldozer for General Use

Photo 7.17 Rehabilitation Work by ABRI

Photo 7.18 Rehabilitation Work by People
