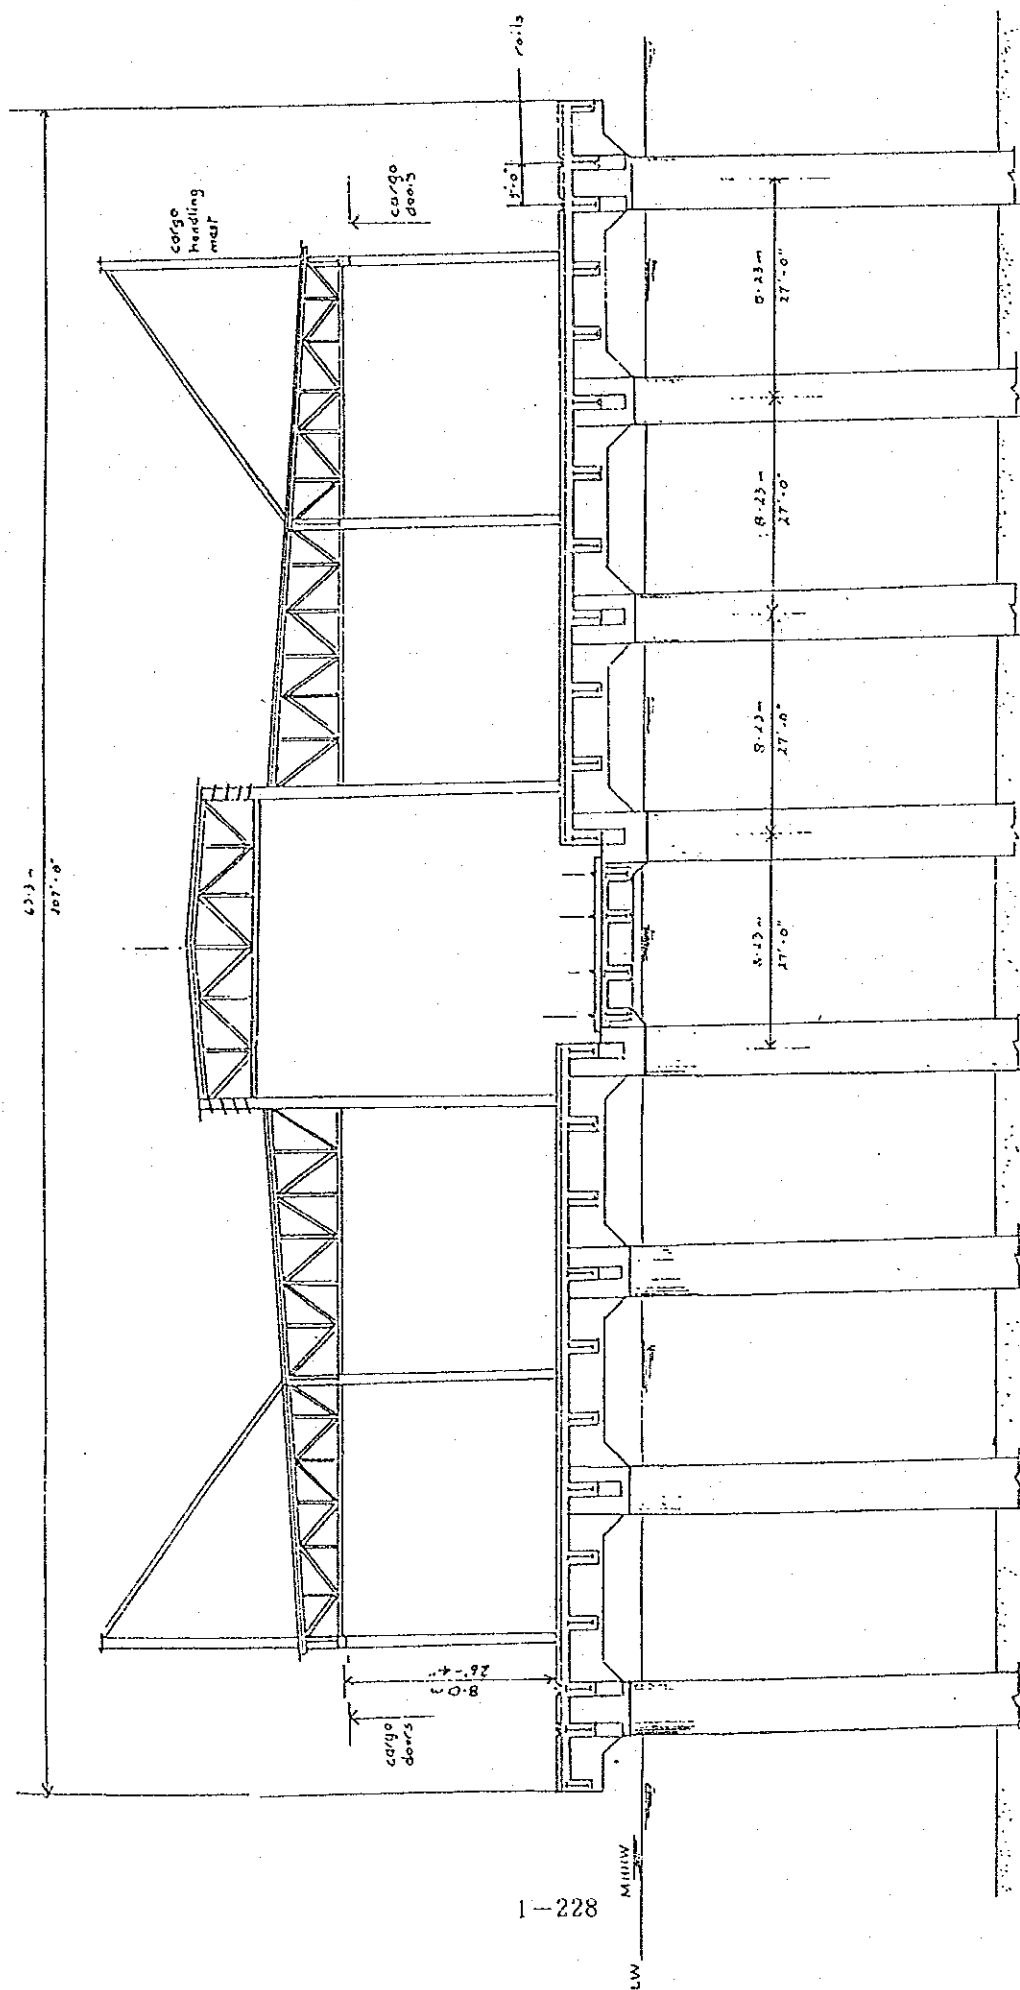
Figure 7-2-4 Typical Section of Pier No. 8

As mentioned before, two rail siding tracks were laid along the pier center. Rail elevation is 1.5 m lower than the deck floor. According to the inspection and the information from the drawings, rails were laid on the lateral beams whose ends are supported by piles. Refer to Figure 7-2-4. This lateral beam is rigidly connected to the piles. It is needless to say that the other beams are all rigidly connected to the piles. No crack or disconnection between the lateral beams and the piles were found.

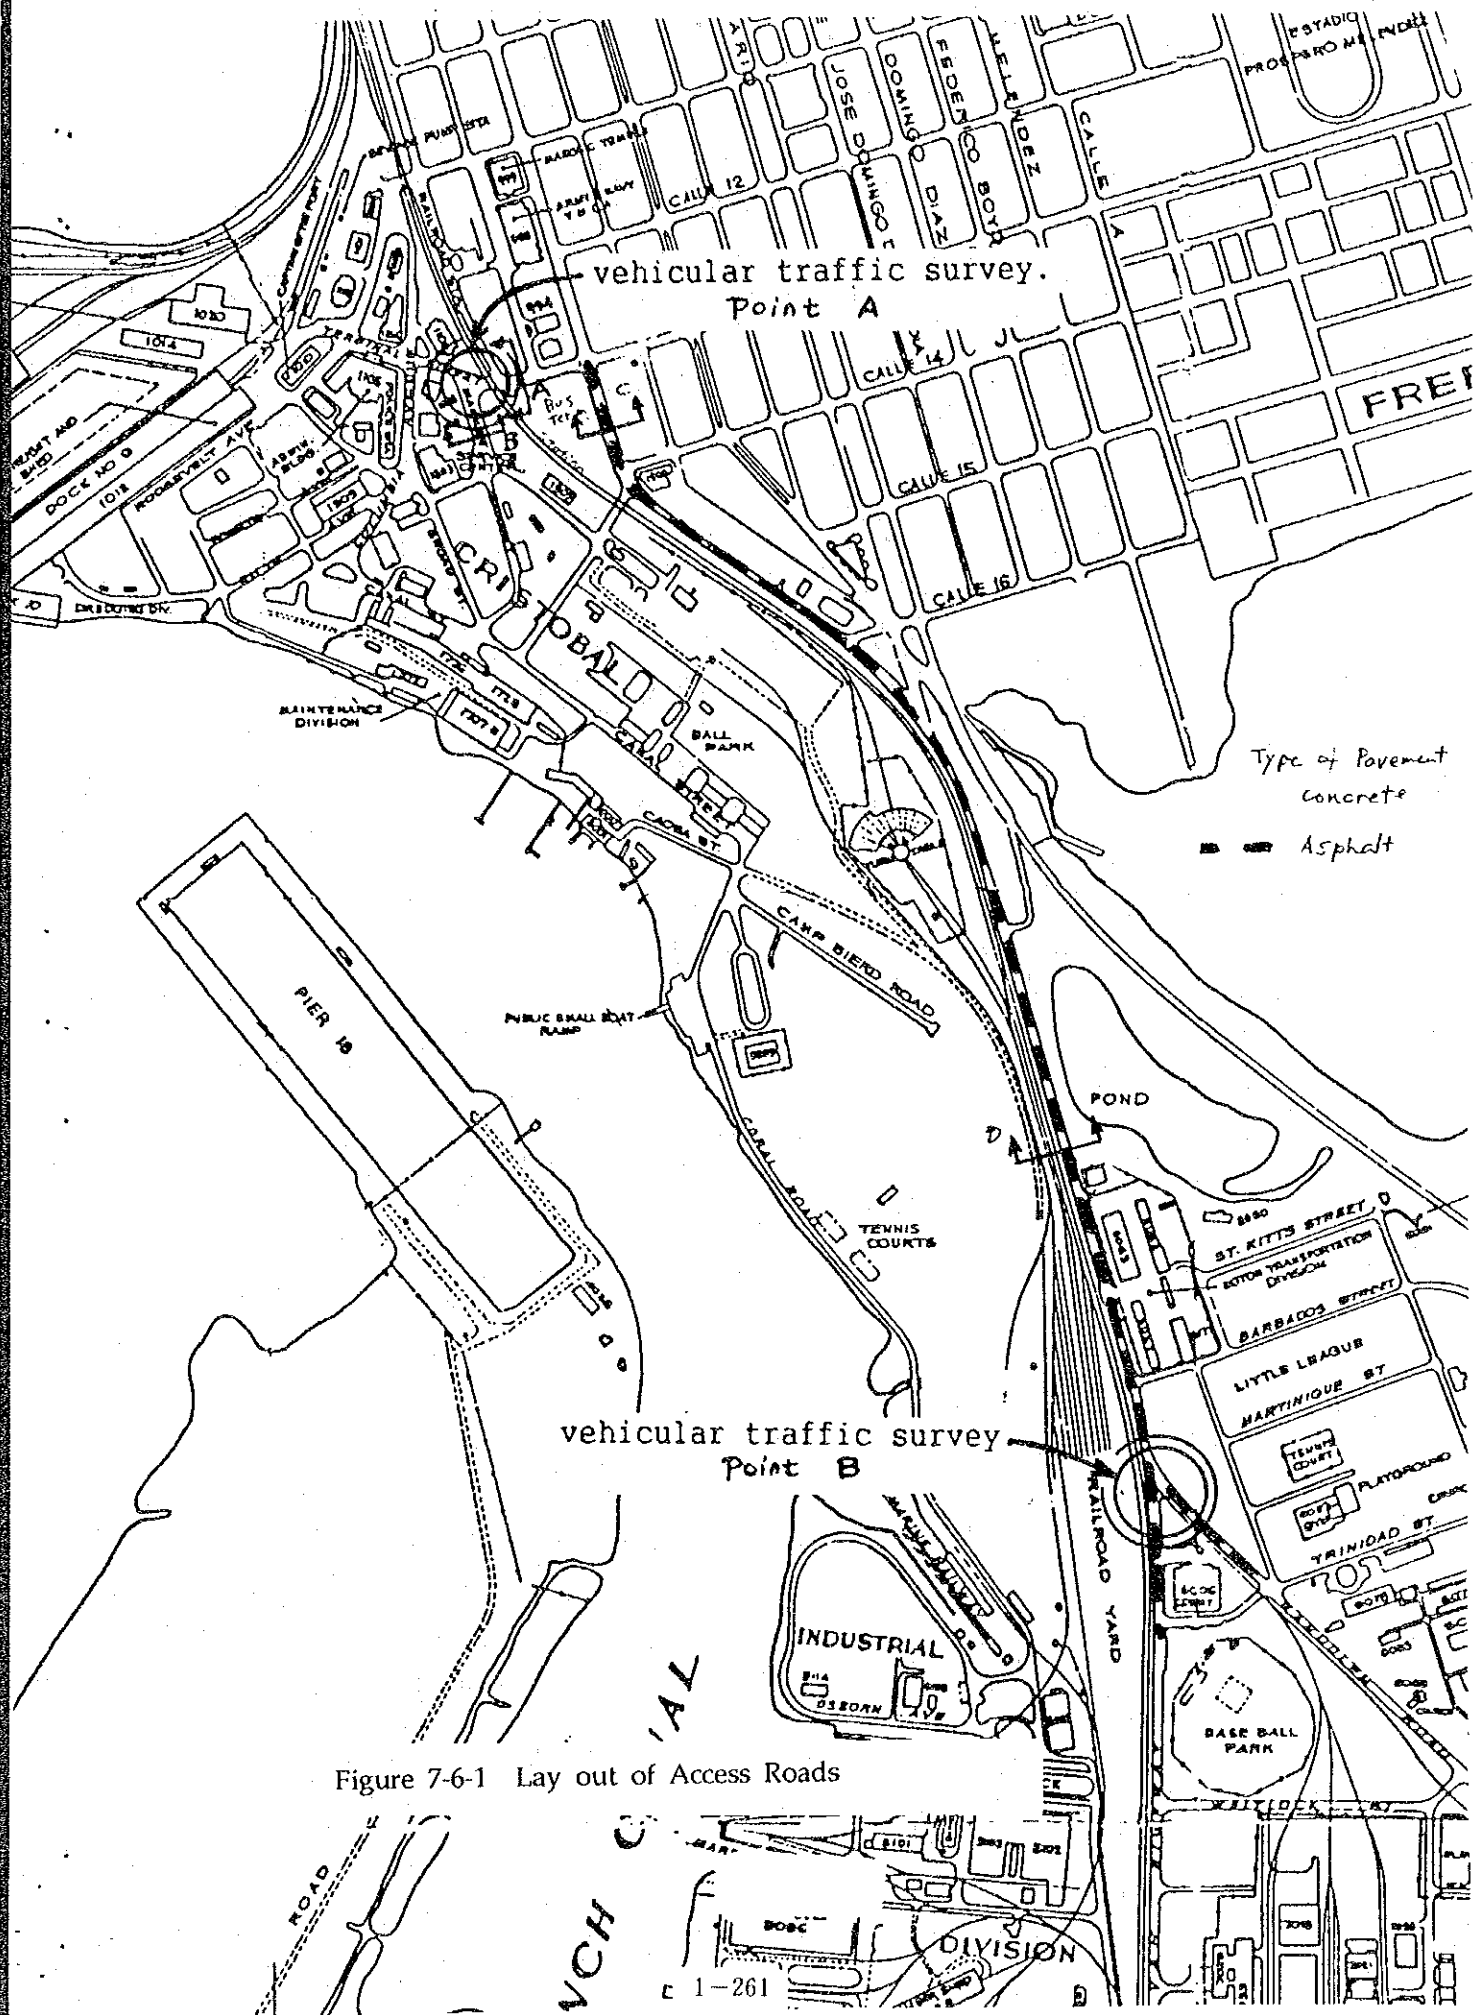
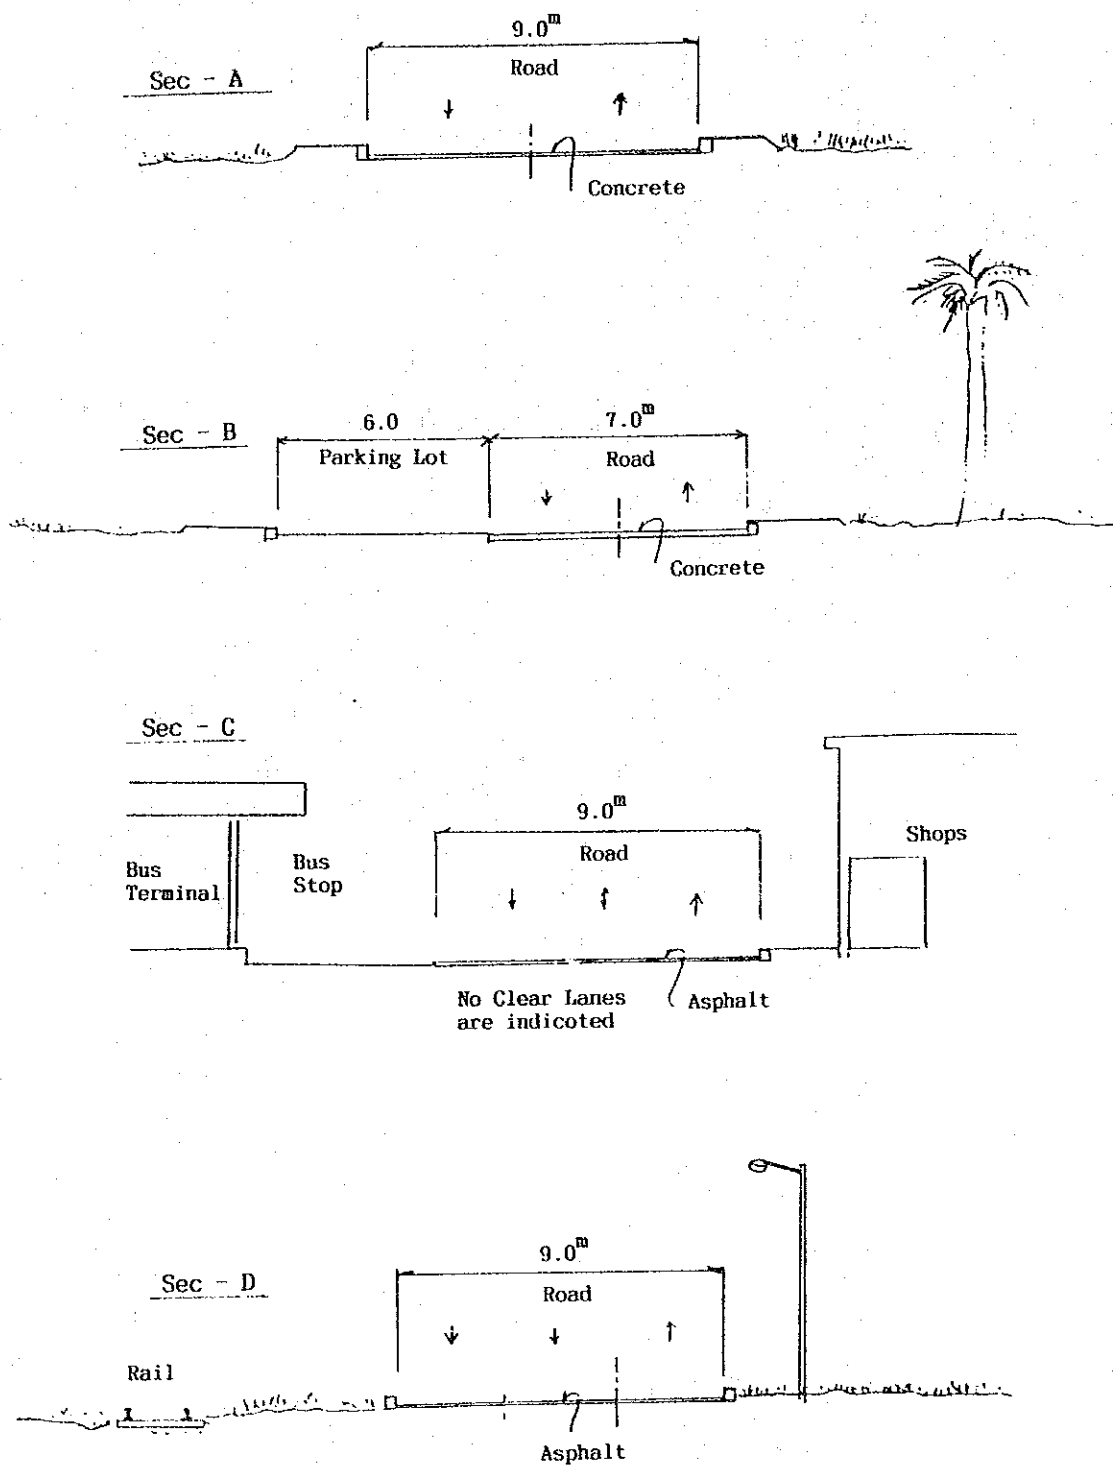
Figure 7-6-2 Typical Section of Access Roads

As shown in Figure 7-6-1, there are two types of pavement, asphalt pavement and concrete pavement. The asphalt pavement has some damages or holes on the surface treatment. They are not critical for the current traffic, however they should be repaired soon for better conditions. As for the concrete pavement, joints are properly provided. Minor cracks caused by the concrete shrinkage are observed, however they are not serious for the current traffic.

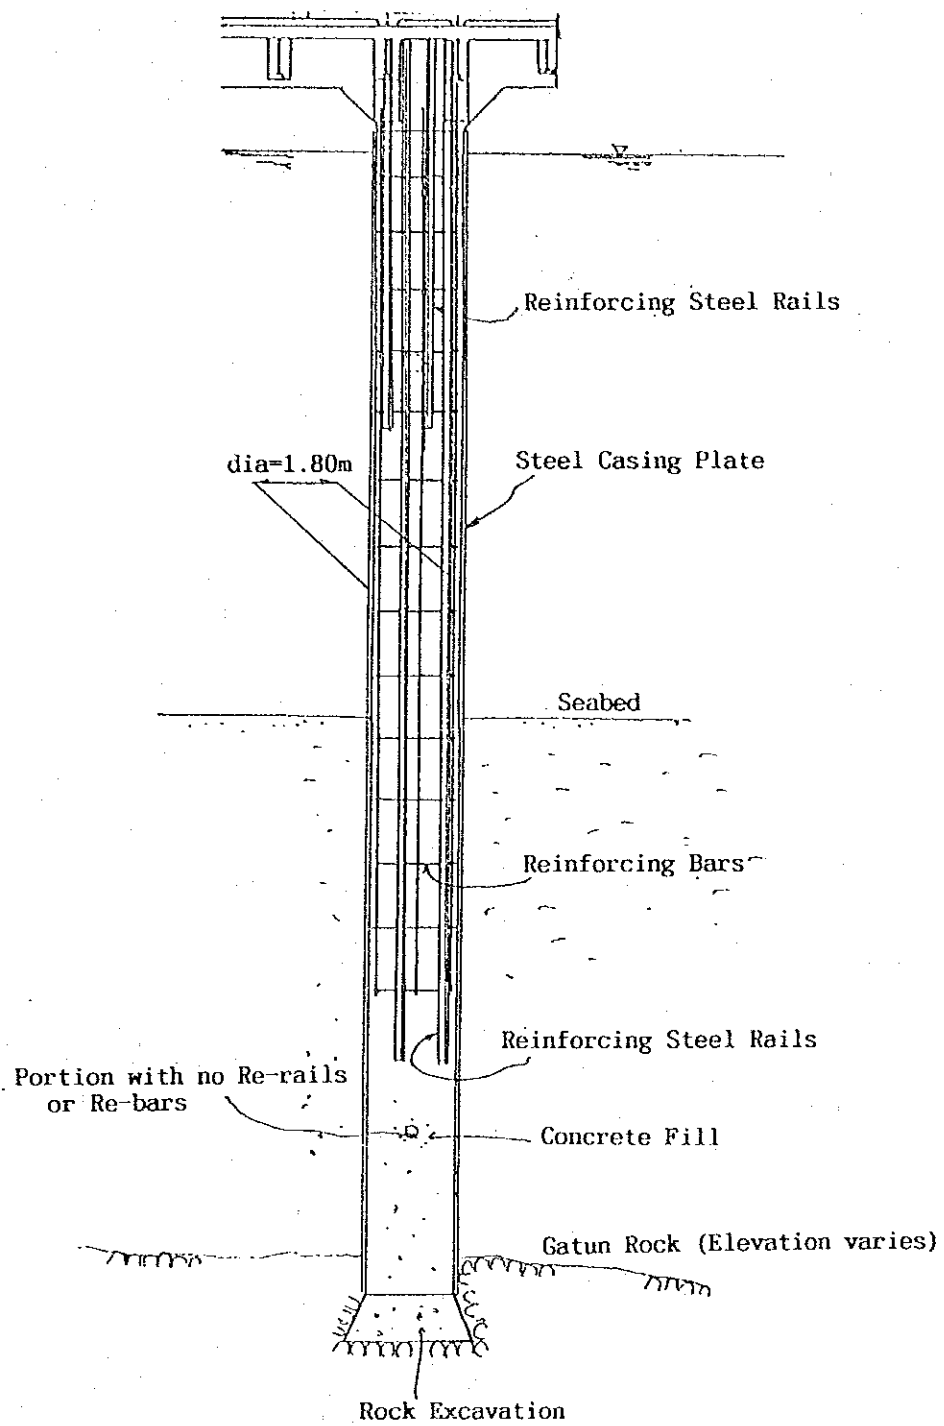
Figure 8-4-1 Features of Foundation Piles

If the rock excavation and concrete filling were done properly, the connection may be regarded as fix. If not, it may be pin. If the pile section is damaged (cracks or disconnection) and sub-soil is disturbed, it may be roller too.
