Preliminary Report

**Flores Island, Indonesia Earthquake
of December 12, 1992**

- Preliminary Investigation and Recommendations -

Japanese Expert Team

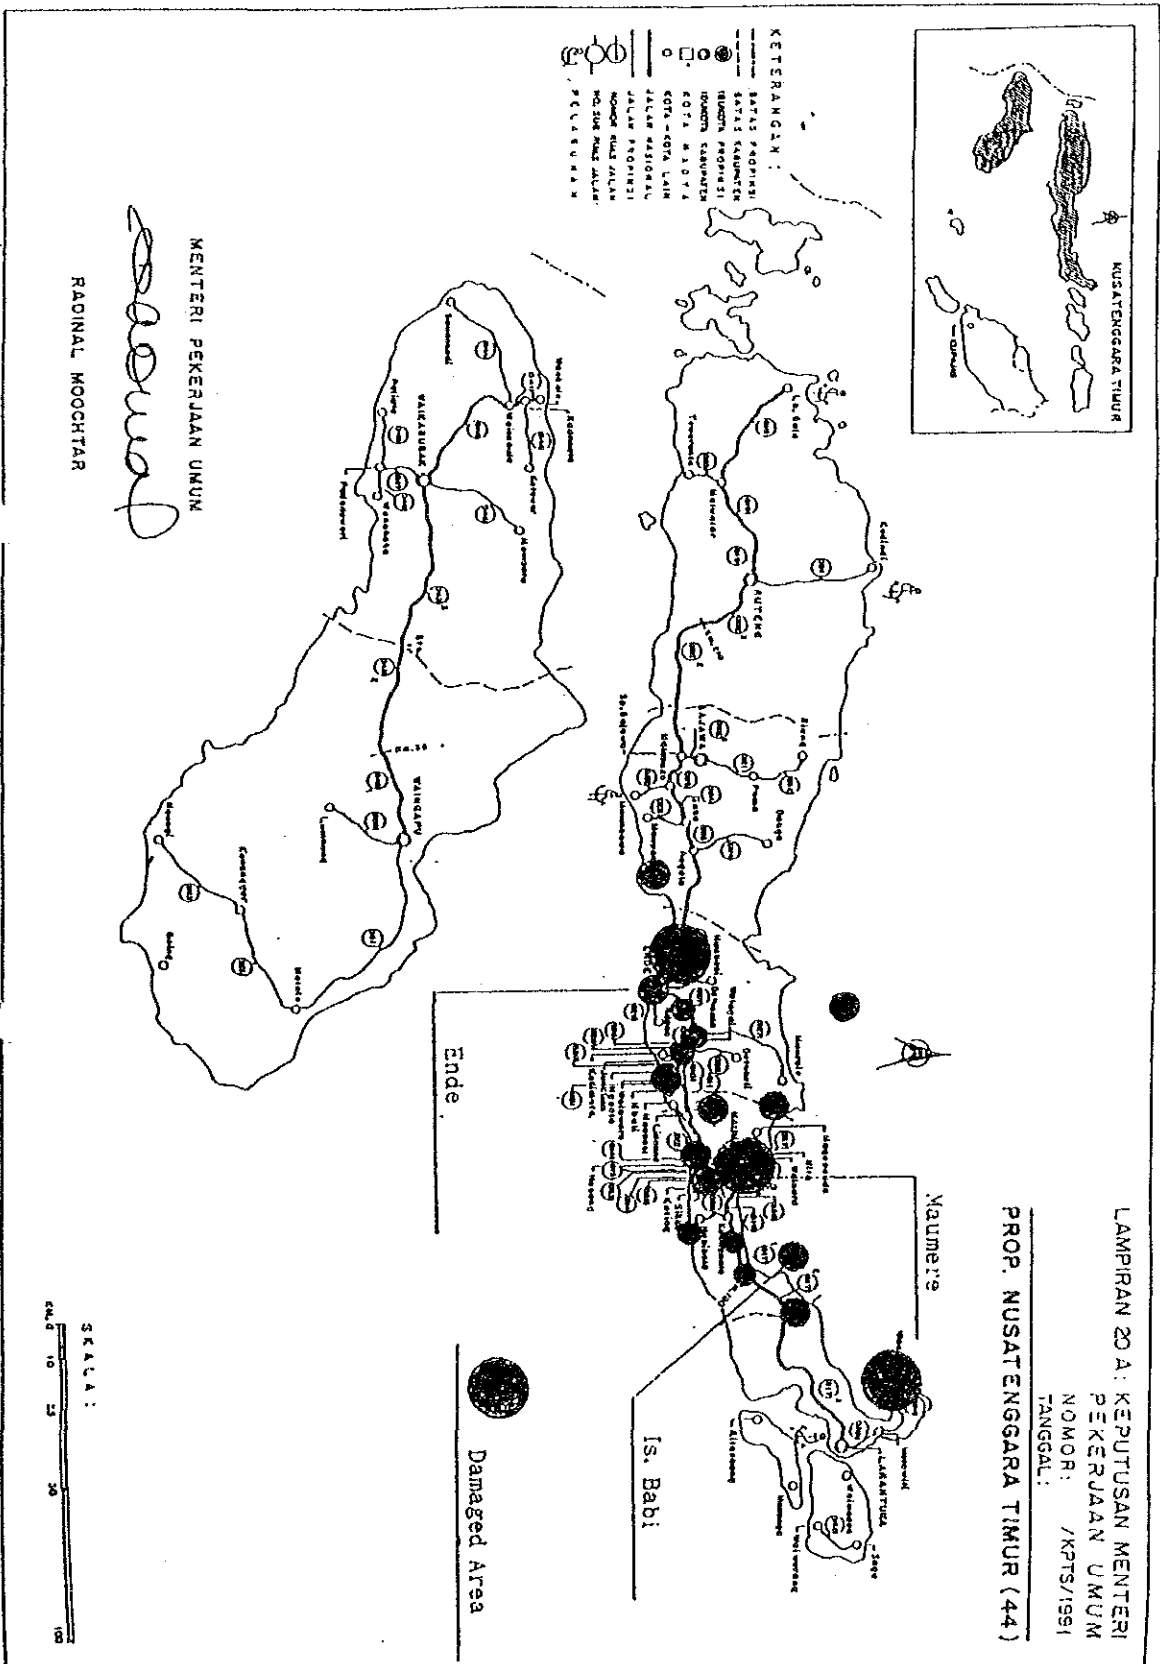
Figure 2-1 Damaged Area

(11)Damage information by the Army Headquarters in Maumere(WAIOTI) Airport is as shown in Figure 2-1 and Table 2-1.

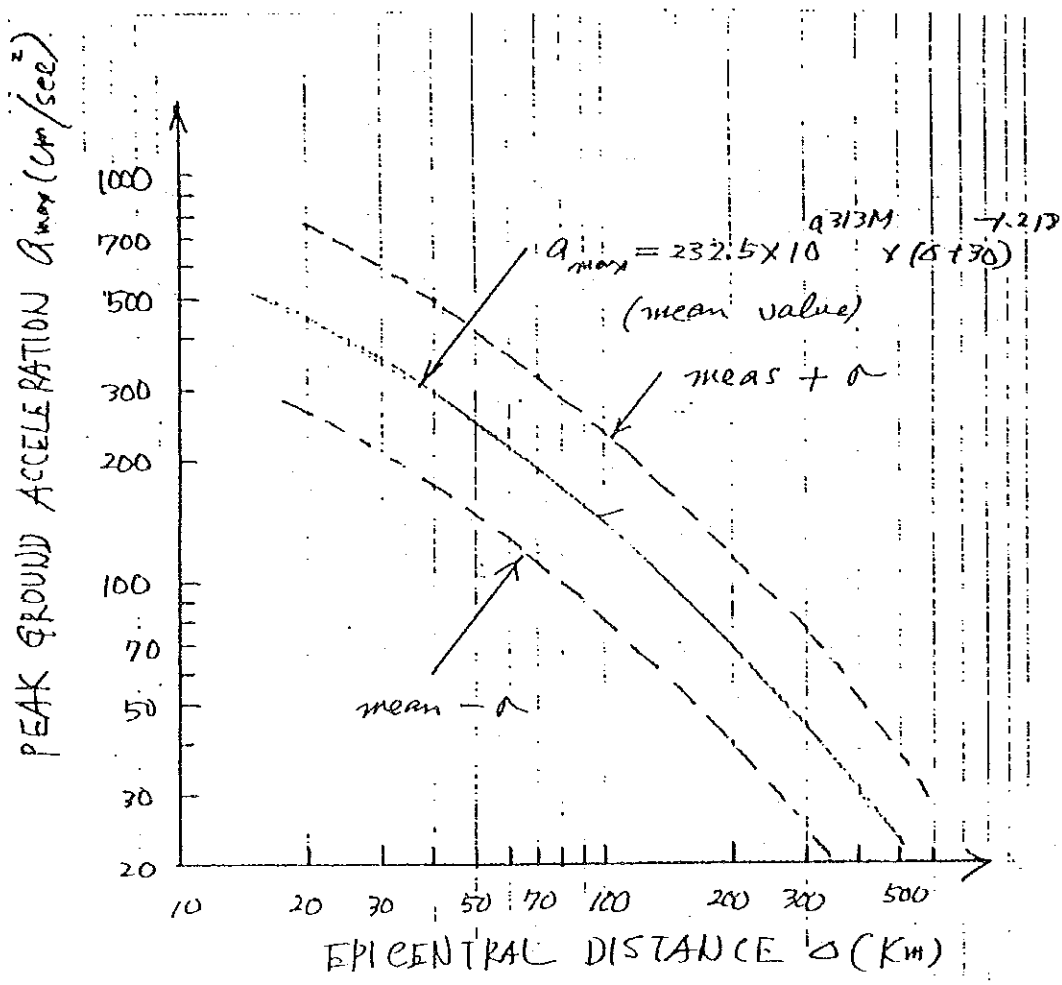
Fig. 5-5 Attenuation of Peak Ground Acceleration
Based on a Japanese Empirical
Attenuation Equation

Assuming that the earthquake magnitude M of 7.5, the peak ground acceleration predicted by Eq. (5-1) attenuates as shown in Fig. 5-5. Because the epicenter of the earthquake was 8.43 degree S and 121.30 degree E, the epicentral distance of Maumere was about 50 km. It should be noted here that because the fault zone is very close to the Flores Island, it is not appropriate to evaluate the distance from the fault zone to the site in terms of the epicentral distance. However if one considers 50 km for the epicentral distance at Maumere, the peak ground acceleration is evaluated as 0.25 g. This value is considered to be a first-hand evaluation for the ground acceleration during the earthquake of December 12, 1992.

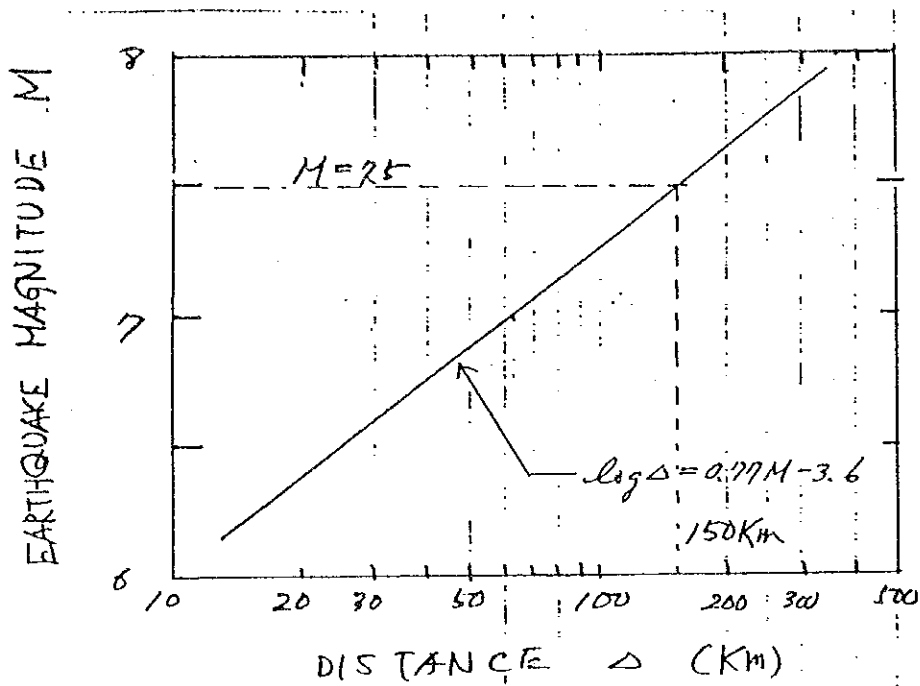
Fig. 5-7 Distance from Epicenter in which Soil Liquefaction was Developed in the Past Earthquakes

Fig. 5-7 shows the empirical relation by Eq. (5-2). It is not surprising from the past experience to have the liquefaction within 150 km from the epicenter for the earthquake of December 12, 1992.
