**BASIC DESIGN STUDY REPORT
ON
THE PROJECT FOR REHABILITATION
OF
NATIONAL ROAD ROUTE 6A
IN
CAMBODIA**

APRIL 1993

PACIFIC CONSULTANTS INTERNATIONAL

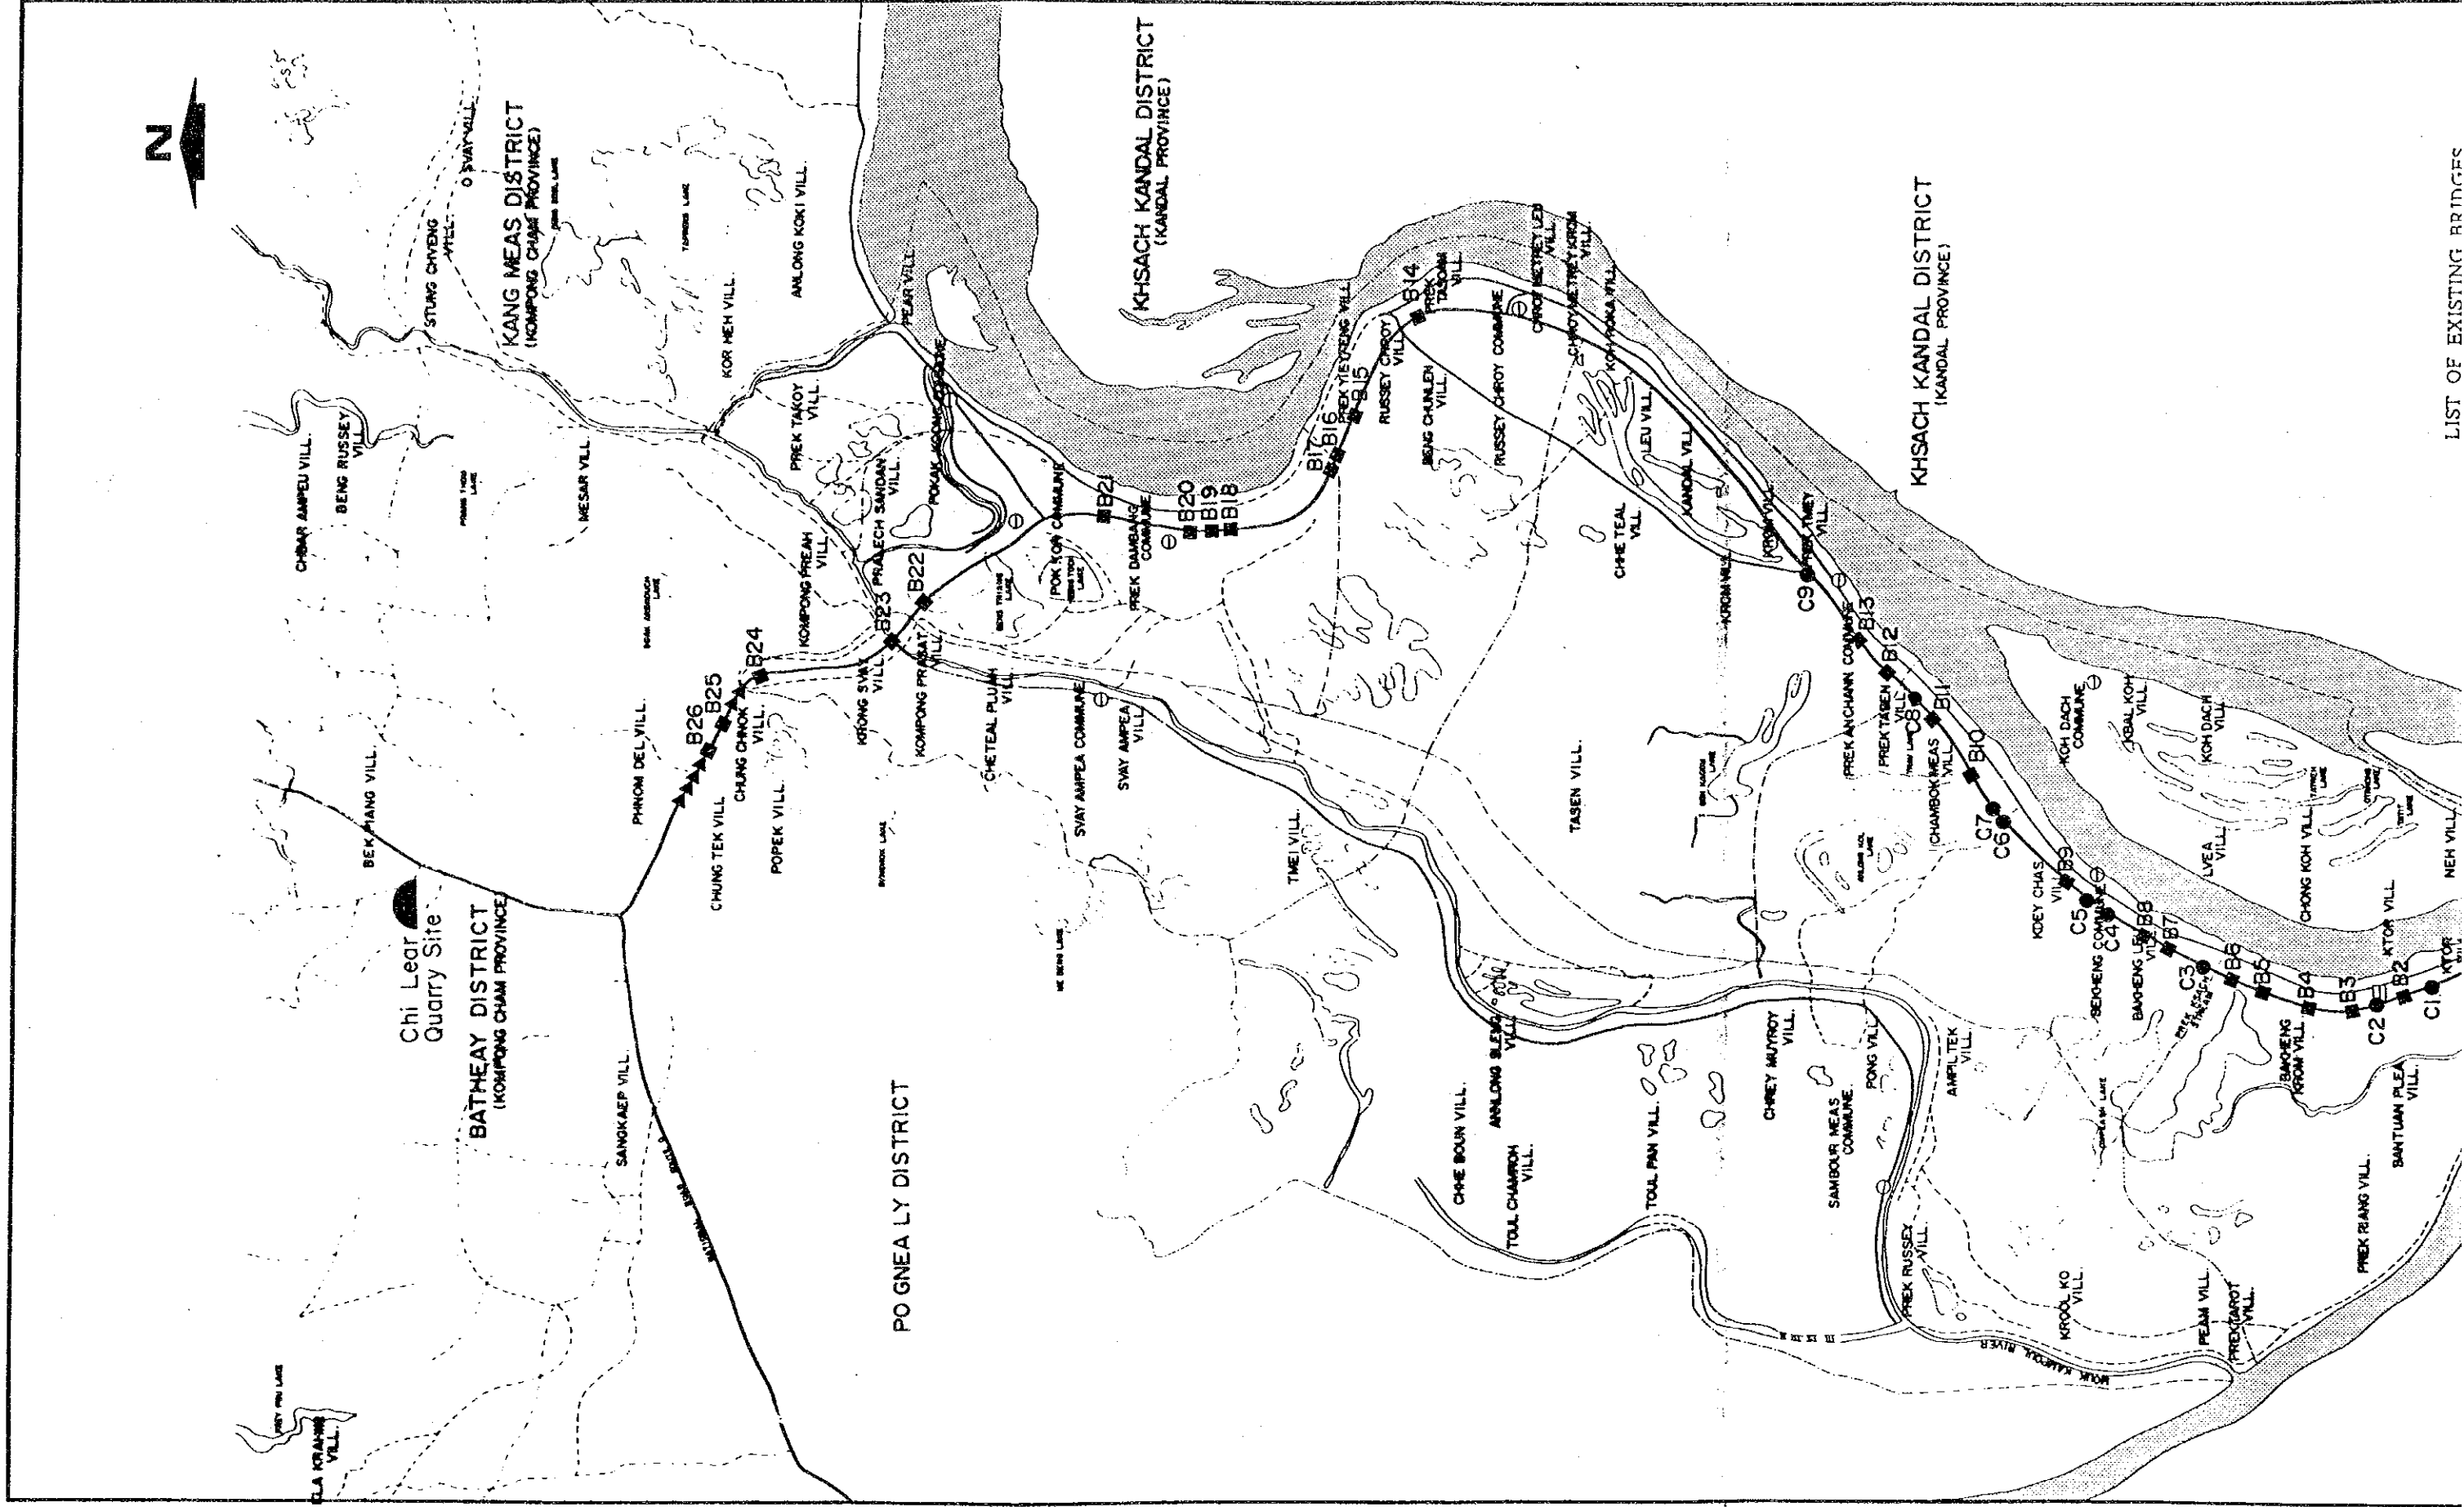
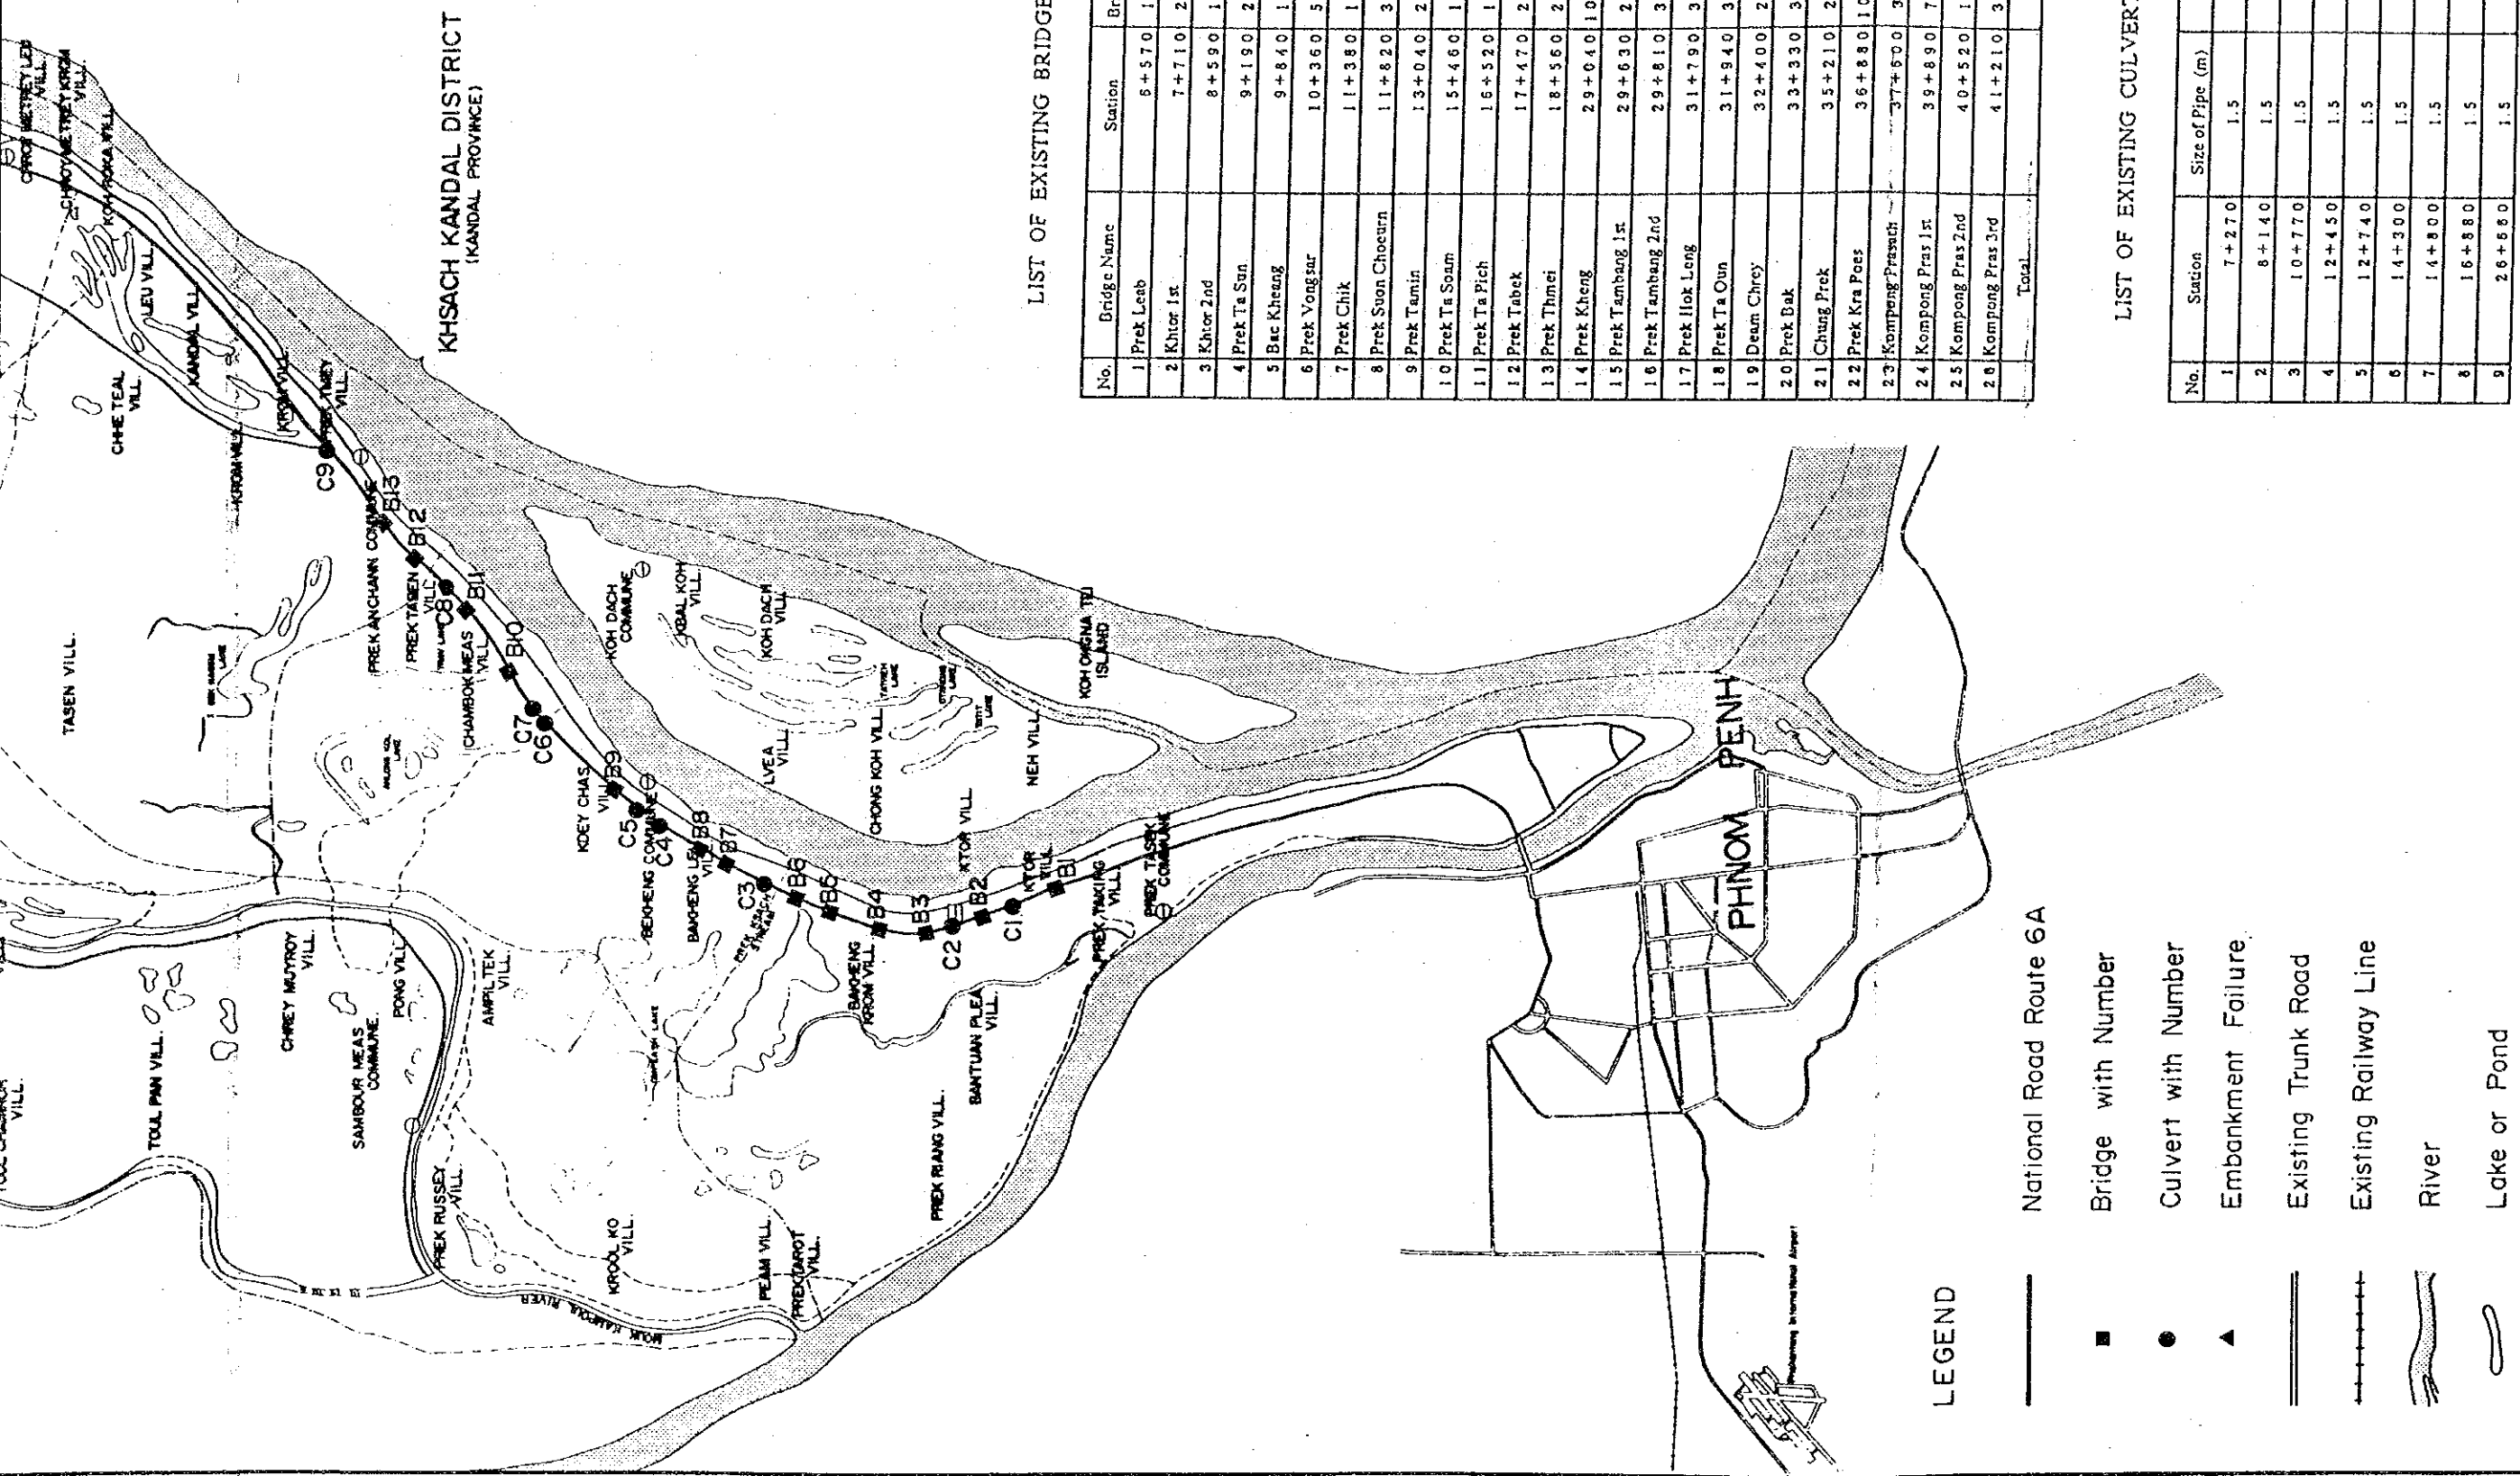
Figure 3.2 Locations of Existing Bridges, Culverts and Major Embankment Failures

The locations of existing bridges, culverts and major embankment damages are shown on Figure 3.2.
