THE ADDITIONAL STUDY ON
COASTAL PROTECTION AND PORT IMPROVEMENT
IN THE COOK ISLANDS

FINAL REPORT

SEPTEMBER 1994

PACIFIC CONSULTANTS INTERNATIONAL
THE OVERSEAS COASTAL AREA DEVELOPMENT INSTITUTE OF JAPAN

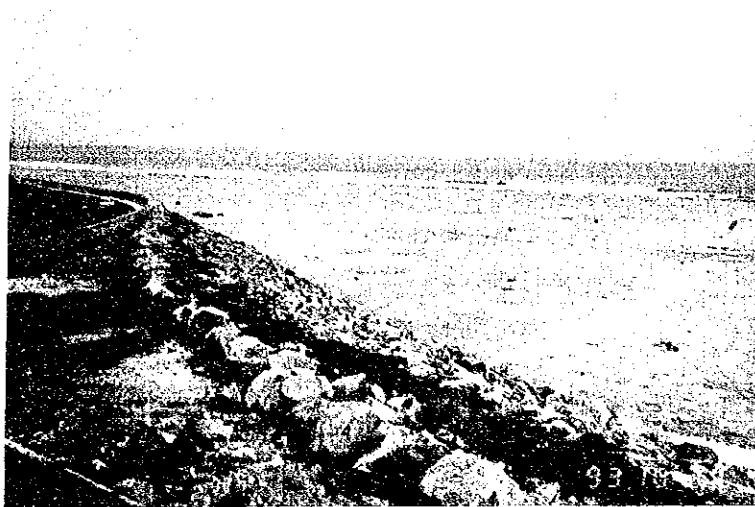
The lagoon is rather narrow, about 120 m at the narrowest. The lagoon is slightly deeper when compared with the other lagoon of the northern coast. Large, but not many, coral boulders are studded in the lagoon. The coast is composed of coral pebbles, cobbles and small boulders. (See Photos 3-1, 3-2.)

Photo 3-1 Lagoon near the western end of the runway.

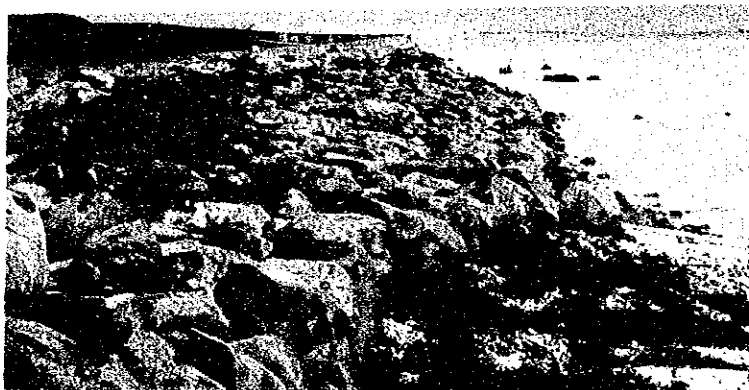
Photo 3-2 Coral fragment beach at the western end of the runway and the temporary revetment with amour rocks.

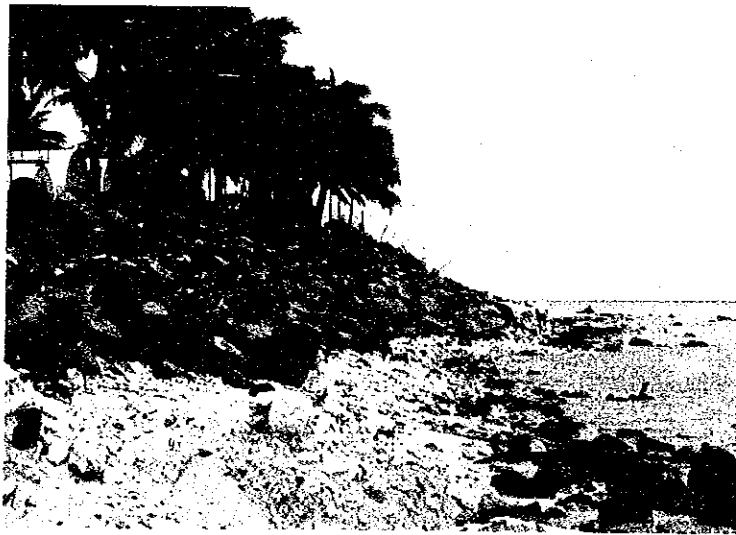
The coast is made of coral boulders. The lagoon is rather narrow (approximately 80 m to 150 m) and shallow. The slope of the coral boulder coast is about 1:2 to 1:5. (See Photos 3-5, 3-6.)

Photo 3-5 Shore protection for the fuel depots.

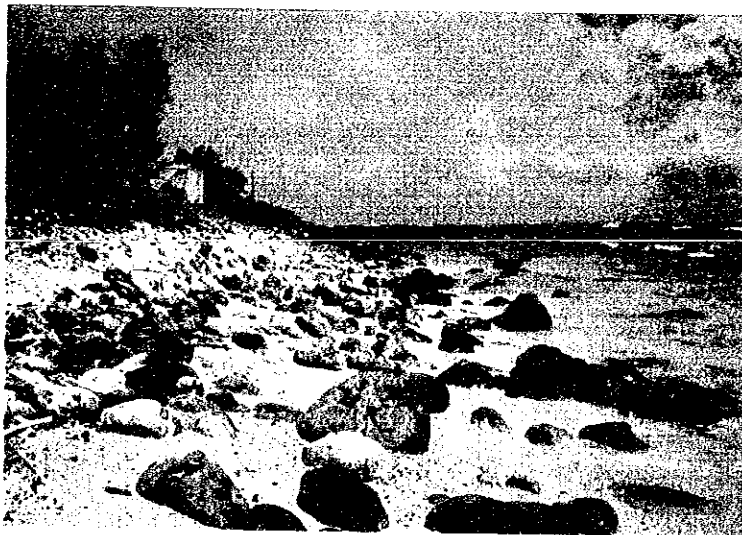
Photo 3-6 Coral boulder shore near the cemetery.

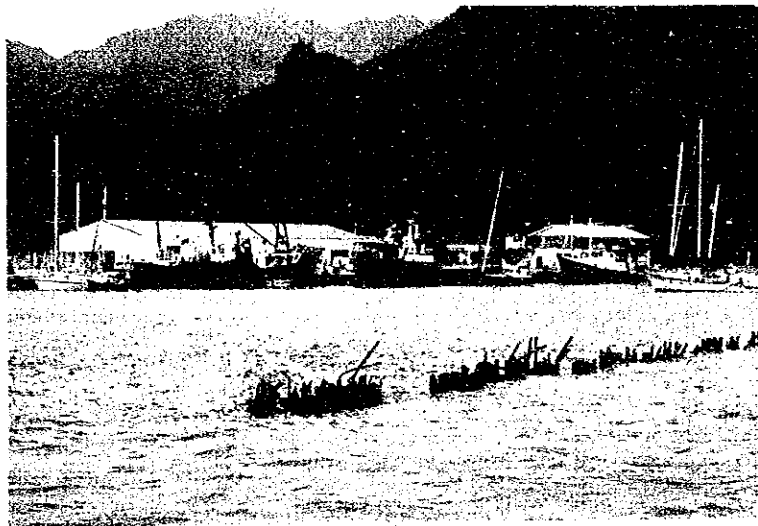
The port accommodates ocean liners up to 3,000 DWT, and leisure boats. The use by both the commercial ships and leisure boats have the port congested. As accidents took place, the Cook Islands Government intends to accommodate leisure boats at Avarua by constructing there a small yacht basin. (See Photo 3-8.)

Photo 3-8 The port basin of Avatiu Port with several leisure boats and commercial ships.

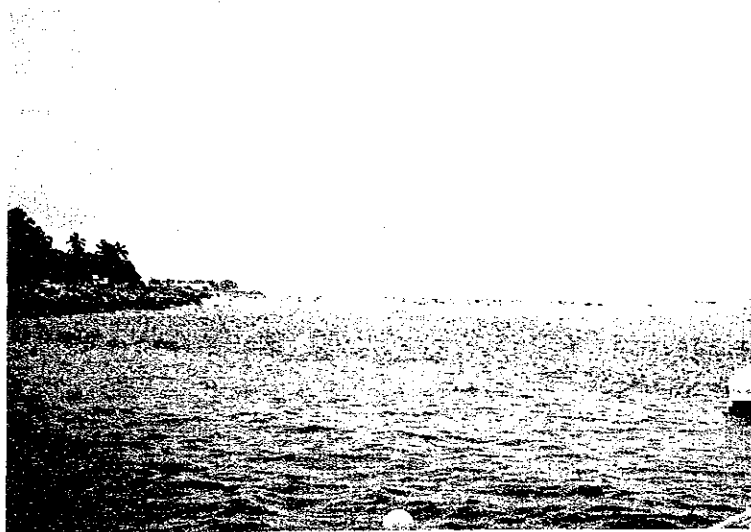
In front of the coast, shallow lagoon is spreading between Avatiu and Avarua. The width of the lagoon is approximately from 100 m to 210 m. The lagoon bed is mainly composed of coral boulders. At the reef edge (algal rim in geological terms), beach rock is formed. The lagoon bed is almost flat at the elevation of -0.20 m MSL. Many coral boulders from approximately 500 kg to 6 ton are studded in the lagoon which the strong waves thrown up onto the lagoon and less strong waves gradually carried them forward to the coast. (See Photos 3-11, 3-12.)

Photo 3-11 Overall view of the lagoon between Avarua and Avatiu.

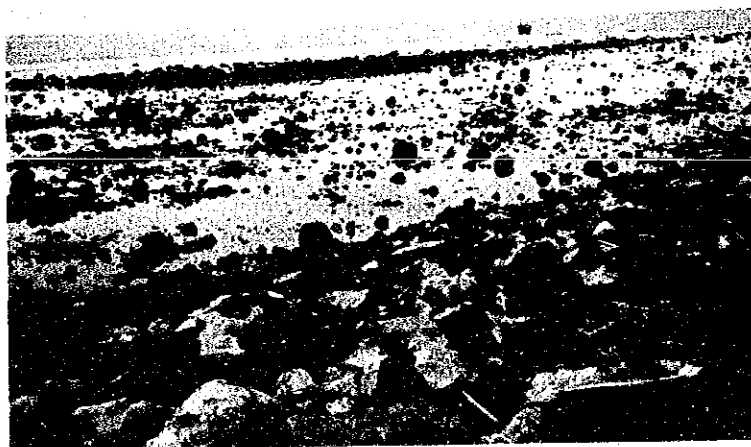
Photo 3-12 Coral boulders studded on the lagoon between Avarua and Avatiu.

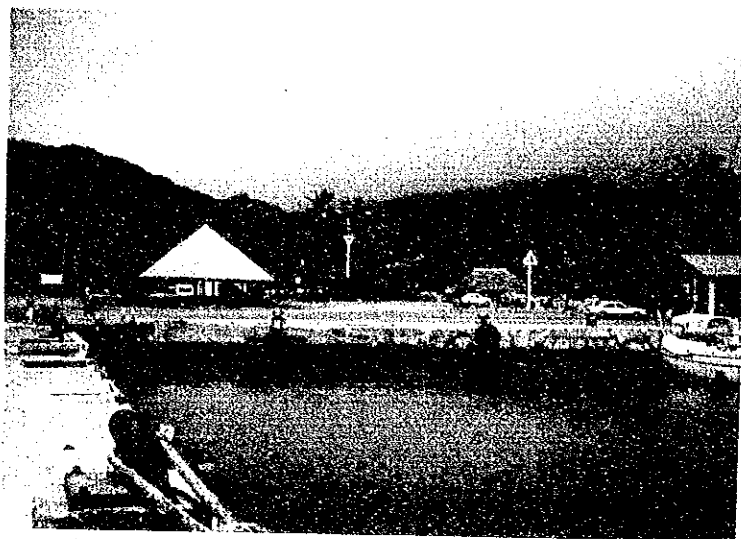
the highest point). The road bank is composed of coral boulders. (See Photos 3-13, 3-14.)

Photo 3-13 The coastal road at Avatiu referred to the sea surface.

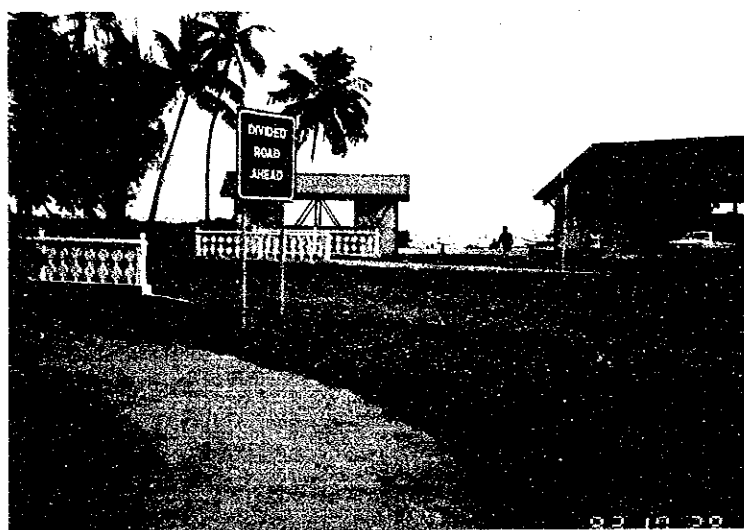
Photo 3-14 The coastal road at Avarua referred to the sea surface.

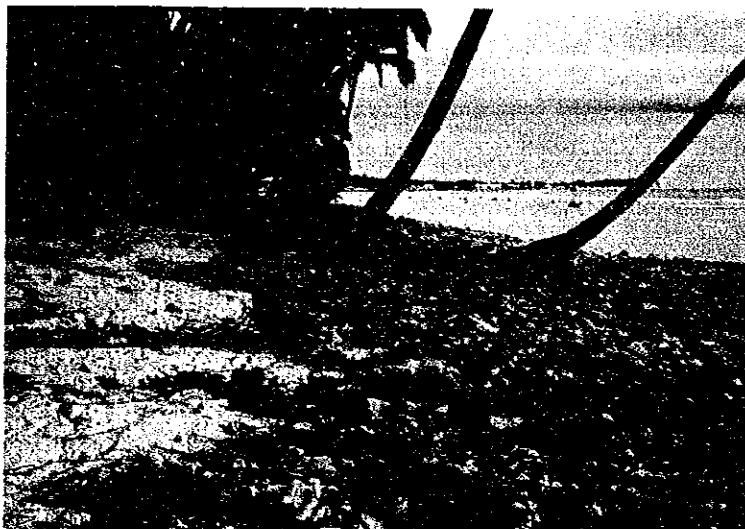
The coast has relatively narrow and shallow lagoon. The coast is mainly composed of coral pebbles and fragments. The natural slope is gentle about 1:5. A few large coral boulders are studded in the lagoon. Hurricane waves were supposedly large and strong enough so that large coral rocks were thrown onto the shore. (See Photos 3-17, 3-18.)

Photo 3-17 Coral fragment and boulder beach at Pue.

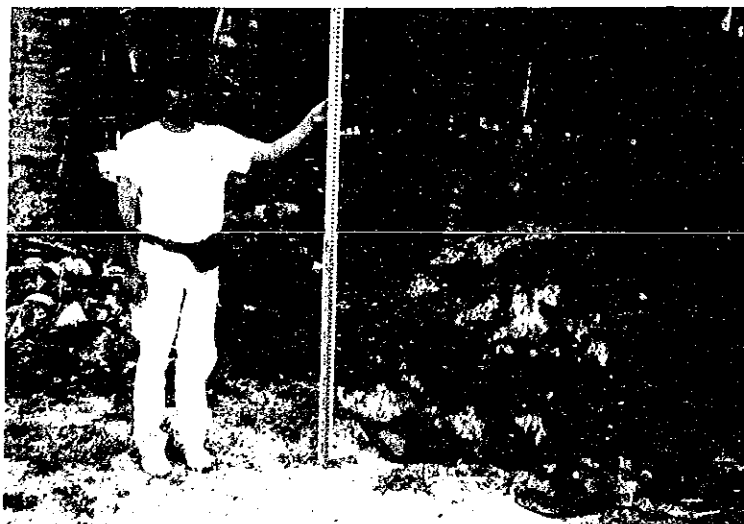
Photo 3-18 A coral boulder in the coconut tree area near the Health Department premises.

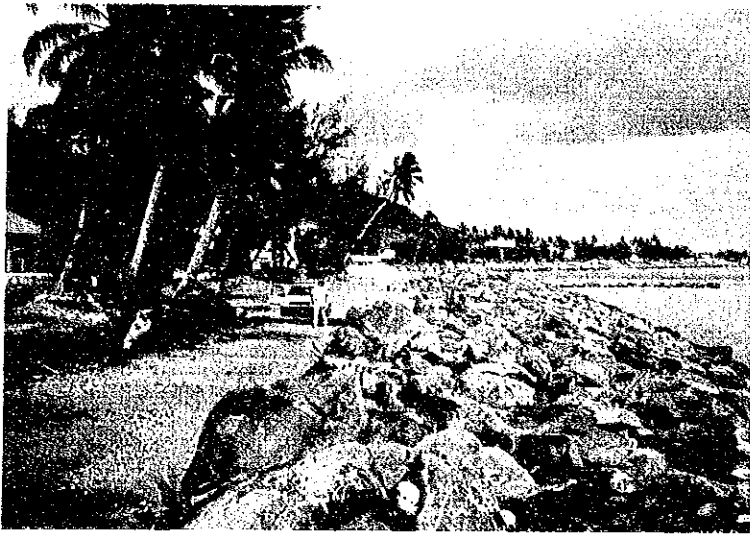
About 300 m from Avarua Port, the coast is protected with armour rocks which were removed from the breakwaters of Avarua Port. (See Photo 3-19.)

Photo 3-19 The temporary coastal protection by use of armor rocks removed from the Avarua breakwaters.

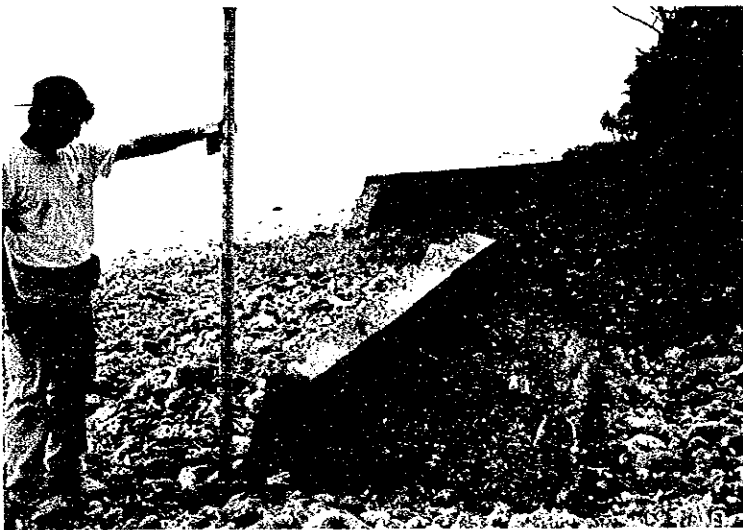
The Health Department buildings are built closer to the coast. The existing low seawall is almost covered with coral boulders, which suggests that high waves ran up over the seawall and intruded the department buildings. (See Photo 3-20.)

Photo 3-20 The seawall at Health Department premises.

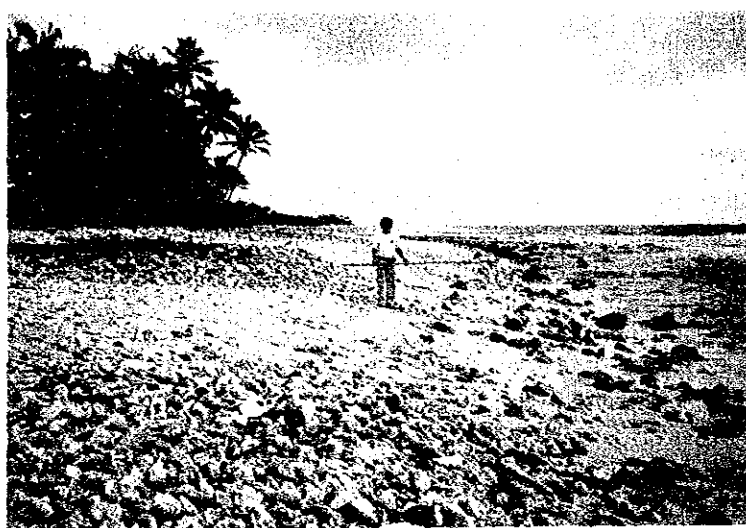
The lagoon is relatively narrow and shallow. The coast is covered with sands and coral fragments and boulders, i.e. transition from the coral boulder beach to sandy beach. The beach slope is tender and seems stable even though the coast faces the prevailing winds. (See Photo 3-23.)

Photo 3-23 Coral fragment beach at Ngatangia Coast.

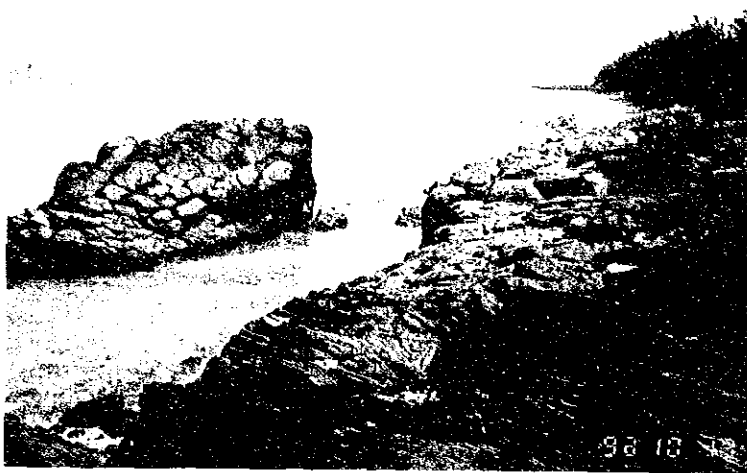
The cape of Black Rock is formed of basalt which is the base rock of Rarotonga Island. This is the only point where the base rock is exposed on the coast. Except this point, the coast around Black Rock is made of sand and beach rock. The lagoon is deep and wide. (See Photos 3-34, 3-35.)

Photo 3-34 Black Rock.

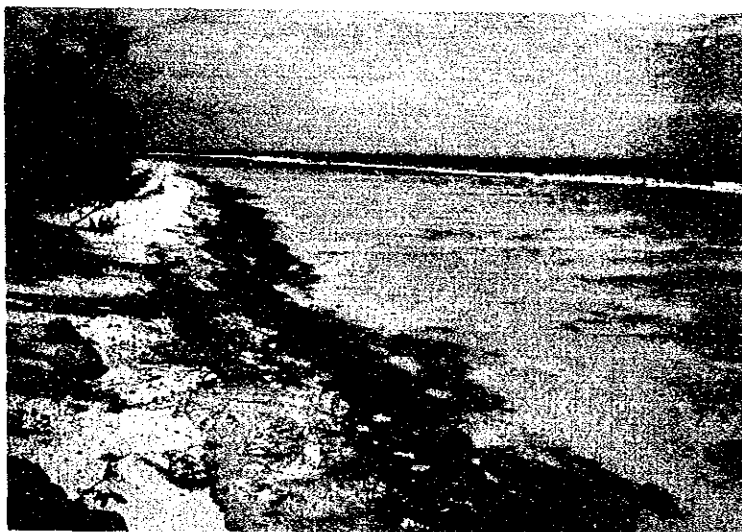
Photo 3-35 Beach with beach rock, taken from the Black Rock.
