REPUBLIC OF PALAU

PRESENT CONDITION SURVEY OF THE

KOROR - BABELTHUAP BRIDGE

FEBRUARY, 1990

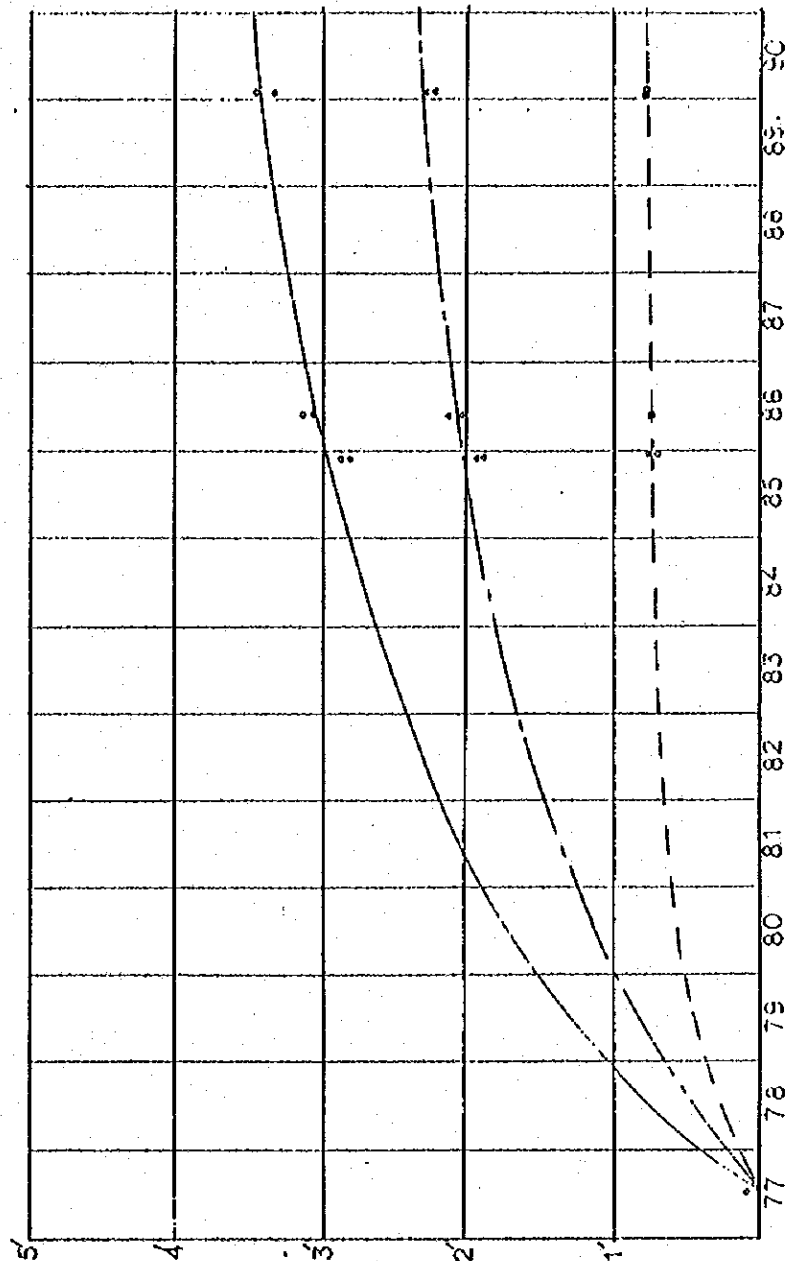
The cause of the sagging of the main beam at the central part of the bridge can be considered to be the creep deformation of the main beam at midspan itself.

Changes in main beam deflections after construction

- Central hinge ( the Koror Island side )
- Central hinge ( the Babelthuap Island side )
- ▲ 25 cm from the central hinge ( the K-Island side )
- △ 25 cm from the central hinge ( the B-Island side )
- 60 cm from the central hinge ( the K-Island side )
- 60 cm from the central hinge ( the B-Island side )
