BASIC DESIGN STUDY REPORT
ON
THE PROJECT FOR THE CONSTRUCTION OF
MULTIPURPOSE CYCLONE SHELTERS (II)
IN
THE PEOPLE'S REPUBLIC OF BANGLADESH

(APPENDIX 6 RESULTS OF SITE CONDITIONS SURVEY
APPENDIX 7 RESULTS OF NATURAL CONDITIONS SURVEY)

JUNE , 1994

JAPAN ENGINEERING CONSULTANTS CO., LTD.

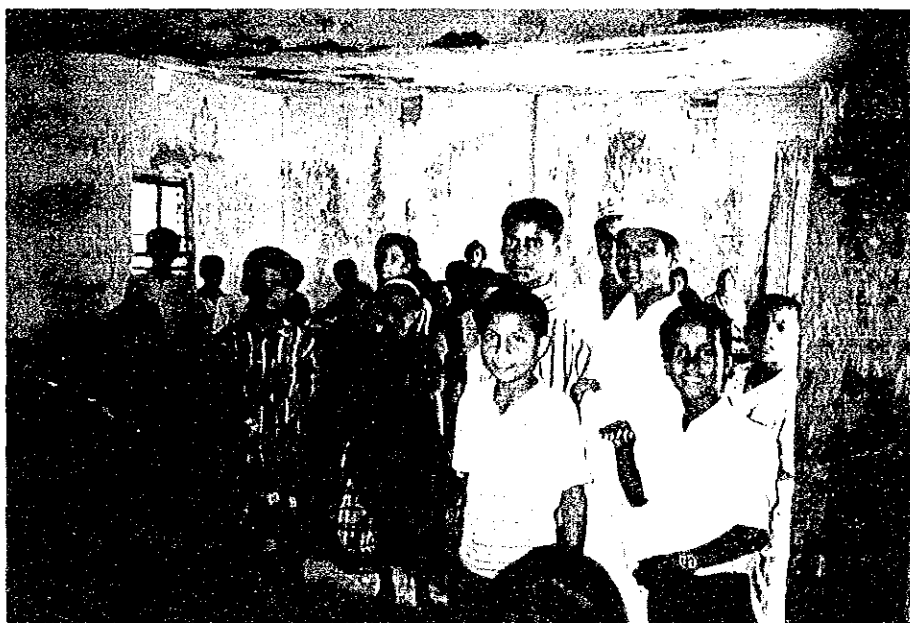
15) Maintenance of Building: Place; *Many cracks on the ceiling, walls and pillars. Roof (Leaking of rain?) - Pillar (Exfoliate of concrete?), Wall (Color painting?), Window (Window door fitting?),*

School building has been severely deteriorated.

Current Conditions
of A Classroom

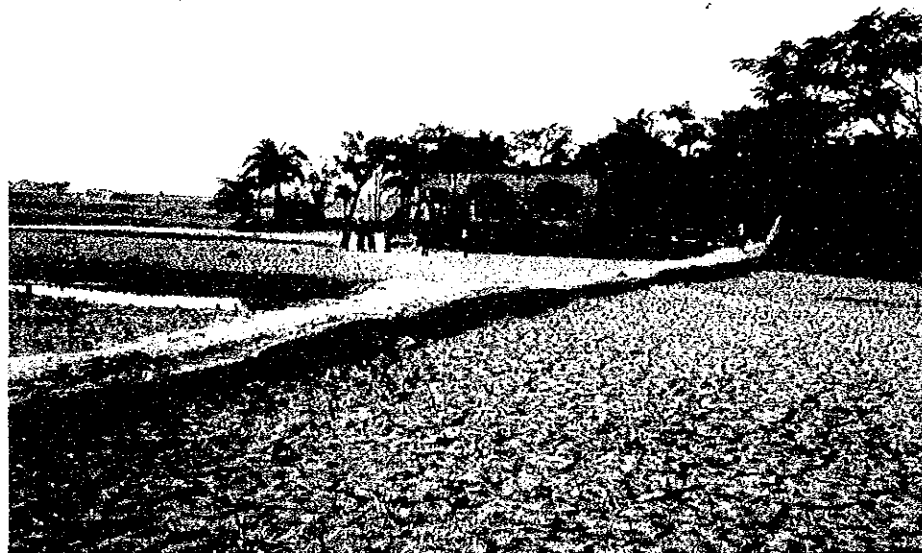
- 2) Road Conditions *Bazar Road*
 - Kind of Pavement: *Earth*, Gravel, *Brick*, Asphalt, Concrete,
 - Condition of Pavement: Good, Not so good, *Bad*,
 - Road Width : *Brick: 2.8 ~ 3 m*
Earth: 1.2 m

- Passable Vehicle: Motor cycle, *Riksha*, Sedan, *Jeep*, *Truck* (— ton)
 - Necessity for Repair of Road: *Yes*, No,
 - Necessity for Repair of Bridges or Culverts: *Yes*, No,

Road Conditions
near the Site

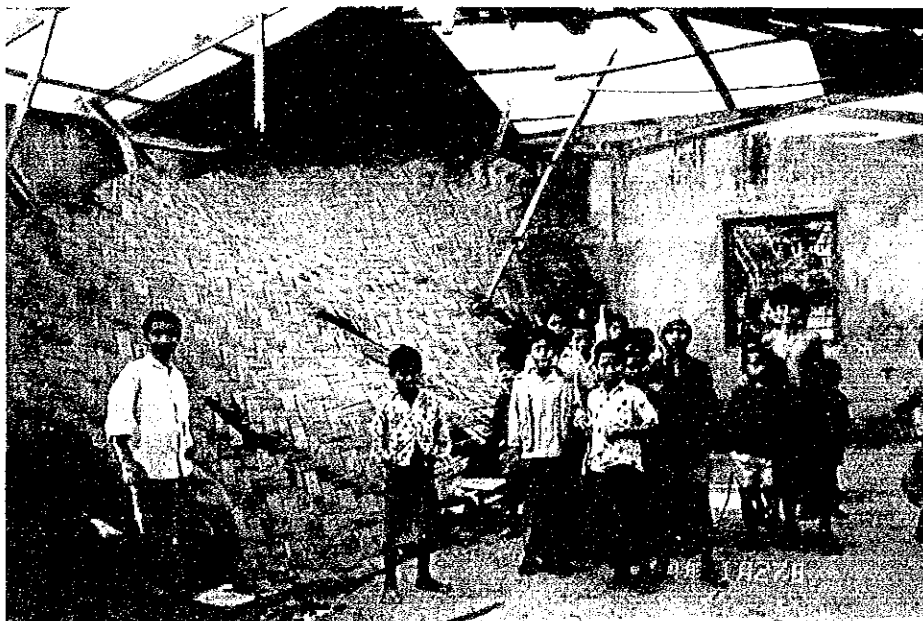
15) Maintenance of Building: Place; *Roof - blew off by 1991 cyclone.*
 Roof(Leaking of rain?), Pillar(Exfoliate, of concrete?), Wall(Color painting?),
Almost abandoned building Window(Window door fitting?),

Current Conditions
of A Classroom

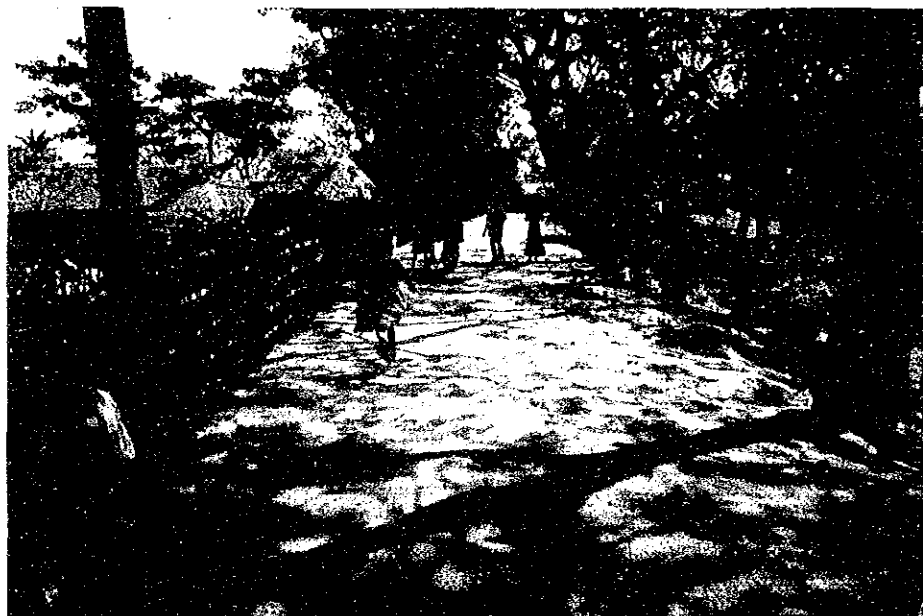
- Condition of Pavement: Good, Not so good, Bad,
 - Road Width : ^{Brick 3m 4m} ~~Earth 3m 3.5m~~
 - Passable Vehicle: Motor cycle, Rikisha, Sedan, Jeep, Truck (— ton)

- Necessity for Repair of Road: Yes, No,
 - Necessity for Repair of Bridges or Culverts: Yes, No,
6. Conditions of School
 - 1) Name of Landowner : Government

Road Conditions
near the Site

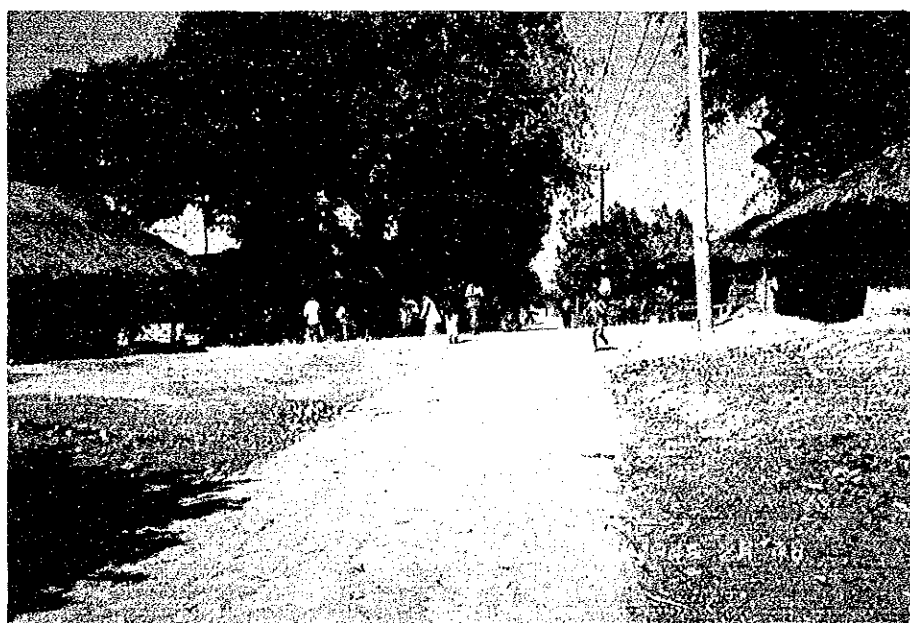
- Condition of Pavement: Good, Not so good, ~~Bad~~,
 - Road Width : 23 ~ 3.5 m
 - Passable Vehicle: Motor cycle, Rikisha, Sedan, ~~Jeep~~, ~~Truck~~ (— ton)

- Necessity for Repair of Road: Yes, No,
 - Necessity for Repair of Bridges or Culverts: Yes, ~~No~~,
6. Conditions of School
 - 1) Name of Landowner : Government

Road Conditions
near the Site

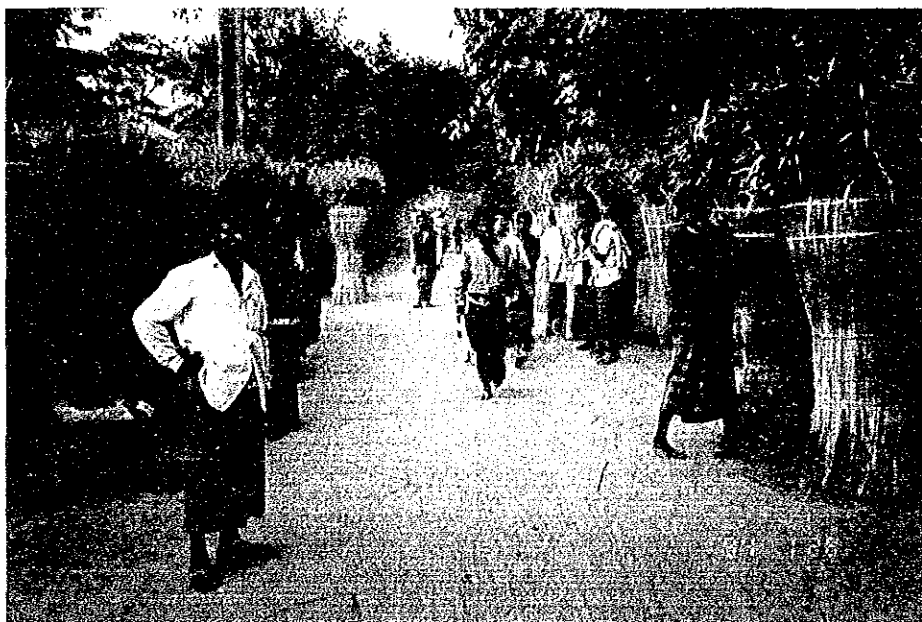
Road Conditions
near the Site

5. Accessibility : Kaman, Head Master of School
 - 1) Nearest Station, Port, (Main Road: Chittagong & Cox's Bazar Road) Distance: 3.6 km
 - 2) Road Conditions

- Kind of Pavement: Earth, Gravel, Brick, Asphalt, Concrete,
 - Condition of Pavement: Good, Not so good, Bad,
 - Road Width : ≈ 4.0 m (3.1+0.9)
 - Passable Vehicle: Motor cycle, Rikisha, Sedan, Jeep, Truck (— ton)

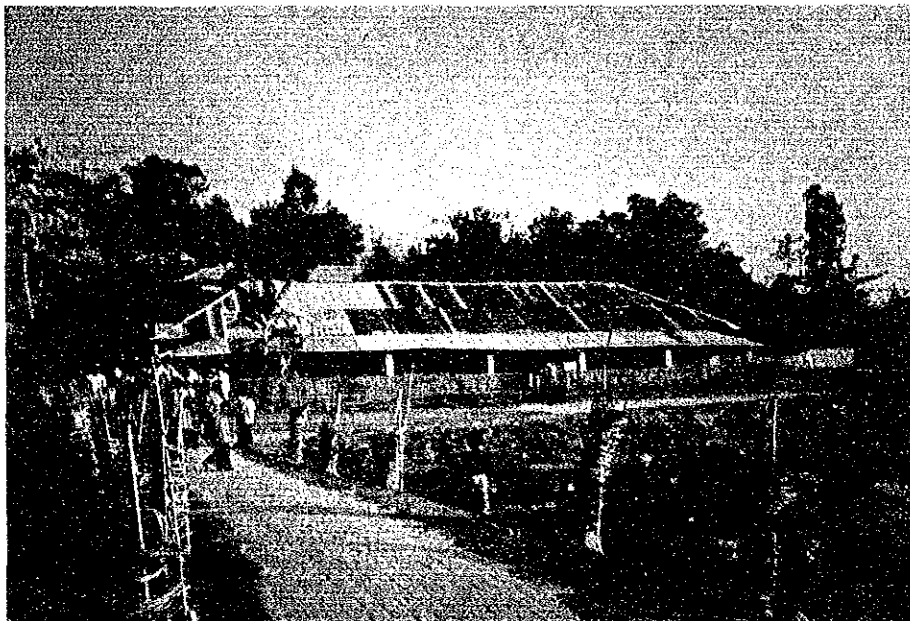
Overall View of
the School Site

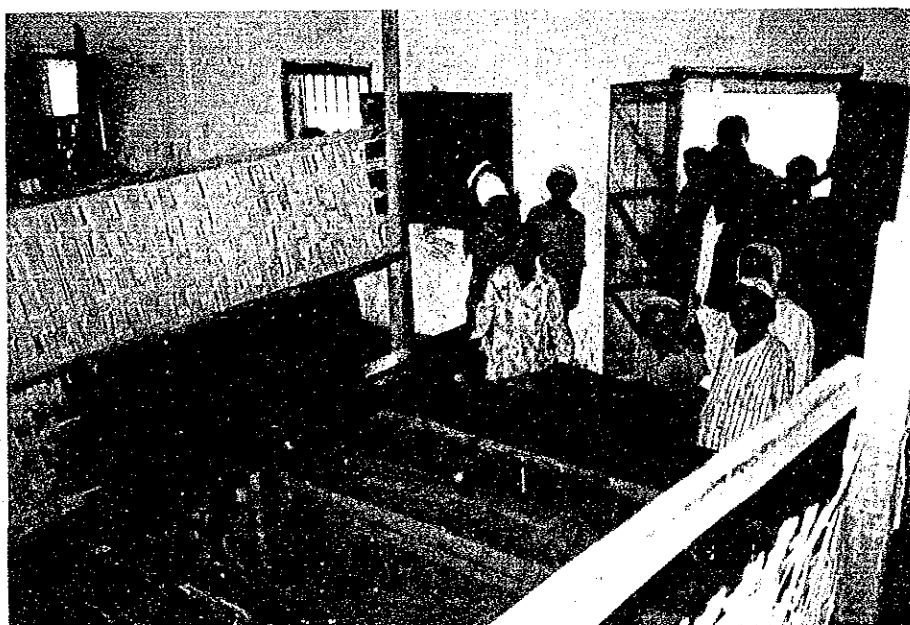
Current Conditions
of A Classroom

15) Maintenance of Building: Place; Roof(^{No leakage}Leaking of rain?), Pillar(^{No exfoliation}Exfoliate of concrete?), Wall(^{Small cracks - Painted white}Color painting?), Window(^{ill-fitted}door fitting?),

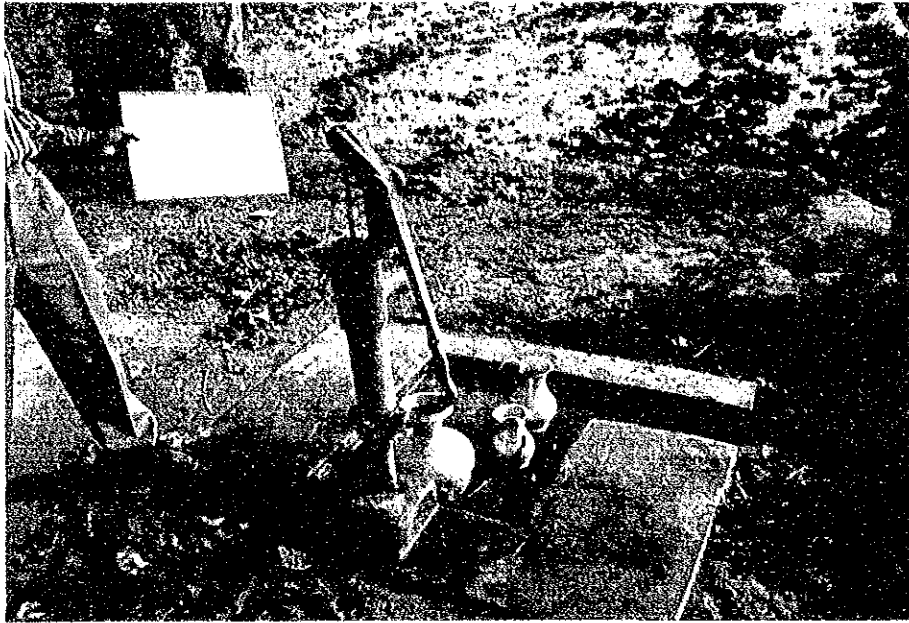
Auxiliary Facilities
of the School Building

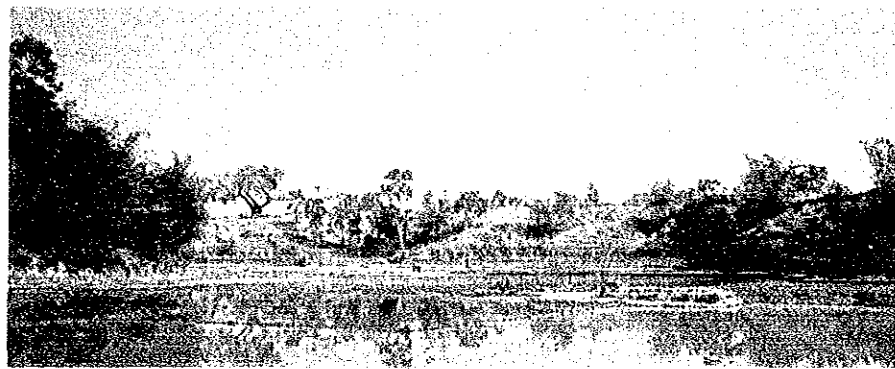
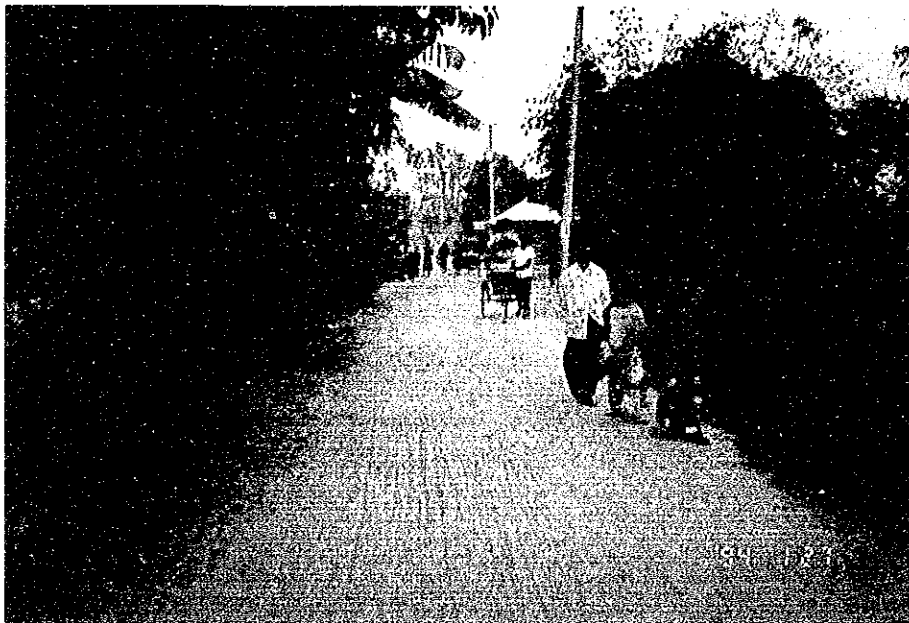
Road Conditions
near the Site

- 2) Road Conditions
Bazar Road
 - Kind of Pavement: Earth, Gravel, Brick, Asphalt, Concrete,
 - Condition of Pavement: Good, Not so good, Bad, (*partially*)

- Road Width : *2.0* m
 - Passable Vehicle: Motor cycle, Rikisha, Sedan, Jeep, Truck(— ton)
 - Necessity for Repair of Road: Yes, No,
 - Necessity for Repair of Bridges or Culverts: Yes, No

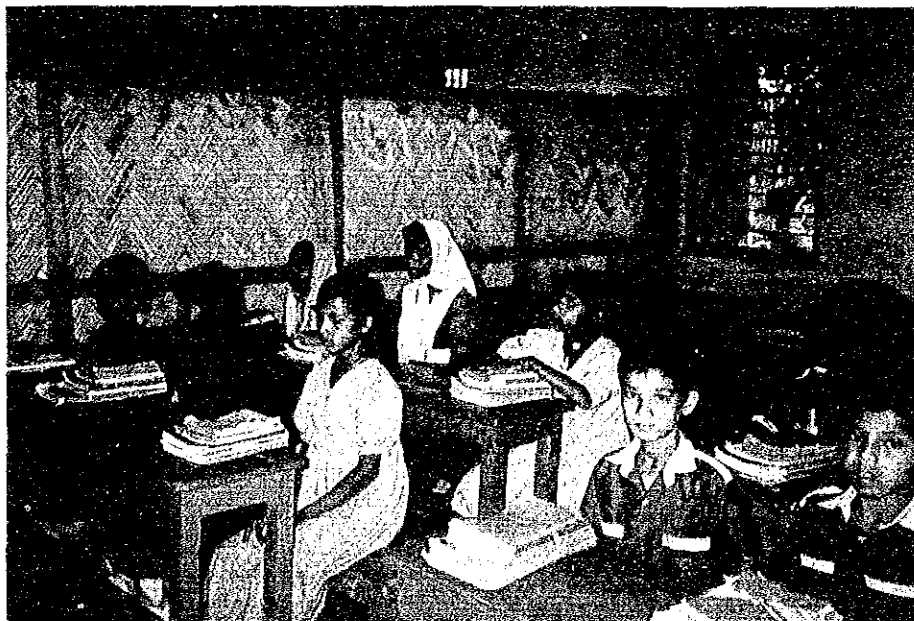
Current Conditions of A Classroom

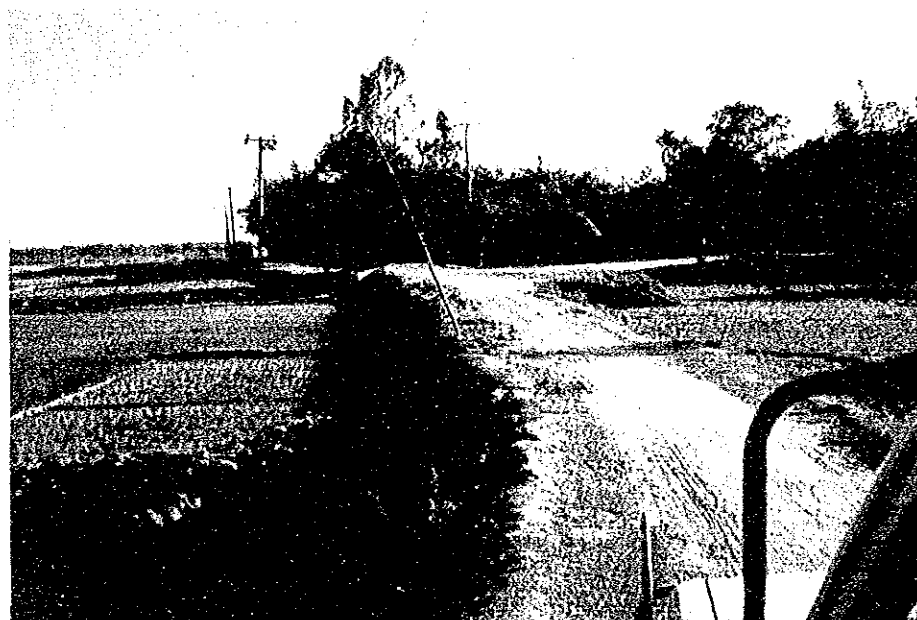
Road Conditions
near the Site

- 2) Road Conditions
 - Kind of Pavement: Earth, Gravel, Brick, Asphalt, Concrete,
 - Condition of Pavement: Good, Not so good, Bad,
 - Road Width: 2.5 m Earth Road Width: 2.0m

- Passable Vehicle: Motor cycle, Rikisha, Sedan, Jeep Truck(— ton)
 - Necessity for Repair of Road: Yes, No,
 - Necessity for Repair of Bridges or Culverts: Yes, No,

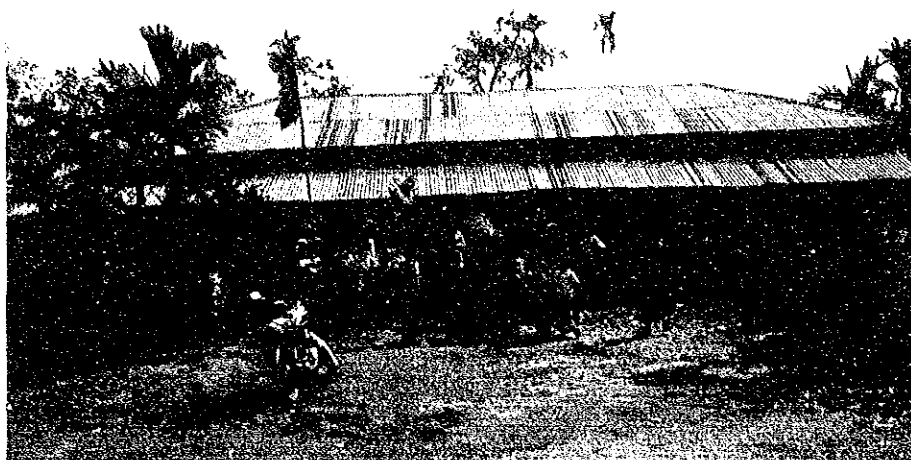
Overall View of
the School Site

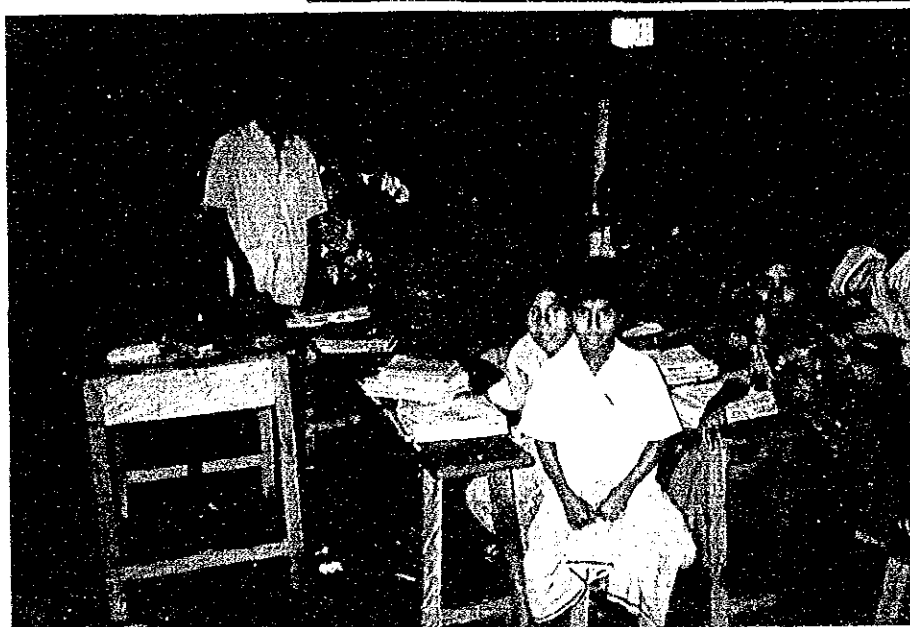
Current Conditions
of A Classroom
